12<sup>th</sup> July 2021

A3516.MW.MP

**RE: A3516 - PW – Mindel House – External wall temporary restraint.**

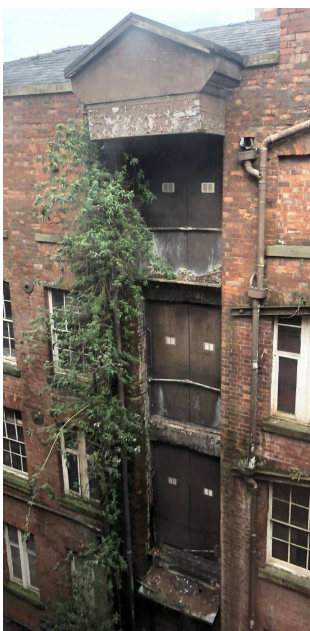
Image 1

Following previous site surveys and meetings at the Mindel House building, we have raised concerns regarding the structural stability of part of the external elevation which faces the Bloom St building. There has been considerable structural movement to the central area of the wall, which is adjacent to the original goods hoist area (see image 1 below). The wall appears to have dropped in level and there is significant movement to the floor structure adjoining at every level (image 3). The timber construction around this area has suffered from rot, due to constant leaking from surface water drainage (and possibly foul in the past). As can be seen on the images below there is also considerable vegetation growth growing out of the masonry to this area.

The movement is concentrated to the masonry return to the goods hoist, which also has windows to the other side. The floors need complete removal and replacement to this area and in doing so the masonry may become unstable during the removal and re-construction, due to both the condition of the masonry and lack of restraint (the hoist and window openings create a tall 'pillar' of unrestrained masonry). We cannot guarantee the wall, and therefore likely further structure to this area, will be stable if any of the current floors are removed.

It is our recommendation temporary restraint is installed, to maintain the stability of the wall while remedial works are carried out. Once the restraint is in place, and safe access enabled, the original damaged, rotten and unstable floor structure should be removed, to allow assessment of the remaining masonry in place. At this point it can be confirmed if further remedial works are required to the masonry. The foundations of the wall should also be exposed and inspected to confirm if the movement to the wall is historic or possibly ongoing.
