**Project Name:** HYDE ROAD MANCHESTER

**Project Date:** 28/05/2021

**Inspection Standard:** MSCC5 Sewers & Drainage GB (SRM5 Scoring)

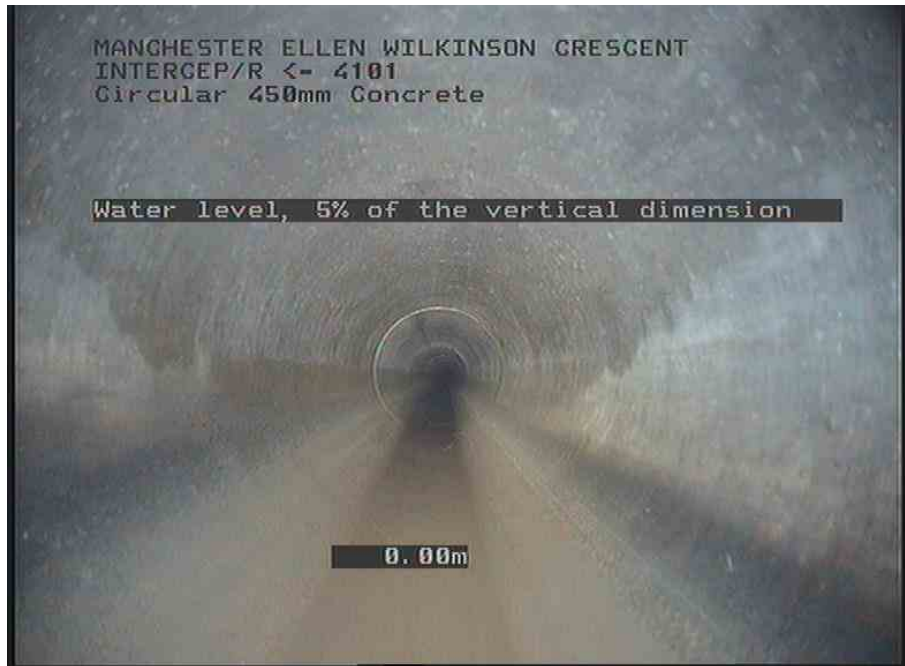
INTERCEP\_RX\_194de98b-e51d-4379-93d6-334079b5f439\_20210528\_084439\_283.jpg,  
00:00:04, 0.00 m  
Water level, 5% of the vertical dimension

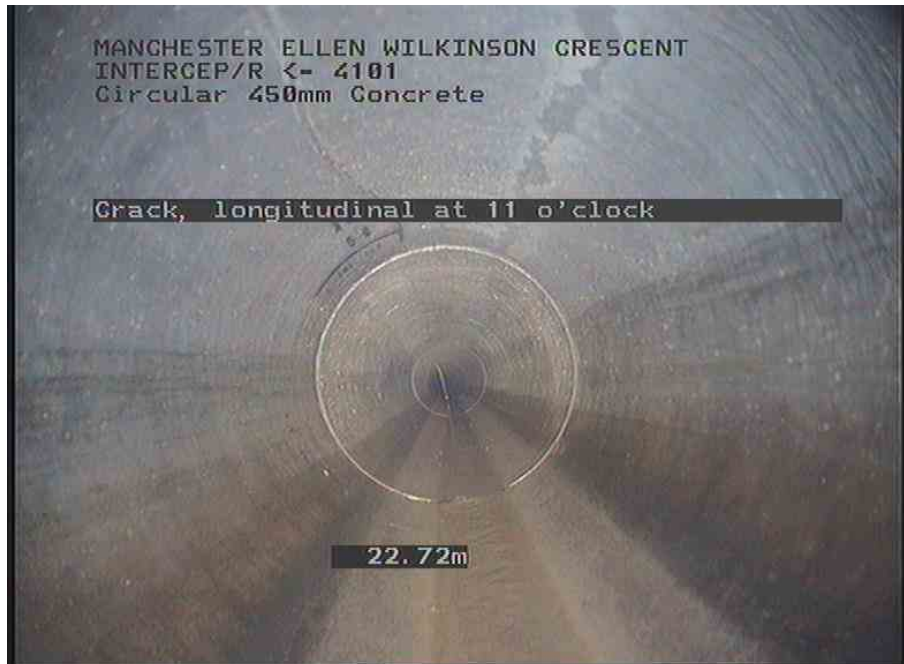
<table><tr><th>Position [m]</th><th>Code</th><th>Observation</th><th>Grade</th></tr><tr><td>22.72</td><td>CL</td><td>Crack, longitudinal at 11 o'clock</td><td>2 / 2</td></tr></table>

INTERCEP\_RX\_bf316faa-fd0a-474b-b224-6eec861e4035\_20210528\_084719\_303.jpg,  
00:02:21, 22.72 m  
Crack, longitudinal at 11 o'clock

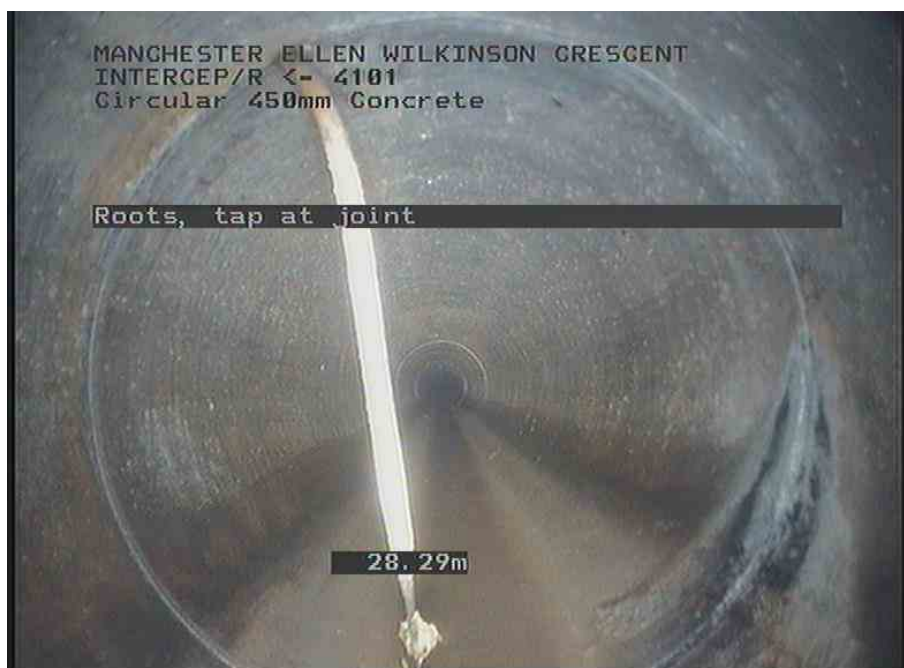
<table><tr><th>Position [m]</th><th>Code</th><th>Observation</th><th>Grade</th></tr><tr><td>28.29</td><td>RTJ</td><td>Roots, tap at joint</td><td>4</td></tr></table>

INTERCEP\_RX\_c812ce8b-762b-461e-a7ab-e9543cf060c3\_20210528\_084754\_115.jpg,  
00:02:53, 28.29 m  
Roots, tap at joint

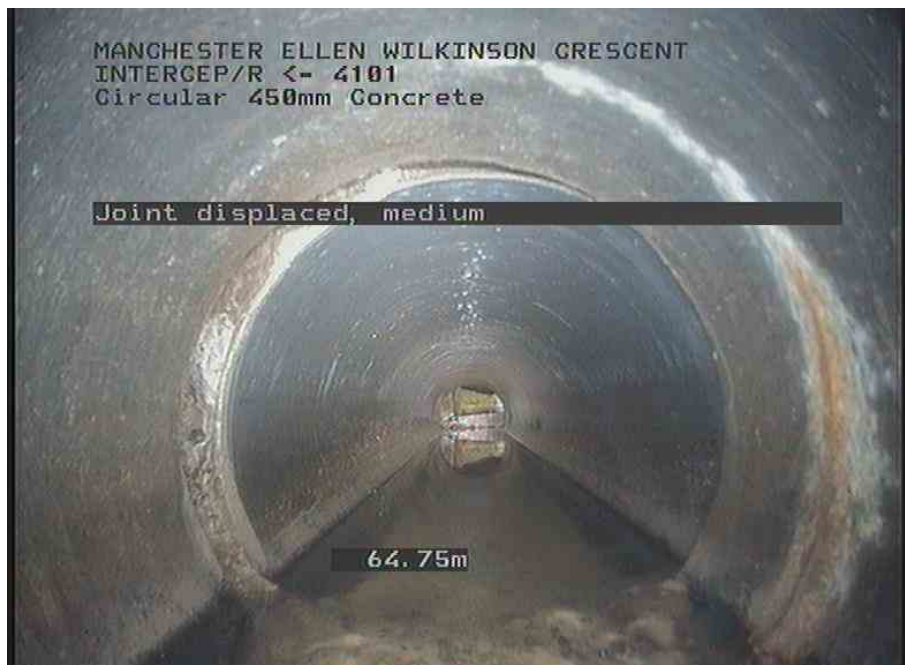
<table><tr><th>Position [m]</th><th>Code</th><th>Observation</th><th>Grade</th></tr><tr><td>64.75</td><td>DEZ</td><td>Attached deposits, other from 5 o'clock to 7 o'clock, 10% cross-sectional area loss: GROUT</td><td>3</td></tr><tr><td>64.75</td><td>JDM</td><td>Joint displaced, medium</td><td>1 / 3</td></tr></table>

INTERCEP\_RX\_1b64a4a2-ccde-4c70-92da-dc94153e0c3c\_20210528\_085145\_416.jpg,  
00:06:02, 64.75 m  
Joint displaced, medium

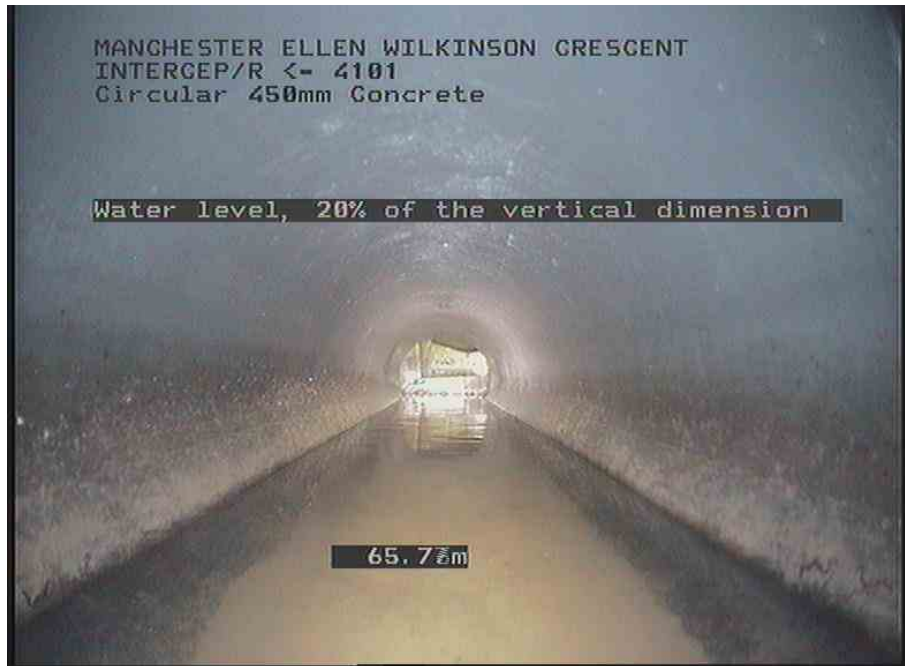
INTERCEP\_RX\_10a5e499-ca44-4d13-8560-51b7bd231790\_20210528\_085203\_547.jpg,  
00:06:17, 66.59 m  
Water level, 20% of the vertical dimension

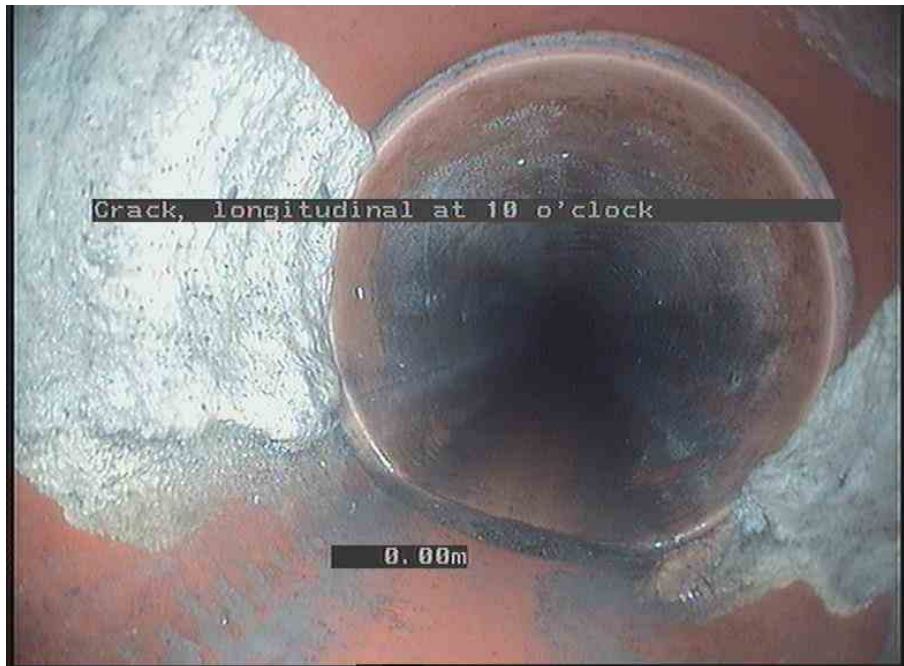
F1X\_d86d64c4-f1a9-4ede-8dd2-538740c4dd34\_20210528\_094751\_541.jpg, 00:00:08, 0.00 m  
Crack, longitudinal at 10 o'clock

| Section Rehab | | | | | | | | | | |
|---|---|---|---|---|---|---|---|---|---|---|
| | 0.00 | CL | Crack, longitudinal at 10 o'clock | | | 00:00:08 | | | 2 / 2 | |

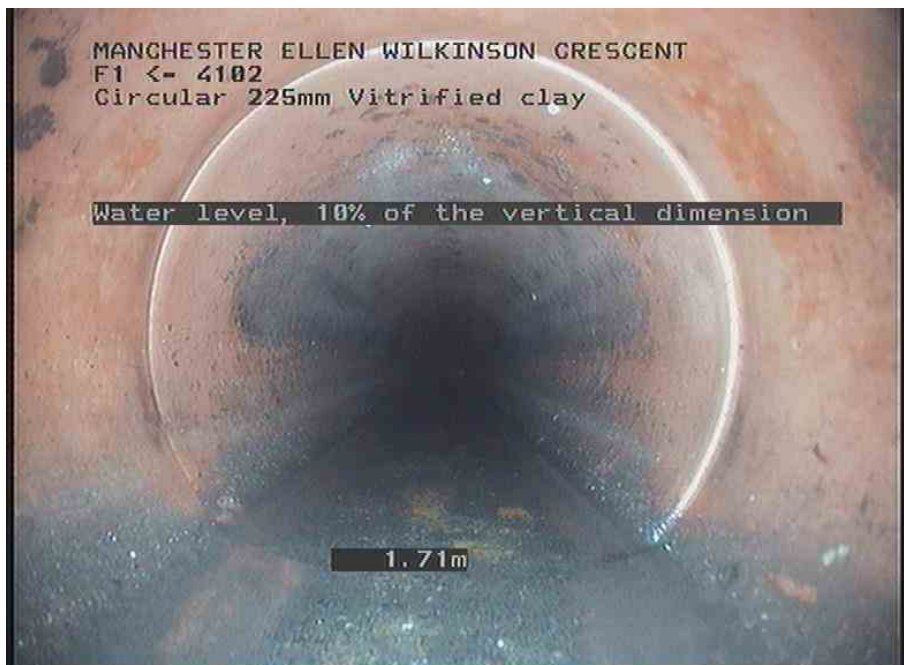
F1X\_dfbcb24-9a0d-4bdd-9c50-3772bae498c7\_20210528\_094826\_308.jpg, 00:00:43, 1.71 m  
Water level, 10% of the vertical dimension

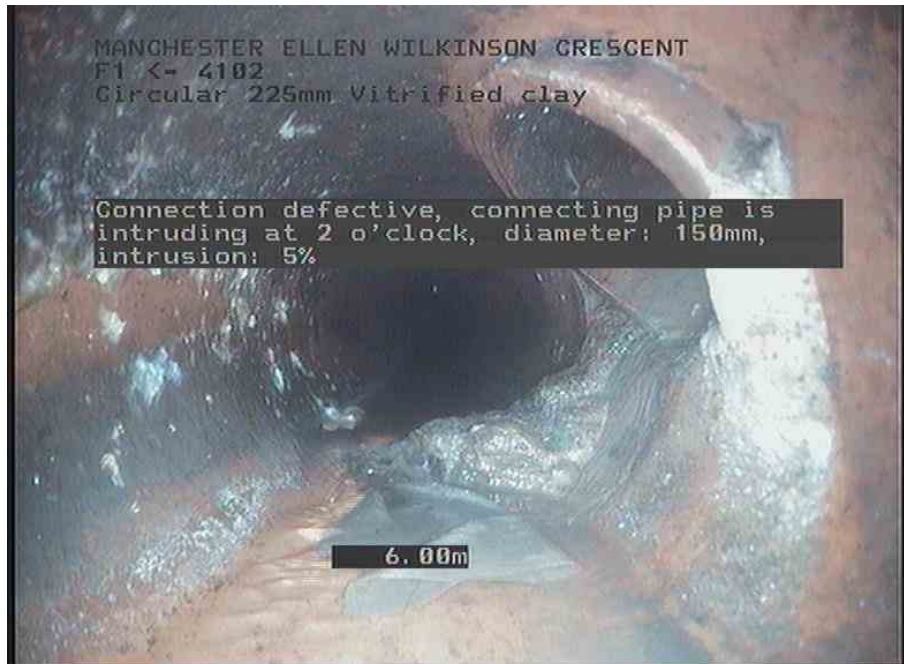
F1X\_c6ccb4a9-1e3b-463f-b38b-864e26e7da76\_20210528\_094927\_694.jpg, 00:01:28, 6.00 m  
Connection defective, connecting pipe is intruding at 2 o'clock, diameter: 150mm, intrusion: 5%

| Section Rehab | | | | | | | | | | |
|---|---|---|---|---|---|---|---|---|---|---|
| | 6.00 | CXI | Connection defective, connecting pipe is intruding at 2 o'clock, diameter: 150mm, intrusion: 5% | | | 00:01:28 | | | 3 | |

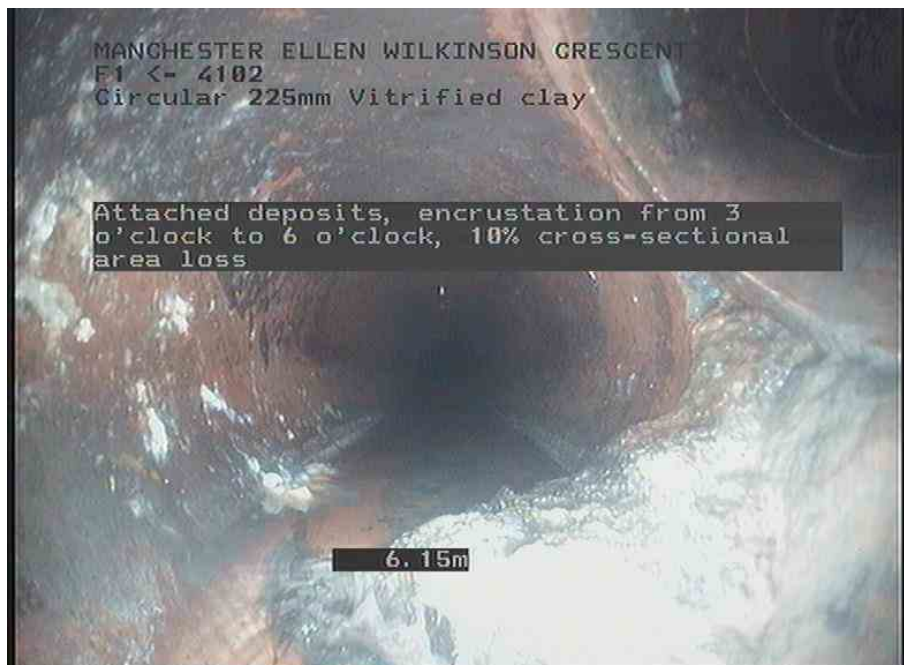
| Scale: 1:390 | Position [m] | Code | Observation | Grade |
|---|---|---|---|---|
| | 6.15 | DEE | Attached deposits, encrustation from 3 o'clock to 6 o'clock, 10% cross-sectional area loss | 3 |

F1X\_88f46f24-c831-48b2-8274-98e42e457bbe\_20210528\_094946\_561.jpg, 00:01:39, 6.15 m  
Attached deposits, encrustation from 3 o'clock to 6 o'clock, 10% cross-sectional area loss

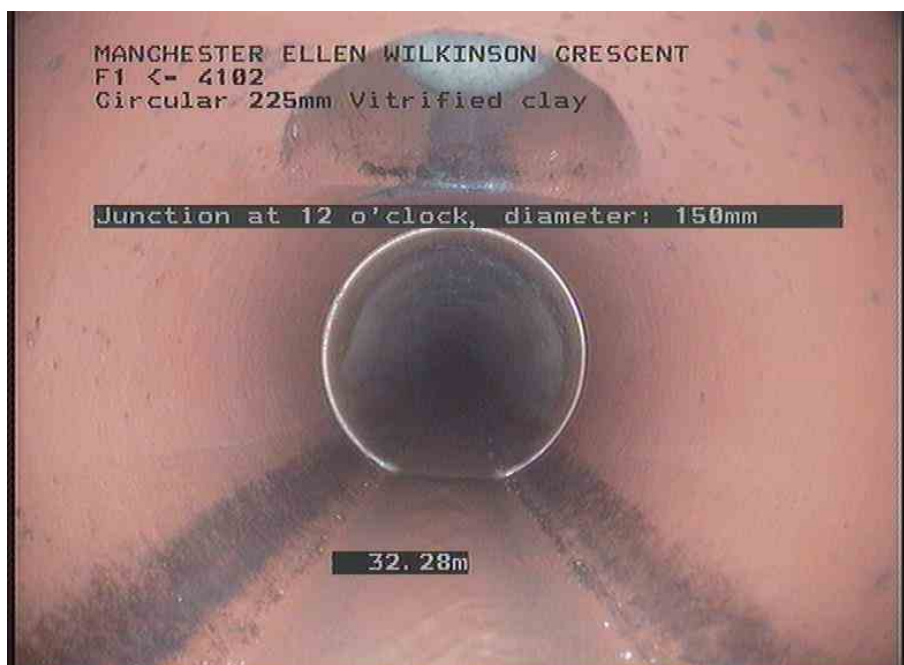
F1X\_6ed753d6-9658-445c-ae76-81d1c2599358\_20210528\_095332\_887.jpg, 00:05:05, 32.28 m  
Junction at 12 o'clock, diameter: 150mm, APPEARS TO BE CAPPED OFF

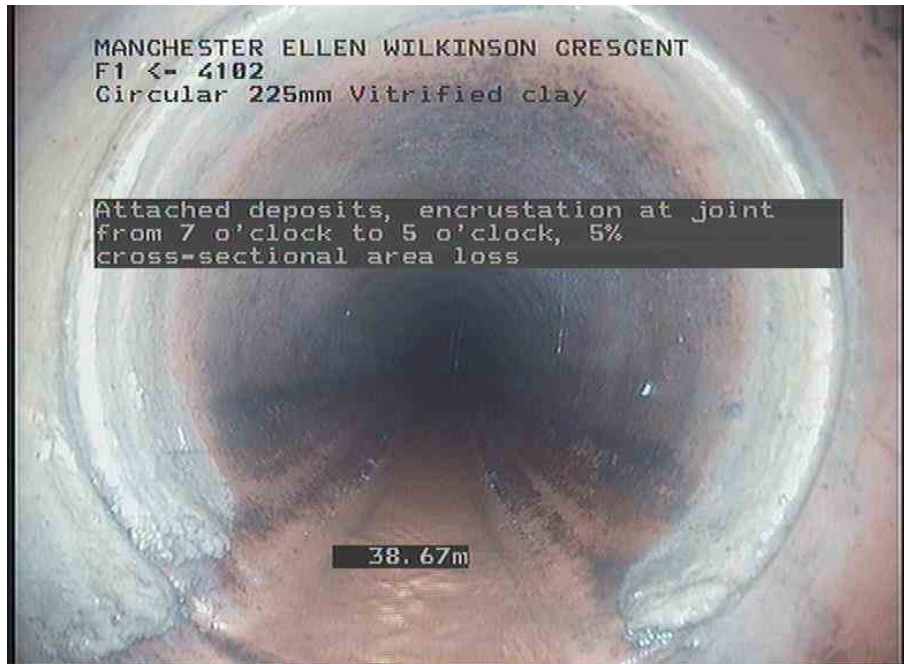
| Scale: 1:390 | Position [m] | Code | Observation | Grade |
|---|---|---|---|---|
| | 38.67 | DEEJ | Attached deposits, encrustation at joint from 7 o'clock to 5 o'clock, 5% cross-sectional area loss | 3 |

F1X\_e9be66f6-579a-4379-b30a-0f6c88459fbe\_20210528\_095439\_621.jpg, 00:06:02, 38.67 m  
Attached deposits, encrustation at joint from 7 o'clock to 5 o'clock, 5% cross-sectional area loss

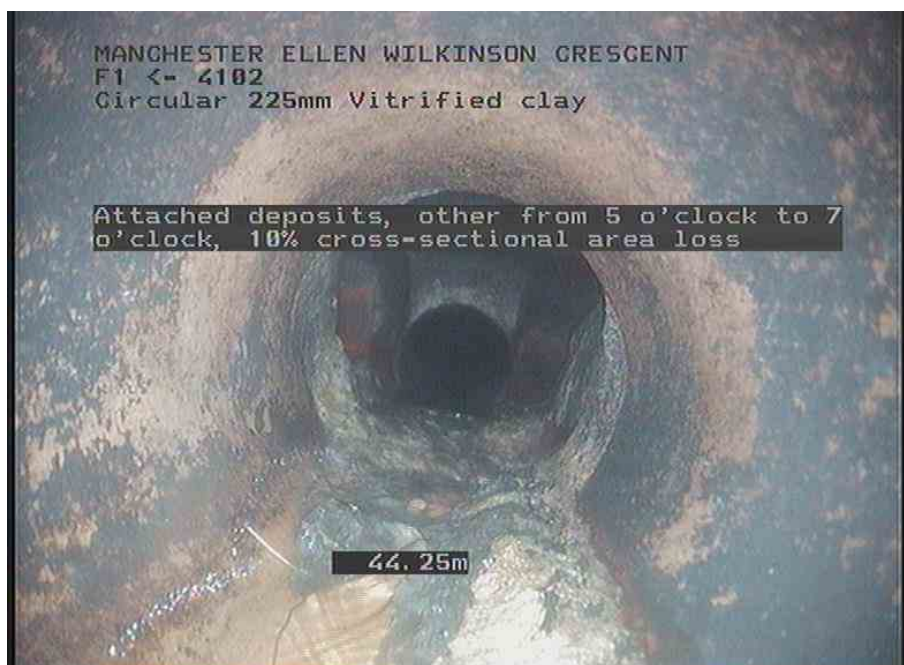
| Scale: 1:390 | Position [m] | Code | Observation | Grade |
|---|---|---|---|---|
| | 44.25 | DEZ | Attached deposits, other from 5 o'clock to 7 o'clock, 10% cross-sectional area loss: GROUT | 3 |

F1X\_dae9d4d5-3a5c-4197-a00c-0af39ca40ebf\_20210528\_095544\_237.jpg, 00:06:56, 44.25 m  
Attached deposits, other from 5 o'clock to 7 o'clock, 10% cross-sectional area loss, GROUT
