**Project Name:** GR20756\_CCTV  
**Project Description:** CCTV Survey  
**Project Number:** GR/20756  
**Project Status:** Issued  
**Project Date:** 01/06/2021  
**Inspection Standard:** MSCC5 Sewers & Drainage GB (SRM5 Scoring)

## Section Inspection - 19/05/2021 - PIPE AX

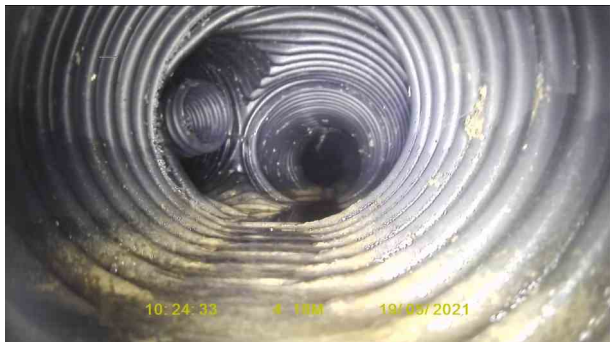
| Scale: | 1:129 | Position [m] | Code | Observation | MPEG | Photo | Grade |
|---|---|---|---|---|---|---|---|
| | | 4.06 | D | Deformed sewer or drain, 5% | 00:00:22 | 1 | 1 / 2 |

1, 00:00:22, 4.06 m  
 Deformed sewer or drain, 5%

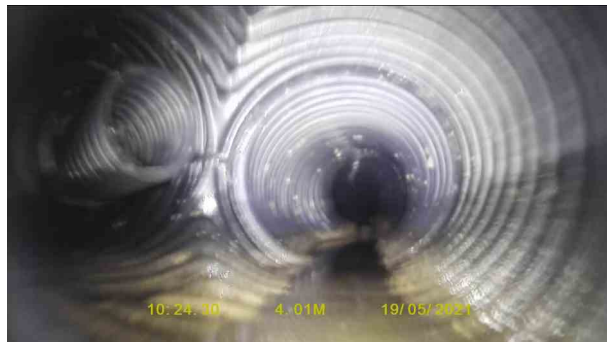
2, 00:00:20, 4.09 m  
 Junction at 9 o'clock, 150mm dia

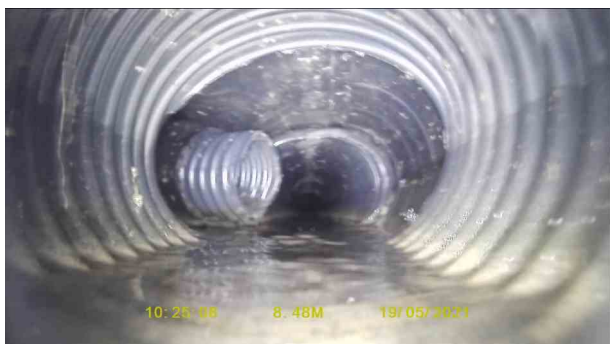
| Section | PLR | Grade | Description |
|---|---|---|---|
| 1 | PIPE AX | 3 | Deformed sewer or drain, 10% |

| Scale: | 1:129 | Position [m] | Code | Observation | MPEG | Photo | Grade |
|---|---|---|---|---|---|---|---|
| | | 8.48 | D | Deformed sewer or drain, 10% | 00:00:58 | 3 | 2 / 3 |

3, 00:00:58, 8.48 m  
 Deformed sewer or drain, 10%

Grade 4: Best practice suggests consideration should be given to maintenance activity to avoid potential blockages.

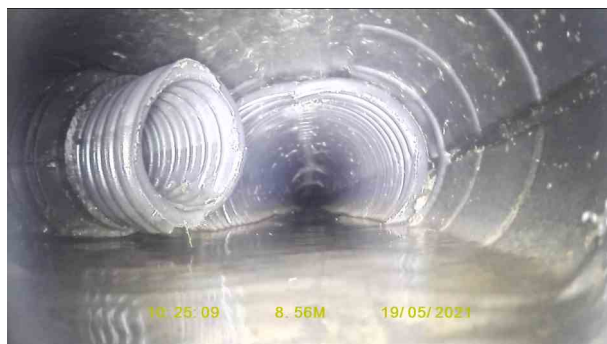
4, 00:00:59, 8.56 m  
 Junction at 9 o'clock, 150mm dia

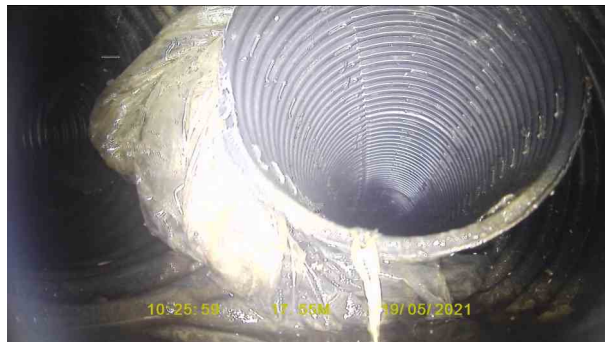
| Scale: | 1:129 | Position [m] | Code | Observation | MPEG | Photo | Grade | | |
|---|---|---|---|---|---|---|---|---|---|
| | 17.50 | | SC | Pipe size changes, new size(s), 100mm high | 00:01:49 | | 6 | | |
| | 17.50 | | SA | Survey abandoned: Unable to pass through reducing pipework | 00:01:49 | | | | |

6, 00:01:49, 17.50 m  
Pipe size changes, new size(s), 100mm high
