**Manchester College – Wythenshawe Park Earthworks and drainage**

## **KNIGHT, KAVANAGH, and PAGE (KKP)**

Report Date: 16<sup>th</sup> May 2021

Visit Date: 22<sup>nd</sup> March 2021

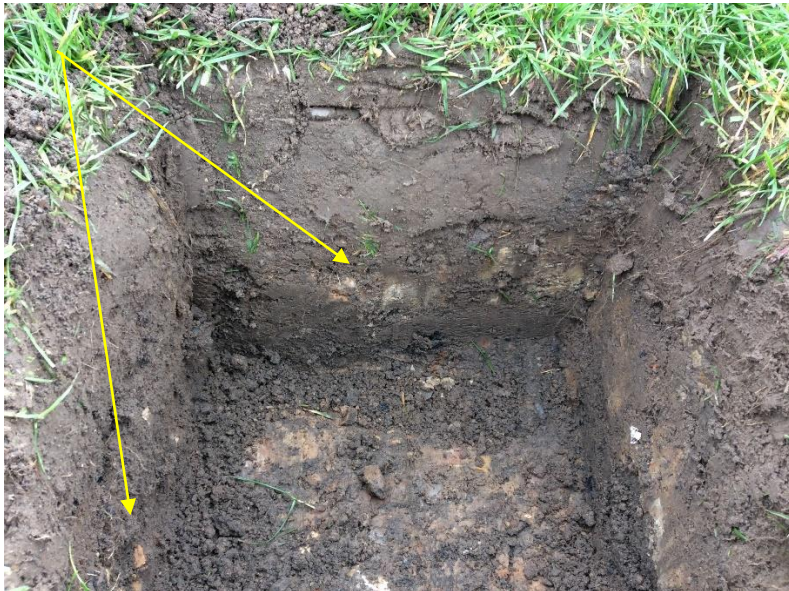
As part of the site assessment soil inspection pits were dug to determine the depth and nature of the topsoil as well as the dominant type of subsoil. Two pits were dug in the Northern and Southern sectors. The Northern pit showed higher moisture content, understandable as it is at the bottom of the site slope. The topsoil was uniform to a depth of 310mm and was of a heavy nature. Structurally it was tight in the upper 50-60mm below which it was more open structured but not crumbly. Throughout the topsoil layer there was evidence of stones and cobbles of unknown origin. Figure 1 shows the distinct layer between the topsoil and the heavier clay dominant subsoil.

**Figure 1: Topsoil layer contained stones (arrows) above a heavier clay subsoil at 310mm depth.**

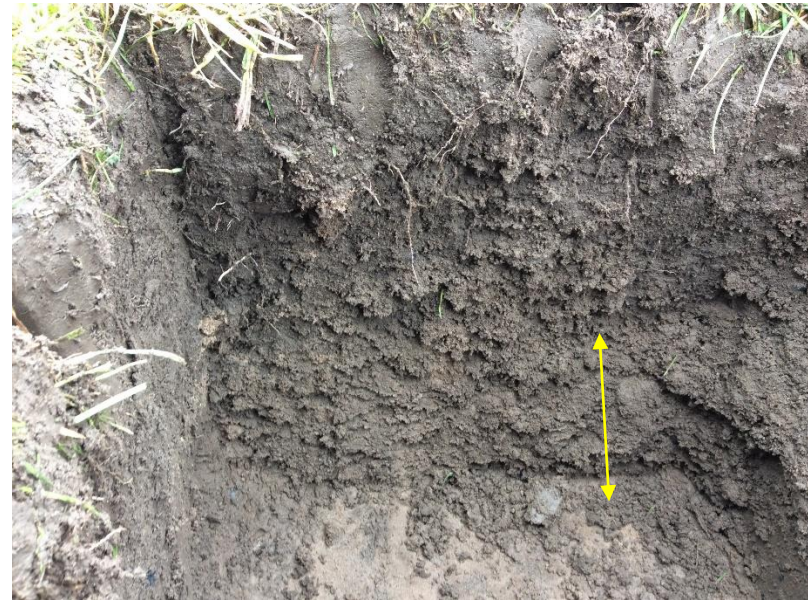
The Southern pit showed a much deeper topsoil layer to 450mm over a sandier subsoil. Structurally the soil was more crumbly and held less moisture than the Northern soils, which being on the higher part of the site is understandable. Figure 2 shows the uniformity of the soil and the sandy nature of the subsoil. This sand layer was noted within the brook embankment but cannot be verified that it is a continuous seam.

**Figure 2: Soil structure and texture is more consistent within the Southern sector to 450mm depth above a sandier subsoil (arrow).**

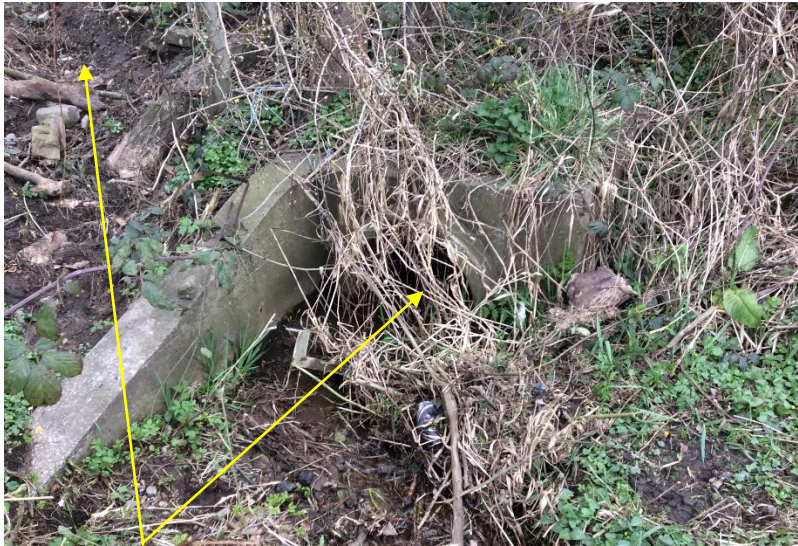
The sites natural slope and contours suggest that the drainage design and installation would be straightforward. No obvious impediments were noted during the inspection that would suggest any additional work would be required. Drainage discharge would be into Baguley Brook on both the Western and Northern boundaries. The precedent has been set for discharge by the presence of drainage pipes, ditches, and culverts from other areas of the site including the residential area to the North of the site. Figure 5 shows an active example of discharge from both a drainage ditch and culvert originating from the playing fields to the Northeast of the proposed site.

**Figure 5: Active drainage discharge into Baguley Brook from other playing pitches via culverts and open ditches (arrowed).**

With the commencement of any earthworks to establish levels, drainage potential of the soil will be changed, often detrimentally. Therefore, the recommendation is to install a primary drainage system at 5 metre centres across the entire area and support this further with a secondary drainage system (sand-banding). Increasing the interception capability of any drainage system will raise the playability and access to the pitches long term.
