## **NCH – Existing Curtain Walling – Stabilisation Solution– Executive Summary**

## **NCH - Existing Curtain Wall Repair Sequence**

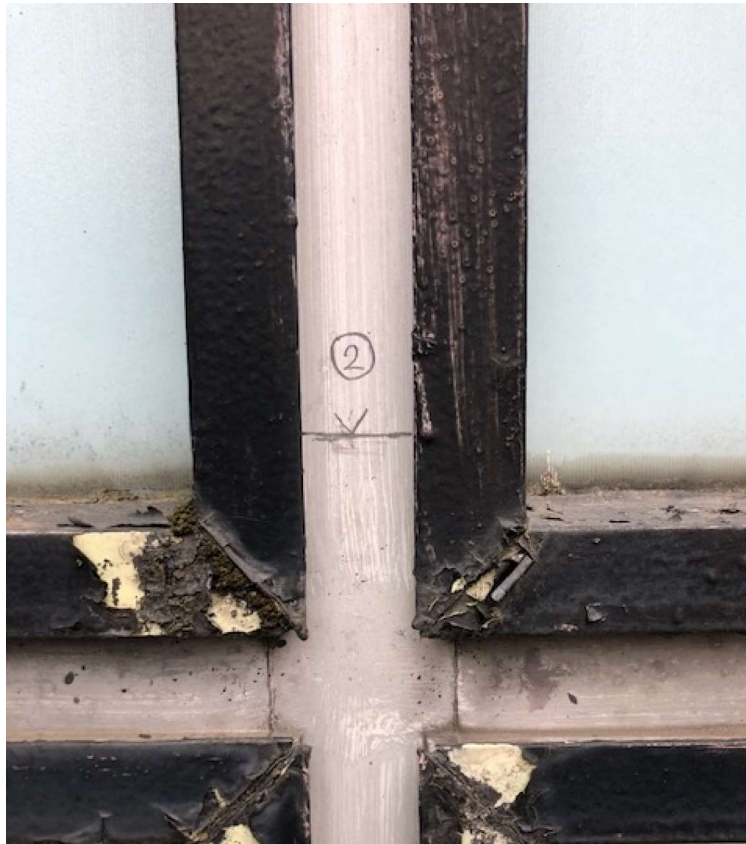
**1. Mark out top of hole**

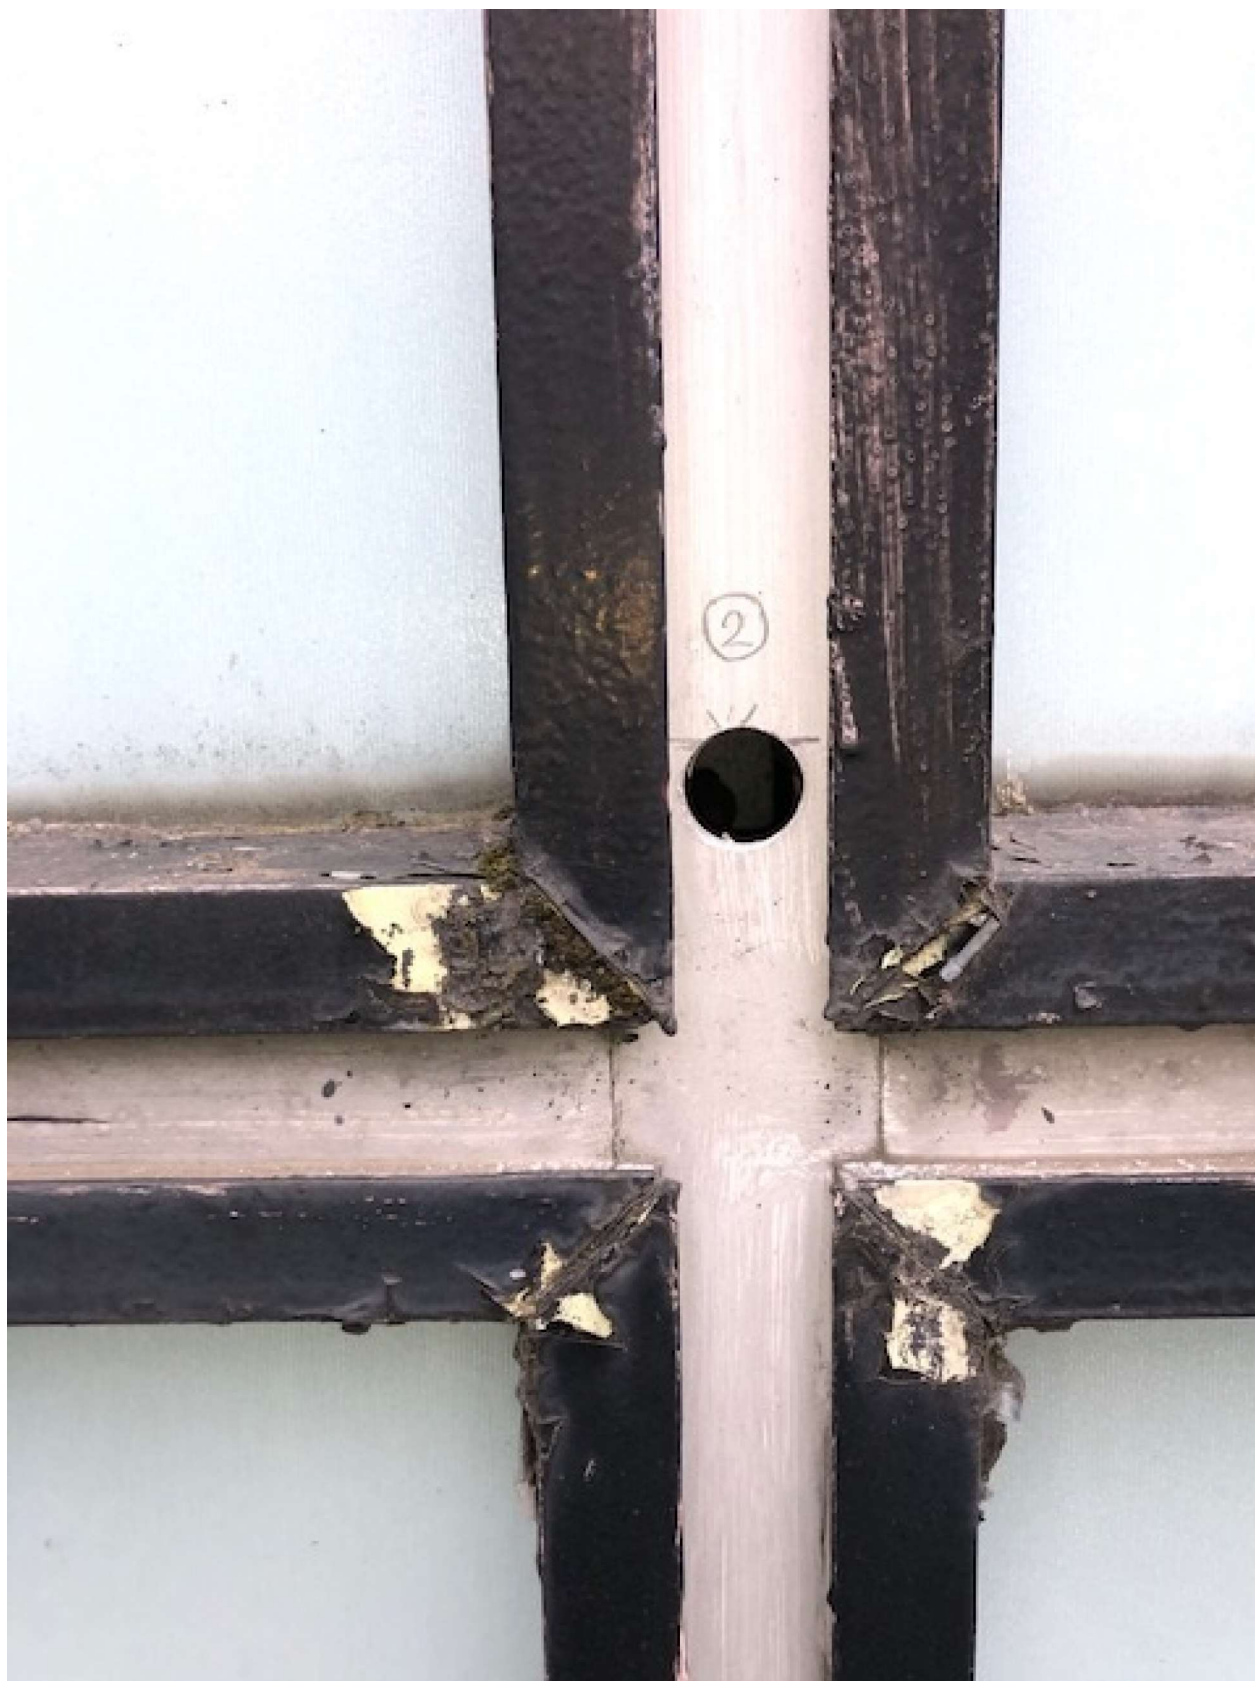
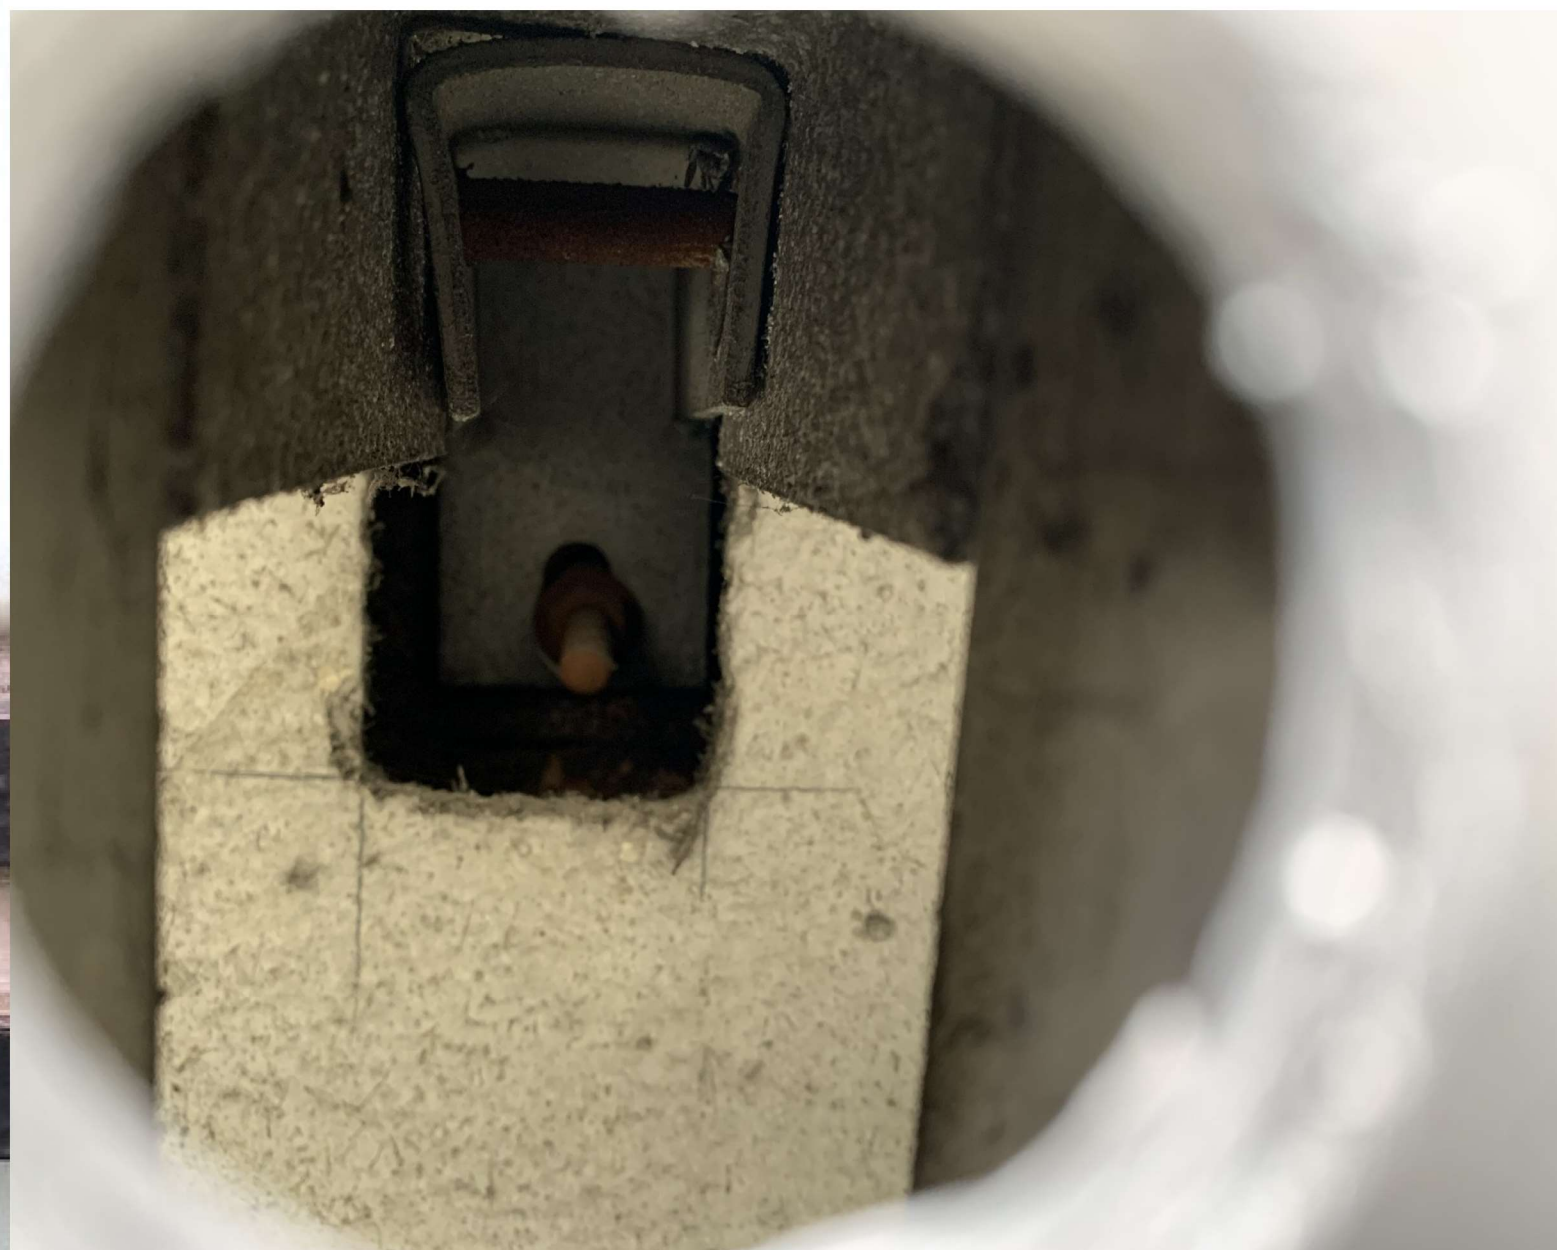
**4. Hole complete for access to drill through original baseplate - avoiding the surrounding AIB**

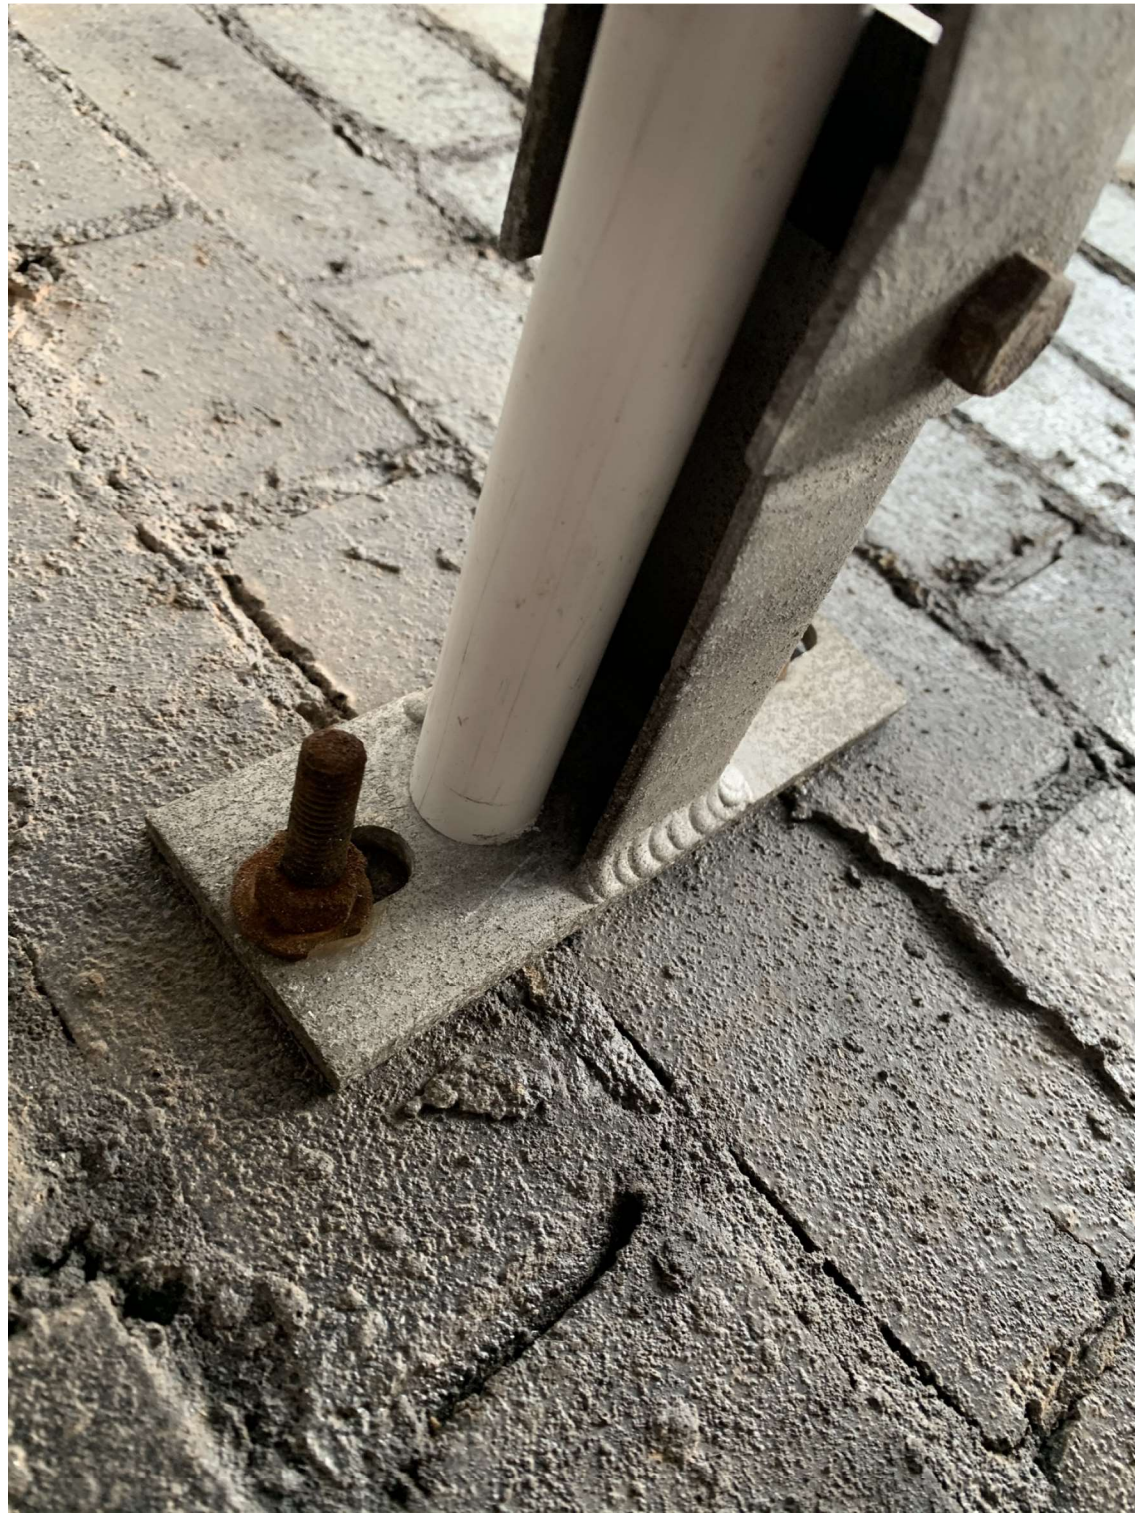
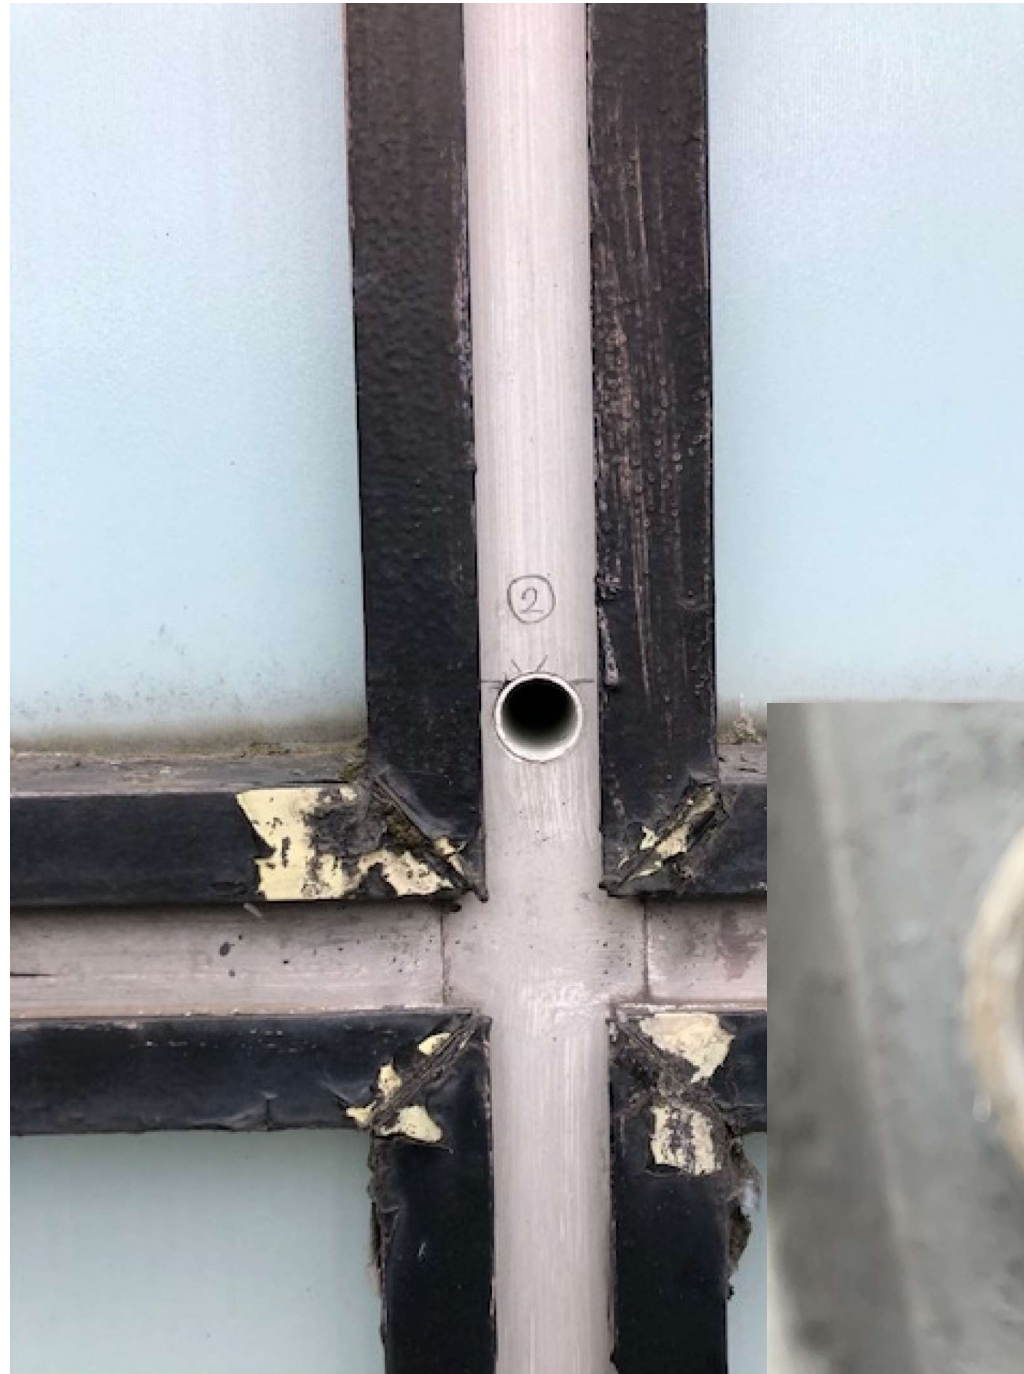
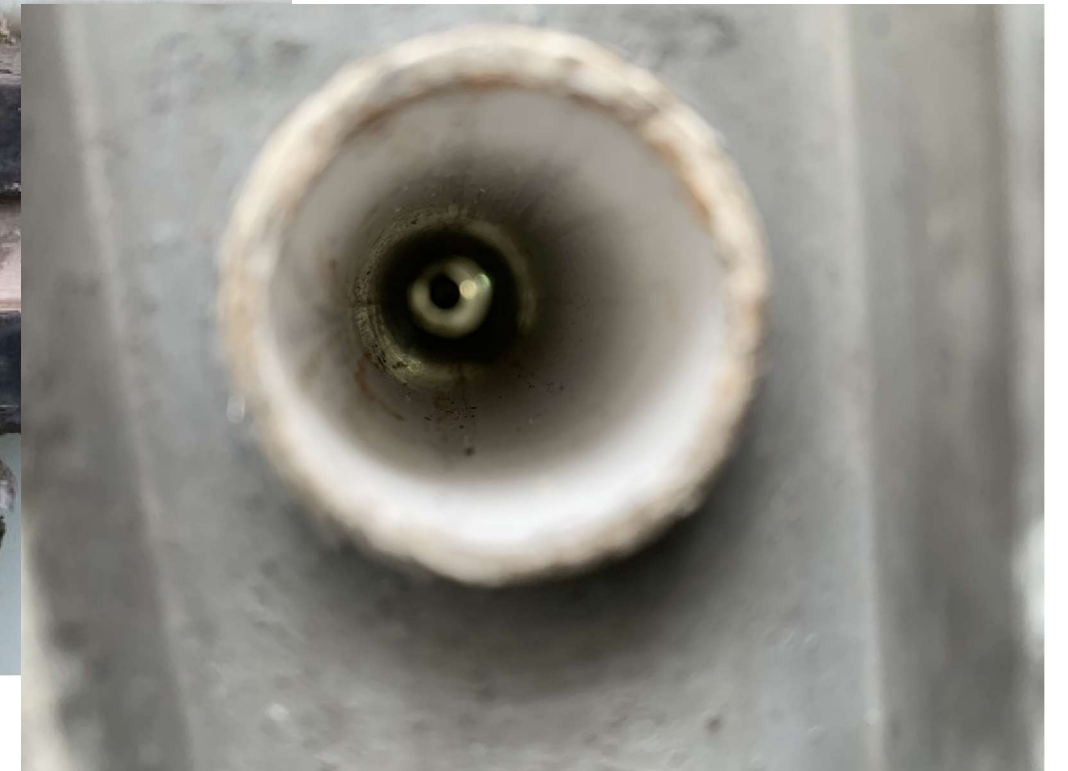
**5. Hole drilled through base plate and 20mm in to masonry to ensure a key is formed for follow on trades. Plastic sleeve inserted to provide a safe void free from asbestos. This is also required to stop any bi-metallic reaction between the steel bar and anodised aluminium frames.**

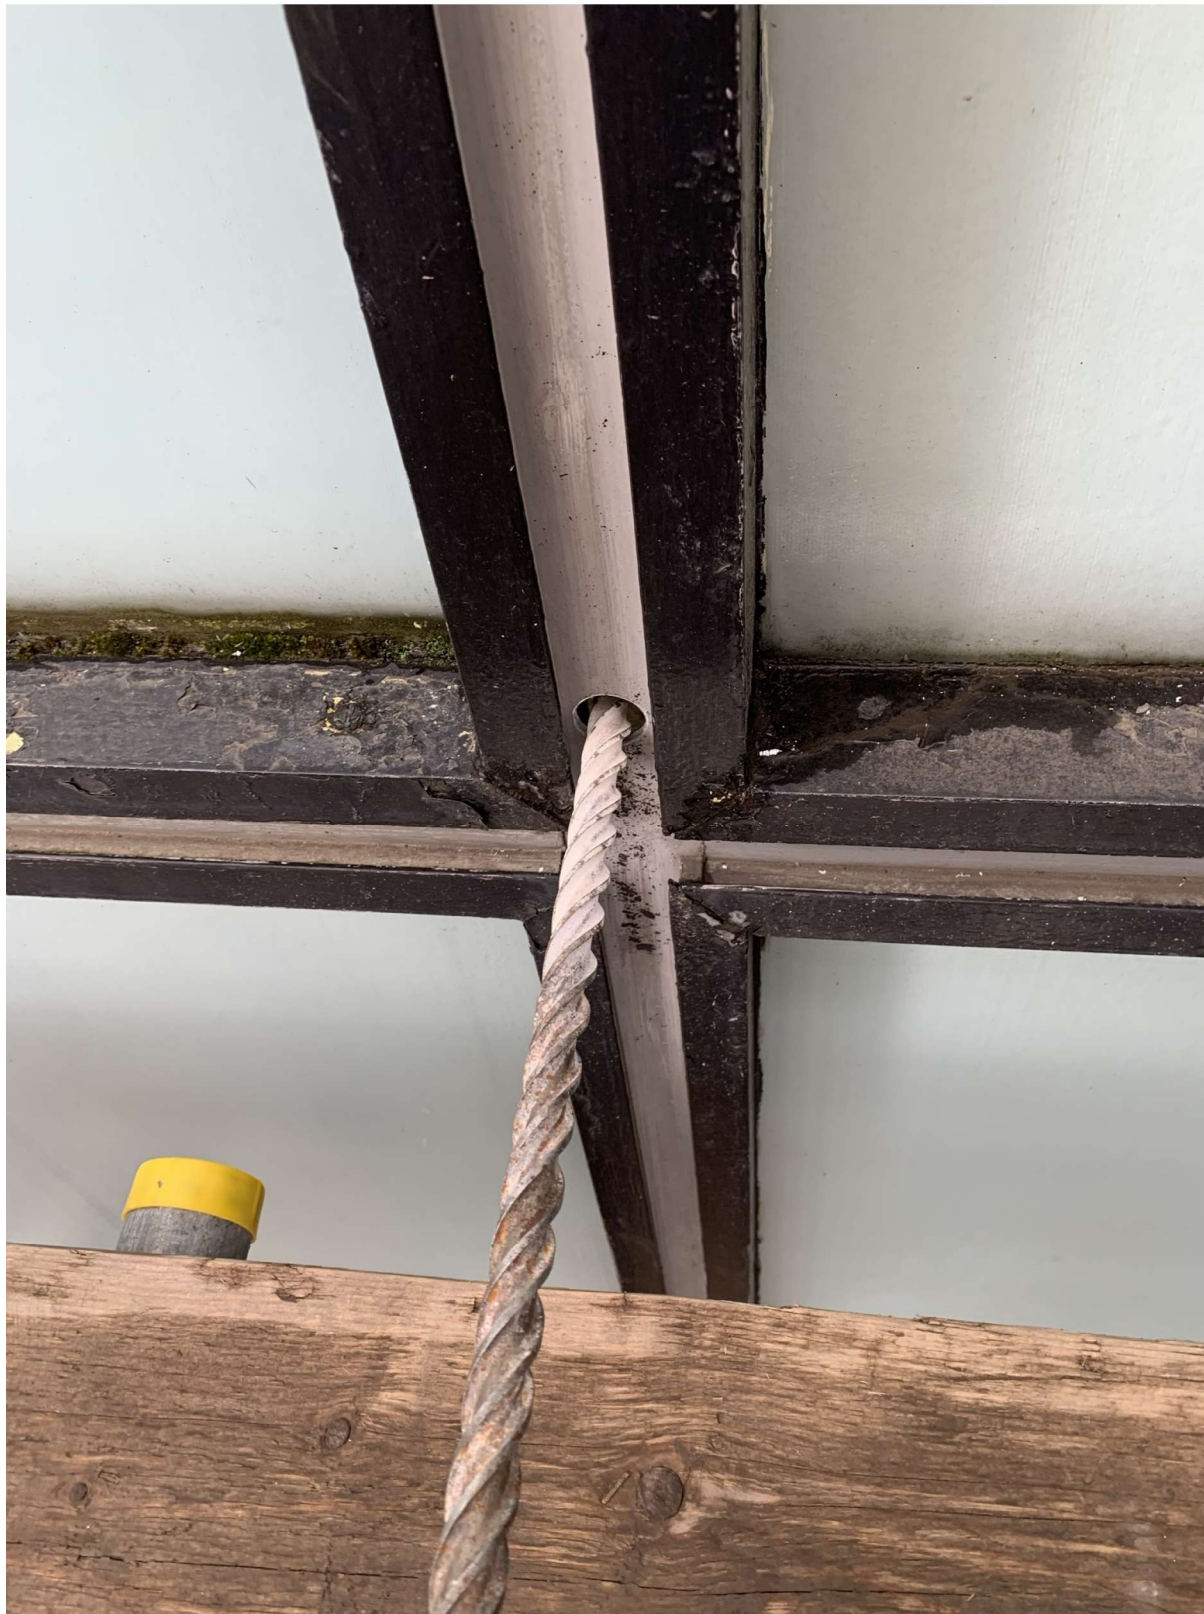
**5. 120mm hole drilled through masonry.**

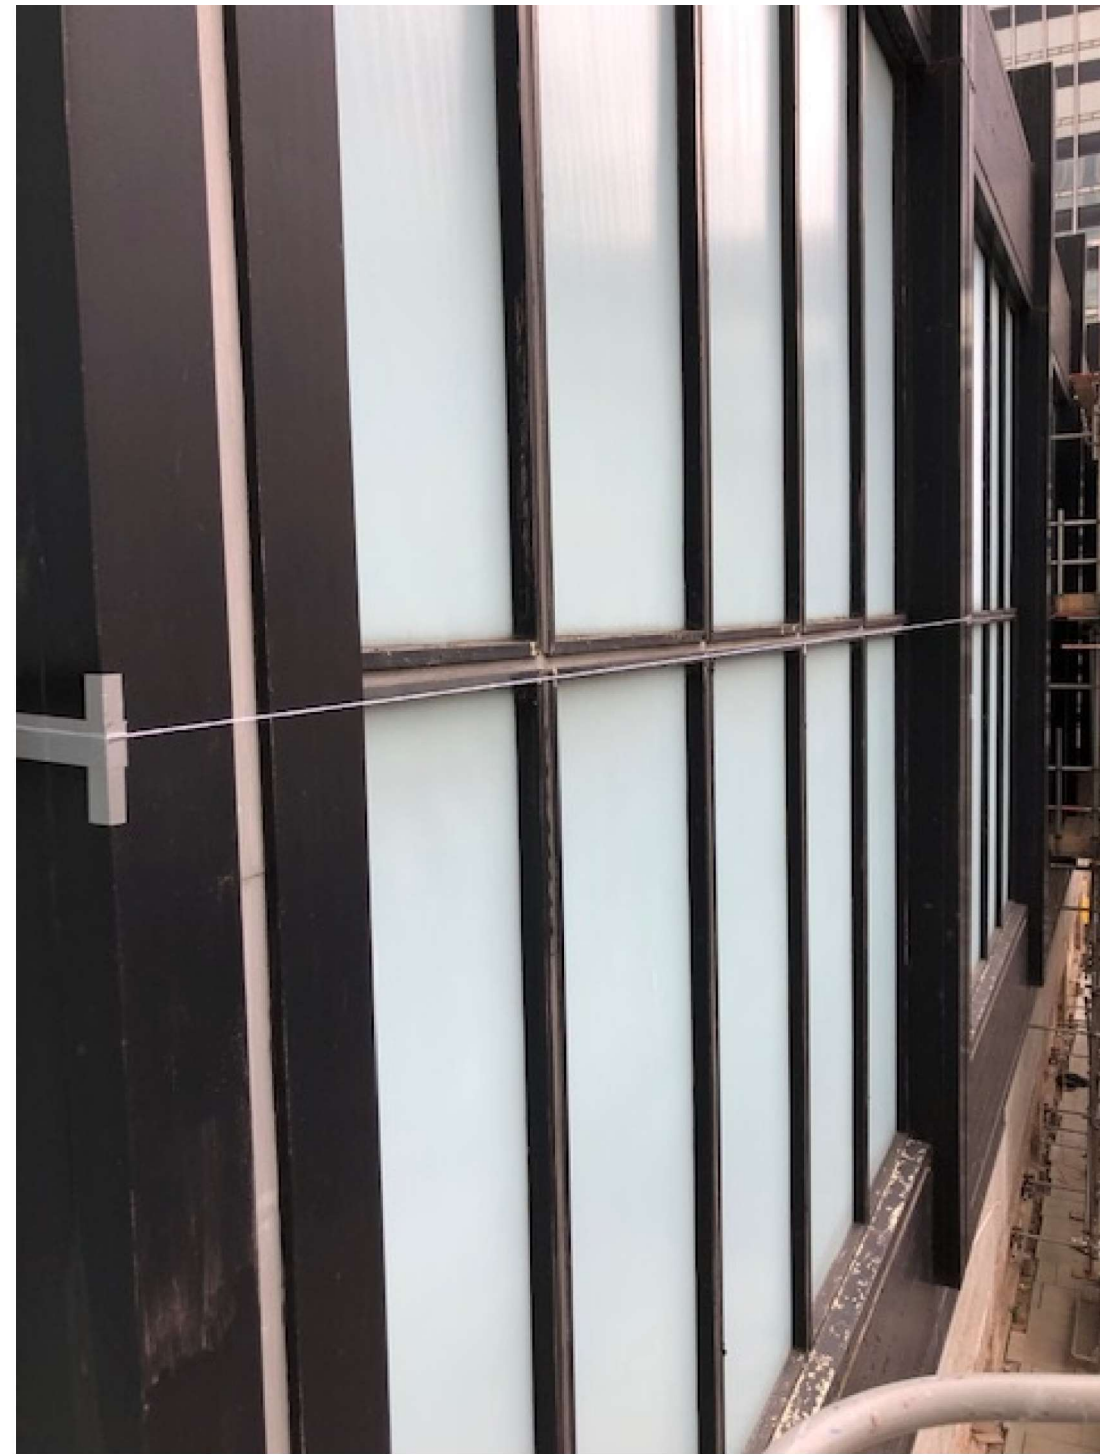
**6. Frame lined up prior to installing resin - Hilti-HY-200**

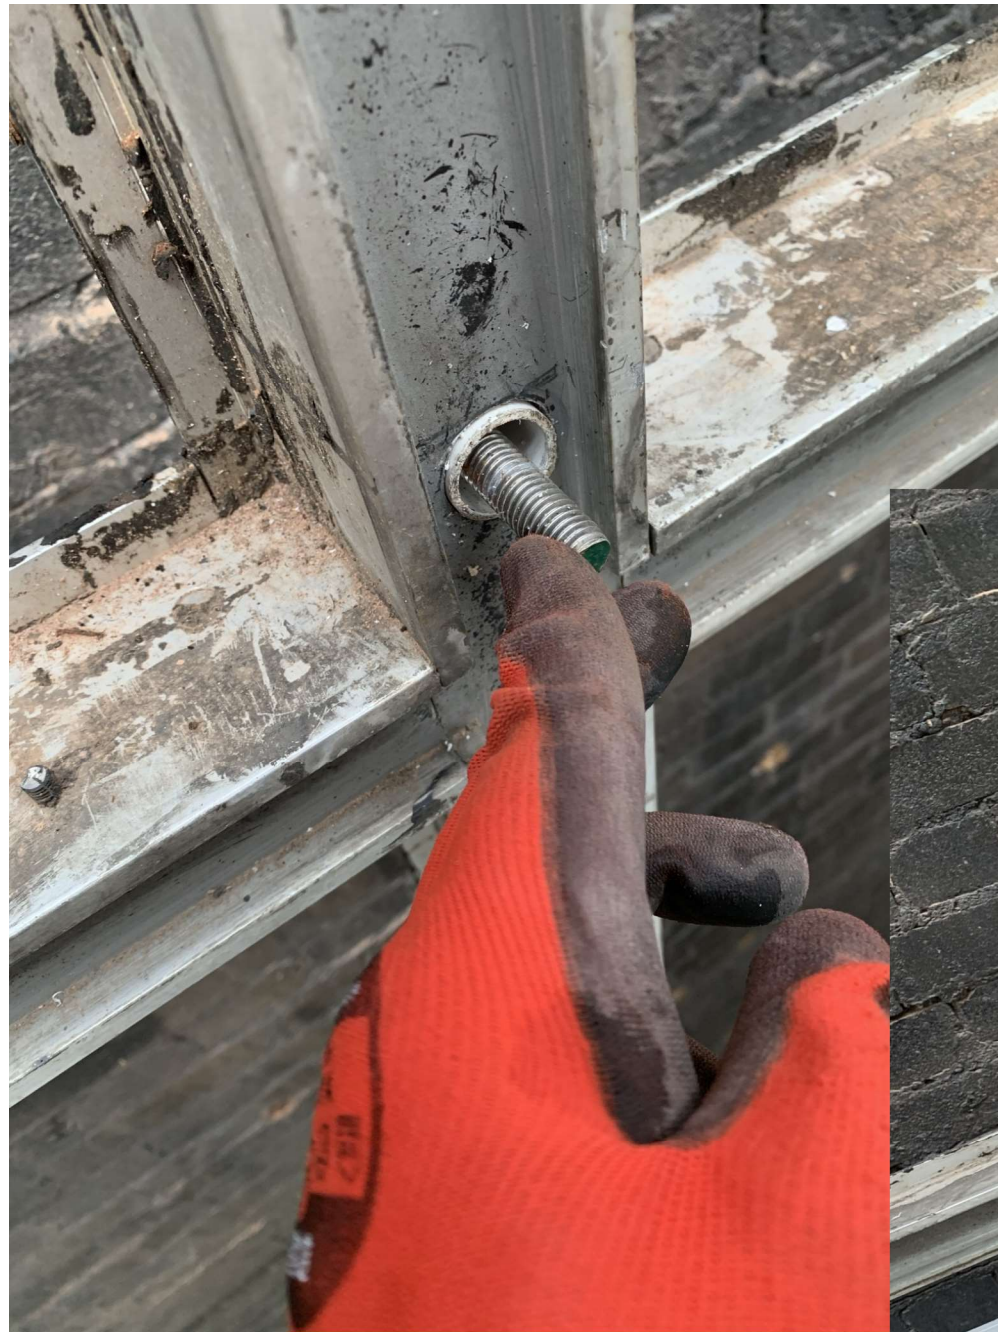
**7. Insert M12  
threaded bar**

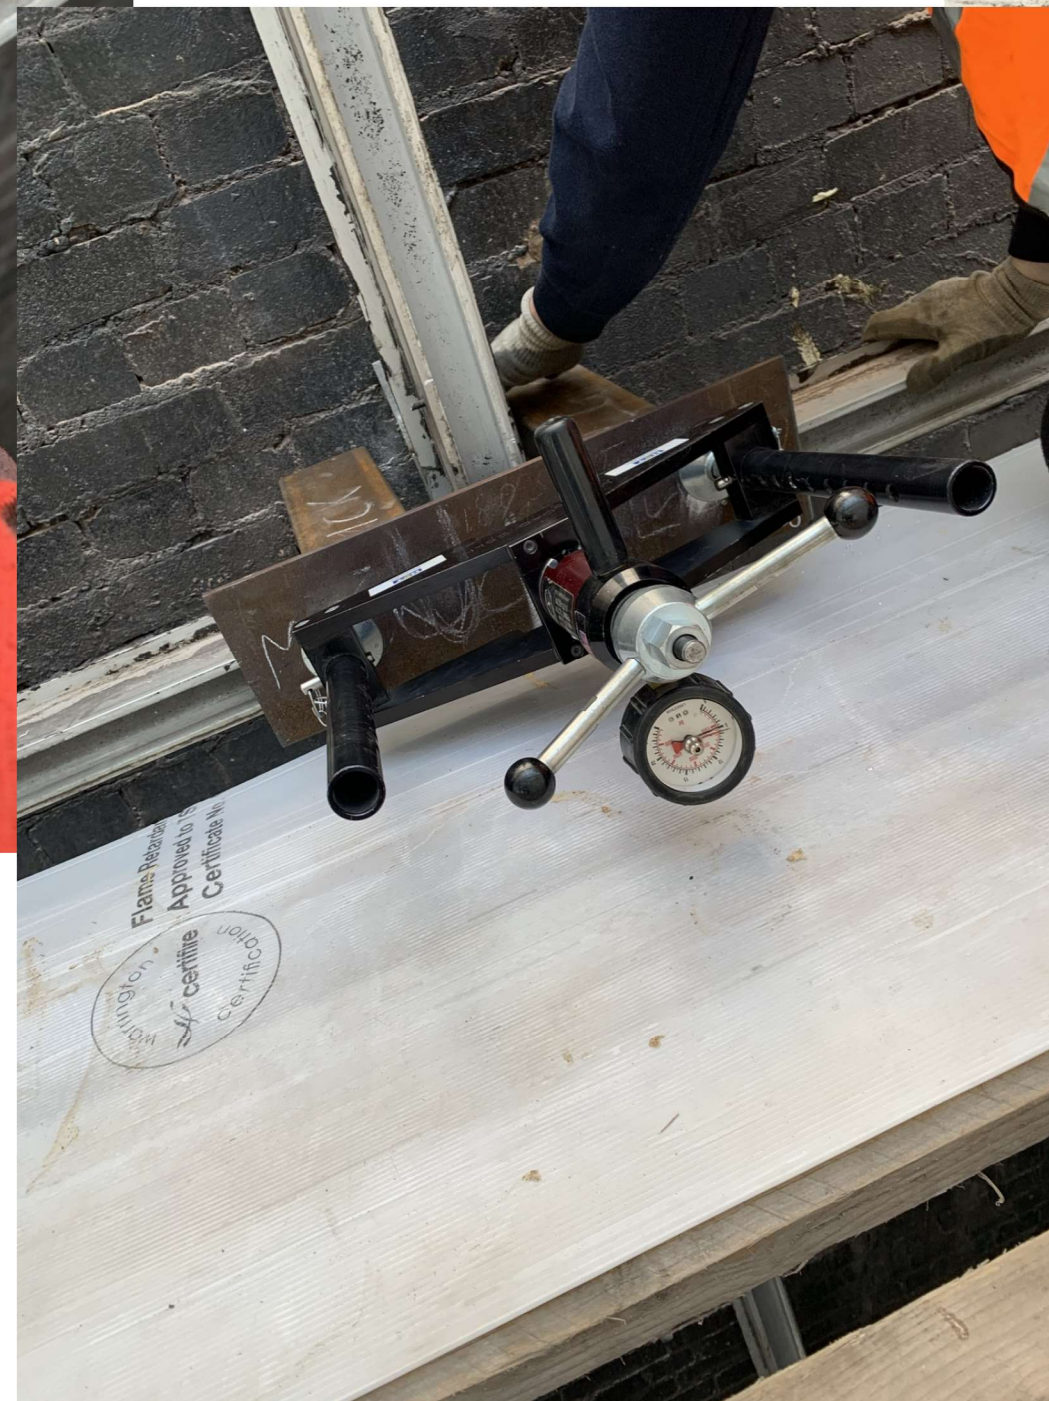
**9. Washer and nut  
installed. Torque to be  
recorded for each fixing**

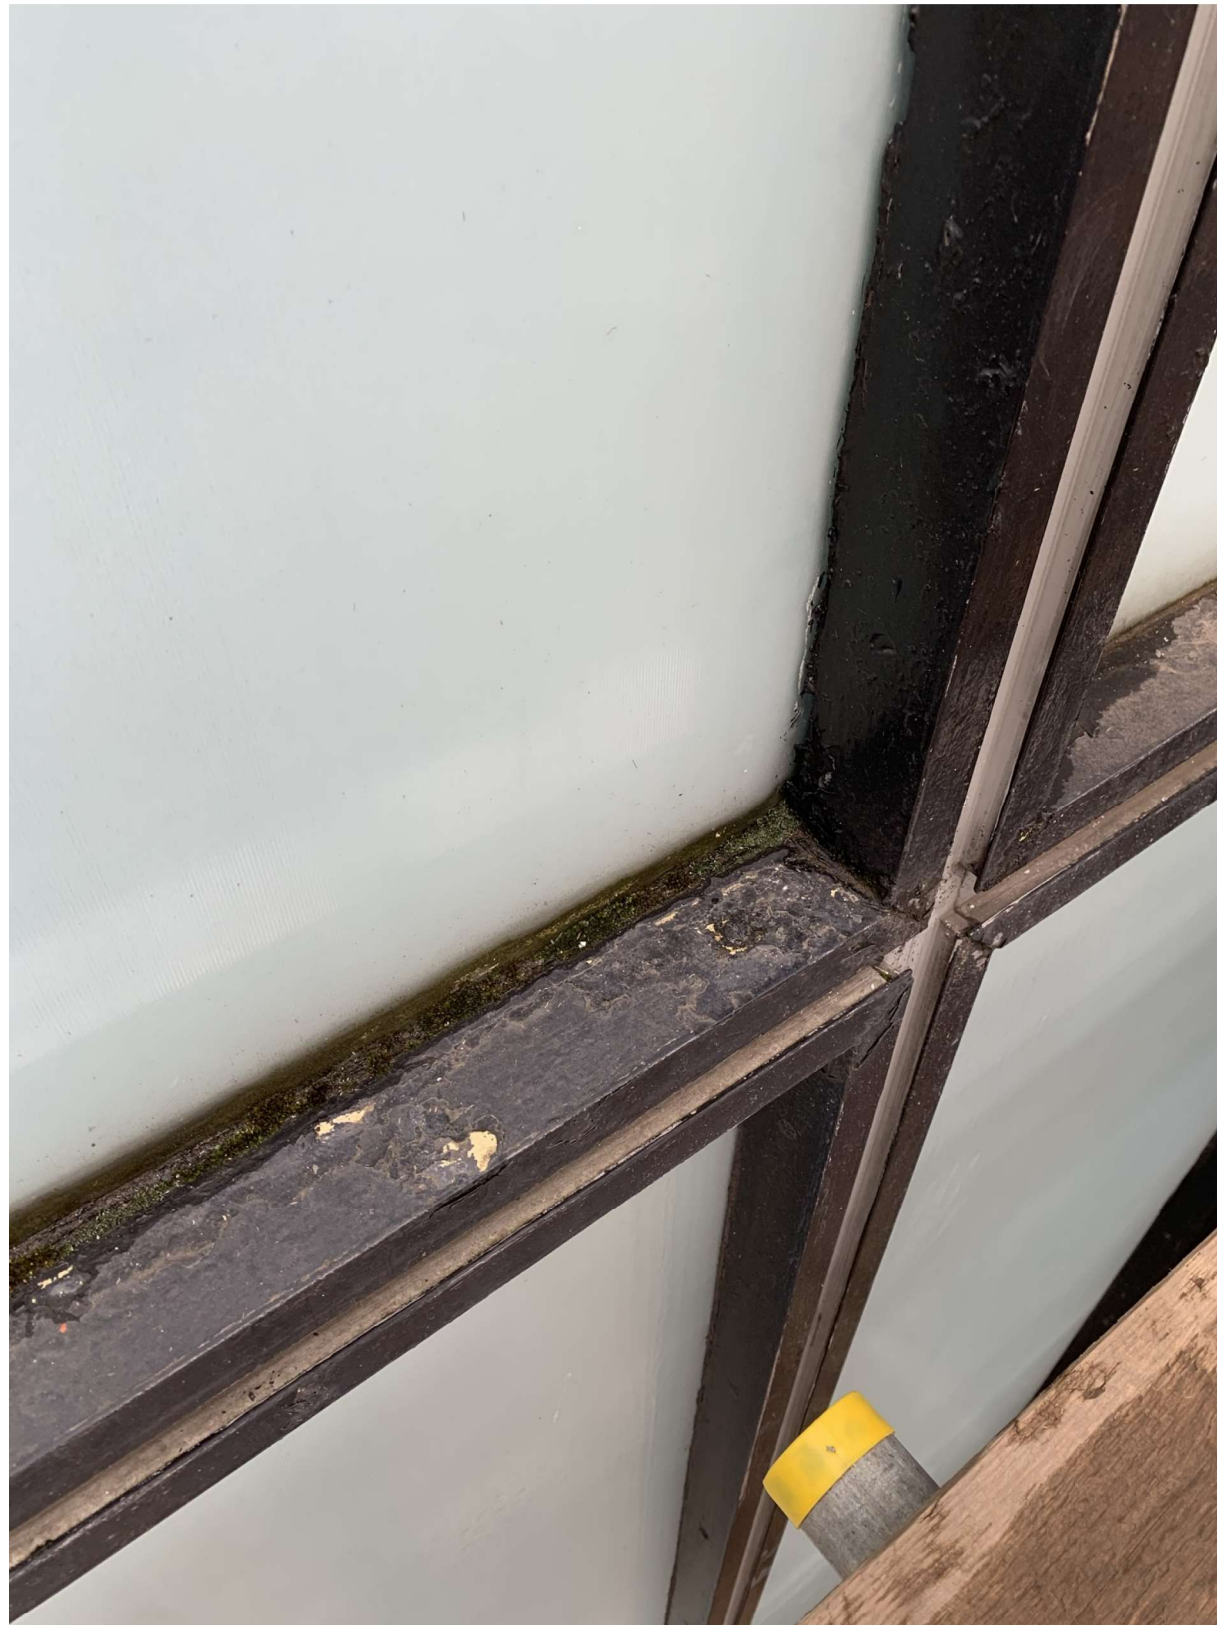
**10. Windows and frames to be cleaned - Soap and clean water only**

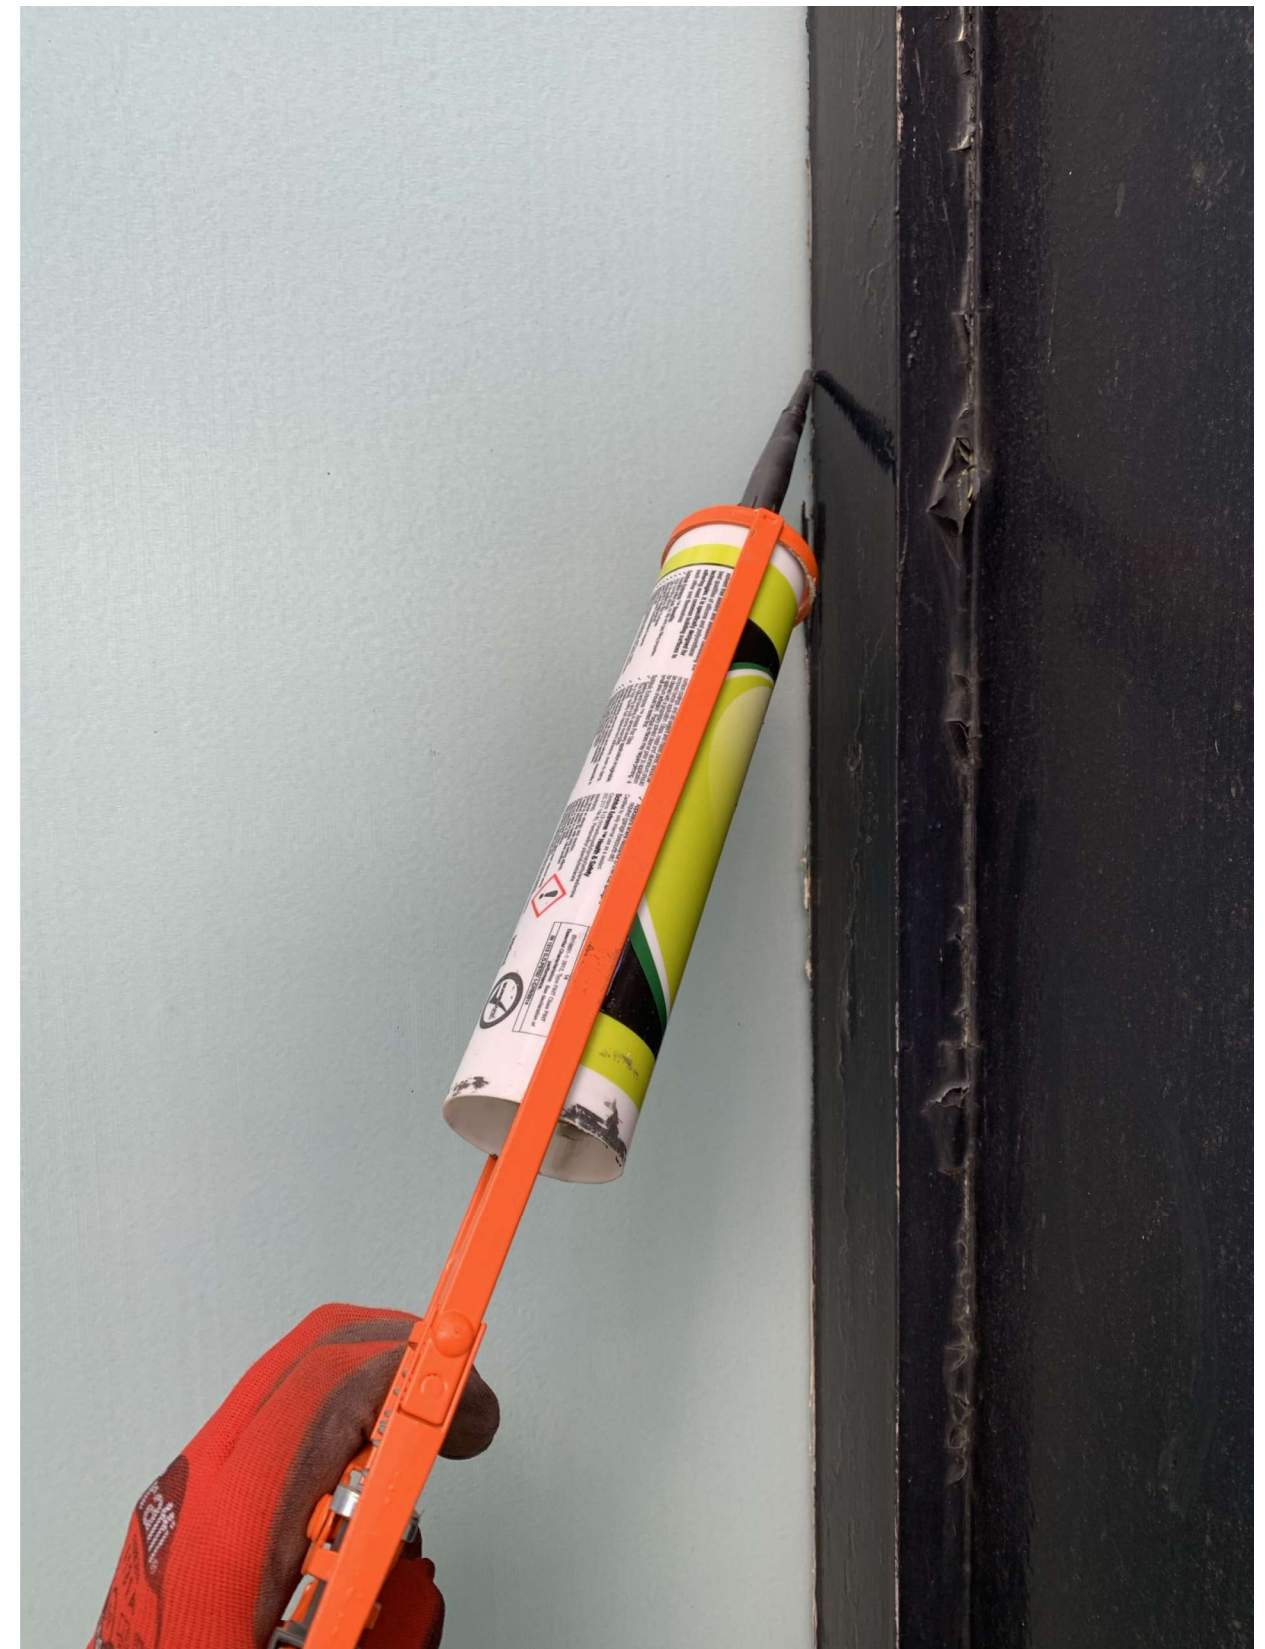
**11. Structural mastic to be installed to the perimeter of all windows**

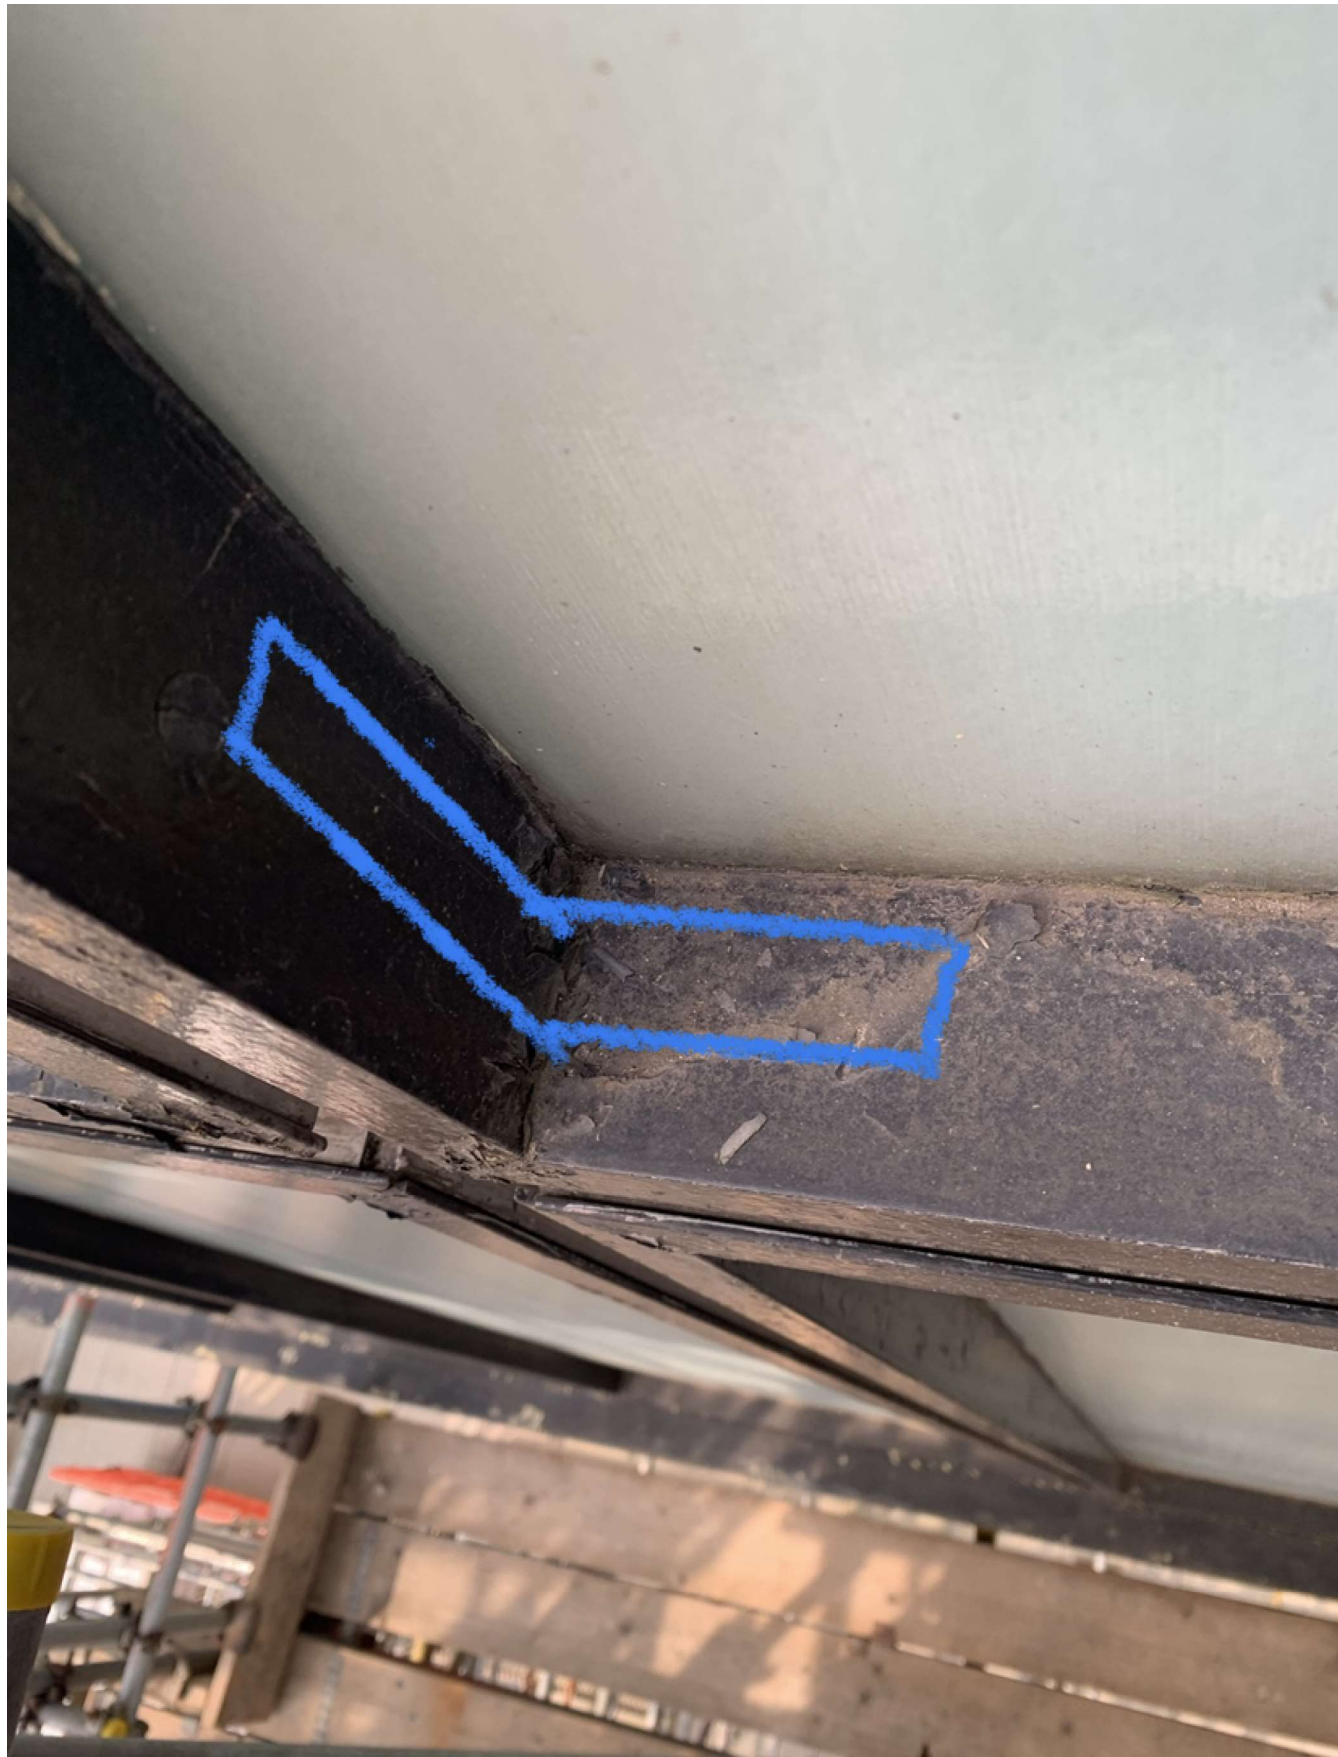
**12. Angles to be installed to all 4no corners the 199 windows**
