## **NCH – Existing Curtain Walling – Stabilisation Solution– Executive Summary**

## **NCH - Existing Curtain Wall Repair Sequence**

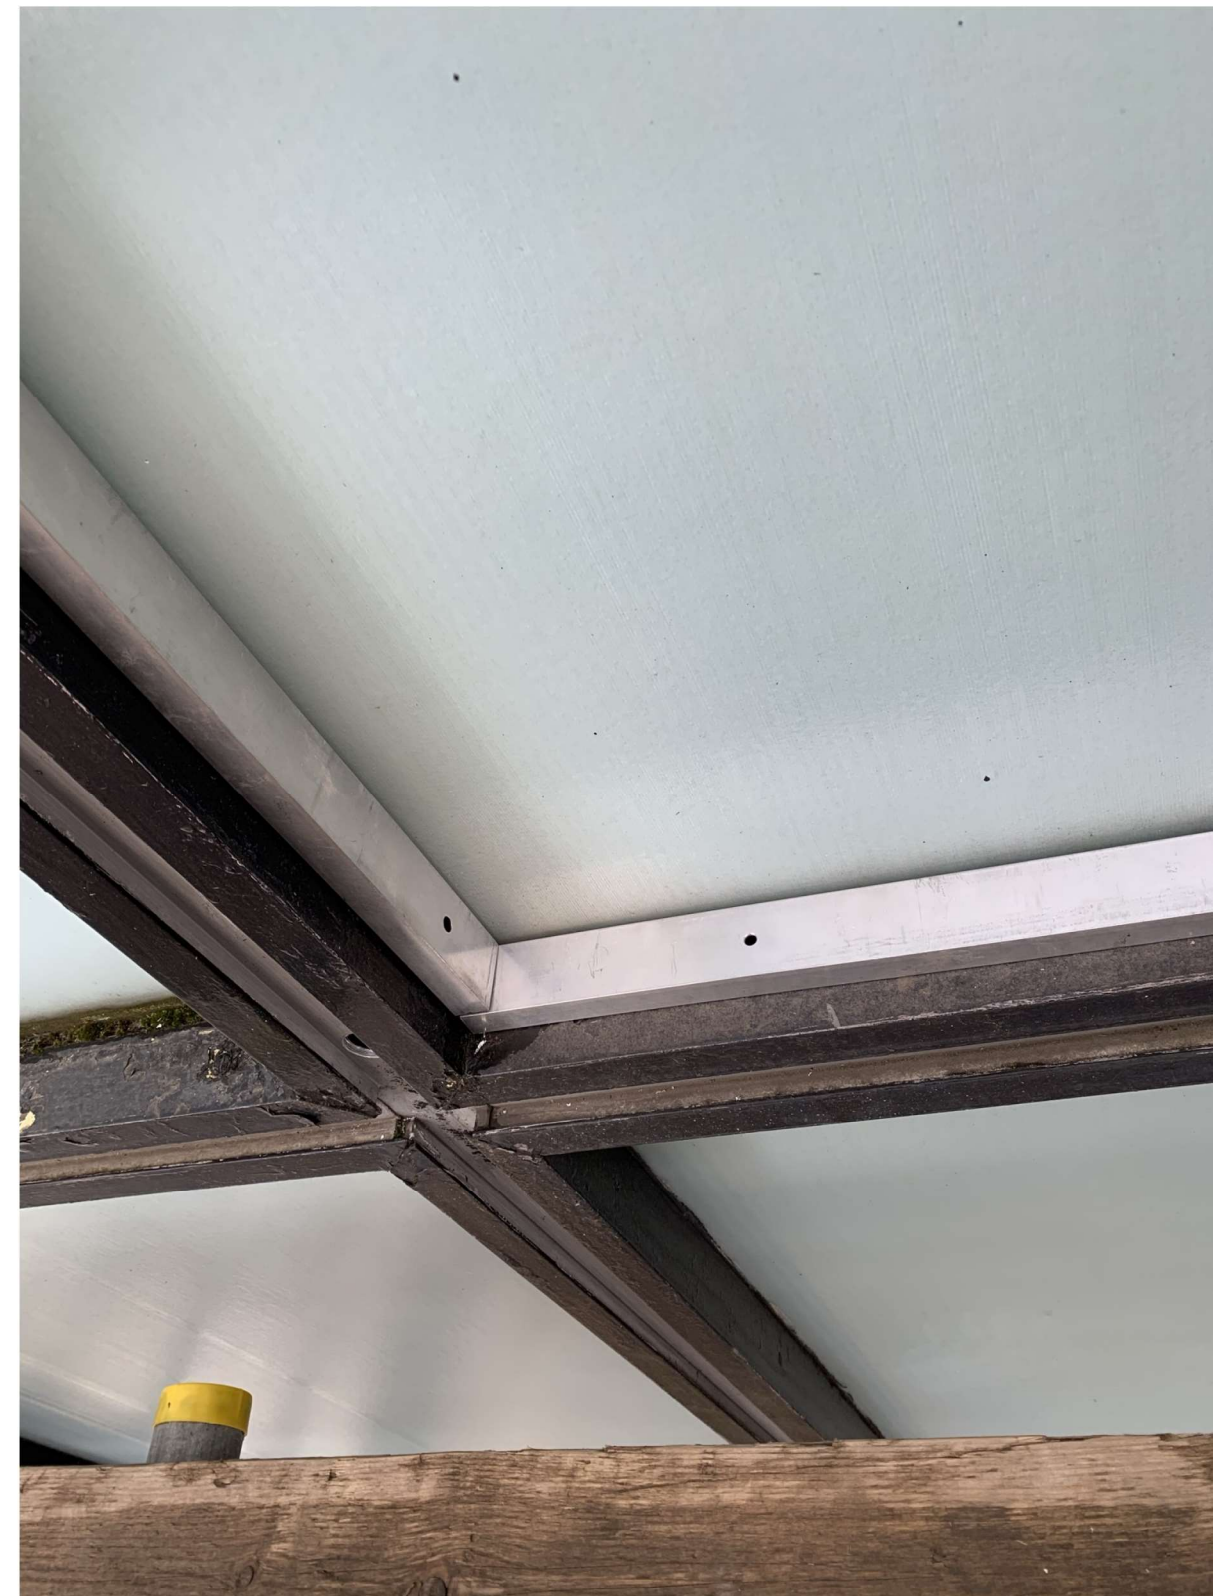
**13. Aluminium beads PCC Black to be installed to all 4no sides the 199 windows. These will be notched around the angles**
