CLIENT AMBASSADOR THEATRE GROUP

PROJECT MANCHESTER OPERA HOUSE

TITLE WINDOW REPAIR - W10-LG

DRAWING NUMBER 19-143- WR10

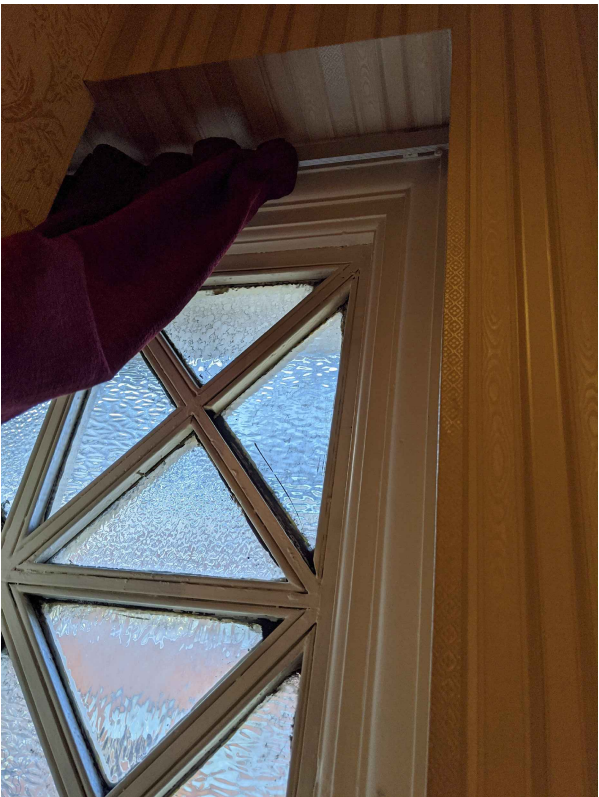
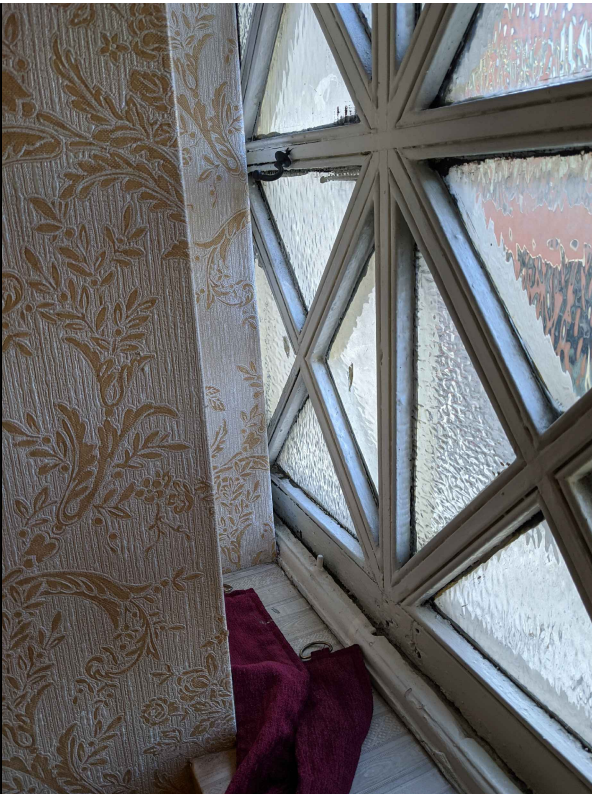
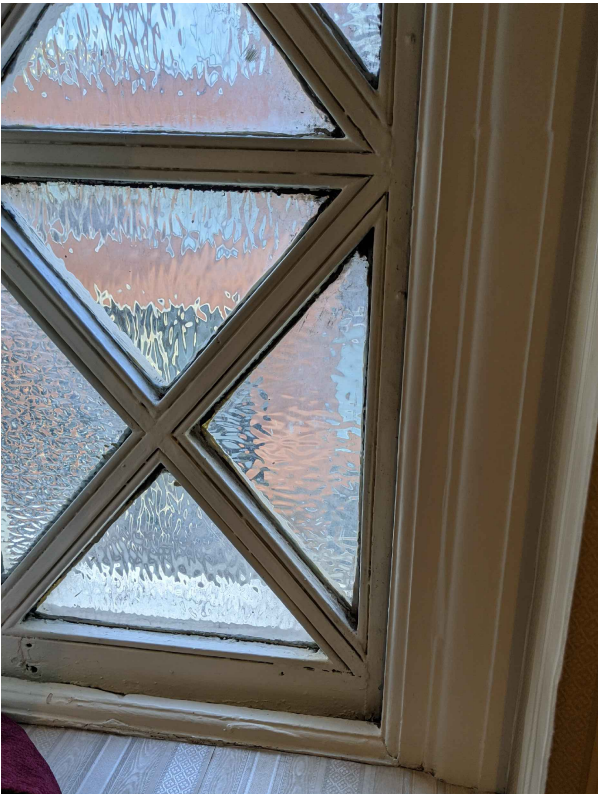
Window W10 - LG

Once casement has been removed and the existing frame has been left in-situ, check frame and cill for and damage or rot. Record areas and inform CA.  
N.B Access to window will need to be external.

Where external cills are to be replaced - replicate the profile of the existing cill in a durable hardwood such as oak incorporating a drip detail to the underside. Any new cill parts should be butt jointed below the casement frame. Finish using linseed oil based paint as described above in the colour to match the existing colour.
