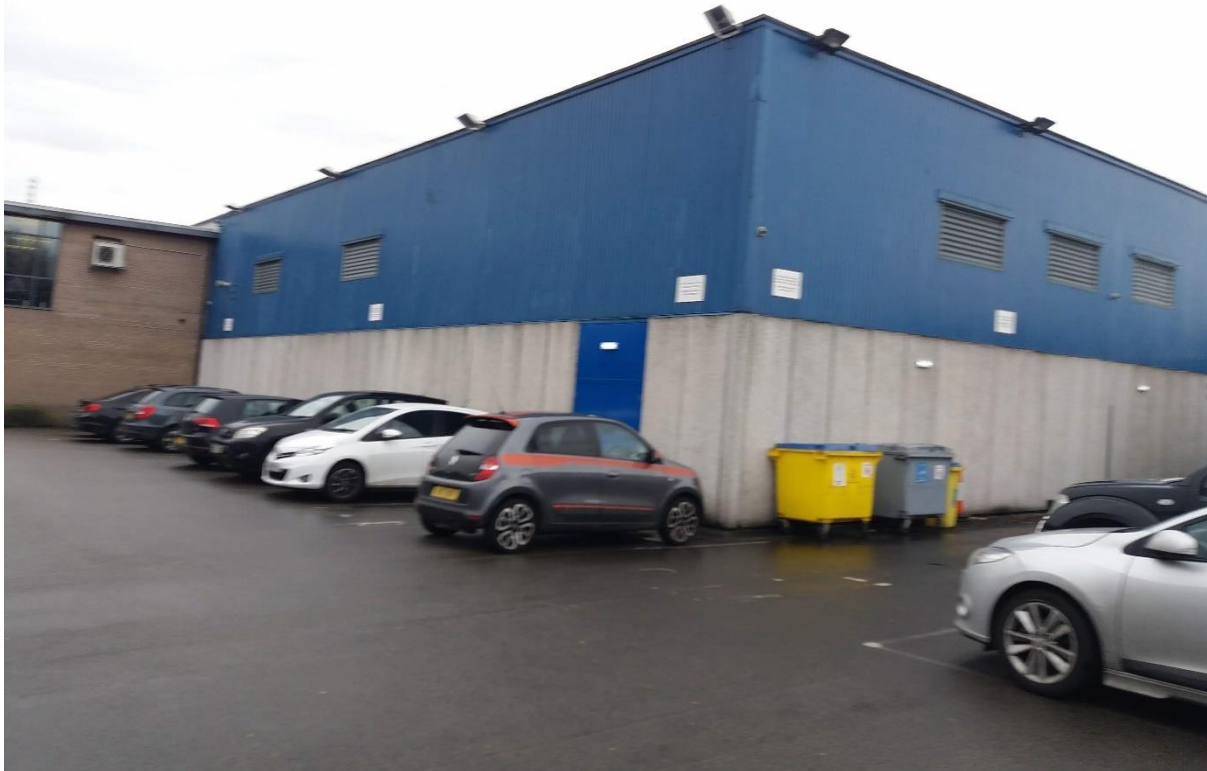
**Photo 2:** Existing blue coloured high-level timber cladding and low-level concrete cladding panel at the car park elevations. Elevation numbers 3 and 4 on drawing reference ALC-MCC-B01-XX-DR-A-0013.

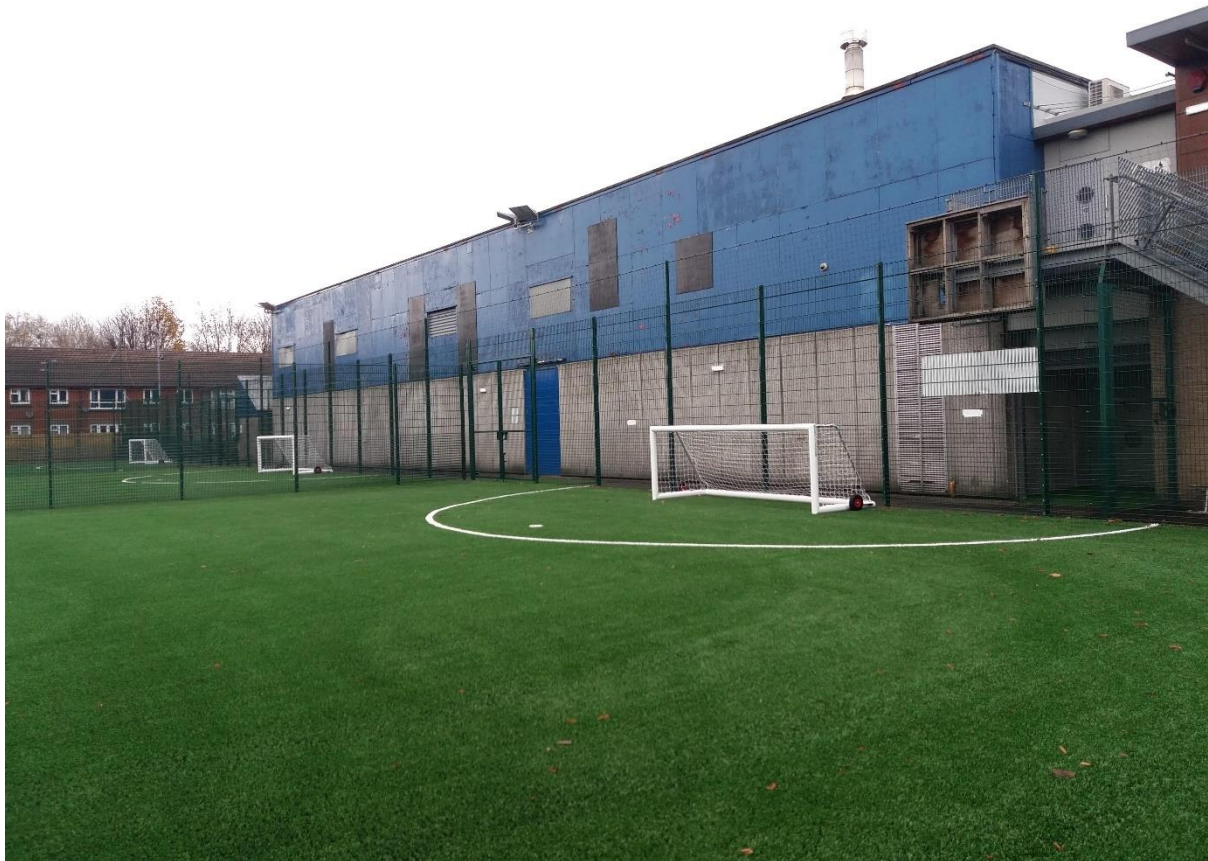
**Photo 3:** Existing blue coloured high-level timber cladding and low-level concrete cladding panel to the external elevation facing the football pitches. Elevation number 2 on drawing reference ALC-MCC-B01-XX-DR-A-0013.

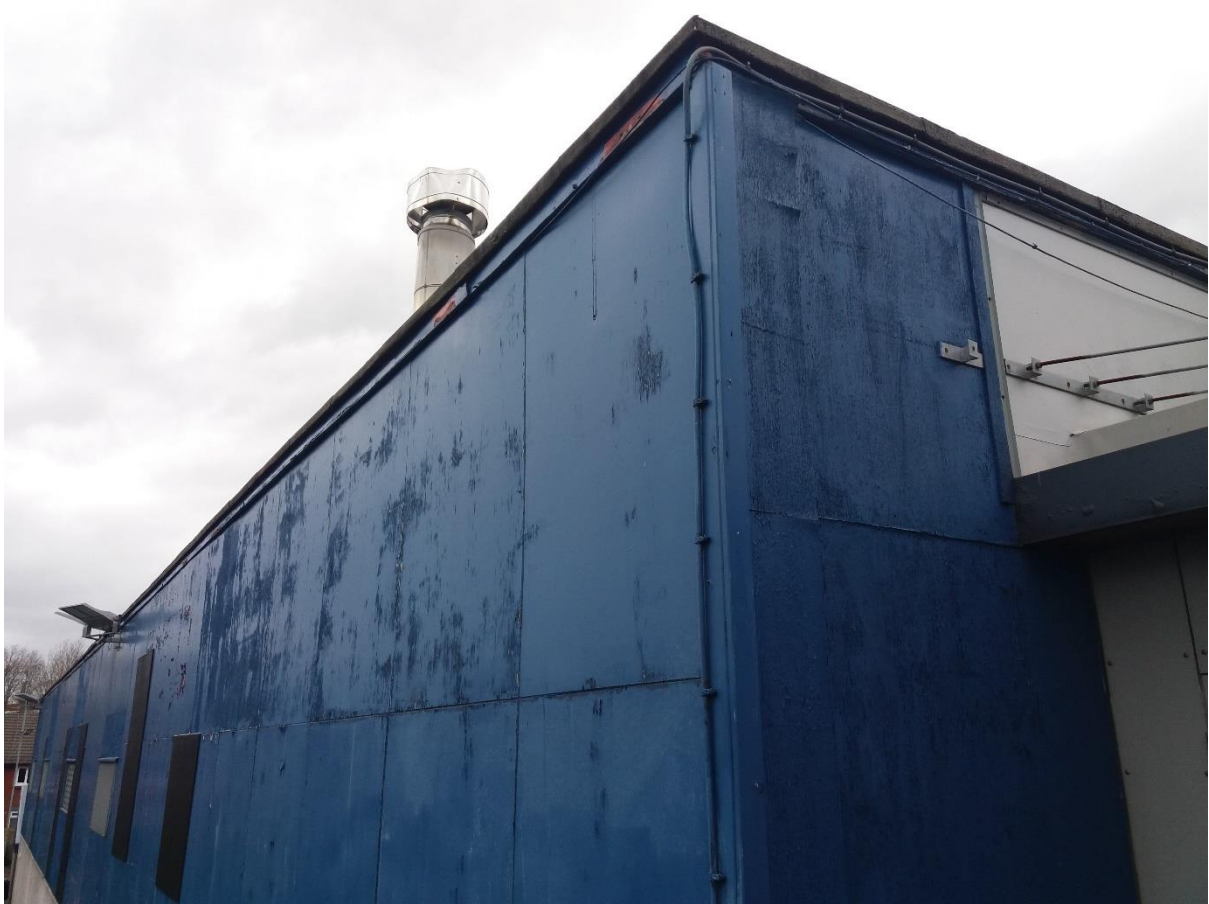
**Photo 4:** High level flat timber cladding at elevation number 2 at junction with first floor fire escape stairs.

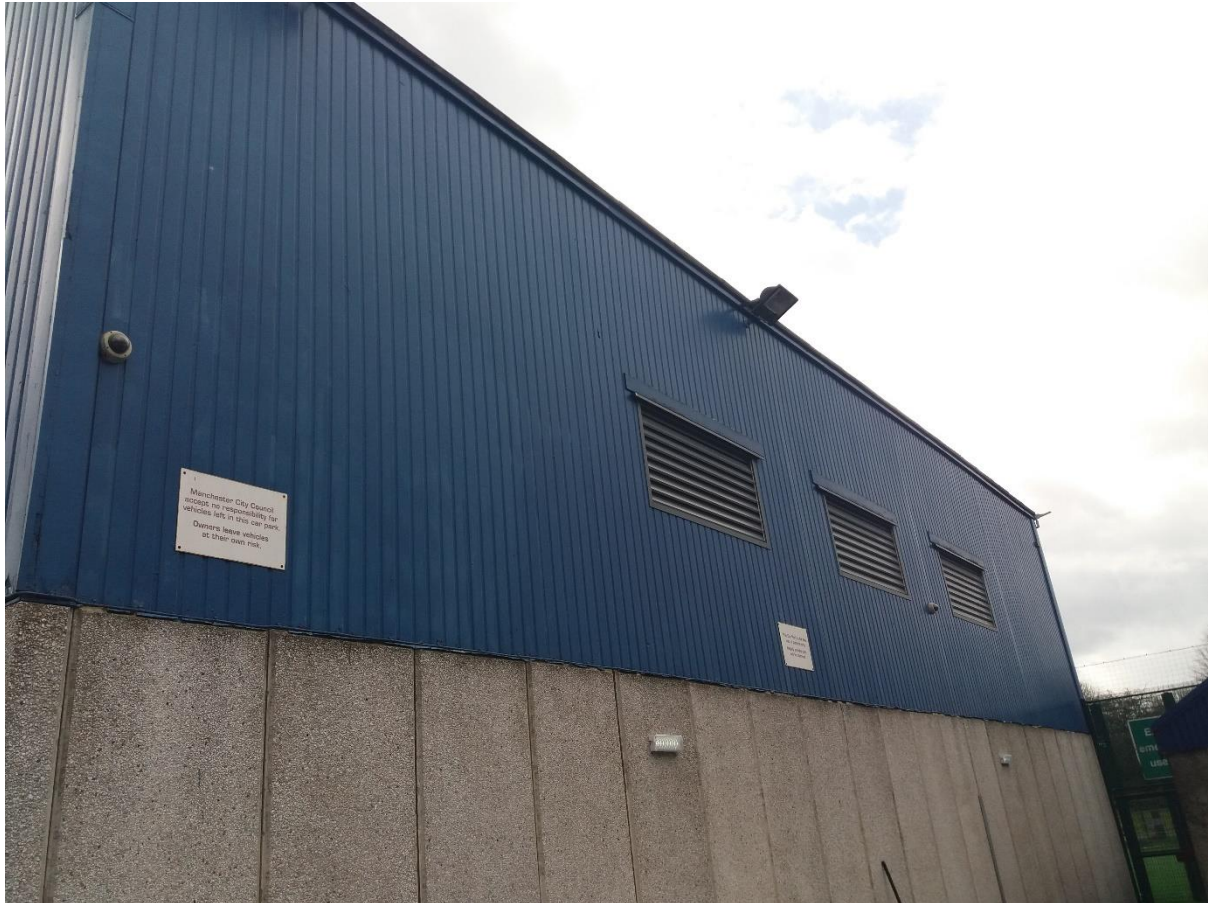
**Photo 5:** High level profiled timber cladding at elevation number 3.

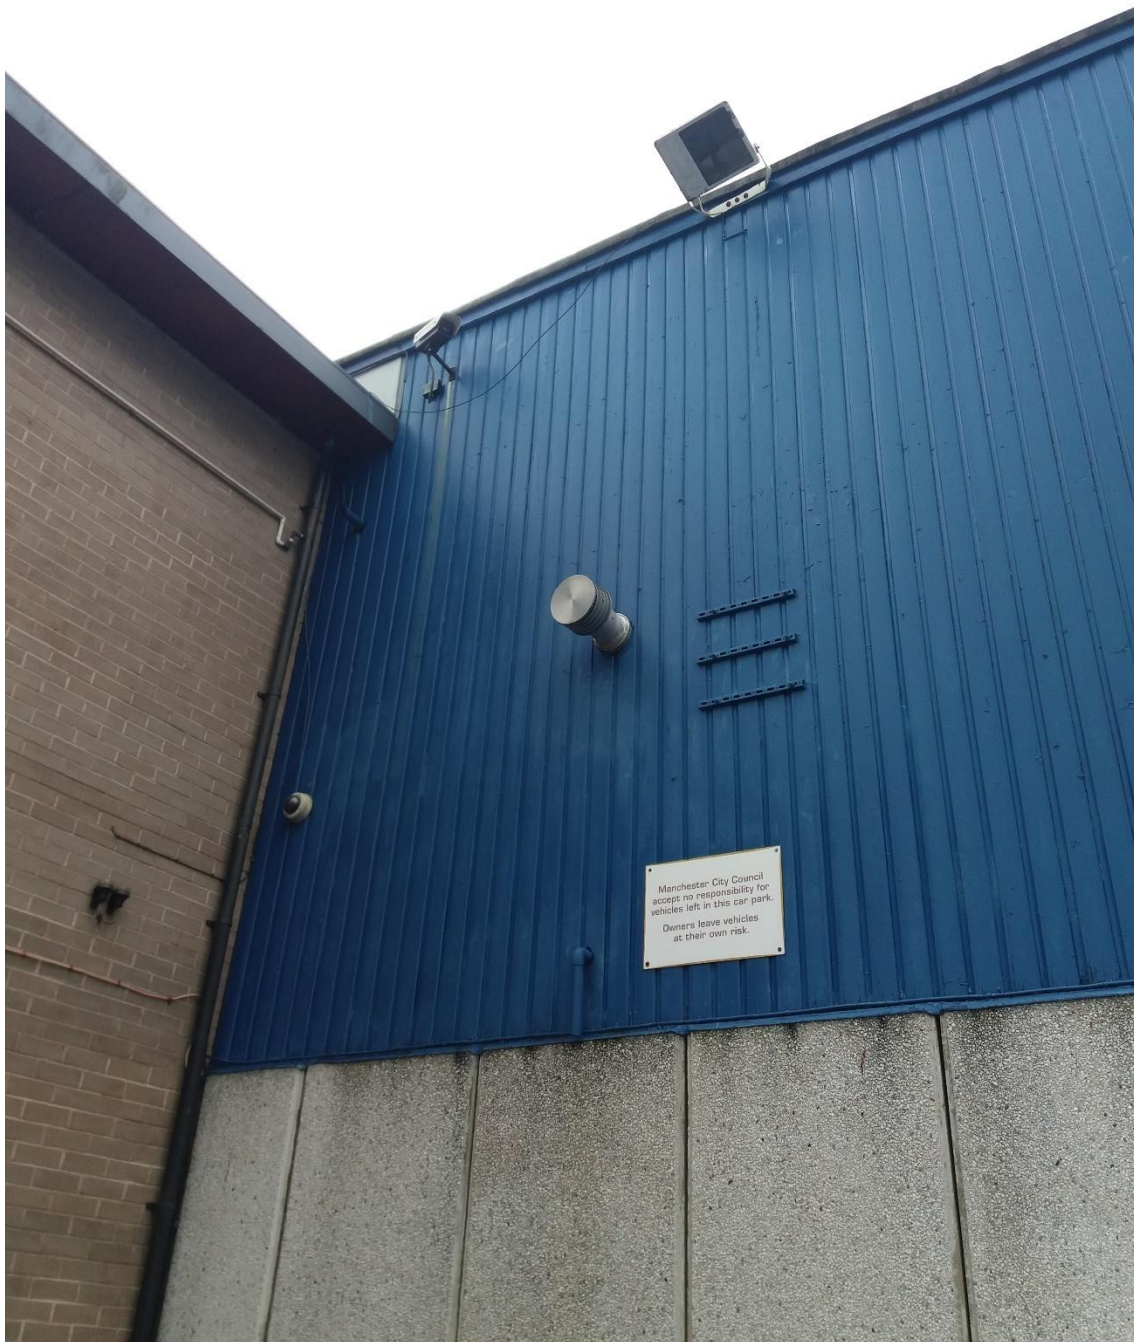
**Photo 6:** High level profiled timber cladding at elevation number 4 at abutment to brick elevation

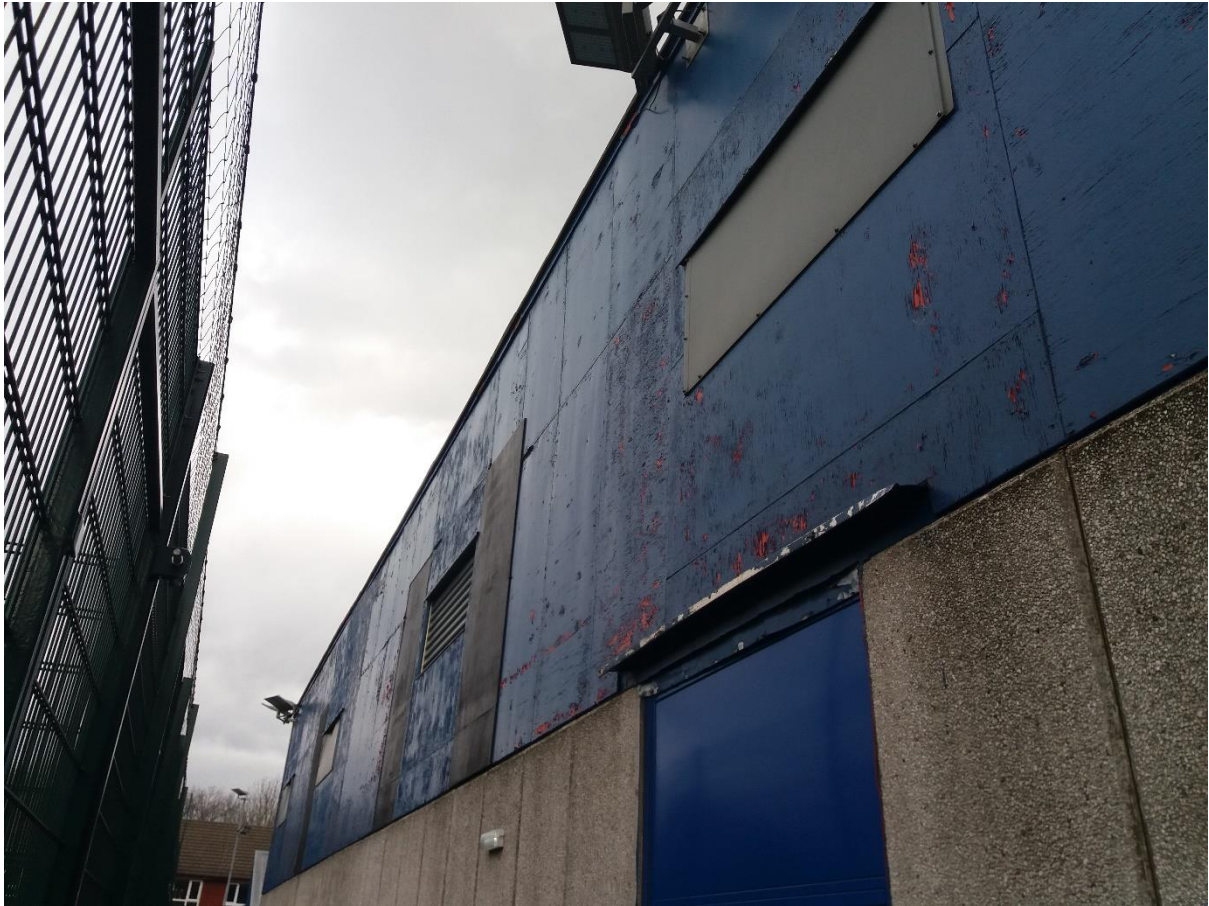
**Photo 9:** Looking up at elevation number 2. This pic shows the covered ventilation louvers and the poor condition of the flat timber panelling at high level and stained concrete panels at low level.

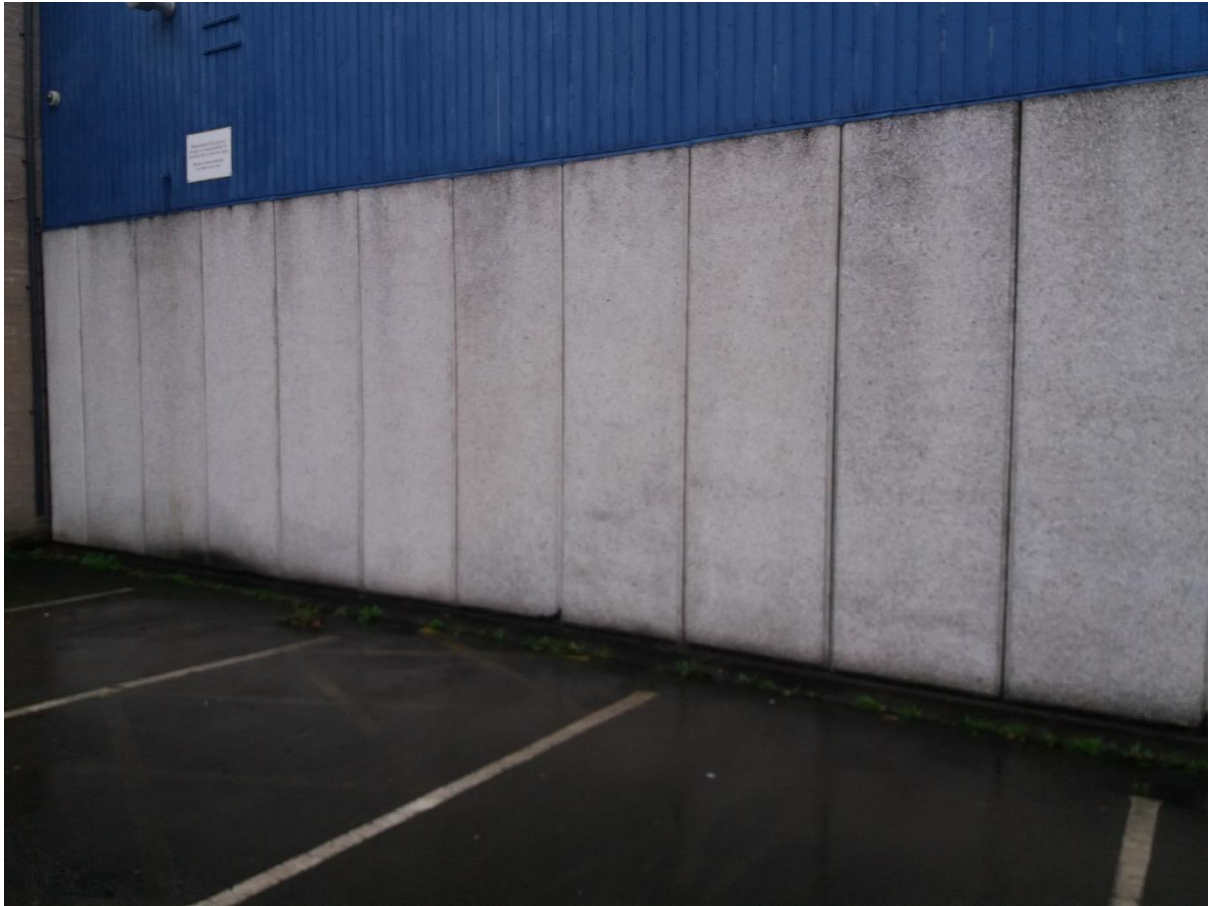
**Photo 10:** Dirt stained low-level concrete panelling at elevation number 4.

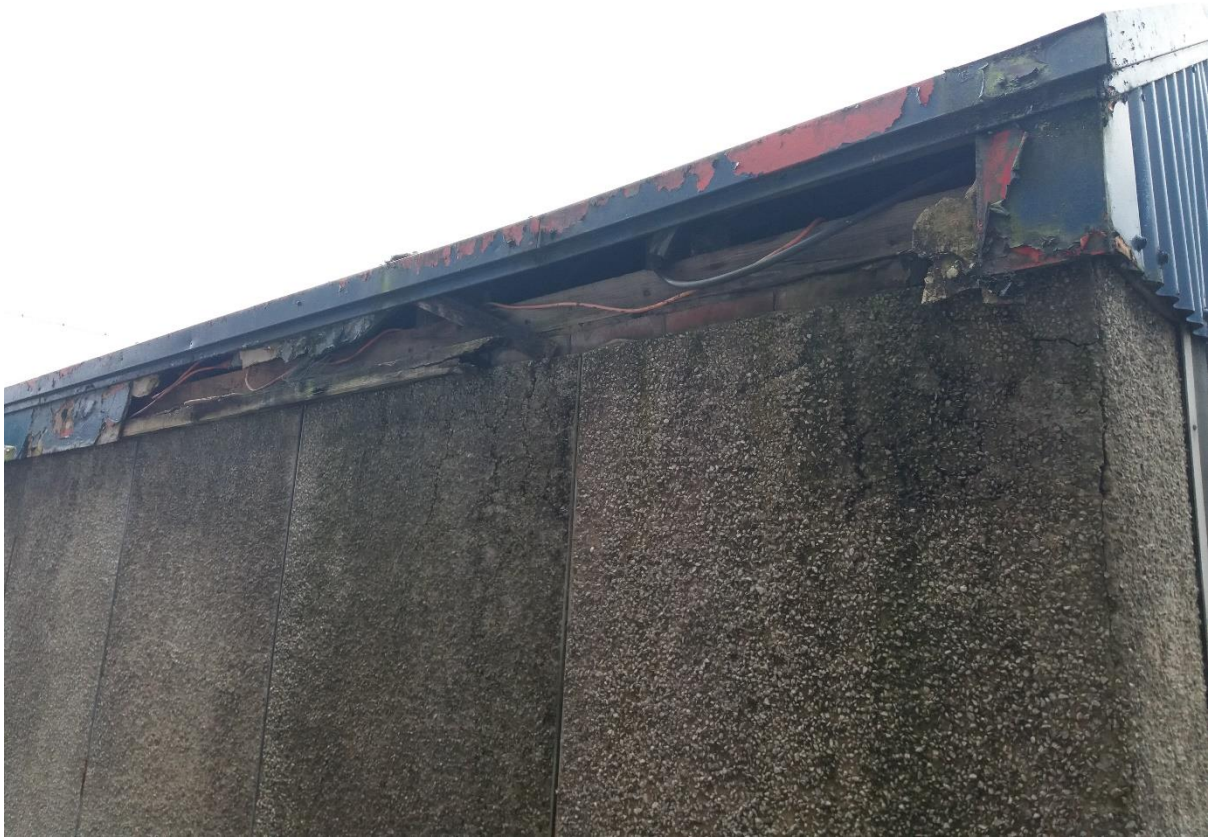
**Photo 12:** Remains of the existing fascia board to the garage outbuilding.

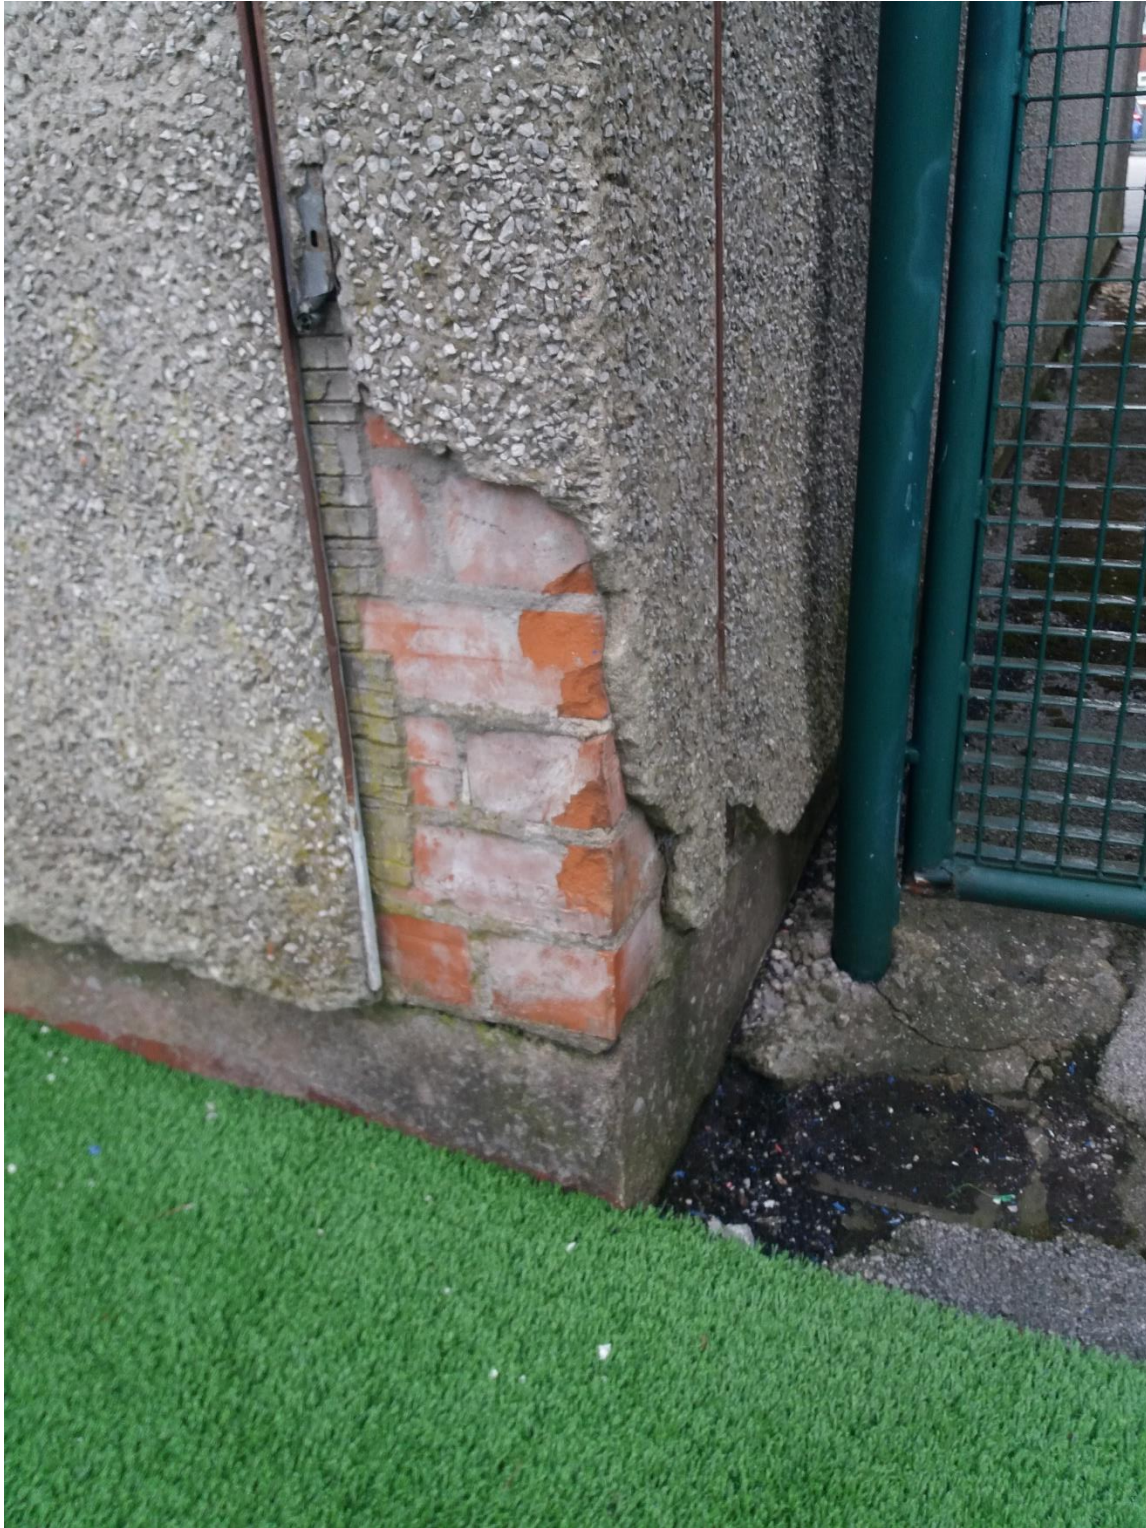
**Photo 13:** The damaged pebble dashed concrete render to the foot of the wall of the garage outbuilding.
