**REPORT ON COAL MINING RELATED SITE INVESTIGATIVE WORKS**

**UNDERTAKEN AT OSBOURNE'S YARD**

**MILES PLATTING, MANCHESTER M40 7PS**

**T190 SFK (TLC1140) rep RP LKConsult 250621 (Rev A)  
June 2021**

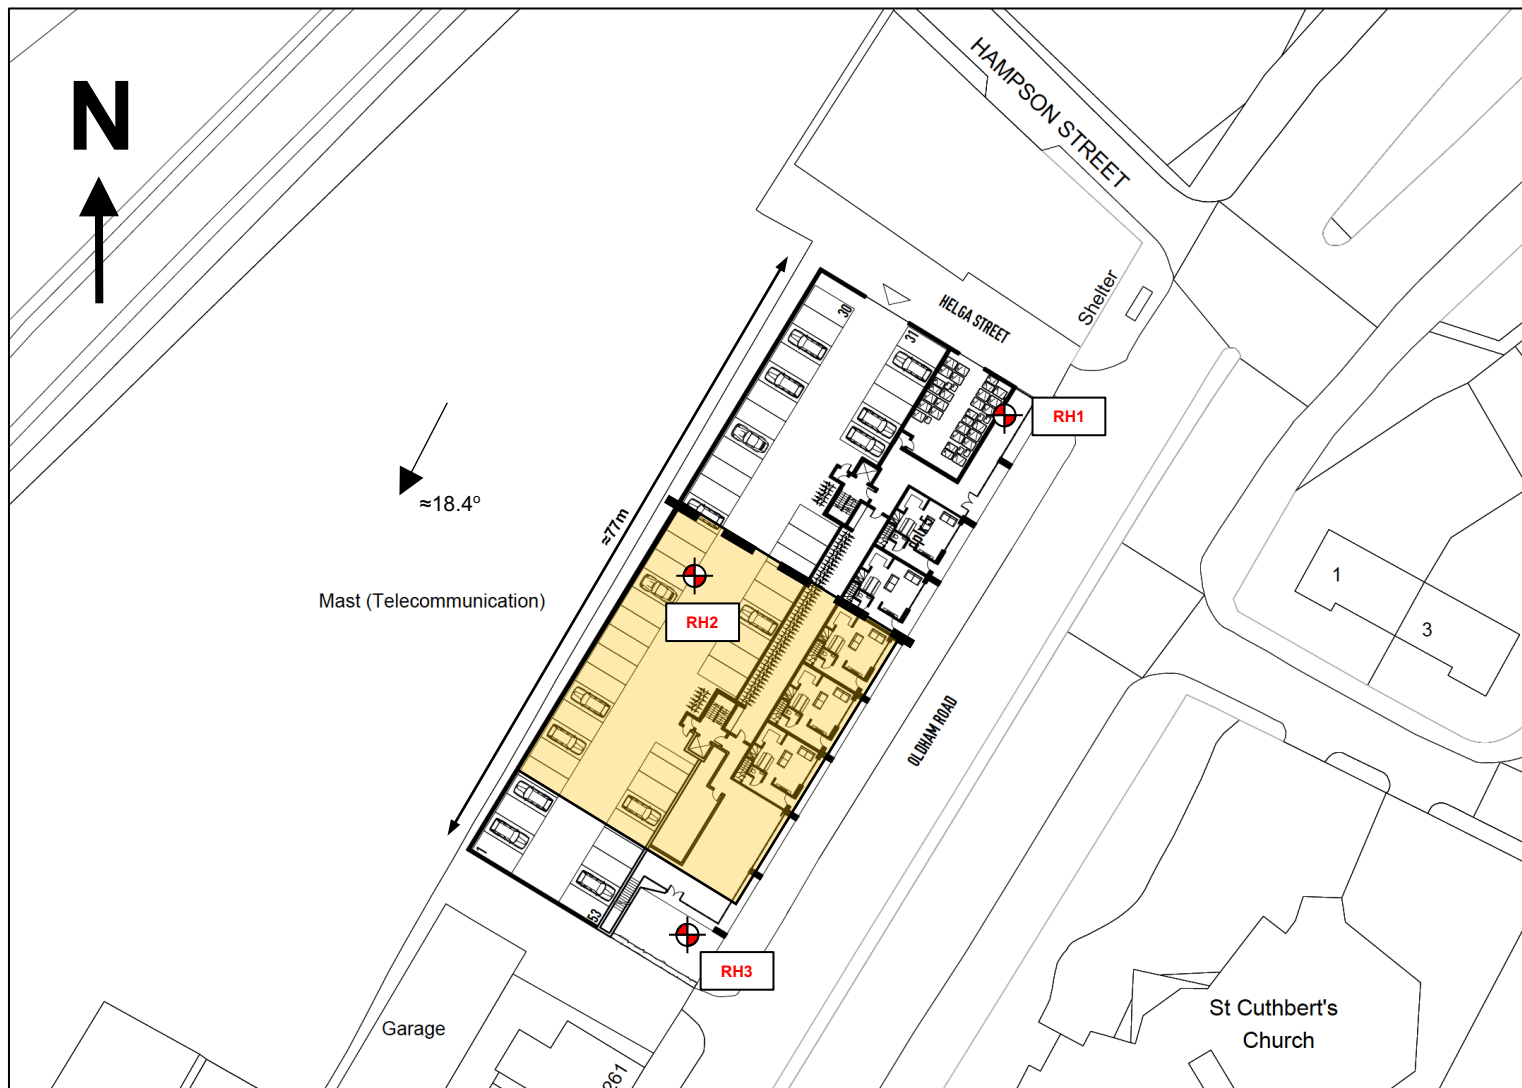
**Drawing No.: TLC1140/03**

- 4.1.1 Open hole rotary drilling, to determine whether the property is actually affected by shallow coal seams/workings, has been undertaken at 3no. locations (RH1 to RH3) across the site. The boreholes have been positioned at the north-east end, central and south-western of the site end as shown on Drawing No. TLC1140/03 in Appendix A.

- 5.3.1 CMS, comprising of horizons of MUDSTONE, SILTSTONE and SANDSTONE were encountered within each drill hole and proven to 40.00m depth. A 0.40m thick coal seam was recorded in RH2 only at a depth of 19.80m bgl. This coal seam could be either the Charlotte coal seam or the Bradford Threequarters coal seam if the BGS plotted positions are out by  $\approx 30$ -50m.

- 5.3.3 In the case of the current investigation, 100% flush returns were recorded throughout. Broken ground and voids were not recorded.
- 5.3.4 With a rock dip of around  $18.4^\circ$  down to the south-west, the RH2 coal seam would be expected to sub-crop  $\approx 10$ m north-east of RH2 and be present at around 33m depth in RH3. Therefore, the coal seam would not be expected to be encountered in RH1 which was sunk in the far north-east of the site. However, the coal seam should have been encountered in RH3 but wasn't – possible reasons for its absence in RH3 are given below:

- 6.10.7 However, the risk to the south-western portion of the proposed development from unrecorded shallow workings within the Bradford Threequarters (or Charlotte ?) coal seam is considered to be low to moderate. Consequently, it is advised that a programme of precautionary proof drilling (and pressure grouting if necessary) is carried out beneath and just beyond the south-western portion of the proposed building; Drawing No. TLC1140/03 in Appendix A displays the area where the works should take place. Holes should be sunk on an ≈12m grid spacing. The grid would need to be reduced significantly in the event that coal workings are proven/suspected.
