**Our ref** 1765/SKR/L001

**Date** 01/06/2021

**RE:** Refurbishment of Roof, 45-47 Dale Street, Manchester

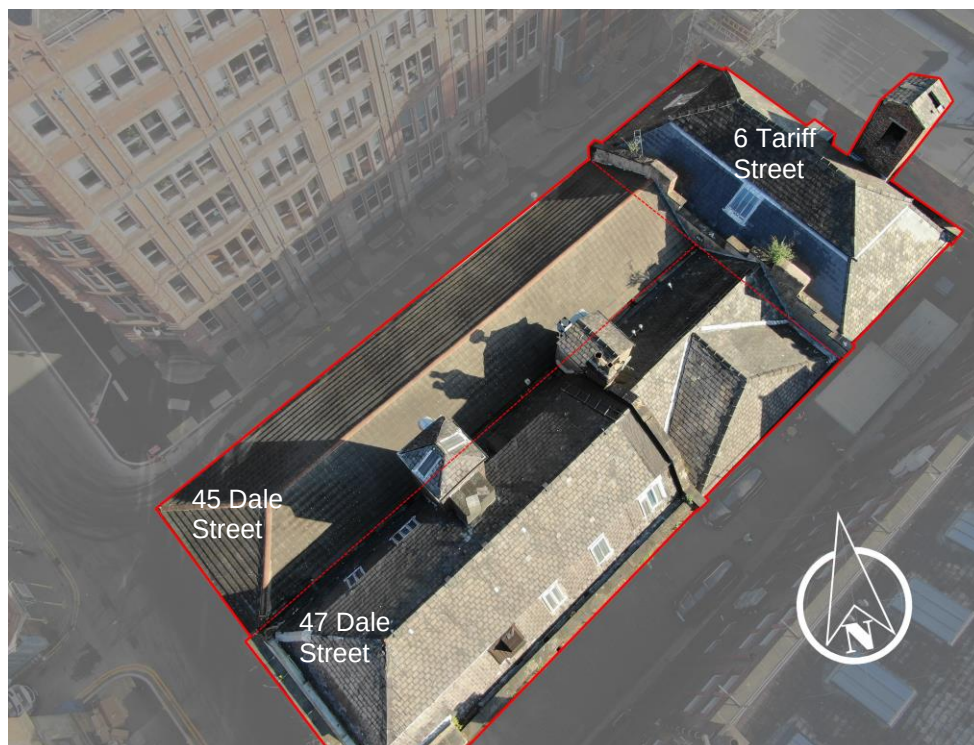
The roof scape is formed by a number of hipped roofs as seen from a drone survey undertaken by Westlakes on the 12<sup>th</sup> April 2021.

**Figure 1 – Image from drone survey**

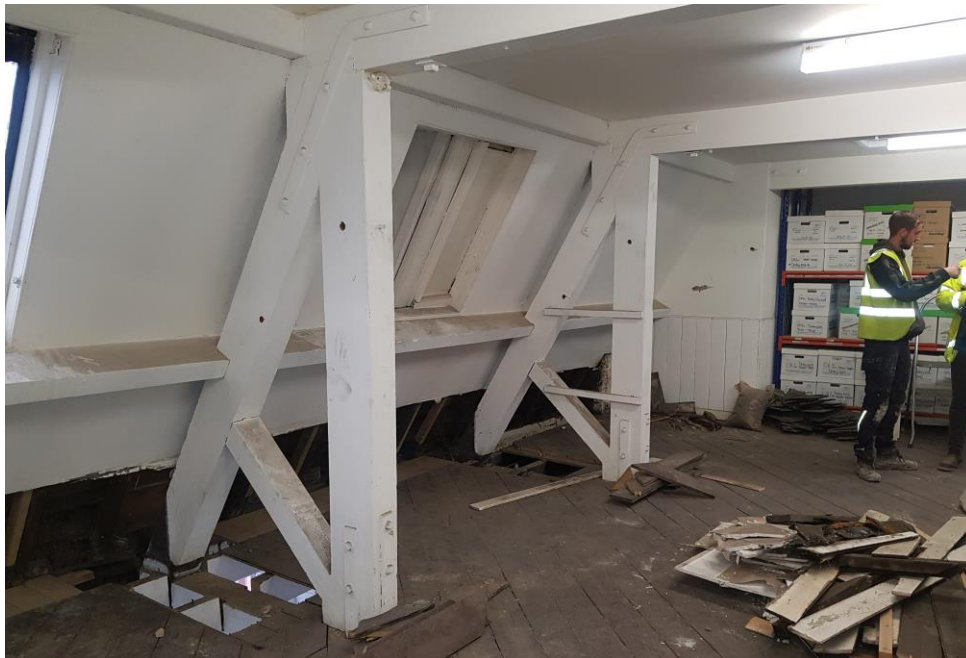
The trusses over 47 Dale Street are typically a form of Gambrel Attic in creating a mansard roof form with space within the loft, currently used for storage. These trusses span from the party wall between 45-47 Dale Street and Lizard Street. The trusses are at approximately 2.55m centres with a span of circa 7.50m refer to Figure 2 below. There are two masonry towers that are located on the party wall line with 45 Dale Street.

**Figure 2: Photograph of internal roof space to 47 Dale Street**

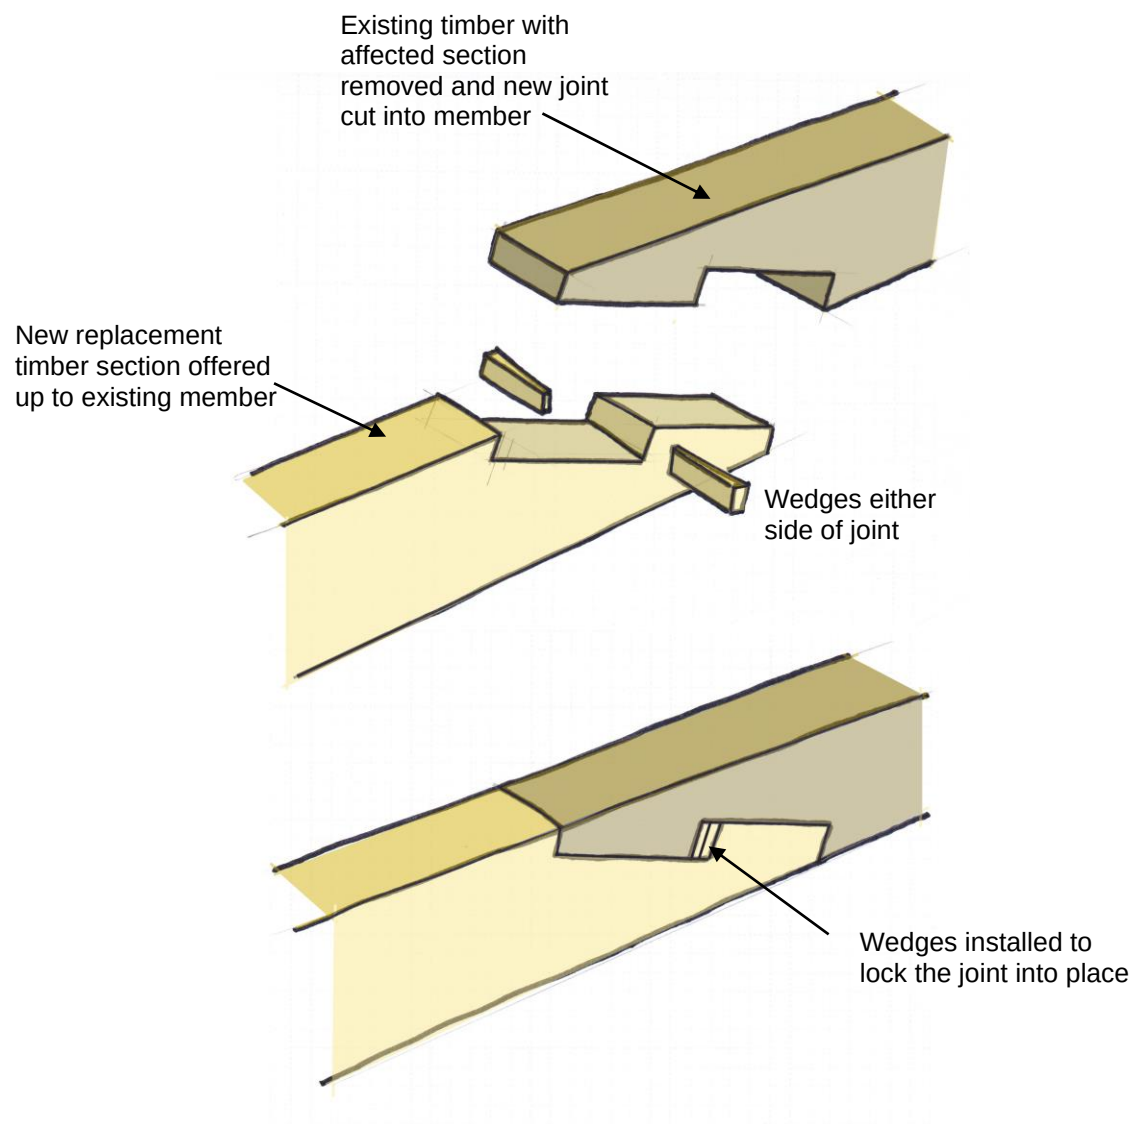
**Figure 3 – Example of a scarf joint**

Where replacement of timber sections is required, it is proposed that the affected timber is cut out and replaced with the same species and grade of timber where possible, utilising scarf joints where appropriate to the situation. An example of a splayed scarf joint with a wedge system is indicated in Figure 3 and would be utilised at the end of members suffering from water damage and or rot.

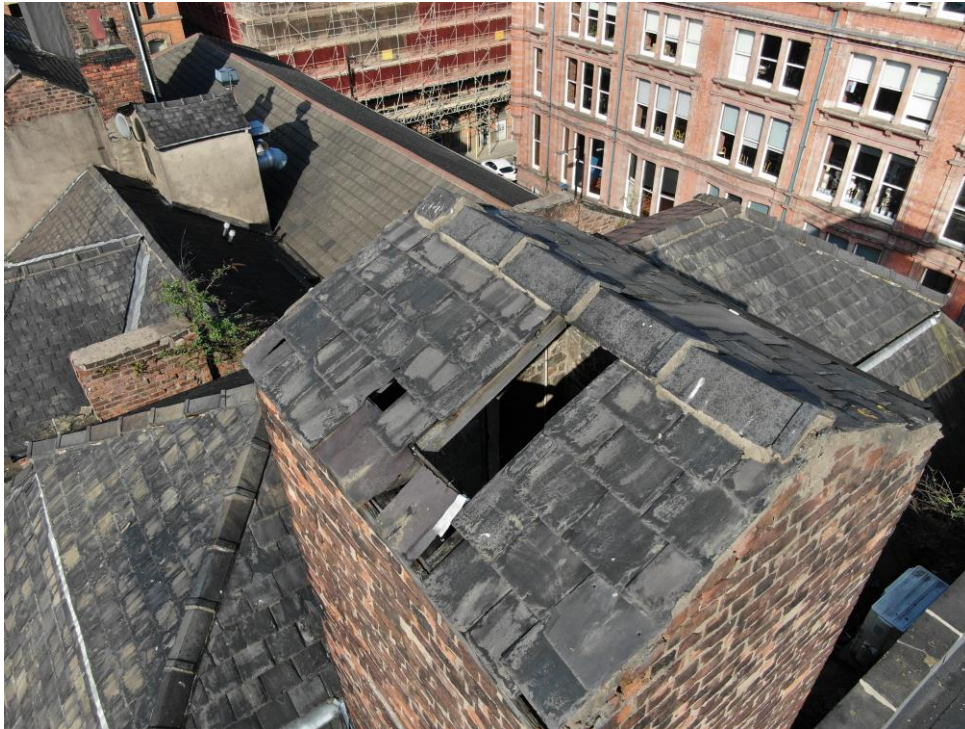
**Figure 4 – Image from drone survey showing the existing lift shaft to be removed in the foreground.**

With regards to the removal of the existing disused lift tower, refer to Figure 4, it is proposed that the masonry tower is deconstructed to below the roof line with minimal impact on the roof structure. The void created in the roof is to be infilled using structural framing to match the existing roof structure to retain the original features of the roof as far as reasonably practicable.
