## **Beech Design & Build**

Mindel House and 11 Bloom Street,  
Manchester

## **Heritage Assessment**

June 2021

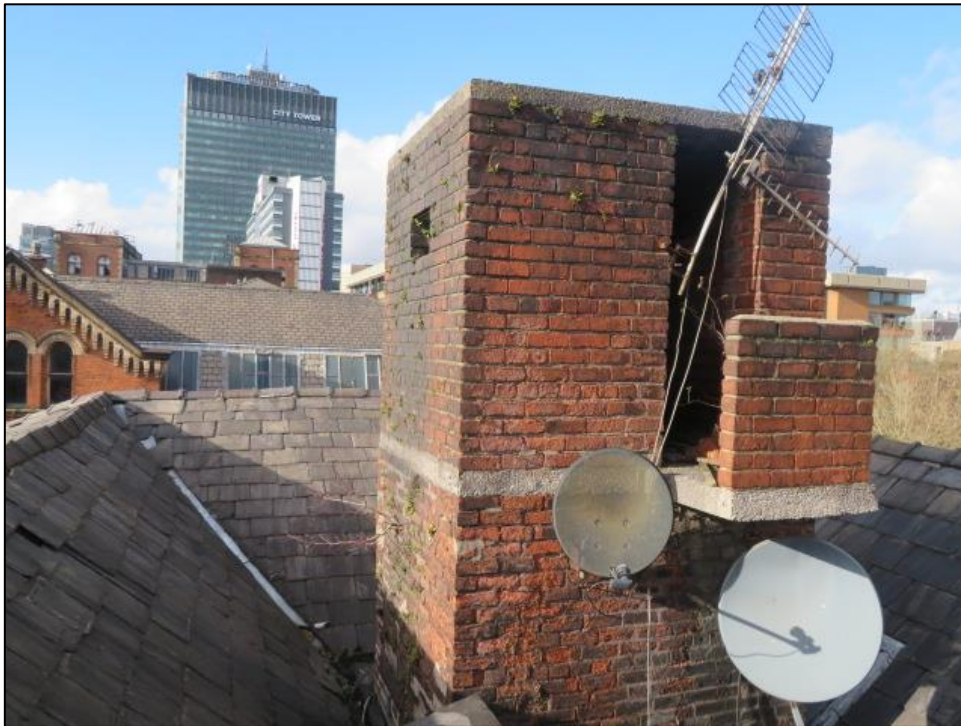
Figure 1: Photograph of brick shaft housing showing concrete slabs, spalling brick and vegetation growth.

- 3.4 The existing brick shaft housing is a later addition to the building. The element is in poor physical and visual condition, with delaminated concrete slabs; signs of structural movement; eroded pointing; loose, spalling and delaminating brick; and vegetation growth. Its exposed position means it will be prone to further weathering and deterioration, whilst access difficulties would make continued maintenance and upkeep difficult. The interface with the inner roof valley pitches also presents issues and is an inherent defect vulnerable to failure and extensive build-up of debris and vegetation. The housing structure/overrun is of no visual merit and does not make a positive contribution to the building. Whilst there was likely to have originally been a central lift shaft feature in the building its appearance is not known.

- 3.5 In term of heritage impact the removal of the existing housing will have **no-minor negative heritage impact**, although it will address future maintenance complications that would be associated with its retention. The new flat roof that will be created within the centre of the building, therefore it will not be visual / prominent from any surrounding buildings and will be concealed by the surrounding pitched roofs. The use of a high performance elastomeric mineral surfaced three layer felt system will provide a long-lasting and waterproof surface which will be backed by a 20 year guarantee covering design, materials and workmanship. The surface will have a blue grey coloured finish ensuing that it will be discrete and will not be prominent if any glimpses are possible from any buildings in the vicinity. The material will also be a cost effective option for this location, enabling investment to be focused on more prominent elements of the building and those of greater heritage significance, rather than expending significant funds on this element of no-low heritage value. Repairing the shaft would be very challenging from an access/practicality point of view, and even after repair ongoing maintenance and the inherent flaws of the design mean that retention is not the best option for the long-term future of the building. The internal shaft is being retained in full as per the existing approval and no works are proposed as part of this amendment. On the basis of the above assessment it is considered that there is a clear rationale for the proposed amendment which should be supported.

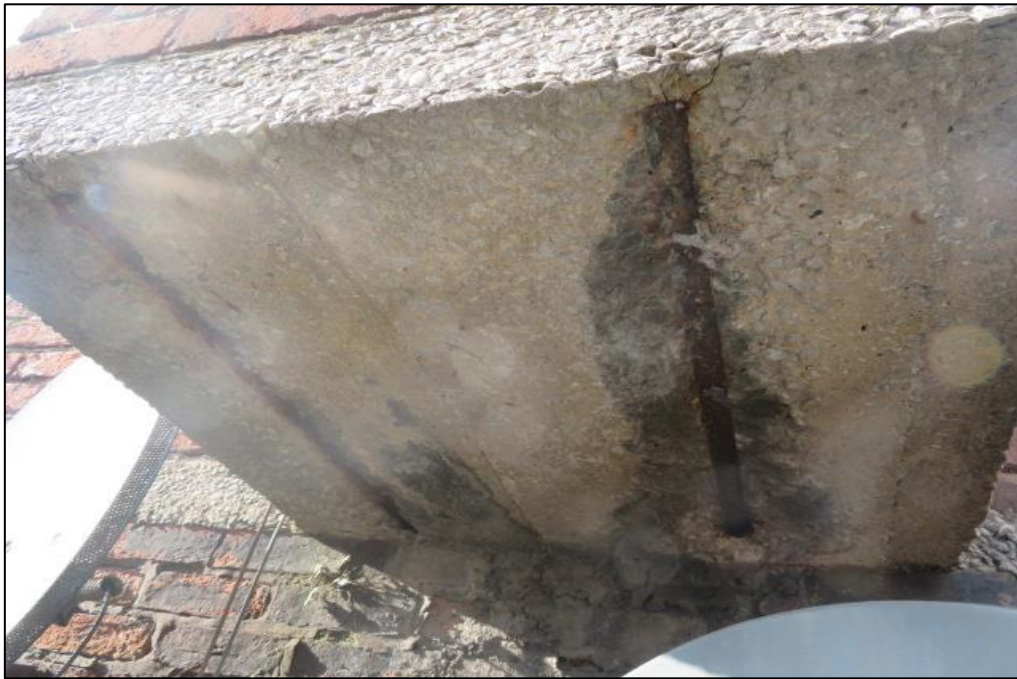
Figure 2: Photograph showing delaminated concrete and spalling brick of the hoist overrun.

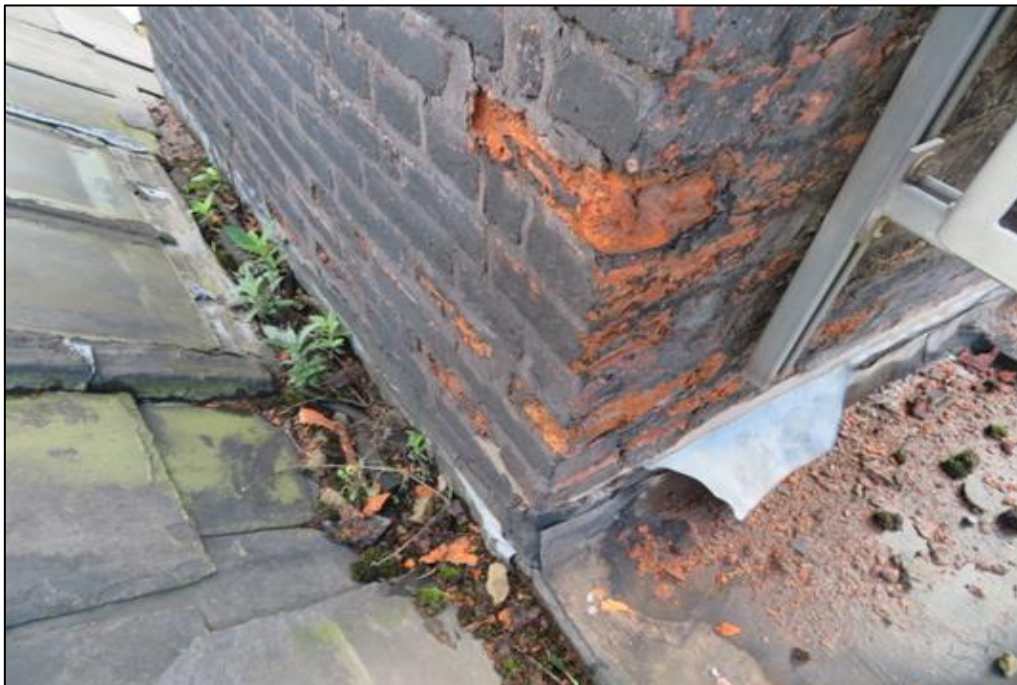
Figure 3: Photograph showing detail of brick shaft with roof valley. The design of which presents an inherent defect vulnerable to failure and build-up of vegetation.

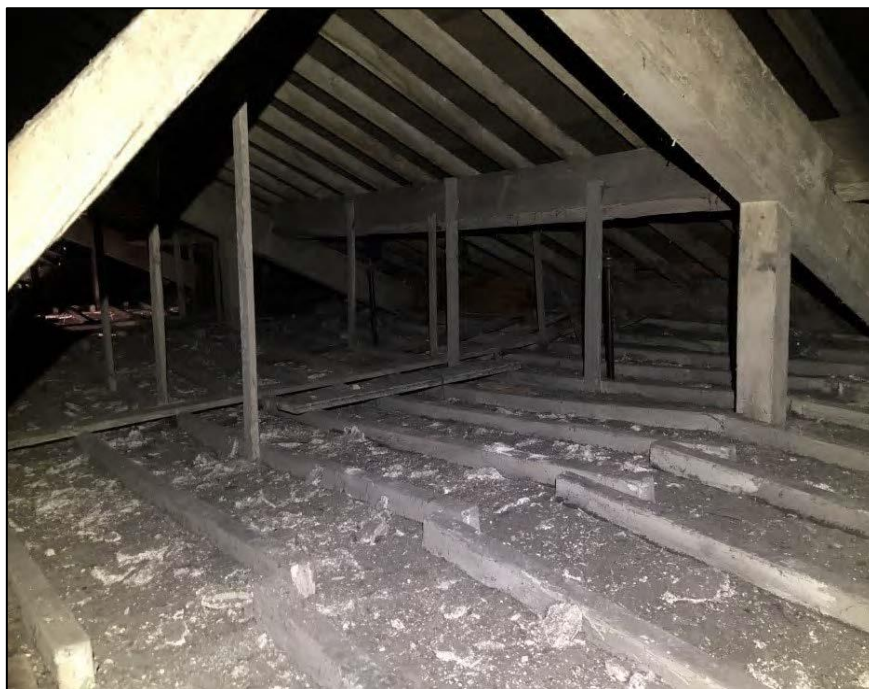
- 3.8 Hutton + Rostron confirm that the condition of the plaster 'keys' varies but, invariably, they are damaged and or non-existent. Deflection of the joists combined with the deposited 'torching' are the most significant contributing factors to the damage observed. The extent of broken plaster keys is causing increased loading on the adjacent plaster keys, increasing the risk of unstable plaster detaching.

Figure 4: Photograph of roof structure showing extensive deposited 'torching'.

- 3.11 Given the structure and condition of the ceiling, replacement is confirmed as necessary by the structural engineers. The proposed amendment involves careful vacuuming / removal of all excess lime mortar debris and all other detritus to expose the top of the ceilings. The existing plaster keys will be removed and the existing timber laths will be carefully removed and set aside for re-purposing, where practicable. Replacement re-sized timber ceiling joists will be installed (according to the structural engineer's recommendations) and new vapour permeable non-combustible fire resistant ceiling boards will be installed to ensure compliance with Building Regulations.

- 3.12 The lath and plaster ceiling will be reinstated to provide a finished ceiling level. Salvaged laths are to be re-used, supplemented with replacement laths where necessary (e.g. riven chestnut or larch) from an approved supplier to complement existing, and nailed to the underside of the replacement timber ceiling joists. Subject to testing, lime plaster appropriately mixed with approved fine sharp washed sand and cashmere goat hair / horse hair will be scratched into the lath. Subject to dampening and adequate drying between coats, a floating coat will be applied with a key provided before the final finishing coat of lime plaster is provided. After adequate drying time, the newly plastered ceilings will be painted with a suitable vapour permeable paint system. Breathable natural insulation material will be laid across the ceiling in accordance with English Heritage / Historic England technical recommendations.

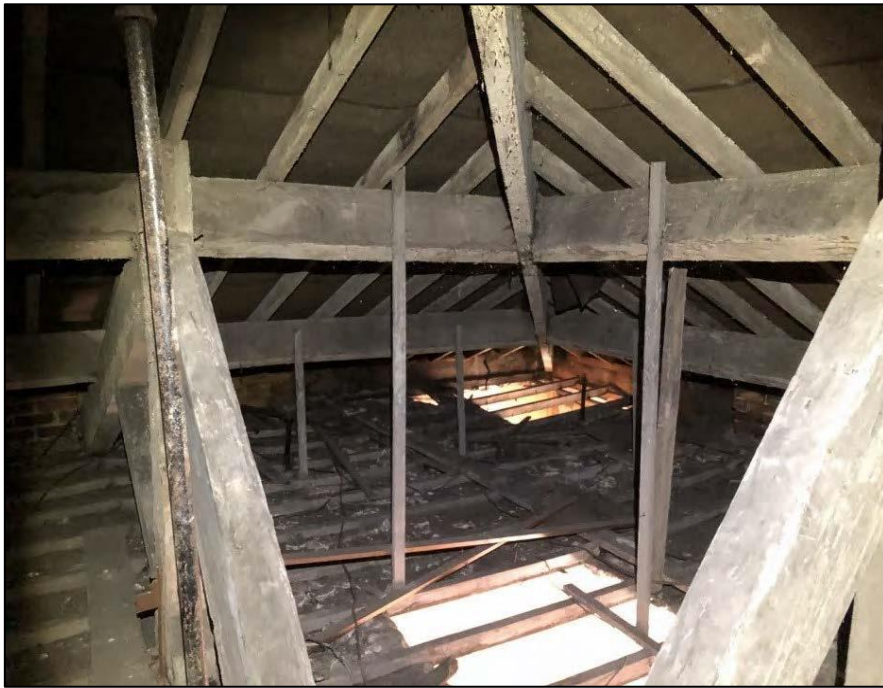
Figure 5: Photograph of roof structure showing extensive deposited 'torching' and failed areas of lath and plaster ceiling.

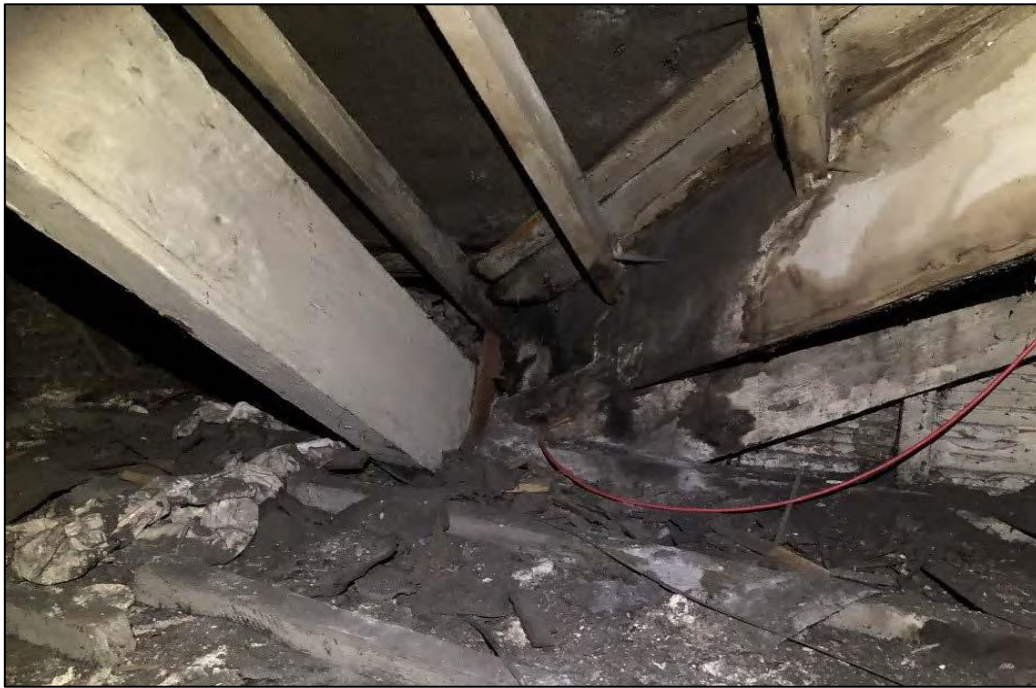
- 3.9 A history of water penetration to the perimeter and centre of the ceiling has resulted in partial decay of the timber laths. Lath and plaster and ceiling joists have also been removed in part to provide access to repair decayed roof timbers. New softwood joists with plasterboard and skim has been reinstated in such areas.

Figure 6 Photograph of roof structure showing water damage.

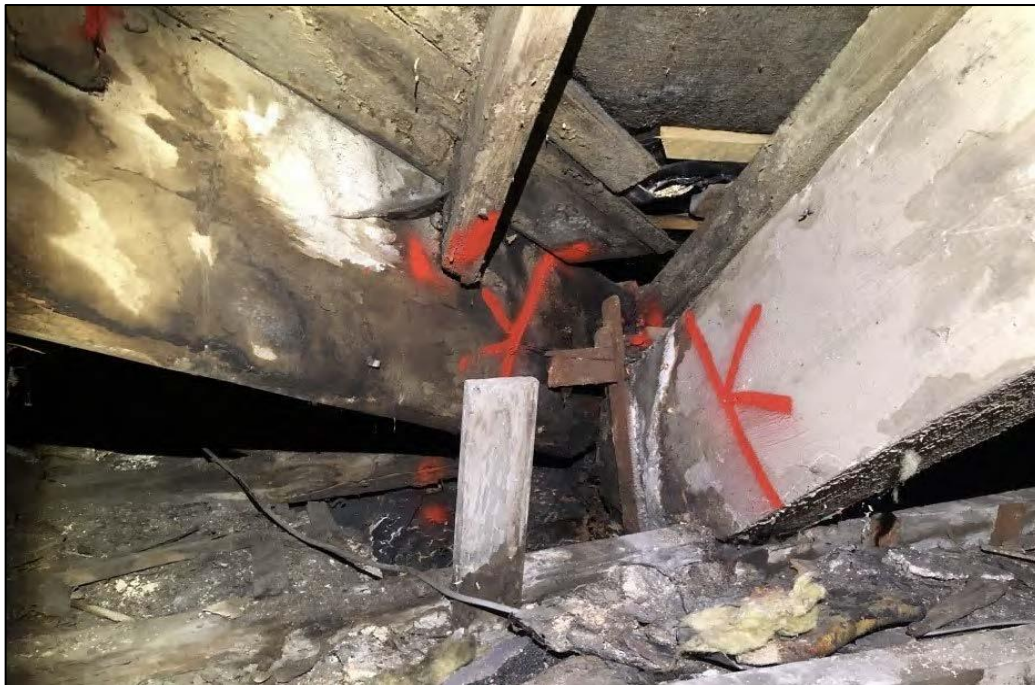
Figure 7: Photograph of roof structure showing water damage.
