**Project****Project Name:** Caddick Construction Ltd**Project Date:** 15/04/2021**Inspection Standard:** MSCC5 Sewers & Drainage GB (SRM5 Scoring)

**Company:** Openshaw Campus  
**Contact:** Andrew  
**Street:** Ashton Old Road  
**Town or City:** Manchester  
**County:** Lancashire  
**Post Code:** M11 2WH  
**Mobile:** 07801968440

**Company:** Lanes Group PLC  
**Contact:** Bradley Offiler  
**Department:** Operations  
**Street:** 17 Parkside Lane  
**Town or City:** Leeds  
**County:** West Yorkshire  
**Post Code:** LS11 5TD  
**Phone:** 0113 3858400

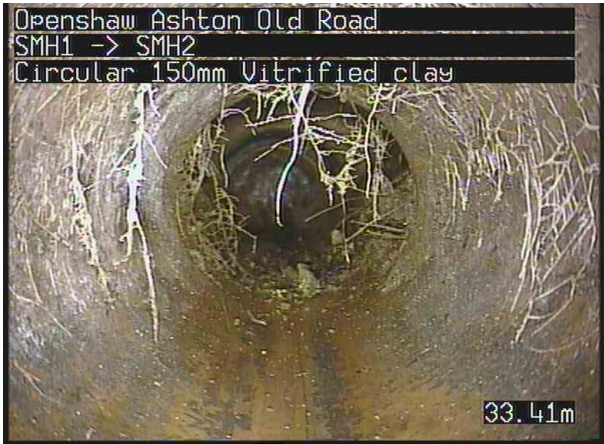
SMH1X\_c4a317ae-44a0-4e5f-b158-8d964b1a9f82\_20210415\_104803\_901.jpg, 00:03:50, 33.35 m  
Roots, tap at joint

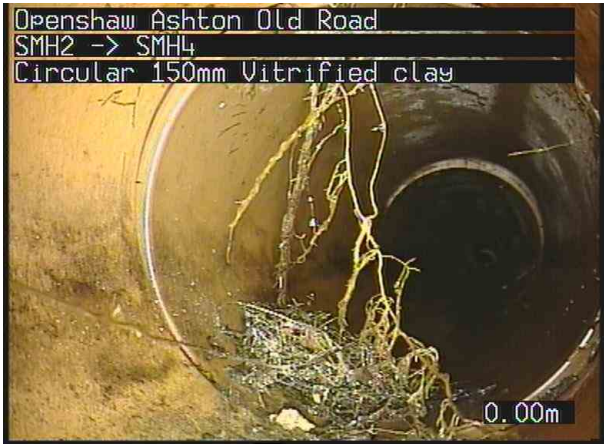
| Scale: | 1:67 | Position [m] | Code | Observation | MPEG | Photo | Grade |
|---|---|---|---|---|---|---|---|
| | 0.00 | RTJ | Roots, tap at joint | 00:00:08 | SMH2X_e<br>e43484f-e<br>7f7-473d-8 | 4 | |

SMH2X\_ee43484f-e7f7-473d-87f7-d22fa0666fb5\_20210415\_112957\_740.jpg, 00:00:08, 0.00 m  
Roots, tap at joint

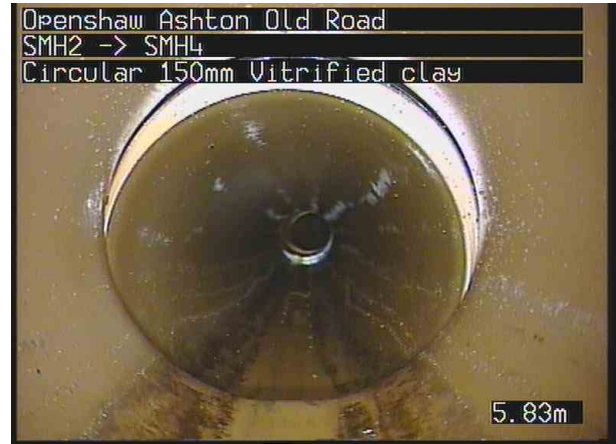
| Scale: | 1:67 | Position [m] | Code | Observation | MPEG | Photo | Grade |
|---|---|---|---|---|---|---|---|
| | 5.83 | JDM | Joint displaced, medium | 00:01:37 | SMH2X_c<br>a212ce1-1<br>c5c-466d- | 1 / 3 | |

SMH2X\_ca212ce1-1c5c-466d-986b-e1789575d57b\_20210415\_113131\_235.jpg, 00:01:37, 5.83 m  
Joint displaced, medium

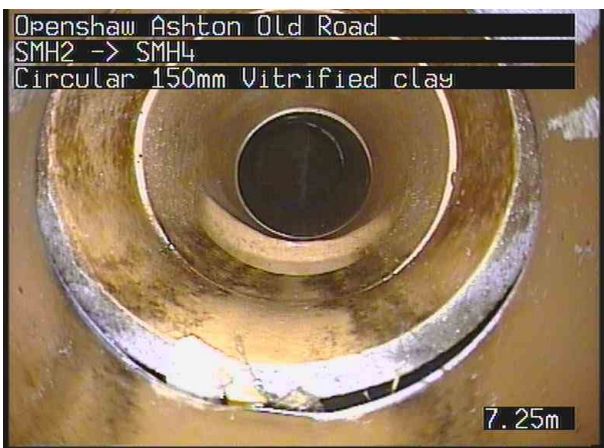
| Scale: | 1:67 | Position [m] | Code | Observation | MPEG | Photo | Grade |
|---|---|---|---|---|---|---|---|
| | 7.25 | JDM | Joint displaced, medium | 00:02:00 | SMH2X_9<br>c6d7cf7-3c<br>68-4f82-b8 | 1 / 3 | |

SMH2X\_9c6d7cf7-3c68-4f82-b8cb-05fd4beaf2af\_20210415\_113158\_400.jpg, 00:02:00, 7.25 m  
Joint displaced, medium
