### Additional Photos:

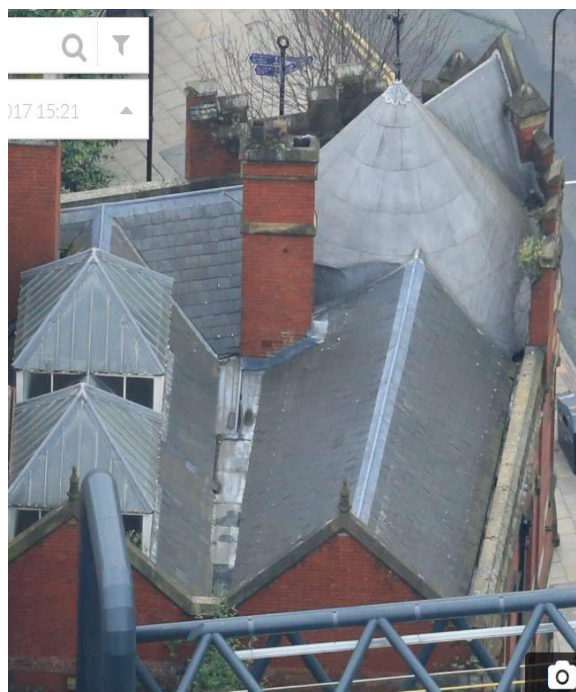
Historic patch undertaken as a result of previous leaks

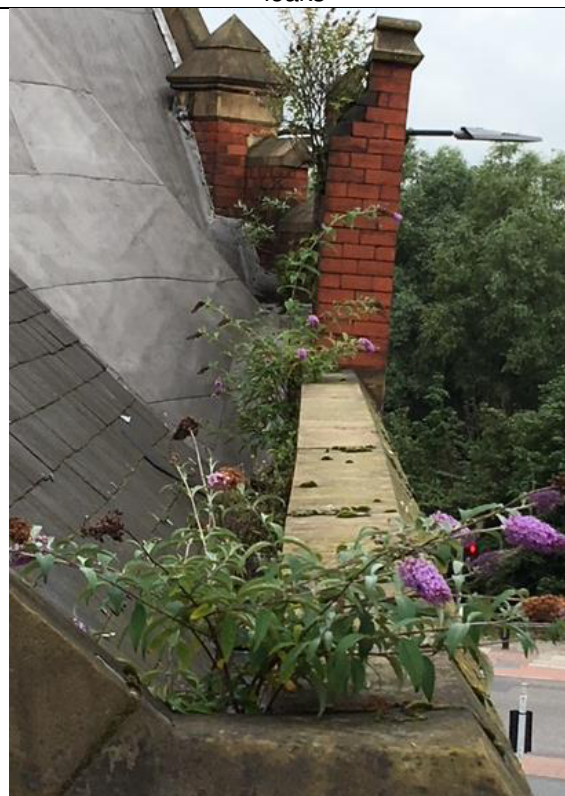
Buddleia through the parapet. Possibly damaging stonework

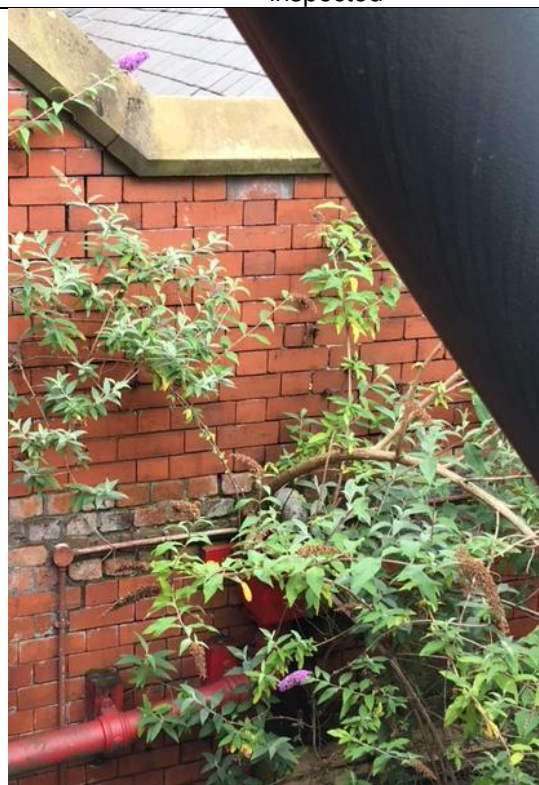
Overgrown vegetation causing damage to brickwork and hopper

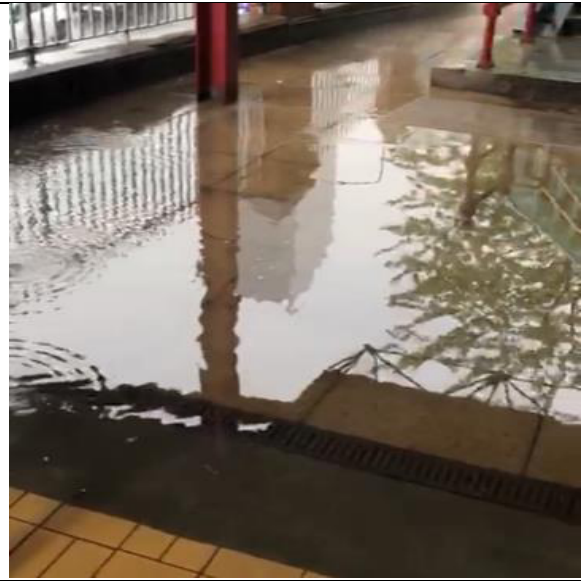
Historic flooding, aco drain not adequate
