## GeoEnvironmental Desk Study

The Manchester College  
Harpurhey  
Manchester

August 2020

**Report No. A3545/20**

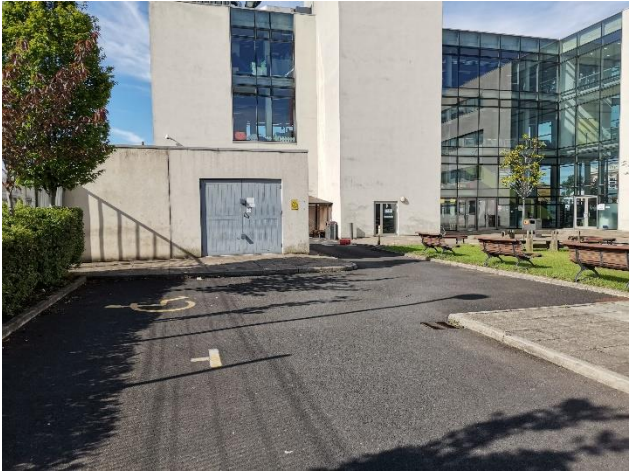
| <p><b>Plate 1 Viewing south from access gate showing substation and northern boundary of the site.</b></p> | <p><b>Plate 2 View showing the electricity substation and ventilation from the building, smoking area and the north western boundary of the site (partly soft standing). Viewing south.</b></p> |

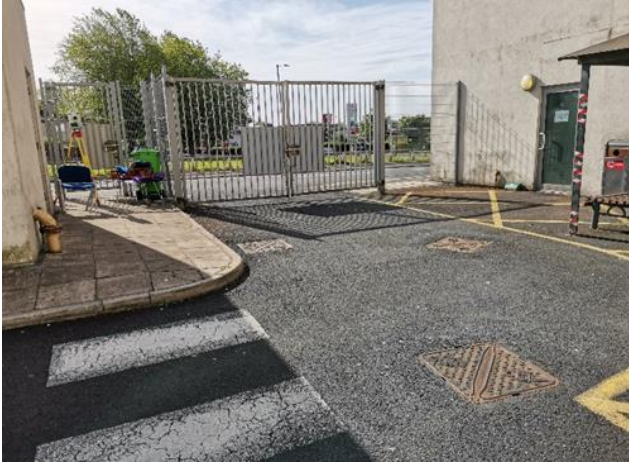
| <p><b>Plate 3 View of the southern side of the site including disabled access to the college campus and manhole covers. Note pipes coming out of both buildings. Viewing east.</b></p> | <p><b>Plate 4 Viewing northeast showing disabled access gate, access to substation and access to refuse store.</b></p> |

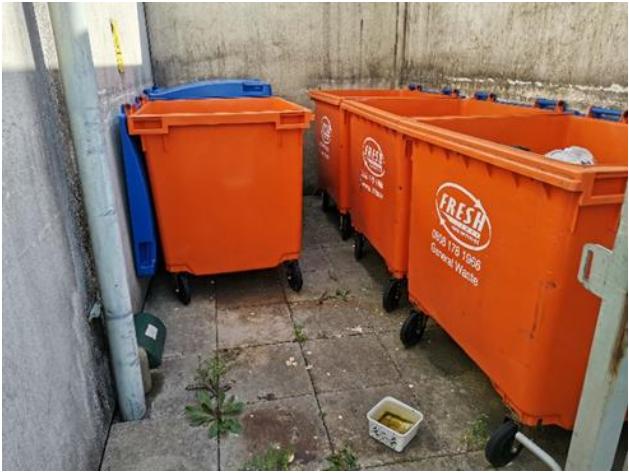
| <p><b>Plate 5 Viewing northeast showing refuse storage including general waste and cardboard. Drainage pipe on east wall of substation with redundant extinguisher and pest control box adjacent.</b></p> | <p><b>Plate 6 View of the western boundary with college building and hard standing adjacent. Soakaway present.</b></p> |

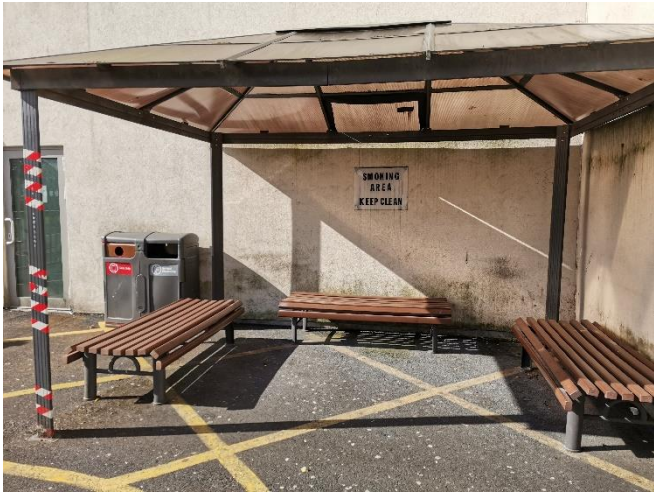
| <p><b>Plate 7 Showing smoking area and shelter in west corner of the site. Shelter 2-2.5m in height with corrugated plastic roof and metal supports.</b></p> | <p><b>Plate 8 Viewing north, showing electricity substation and college campus in the background. Water feature lies adjacent to site and large chimney is a listed building from old public baths.</b></p> |
