## GAS MEMBRANE VALIDATION

| <b>Site: Bowes Street</b> | |
| Date: 26-11-2020 | Project Number: 11-813 |
| Ground Gas Risk Assessment: <b>Characteristic Situation 2 / Amber 1</b> | |

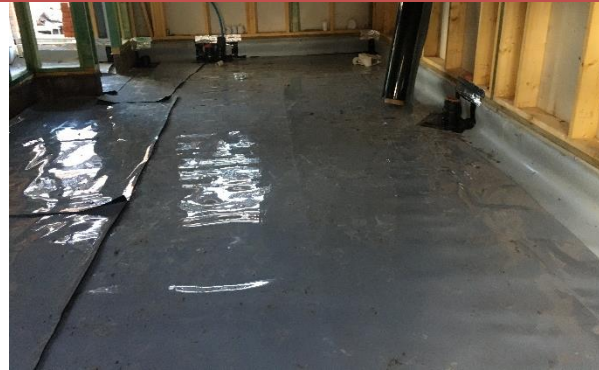
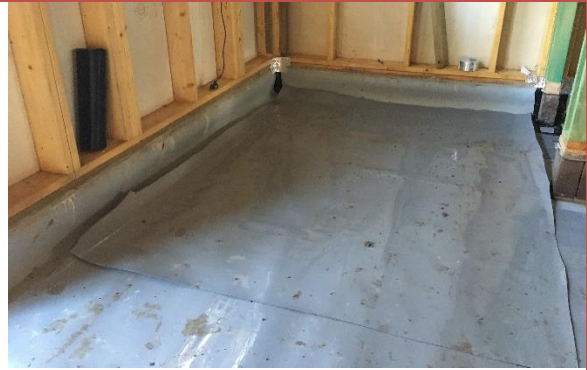
**Plot – 7**

**General Condition of Membrane-Good Condition**

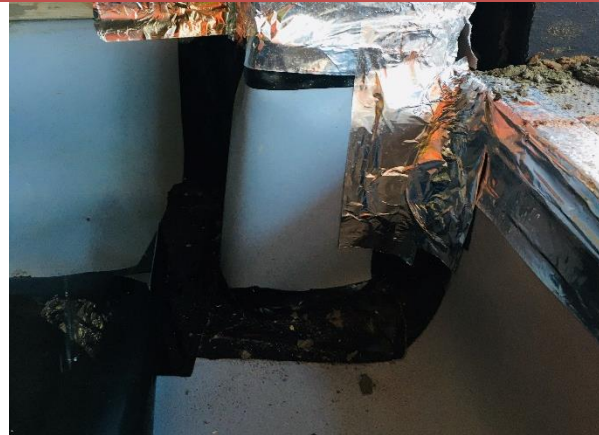
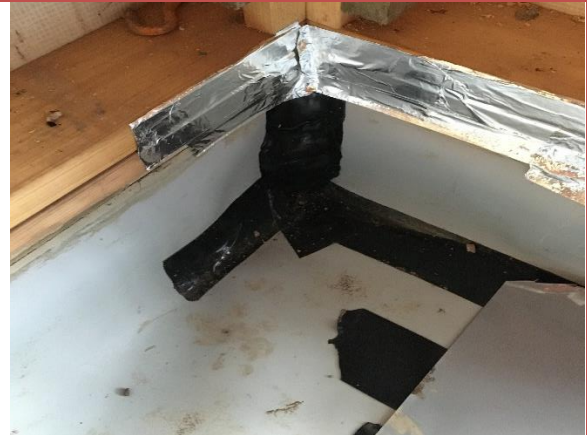
**Verification of Joints and Seals-Good Condition**

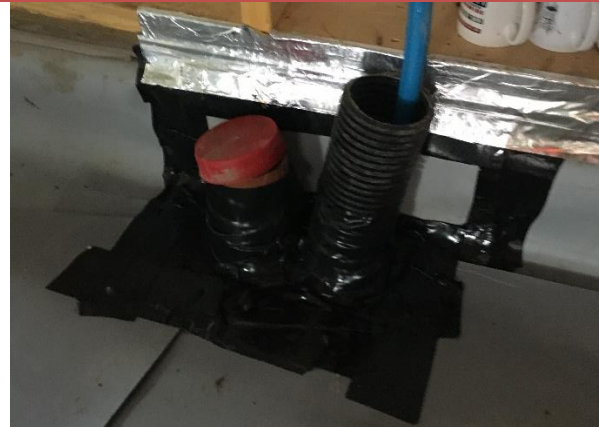
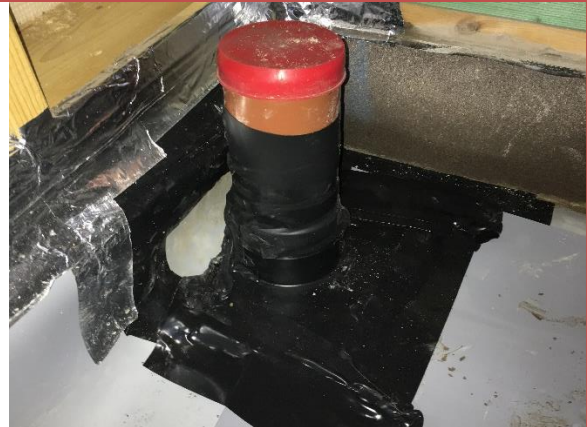
**Verification of Service Penetrations-Good Condition**

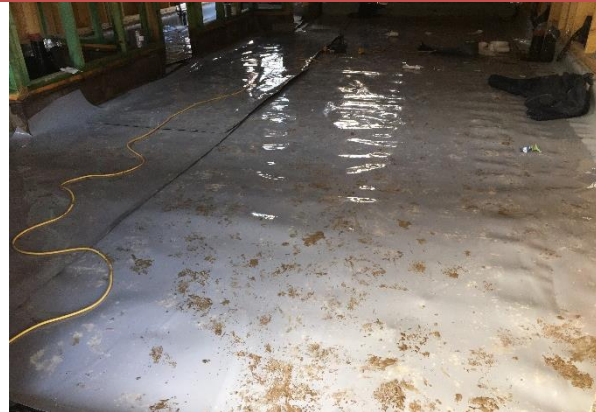
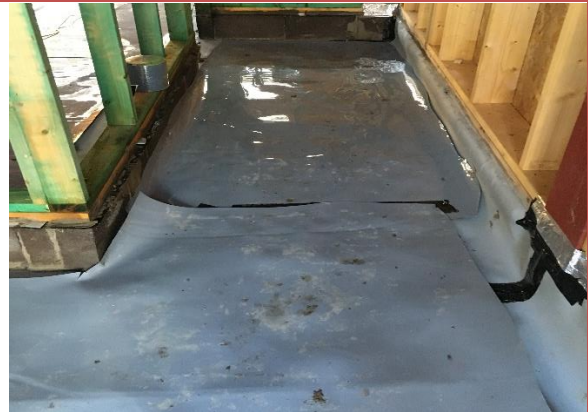
**Plot - 8**

**General Condition of Membrane-Good Condition**

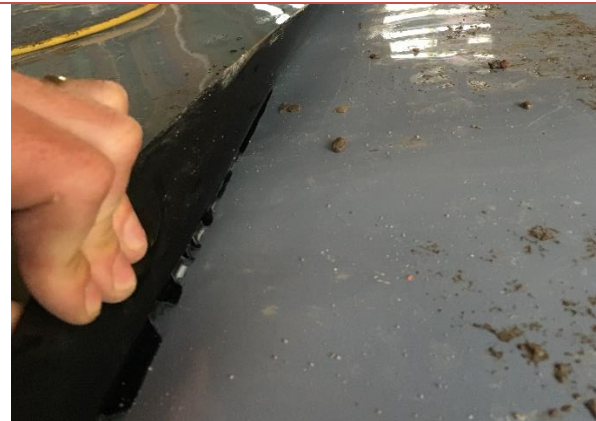
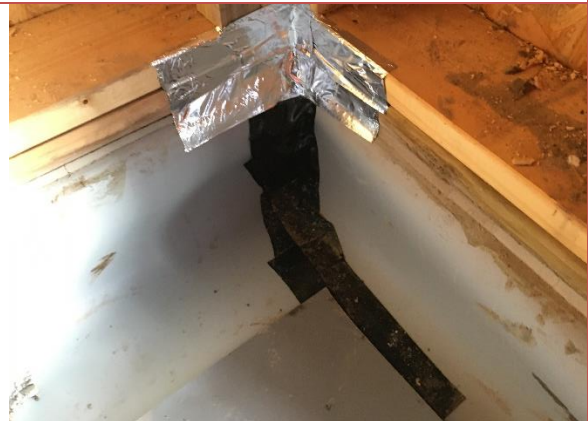
**Verification of Joints and Seals-Good Condition**

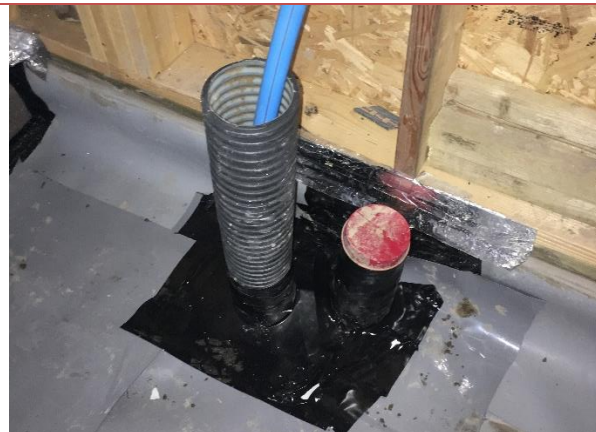
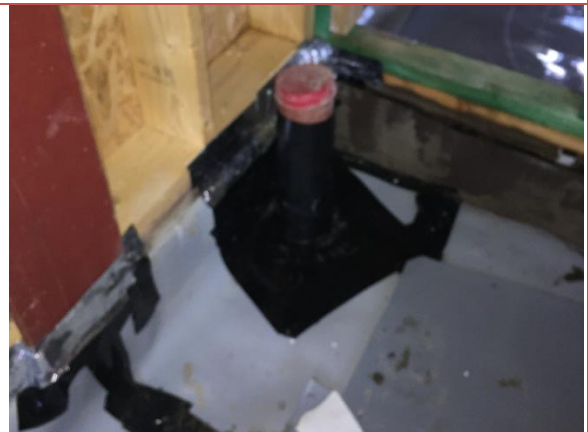
**Verification of Service Penetrations-Good Condition**

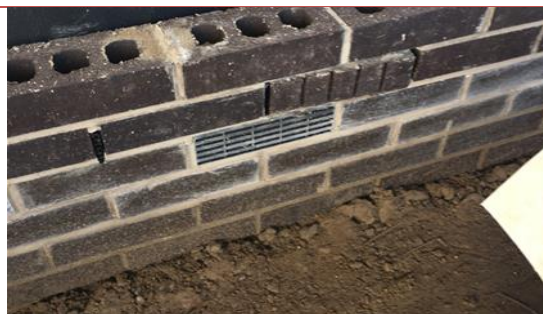
**Verification of Ventilation- Good Condition**
