## BASEMENT

The basement contains remnants of machinery in the form of; a cast-iron bulkhead to the crane loading doors and an integral rail for sliding doors, cast iron corrugated fireproof shutters and doors to the original hoist and some pulleys and cables. The manufacturer's name of Edward Wood and Company survives on a name plaque. They were one of the largest iron foundries in Manchester.

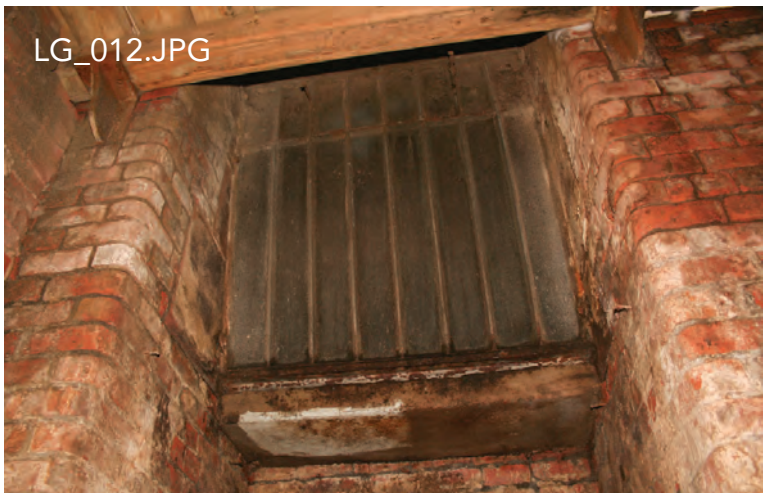
LG\_012.JPG

Cast-iron windows to basement in-situ with original glass. The original windows to the south and east elevations were located below ground level and provided limited ventilation. Windows have been blocked up from the exterior.

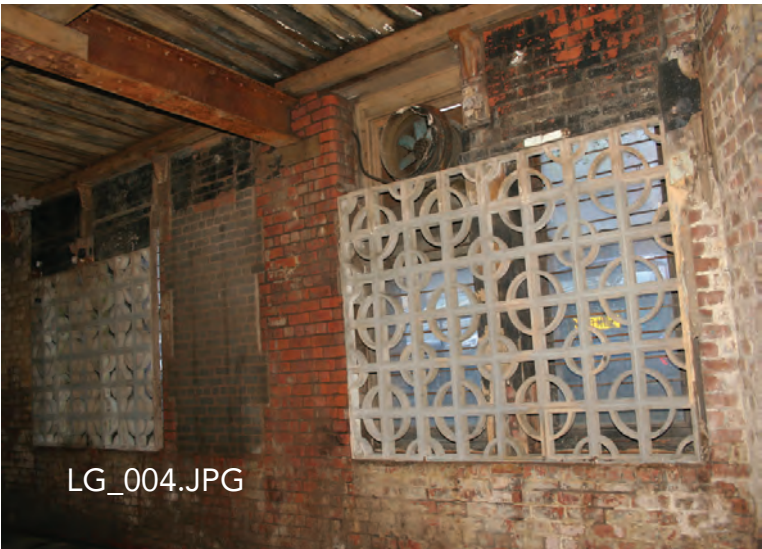
LG\_004.JPG

Sash windows to the west elevation (LG\_004.jpg) have been blocked up from the inside.

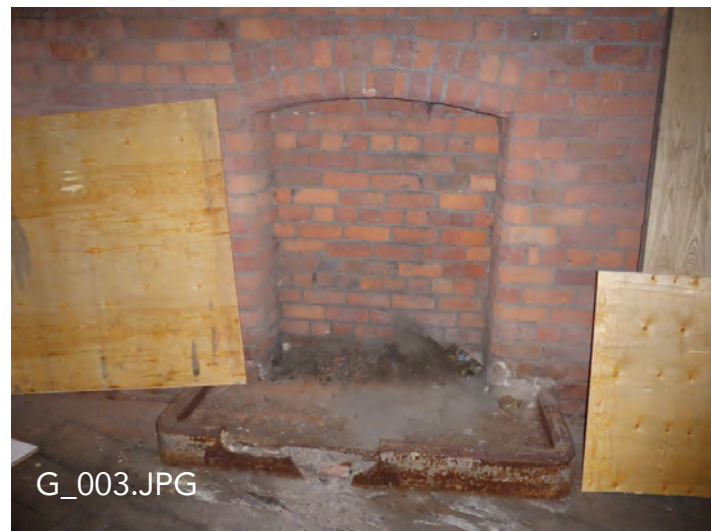
Shallow hearth with deep cast-iron fender and small flue, all part of the heating for offices. The original enclosed stove has been removed. Right - oak panelling lines the lobby but was removed from the stairwell.

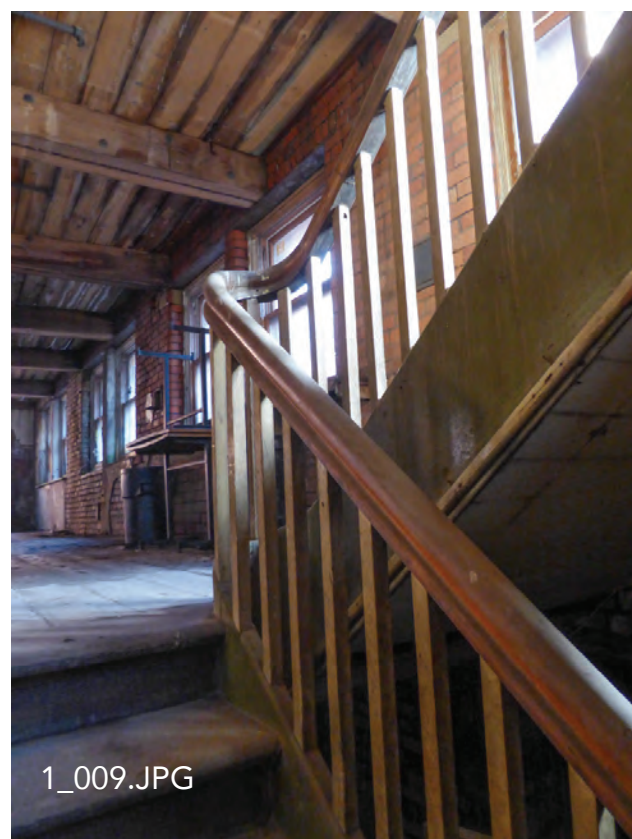
1\_009.JPG

Handrail and balusters to corner staircase (left) of reasonable quality, considering the utilitarian function of this part of the building. The secondary staircase (below), with cast concrete cantilevered steps, is of some interest, as part of the building development, but adaptations to the building were of low aesthetic value. Cast concrete over steel, with earlier wrought iron beam in-situ.

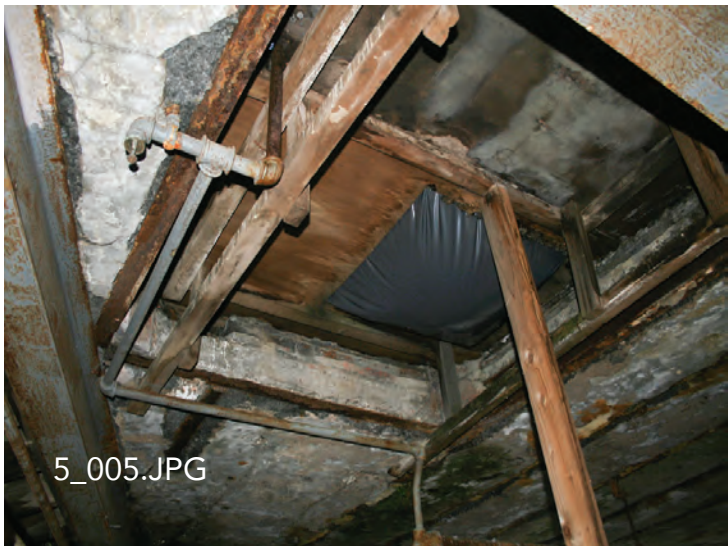
5\_005.JPG

Evidence of original hoist (5\_005.jpg) in the form of a cast metal frame within the concrete slab roof, with later modifications - of evidential value (2). The later 1920s lift machinery is largely intact but unusable (of low interest 2). The lift punctured the original roof slab.

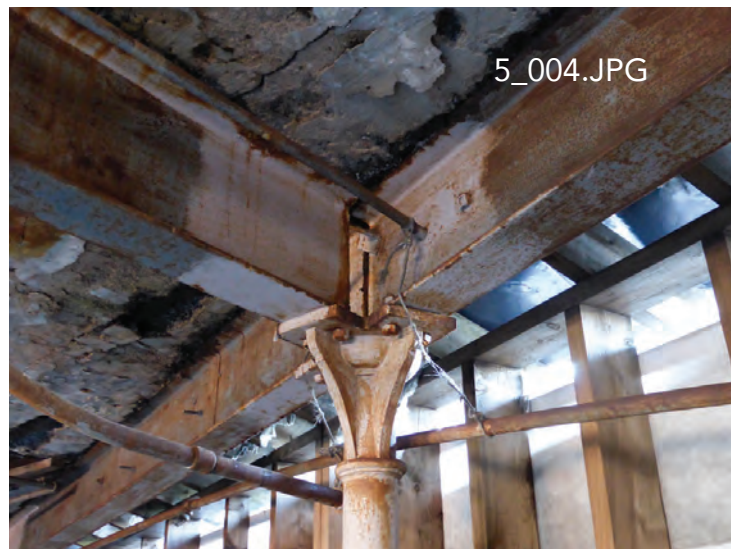
5\_004.JPG

Bottom right - cast-iron column with flanges cast into the capital on the same skewed alignment as the I-section wrought iron beams. The fit is poor and appears unfinished. Skylights to the west have been removed.
