## 2 Swinbourne, Withington

### Photographic schedule - House 1<sup>st</sup> floor

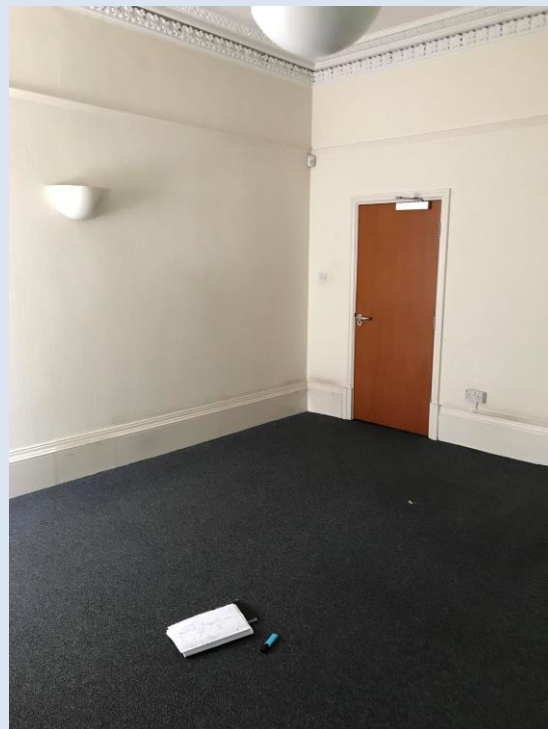
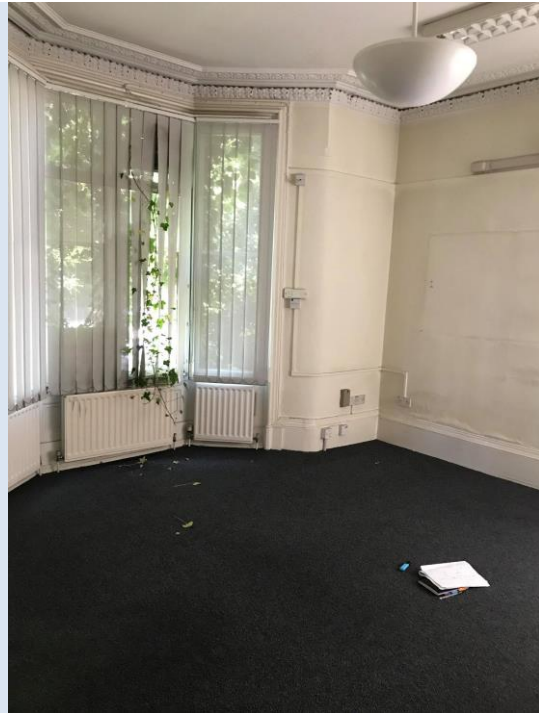
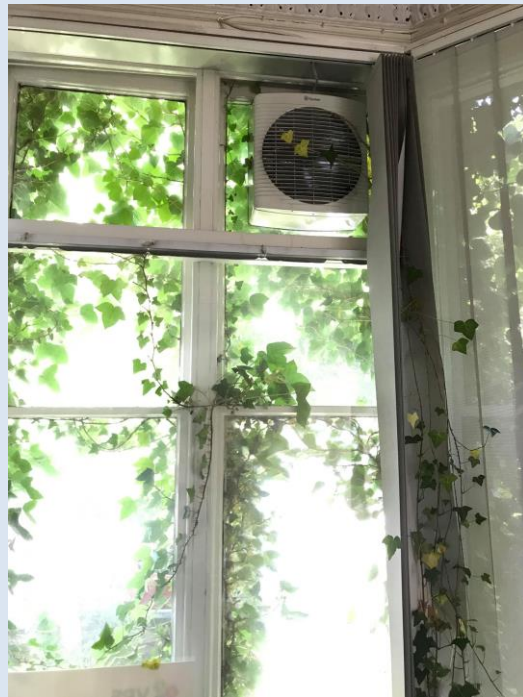
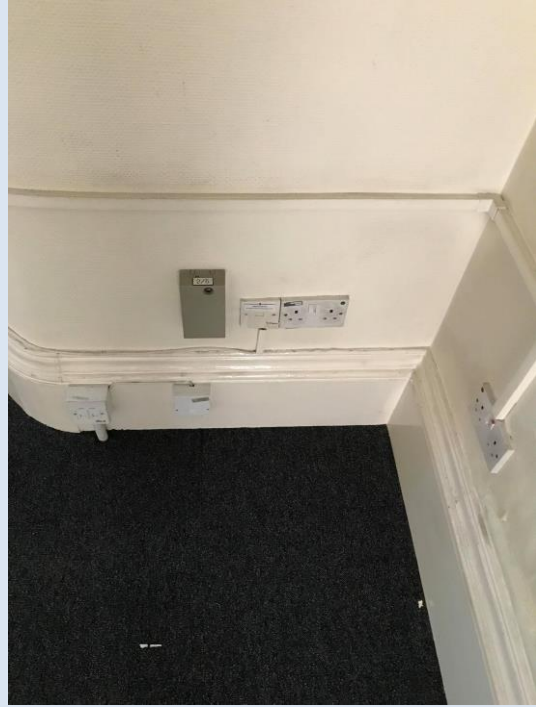
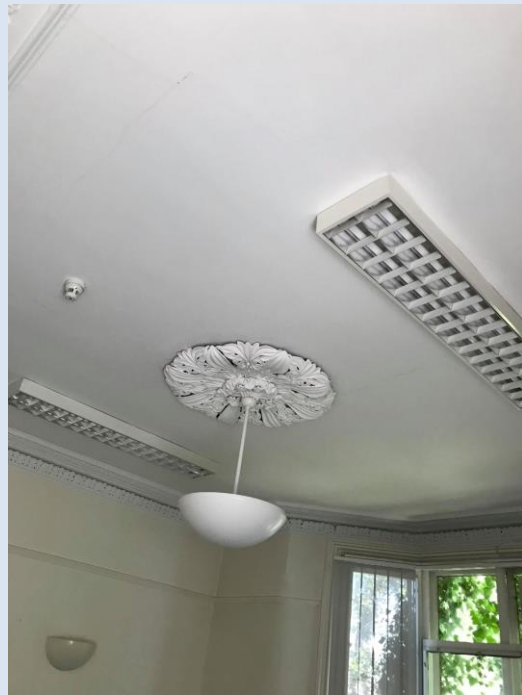
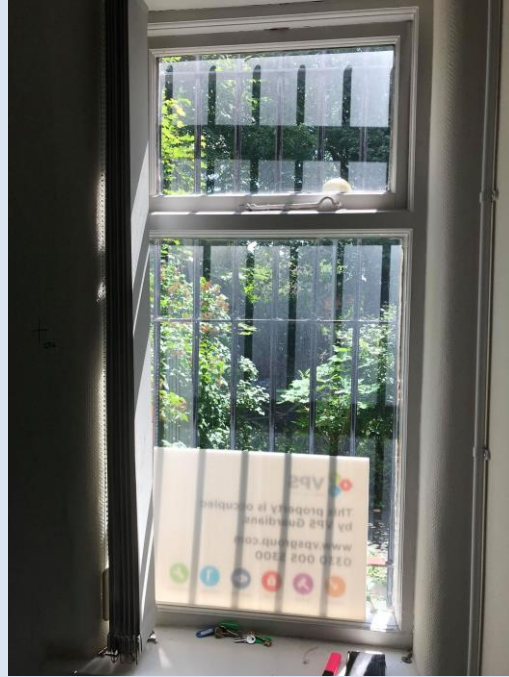
Office area with bay window and high decorative ceiling. There are no signs of damage in the room other than. On window 10 the exterior of the window is almost completely covered in Ivy. The ivy has begun to enter the room through the extraction fan, which has been retrofitted to the window. There are two windows in the room numbered 10 and 11. Windows 10 is a wooden sash construction and window 11 is a wooden frame, which opens at the top, however this has security bars on the outside. The frames themselves appear to be in reasonable condition however but may require repainting. The room also contains an air-conditioning unit.

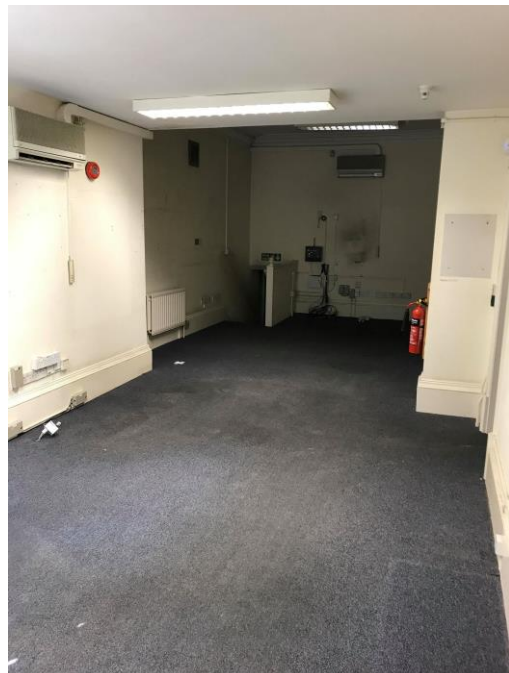
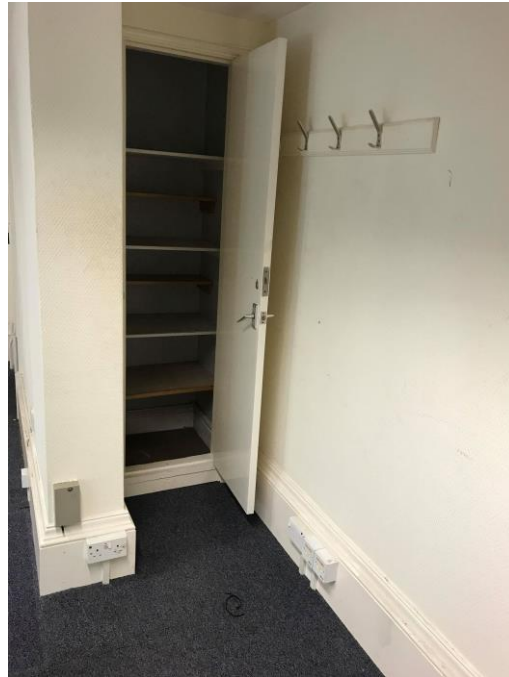
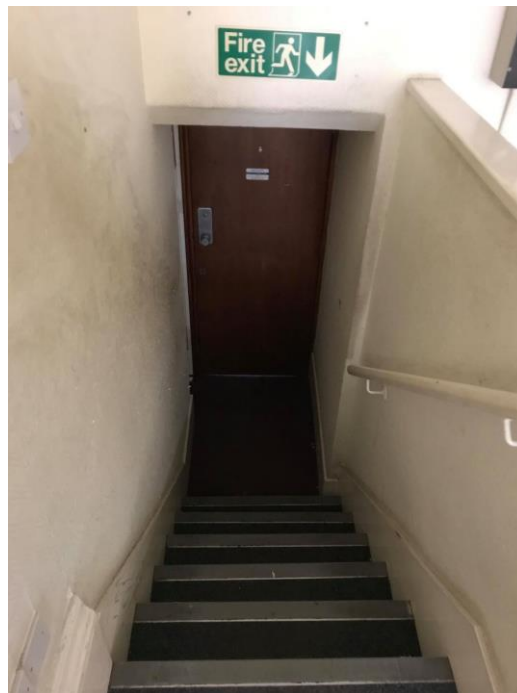
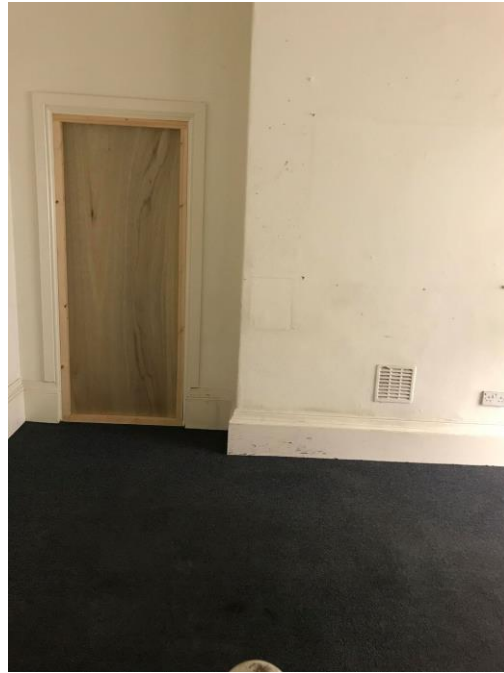
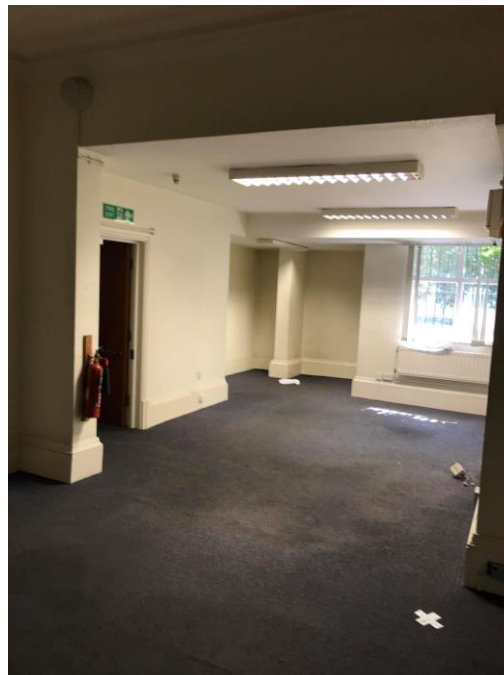
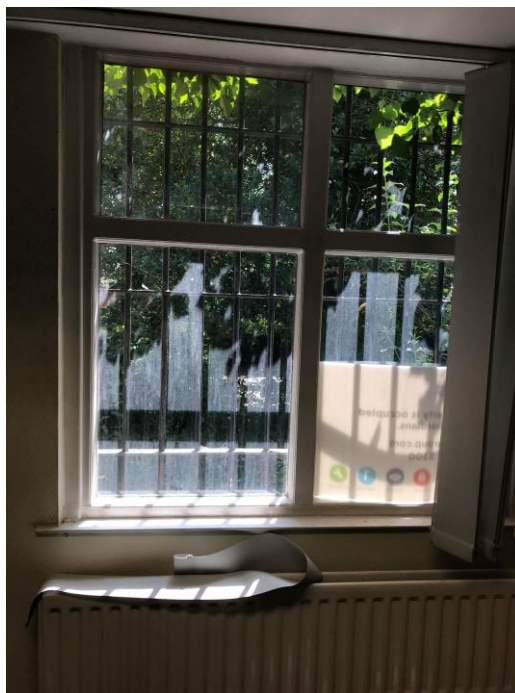
This is a large office space at the back of the house with a varied ceiling height. This room connects to the stairs shown in image 9. The window in this room is number 12 and it is a wooden framed window, which opens out at the top. The window appears to be in good condition and has security bars on the exterior. The carpet in the room is showing signs of wear and the room also has an air-con unit.

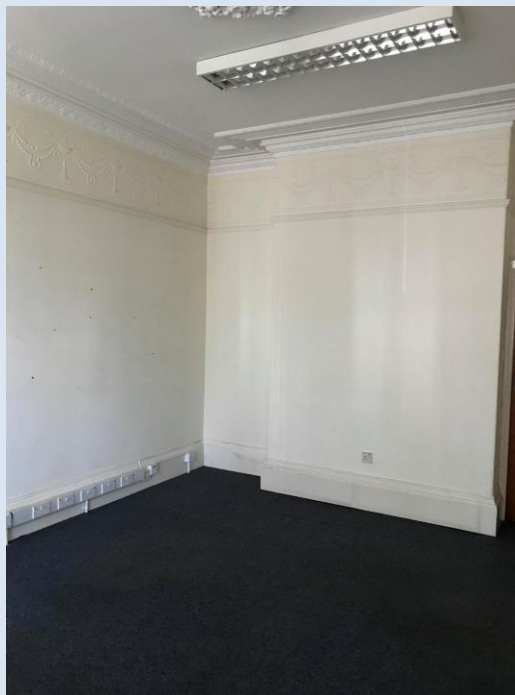
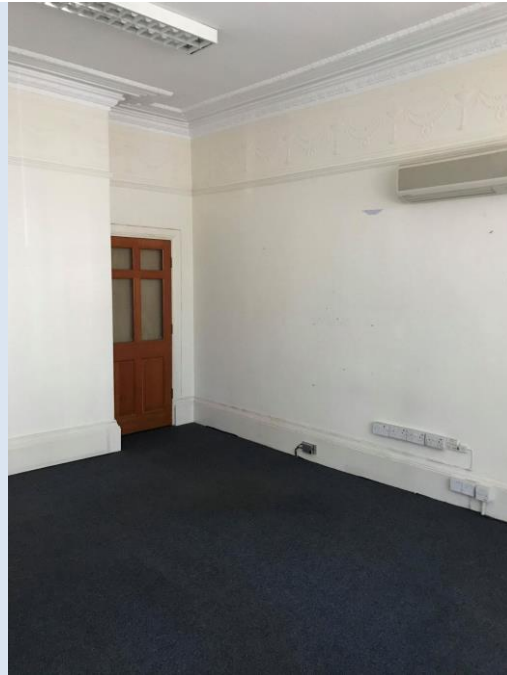
Is a similar room to office 2 with a bay window and similar high decorative ceiling. The door at the back of the room has been blocked out. There is an air-con unit in the room. The window is number 9 and is in good condition on the inside.

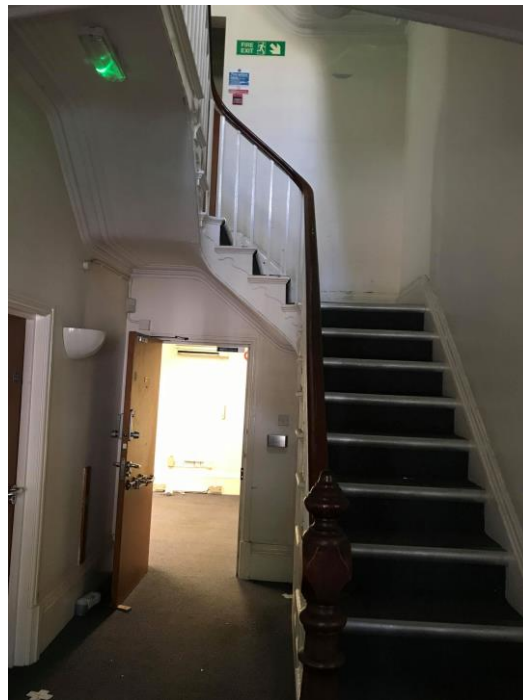
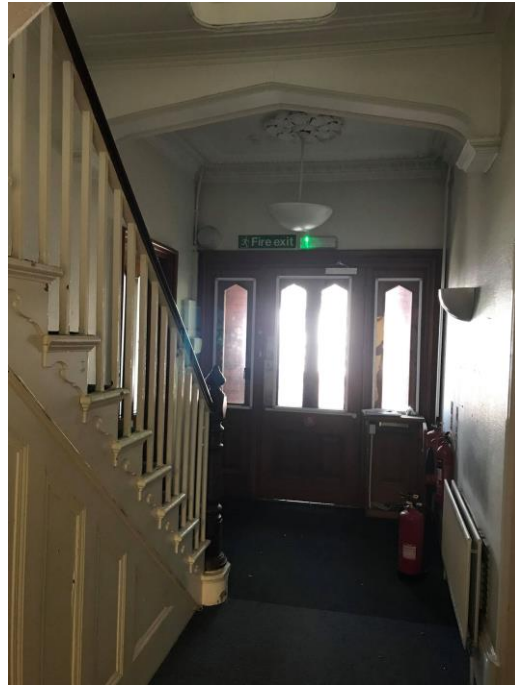
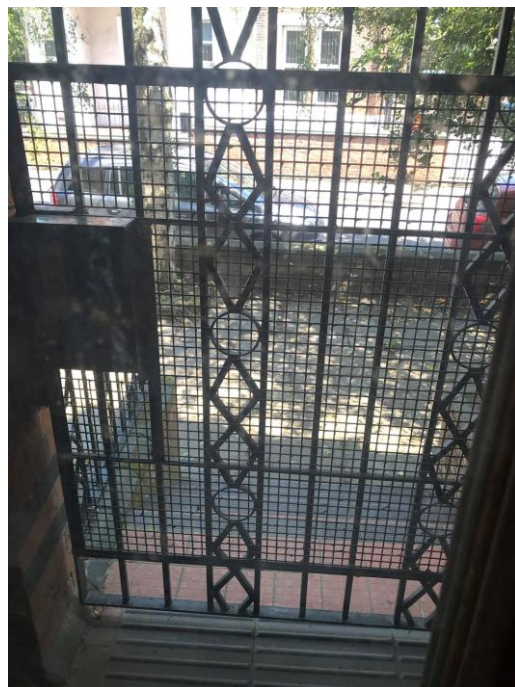
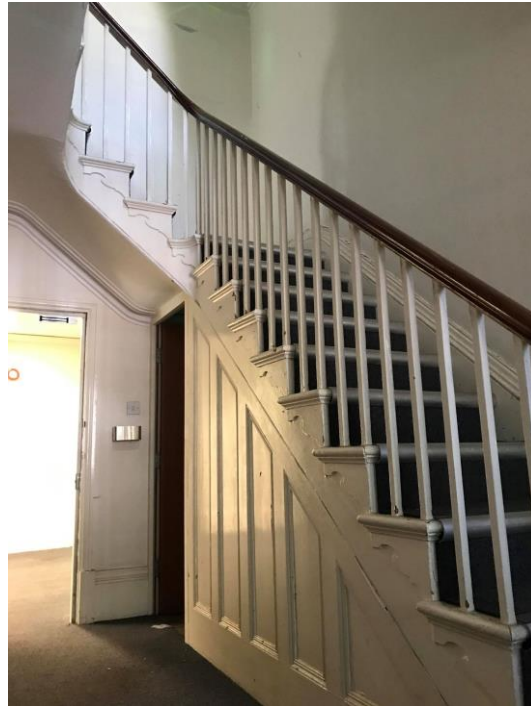
The entrance hallway again has a high ceiling with decorative details. The hallway leads to office 1 & 2, the back workspace and the basement. The wooden staircase curves back on its self and is in good condition:

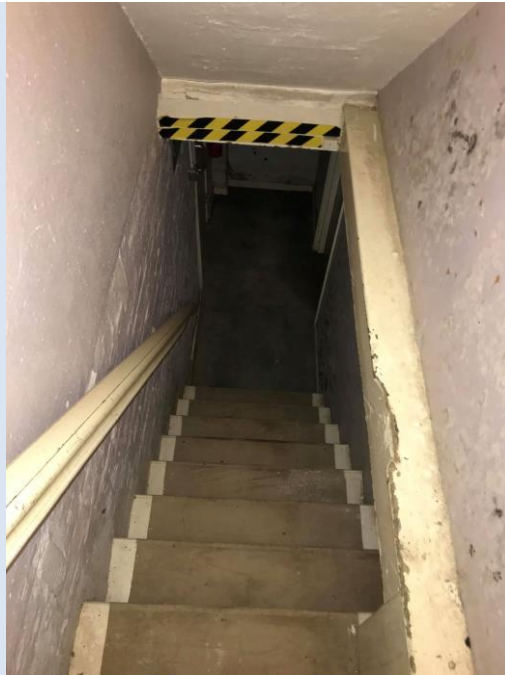
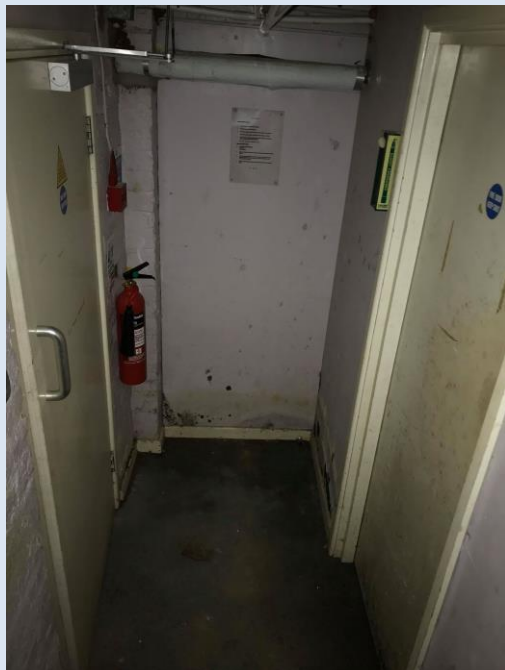
The basement staircase shows signs of heavy use but no obvious items of significant disrepair. There are also signs of damp on the walls.

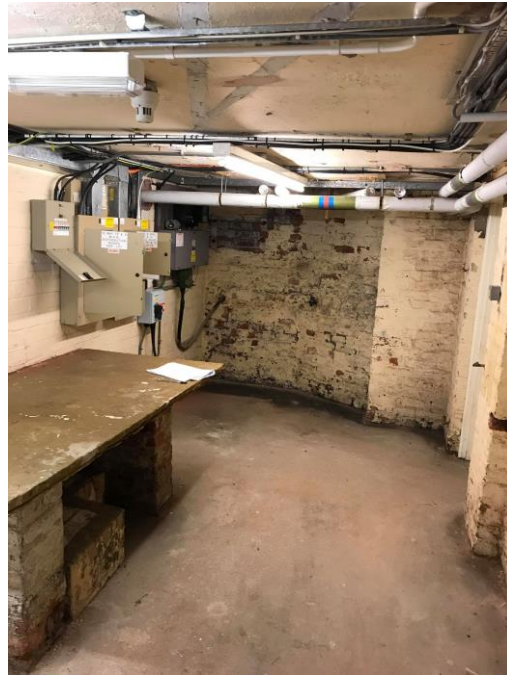
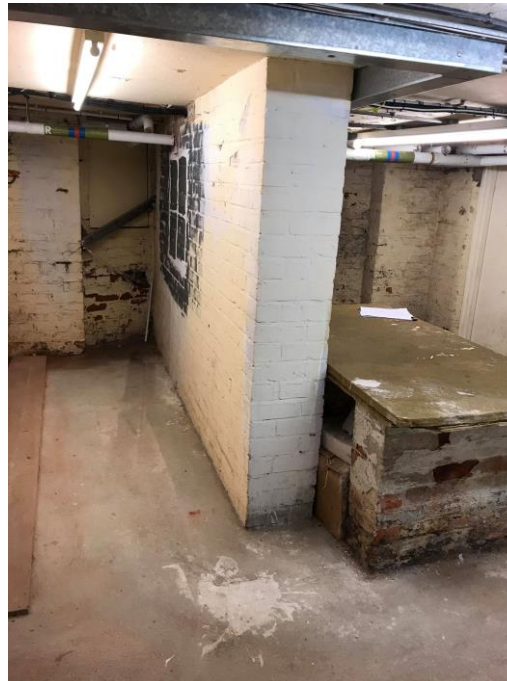
The storeroom is the area where the electric services enter the building. Much of the paint in the room was

peeling off and there damp  
throughout the walls in this room.

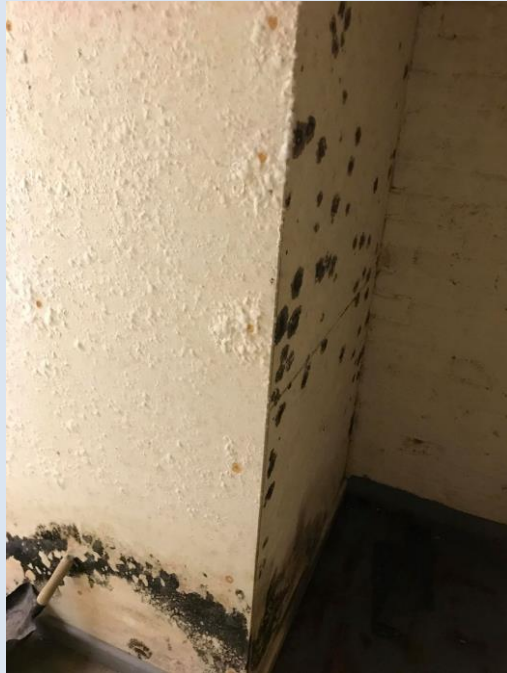
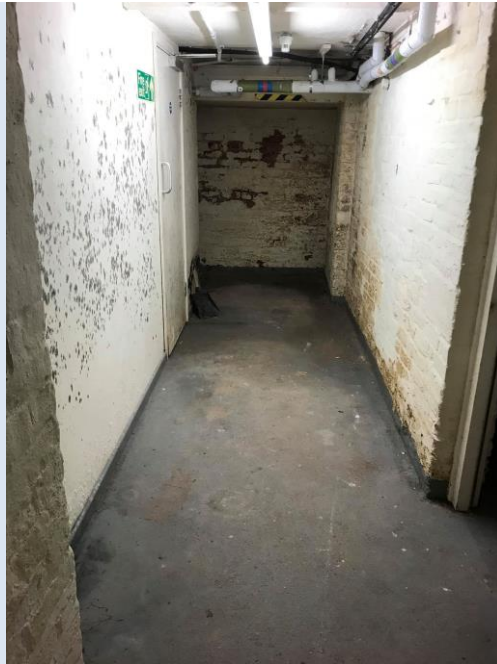
The hallway is showing significant signs of damp and mold, which will need addressing.

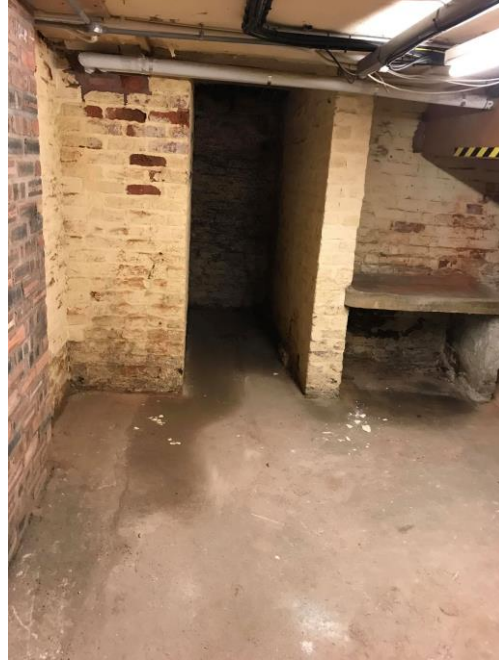
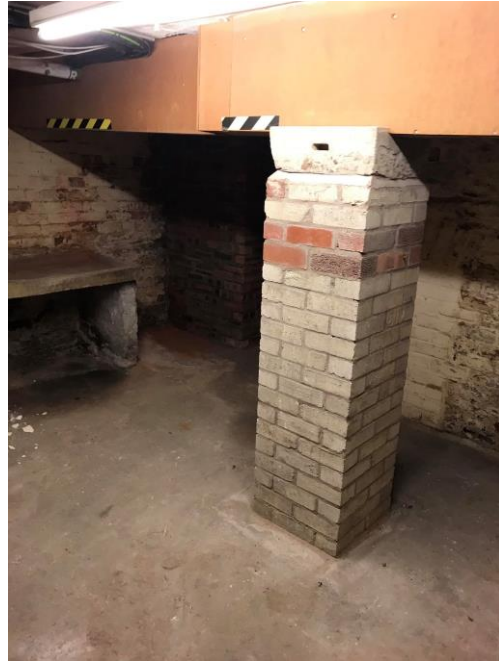
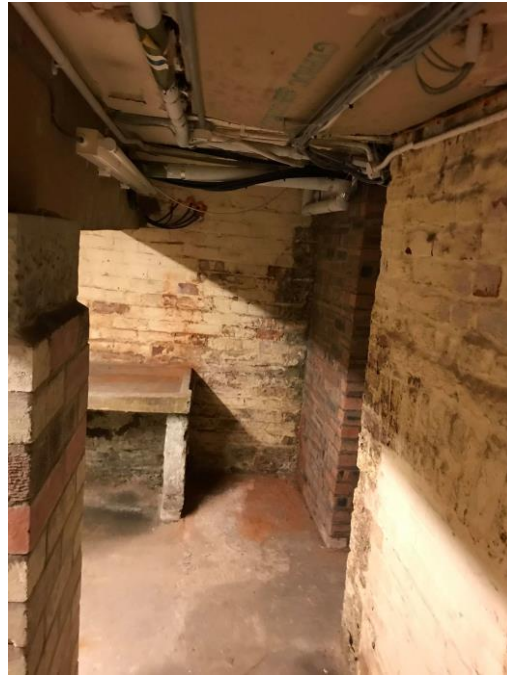
This store is at the back of the house. Much of the area is restricted by the supporting structures for the house above. There were some signs of damp but much less severe than other areas in the basement.

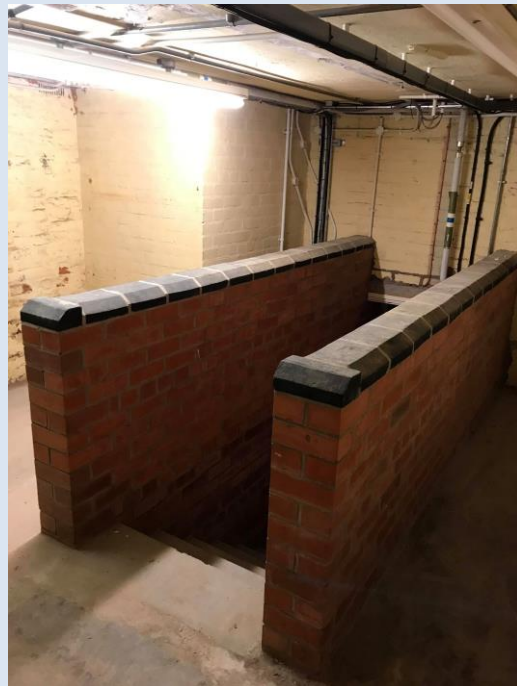
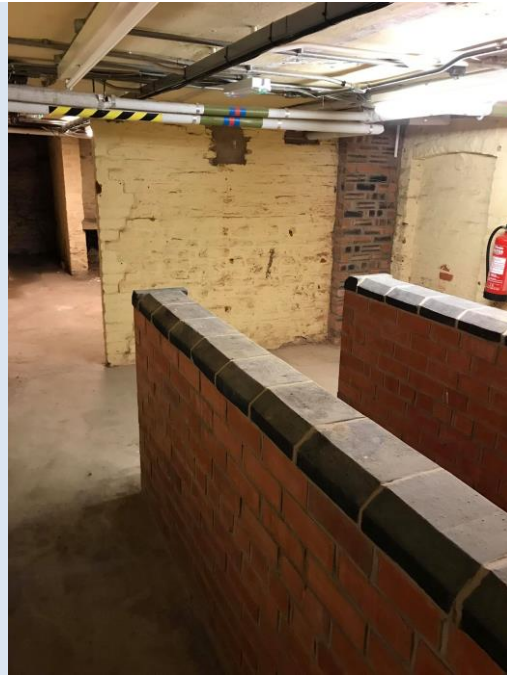
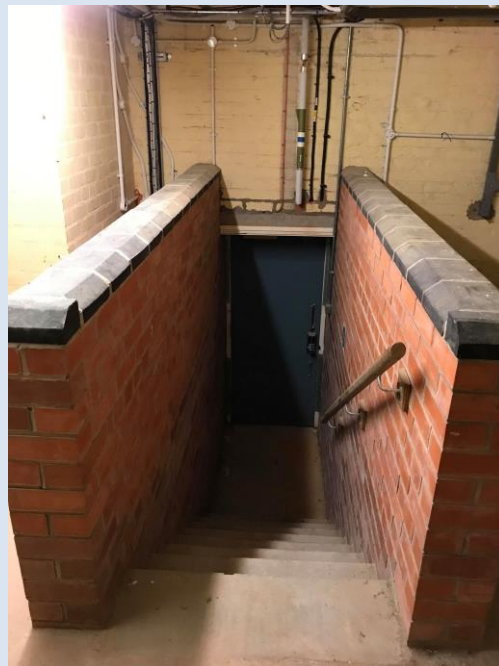
This basement store is in a similar condition to store 2, however much of this room is taken up by the staircase, which connects this basement to the basement of the bank.

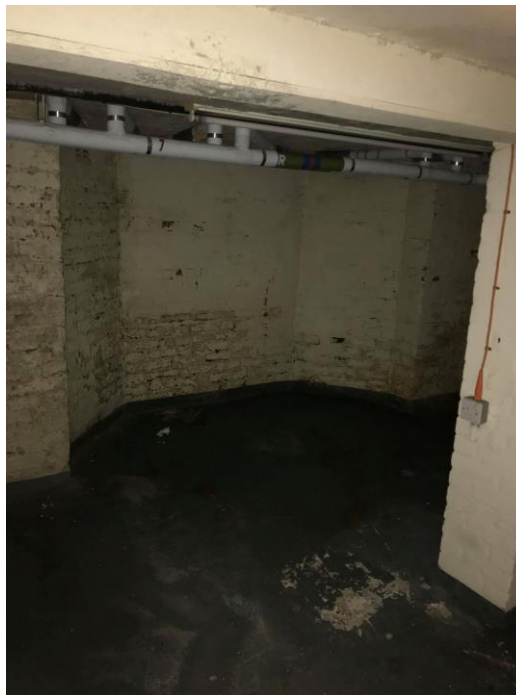
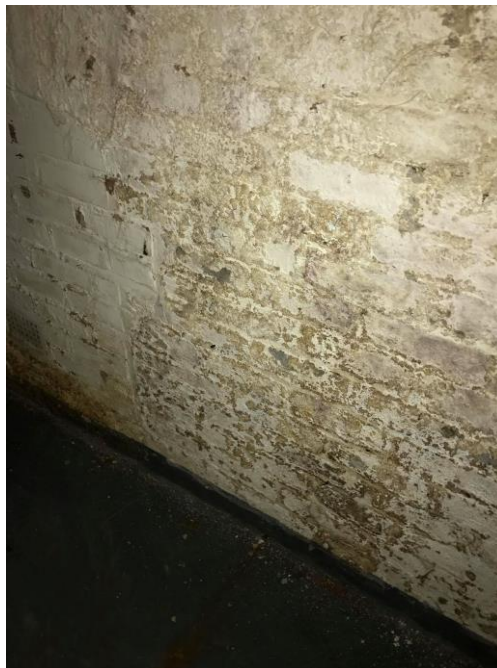
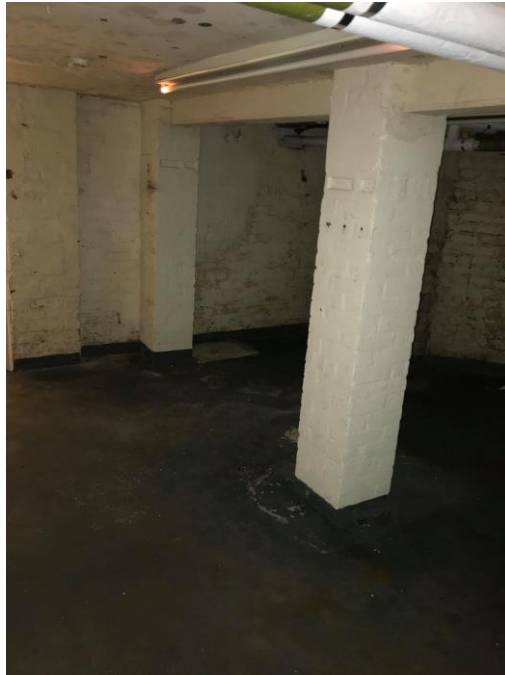
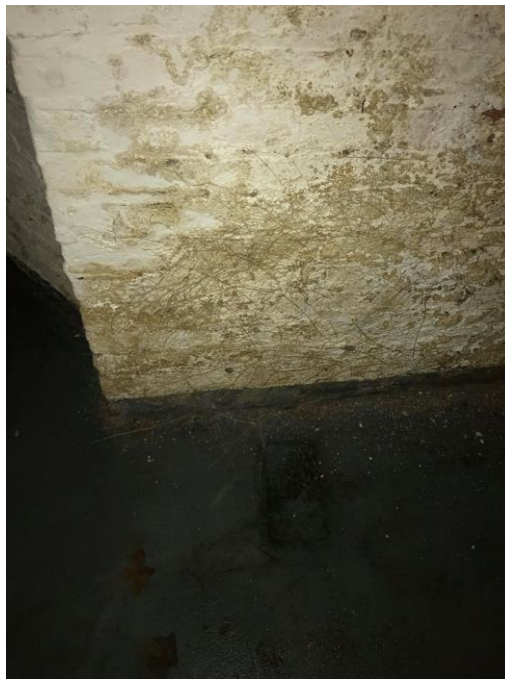
This store is at the front of the house and is underneath office 2. The room is significantly damp and, which appears to be affecting the brickwork. The room also has considerable signs of mold. The lights in the room were also not working when inspected

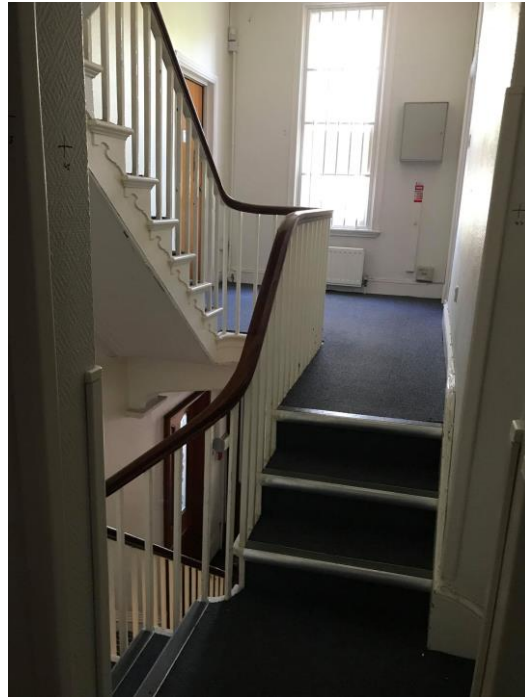
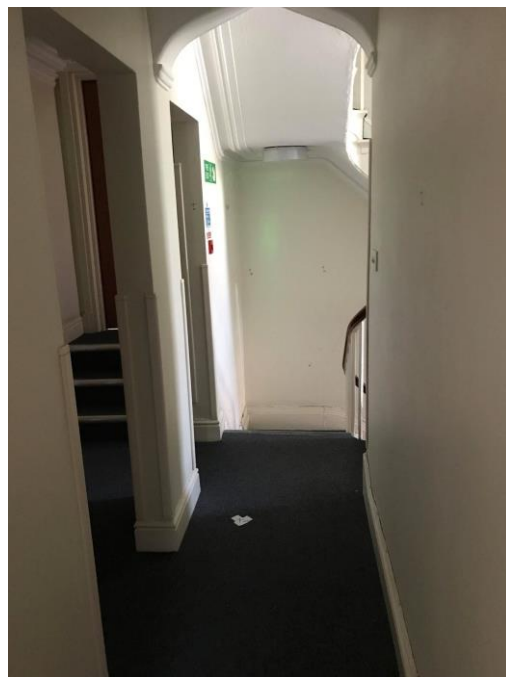
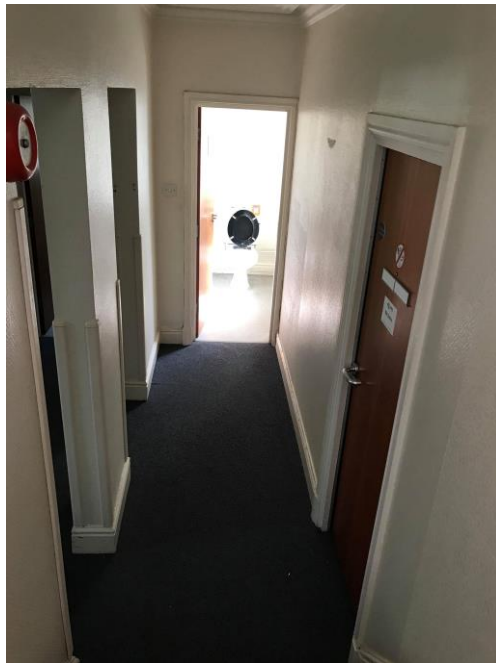
The entire hallway appeared to be in good condition with no noticeable defects.

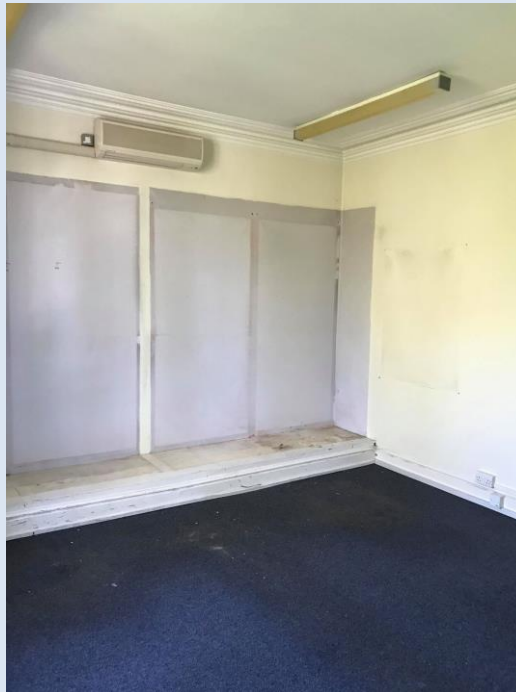
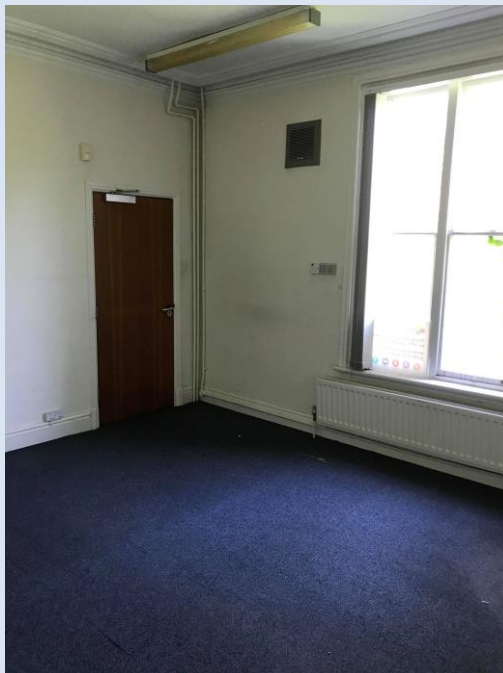
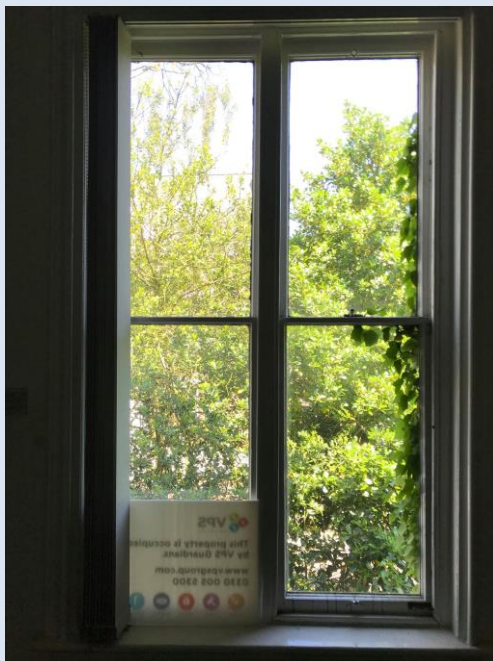
The office has clearly had large shelving units removed, these units were sat on a raised platform. It is not clear what the raised platform is for. There is an air conditioning unit in the room. The window in the room is numbered 15 and is a wooden sash construction, it appeared to be in good condition upon inspection but did have some ivy on it externally.

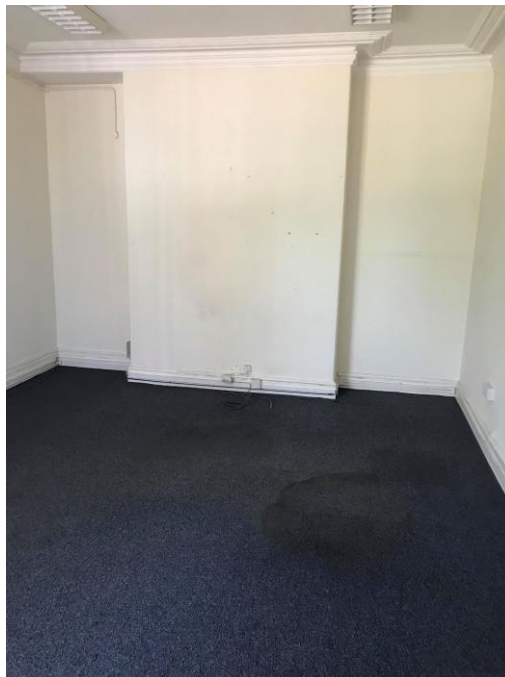
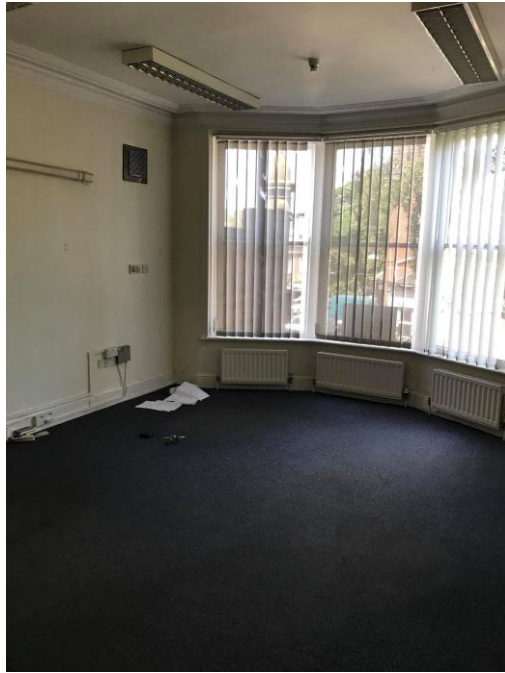
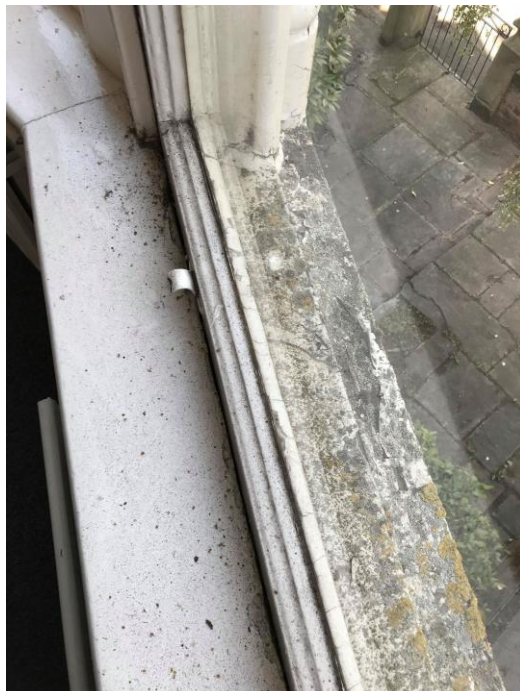
This office has a large bay window numbered 13 at the front. The room its self was in good condition with no obvious defects. There is an air-con unit in the room

The window itself is a wooden sash construction and is in a good condition internally but there are visible signs of flaking paint on the exterior

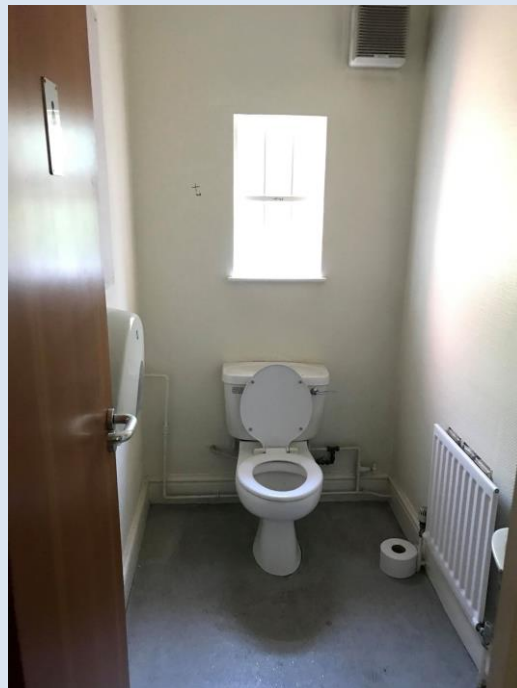
54

The men's toilet was in a reasonable condition with no significant defects. The window at the back is numbered 16 was a wooden frame, which appeared to be in good condition. It also has security bars externally.

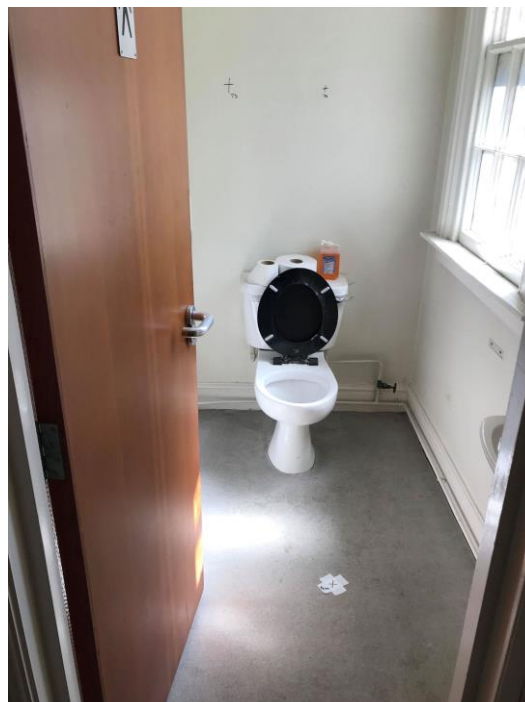
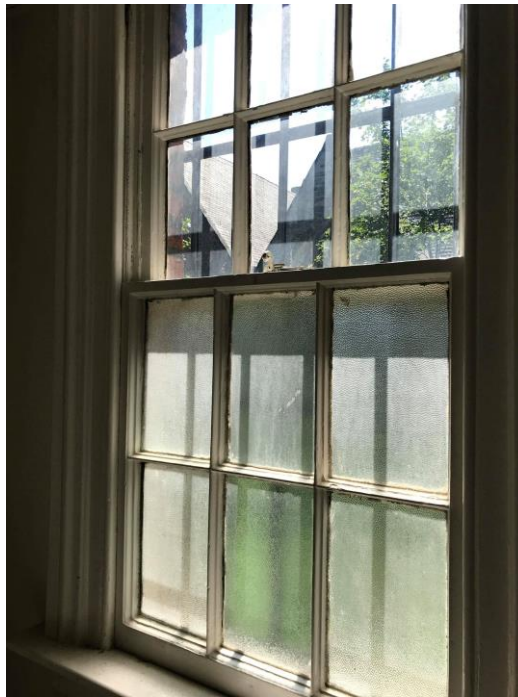
The women's toilet is similar to the men's toilet but has a larger window at its side, which is a wooden sash window with security bars externally. The window numbered 17 appeared to be in good condition.

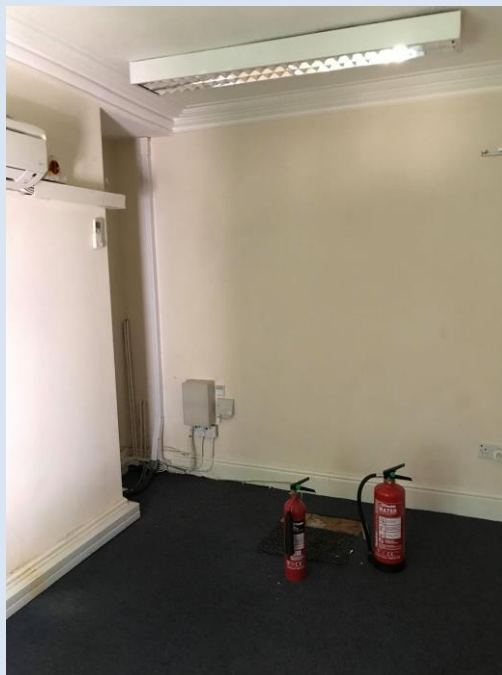
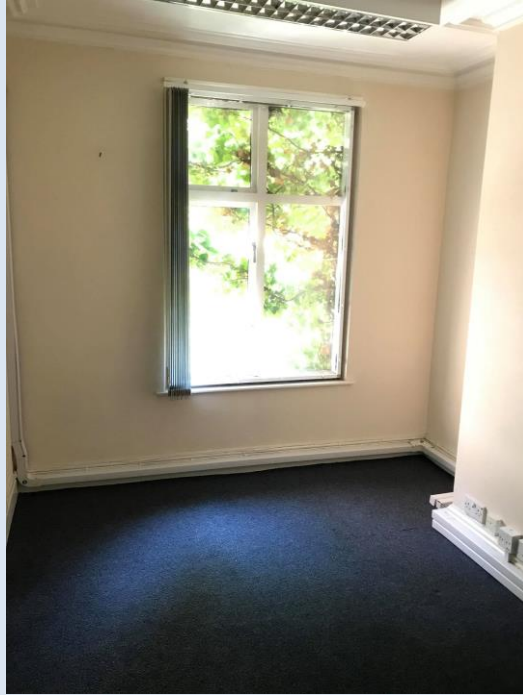
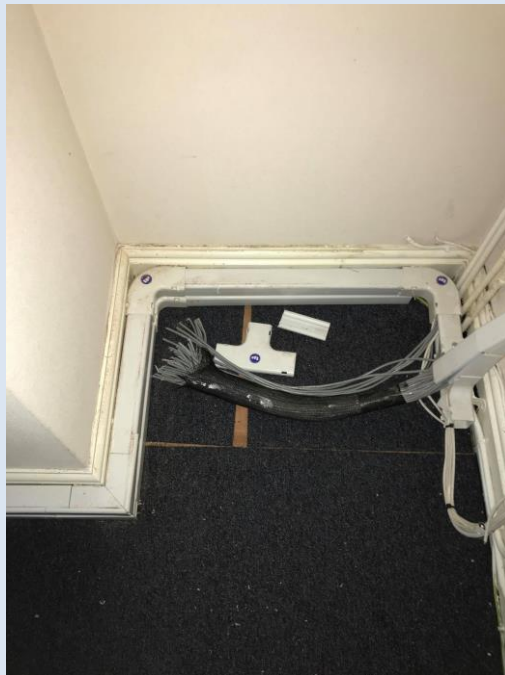
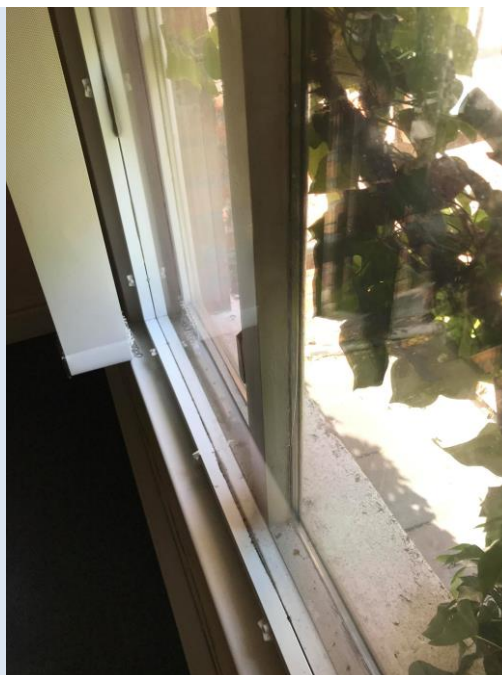
The machine room is a small room at the back of the house, which formally housed the banks server. There were a significant number of wires leading into the room as a result. The window, numbered 18 in the room was a wooden construction with secondary inner glazing. it appeared to be in a good condition but had ivy growing up it externally.

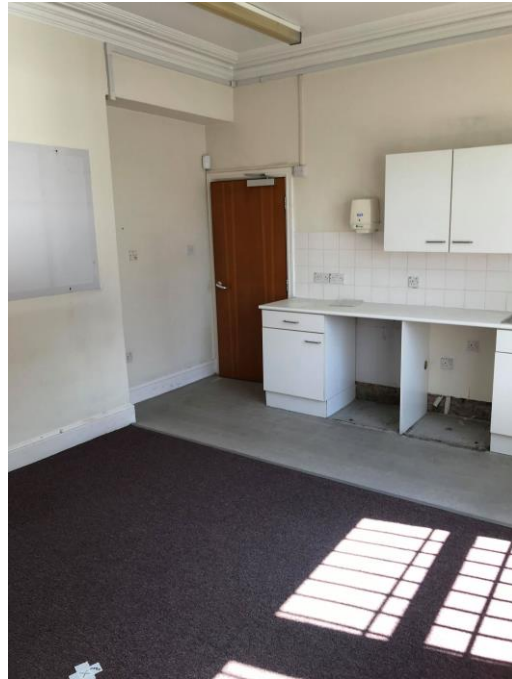
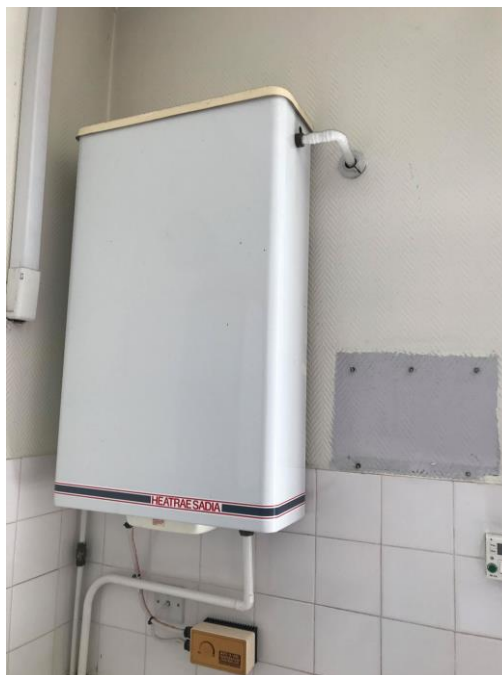
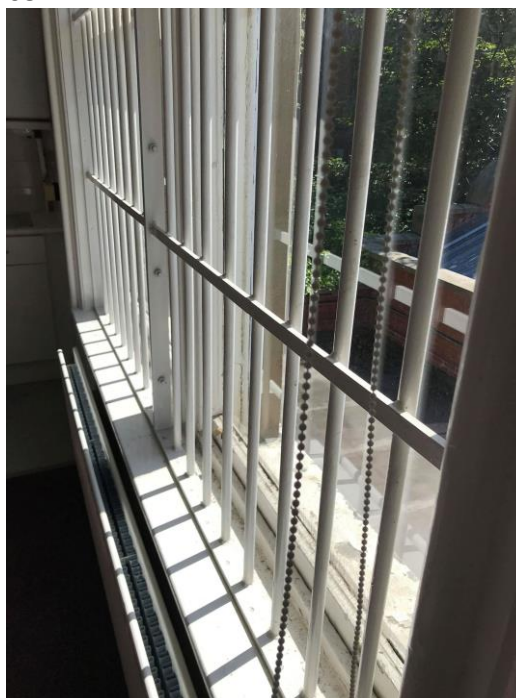
The staff room is a large room with higher ceiling than found elsewhere on the first floor. It has a small kitchen area which was worn but all appeared to be operational. The window numbered 19 is very large and has security bars internally. The window looks to have been refitted but is in good condition internally but externally the paint is flaking.

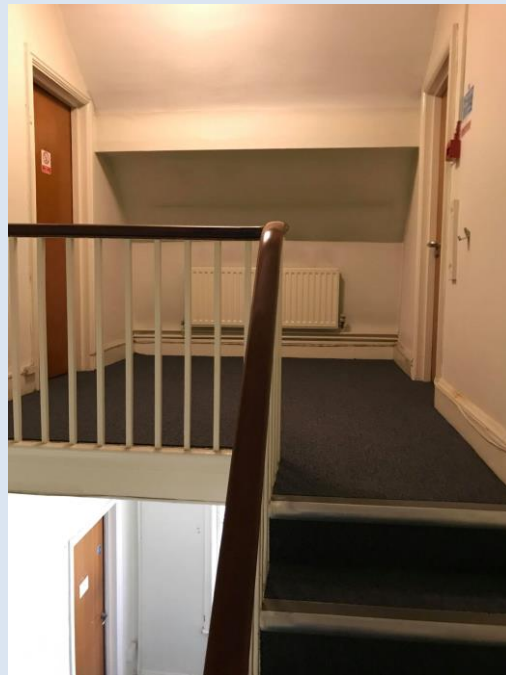
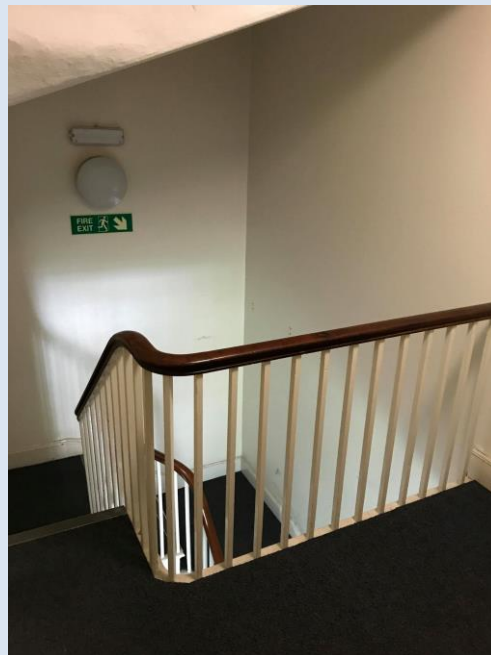
The second floor leads to all four second floor offices. It is cut into by the roof structure but there were no obvious signs of damage upon inspection.

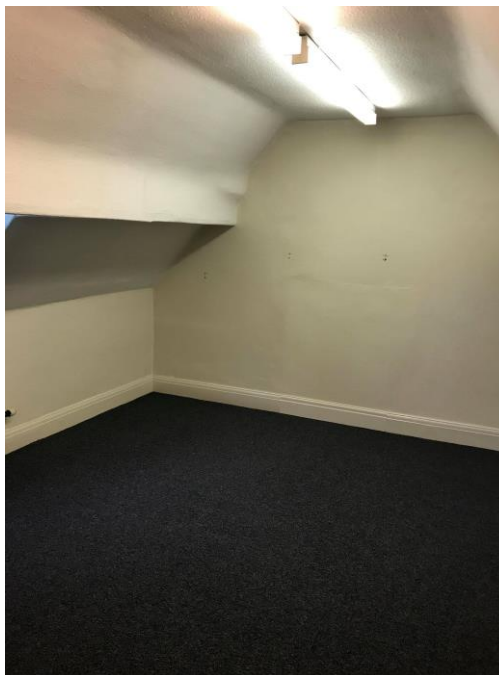
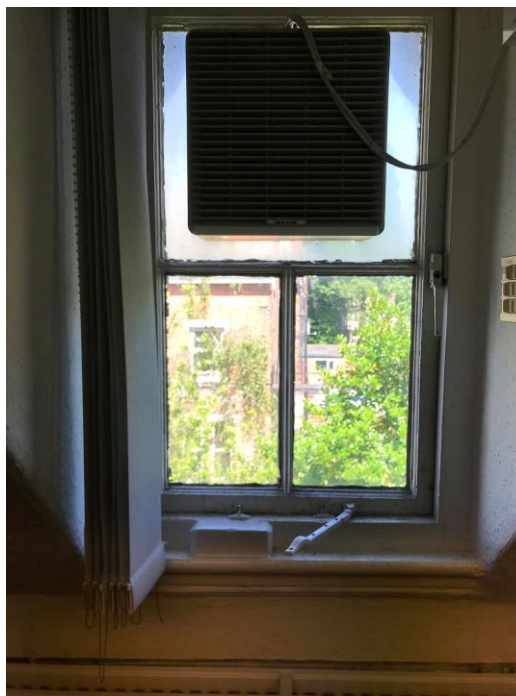
The room on inspection had no clear signs of any damage. The roof structure cut significantly into the workspace and the beam supporting the roof cut most of the light out from the small single dormer window. The window is numbered 19 and is a metal frame which is in good condition, however the window has had an extractor fan retrofitted.

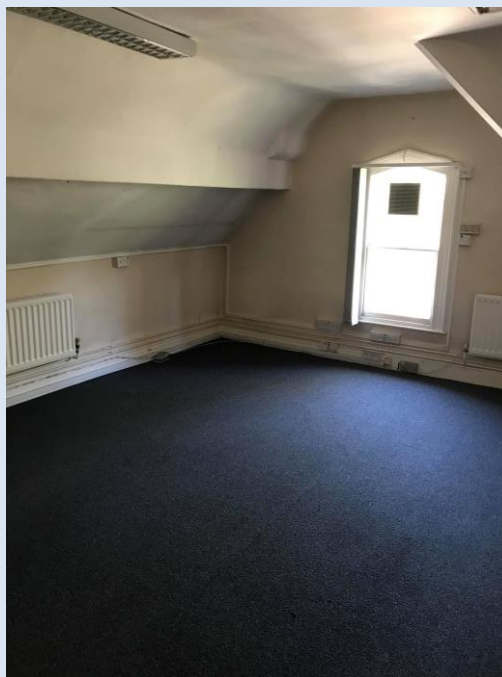
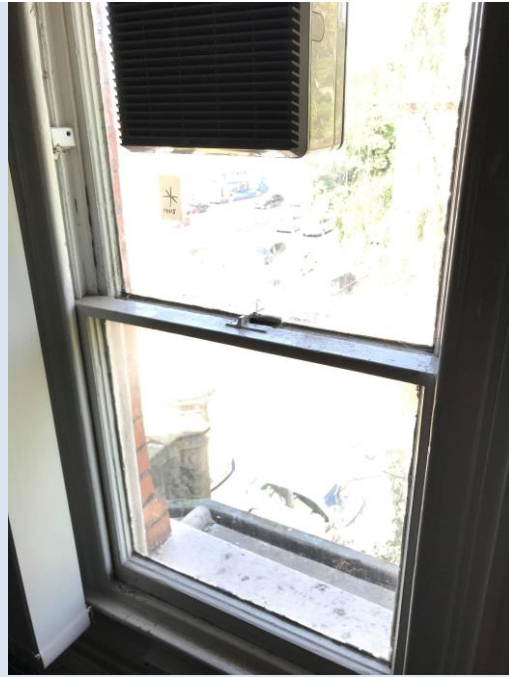
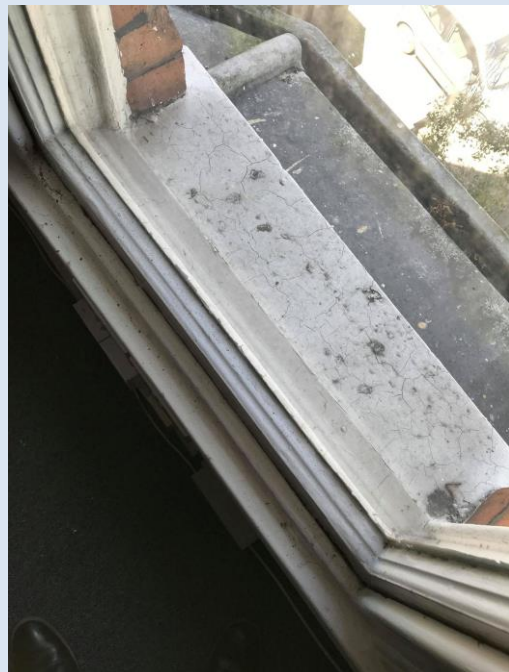
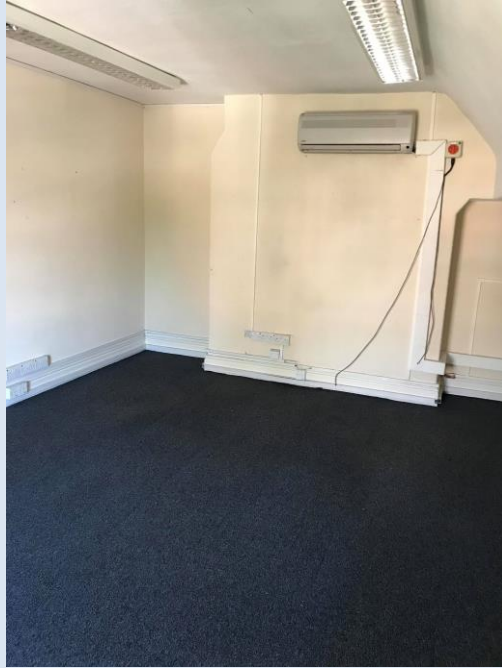
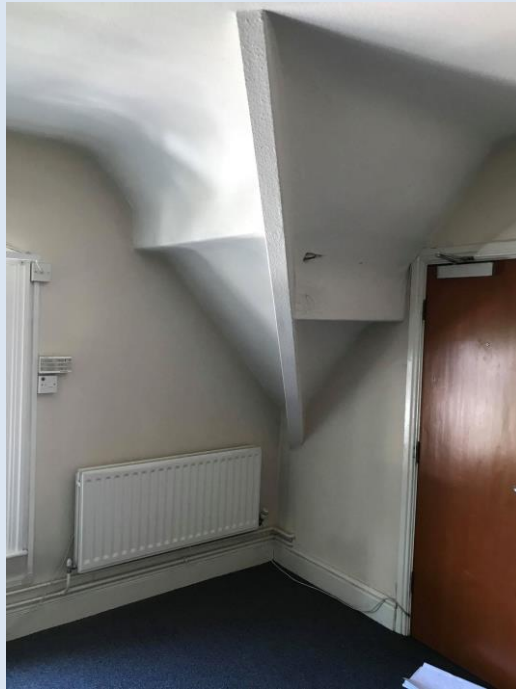
This room is arranged perpendicularly to the meeting room in the roof space. The room has a window, numbered 20, again with an extractor fan installed meaning it will no longer open. The window is wooden framed and externally the paint is flaking. In one corner of the room a hip joint in the roof significantly cuts into the space. There is an air conditioning unit in the room.
