## 2 Swinbourne, Withington

### Photographic schedule - House 1<sup>st</sup> floor

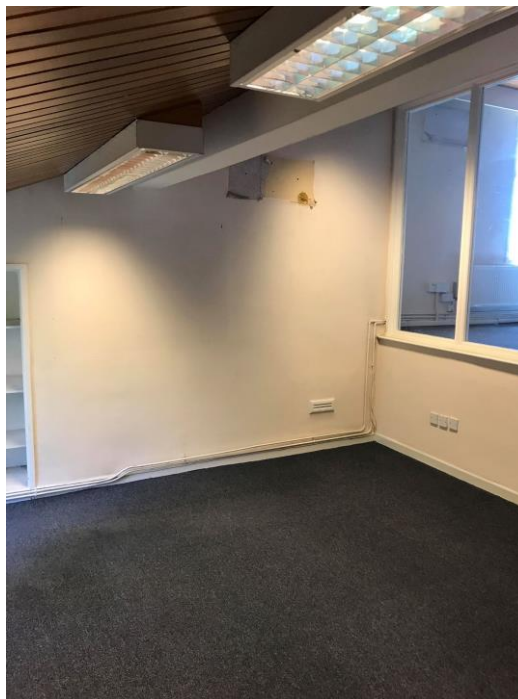
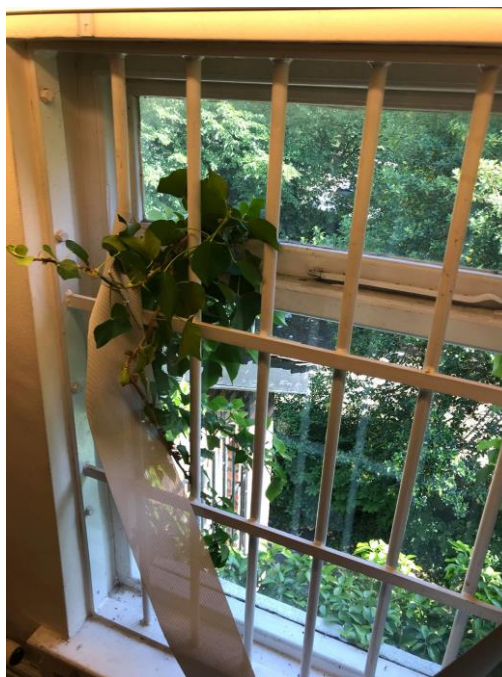
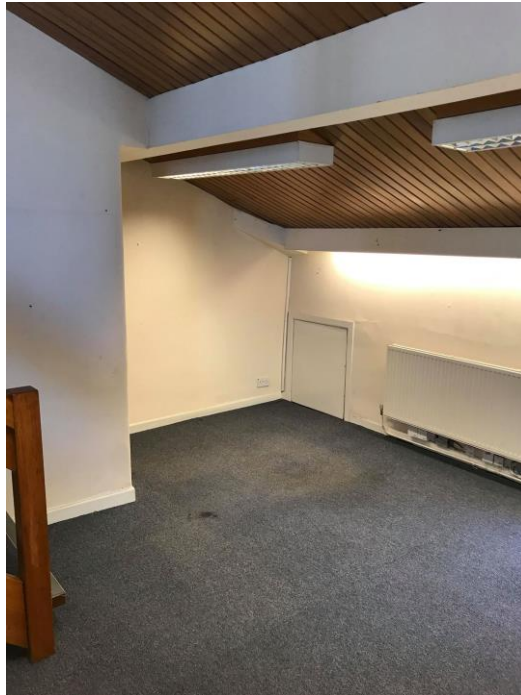
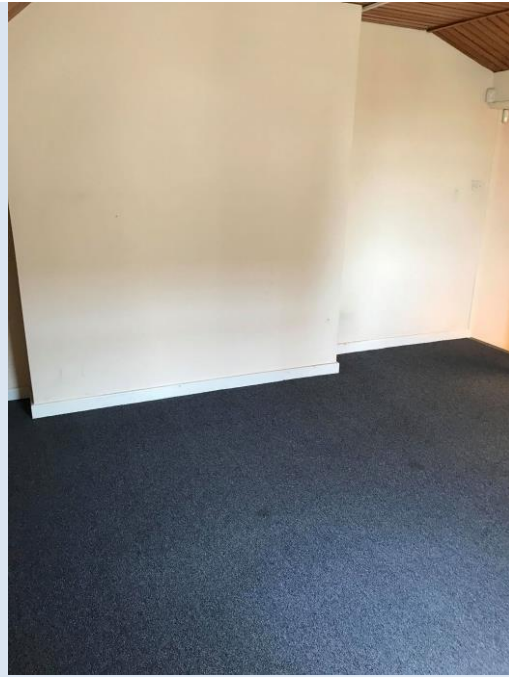
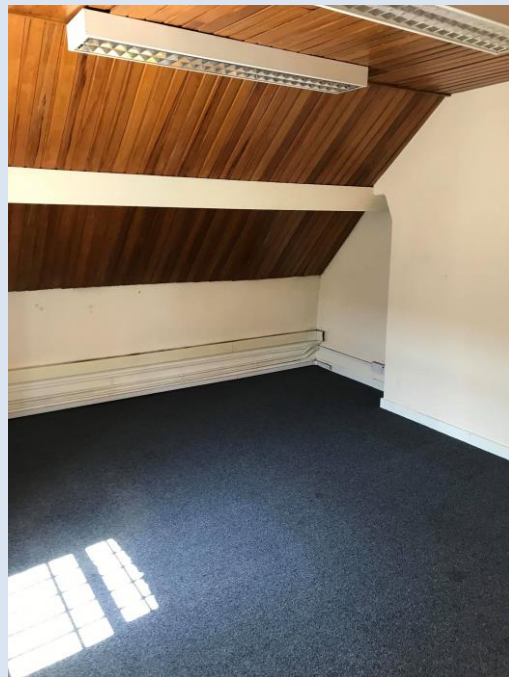
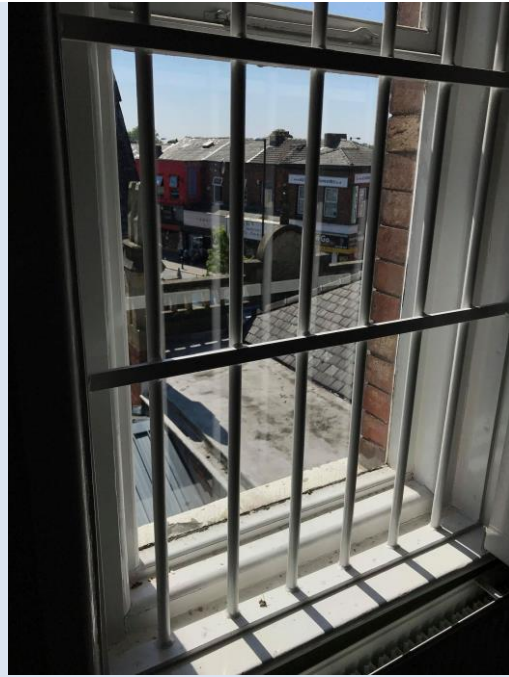
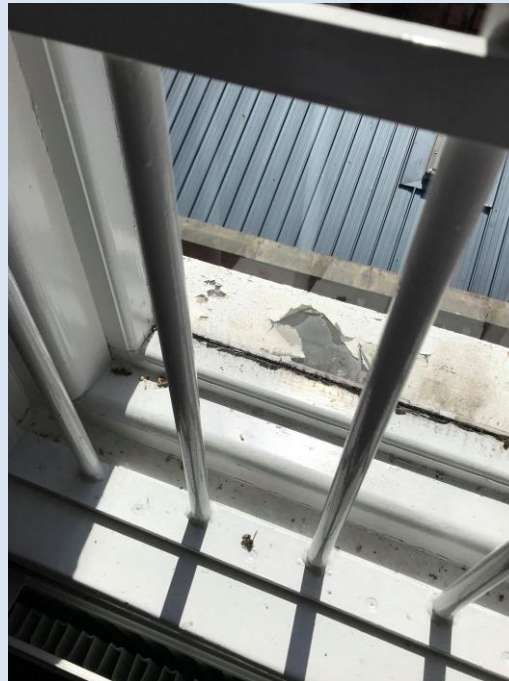
There are a pair of two offices at the back of the building on the second floor that are at a lower height than the second floor meeting room. The rooms are in good condition except for the ivy working its way in through the window. The windows in this back office area numbered 20 & 21 and are a wooden construction. The windows both have security bars internally and are in good condition apart from the ivy externally on 20 and an area of peeling paint on the sill of 21. There were no noticeable defects in the offices, which are separated by height and a glass partition.
