## REMEDIATION AND ENABLING WORKS VALIDATION REPORT

Former Stagecoach Bus Depot  
Land off Bowes Street  
Manchester

Report Ref: 11-813-R2- Rev C  
Date Issued: August 2019

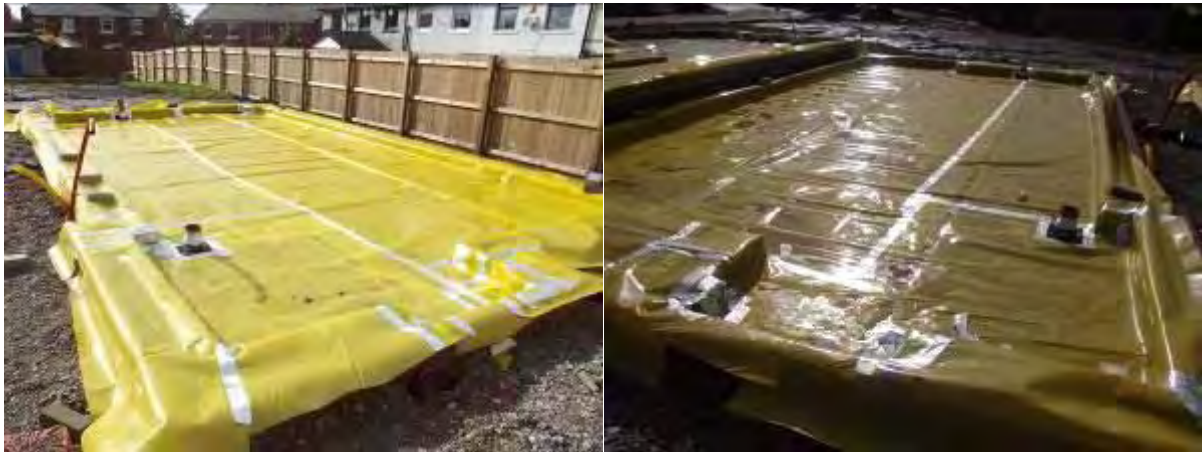
*Photographs 1 and 2: Check general condition of membrane for punctures / tears etc*

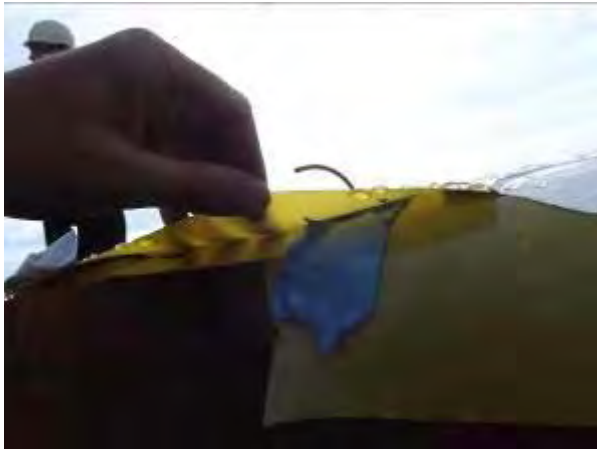
*Photograph 3: Confirm membrane product type and check joints between rolls of membrane to ensure 150mm overlap and presence of double sided butyl tape (by touch – may not be visible) and girth jointing tape.*

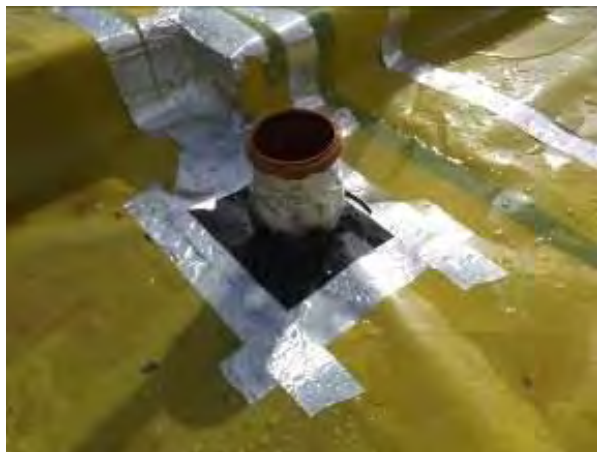
*Photograph 4: Check top hat is sealed to membrane and pipework. If the formed top hat is not tight to the pipework then also confirm presence of jubilee clip beneath butyl tape.*

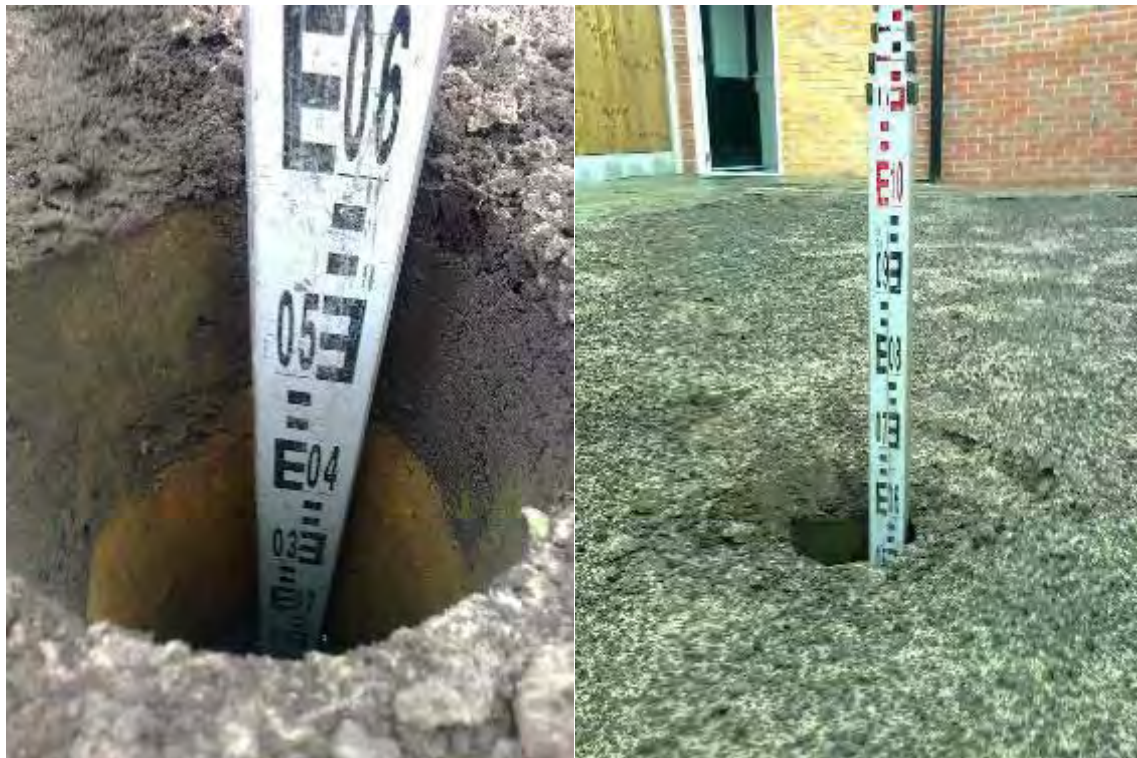
*Photographs 1 and 2: Examples of validation photographs demonstrating clean cover.*
