**Project Name:** Caddick Construction Limited - Openshaw Campus - PJ379716  
**Project Description:** Converted project from v8 project  
**Project Number:** PJ379716  
**Project Date:** 04/09/2020

As requested, we have recently carried out a drainage CCTV survey at the site location and our full and detailed findings are contained in the attached CCTV report which you can review at your leisure.

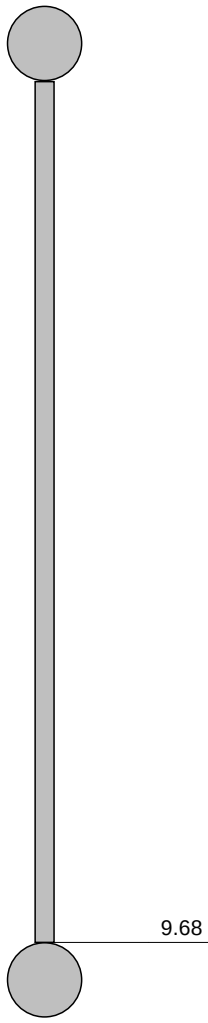
| Scale: | 1:85 | Position [m] | Code | Observation | Grade |
|---|---|---|---|---|---|
| <p>Depth: m</p> <p>CULVERT</p> <p>9.68</p> <p>REM REM: General remark: DYE FROM FOUL LINE</p> <p>CULVERT</p> <p>Depth: 3.59 m</p> | | | | | |
