**Reference: A153-0421**

**RE: Structural Engineer Report: 623 Burnage Lane, Manchester**

## **Introduction & Clients Brief**

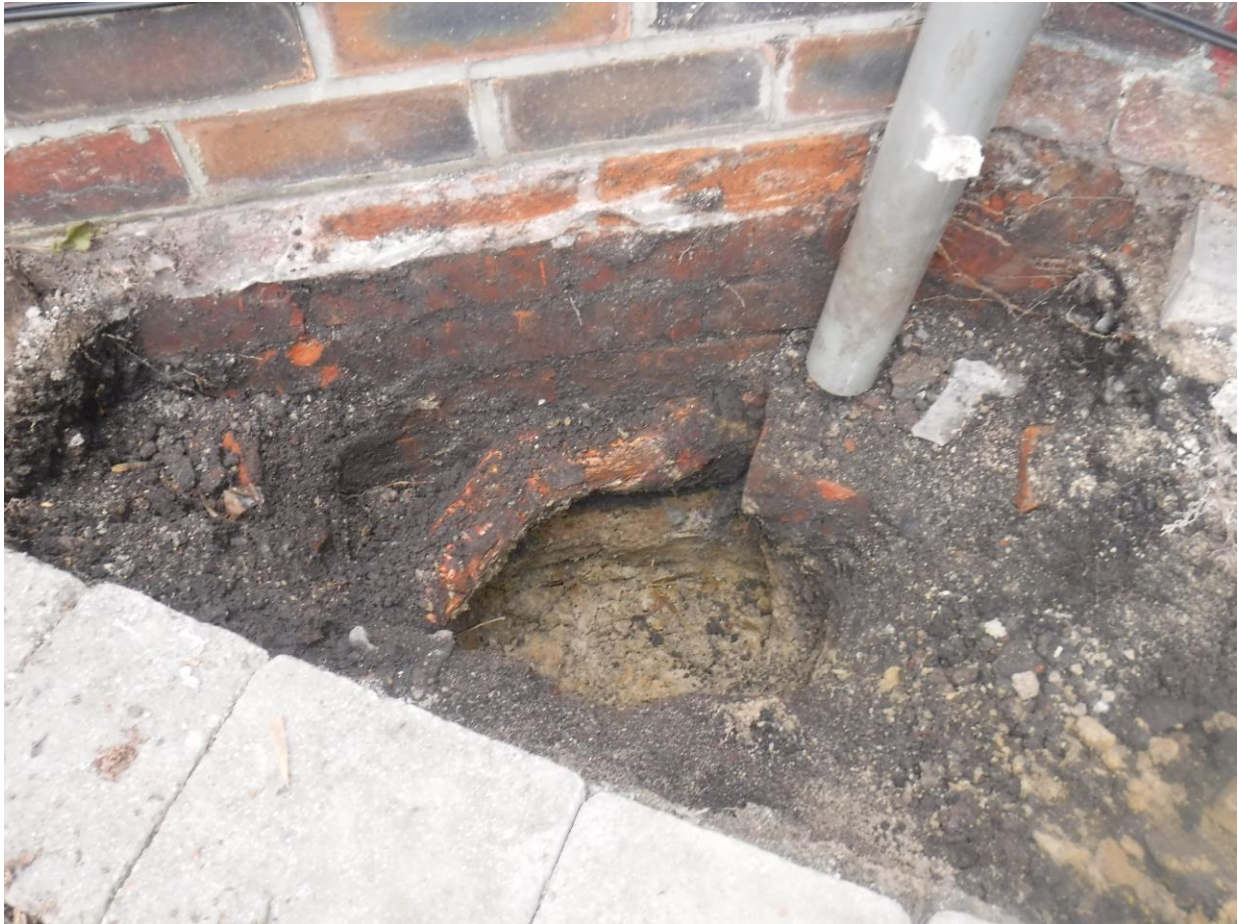
A large woody tree root was discovered in the trial pit passing through the cavity brick wall of the bay structure. The root is of considerable diameter and had obviously been growing through the wall for many years. The root appears to be

from the large tree (possibly an Elm tree) located alongside the front drive of the neighbouring property.

The trial pit confirmed the bay structure is bearing onto sandy clay cohesive stratum and has relatively shallow footings. As the subsoil is clay, it will be susceptible to seasonal variations in ground water due to the nearby trees.

Trial pit – large tree root passing through the wall of the bay window. Base of hole at foundation depth.

Once the tree is removed, I would recommend the entire bay structure be underpinned due to the shallow foundations. The area where the large tree root has passed through the brickwork should also be rebuilt. Where bricks have cracked, they should be replaced. Helifix Helibar bed joint reinforcement should then be installed to strengthen the masonry below the ground floor bay window. The 8mm diameter Helibars should be installed at 300mm vertical centres the full width of the bay and be resin fixed in place. The wall should then be repointed in matching mortar.

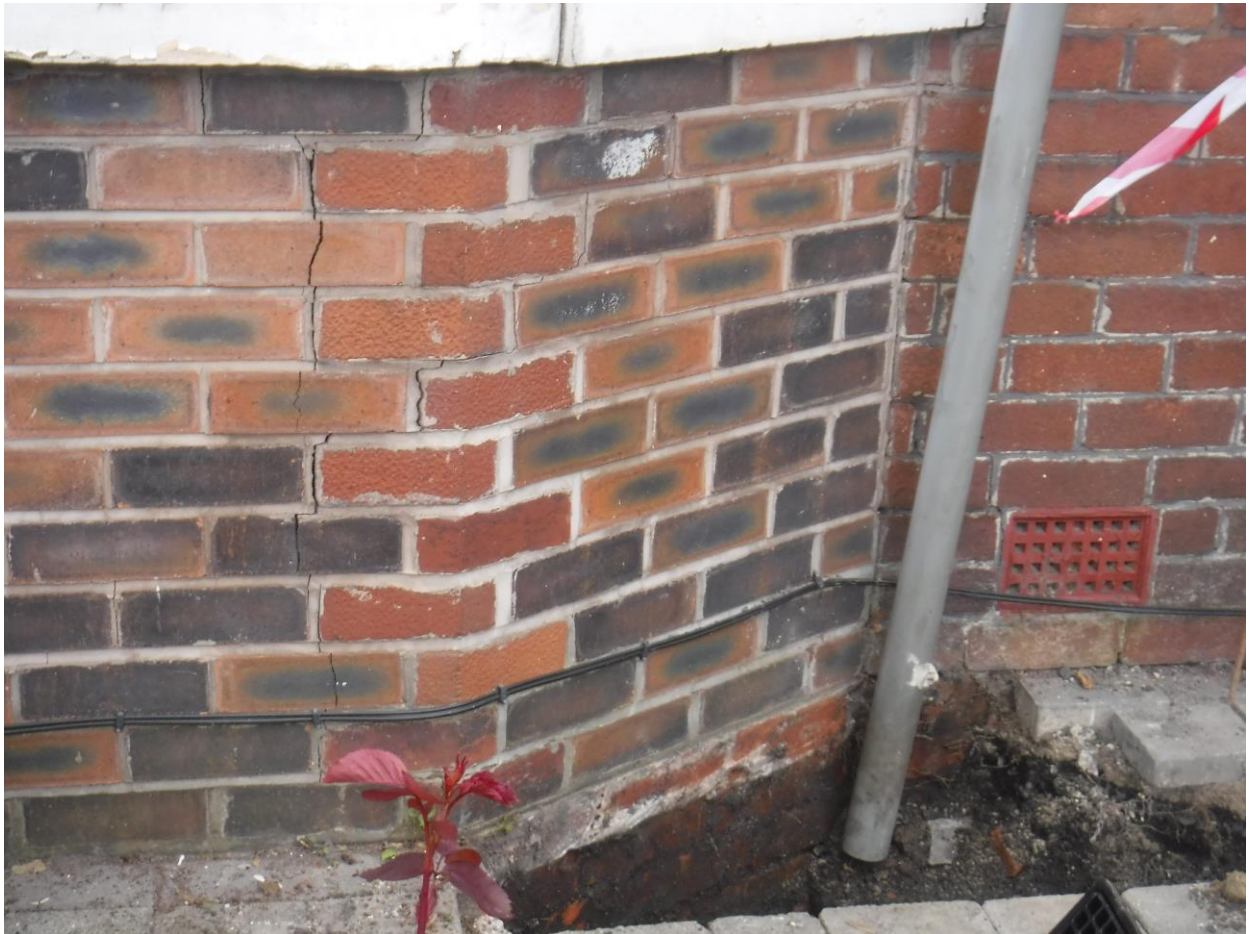
Our Client has recently noticed new external cracking at the front right-hand corner of the front bay window. A trial pit was excavated below the area of cracking to allow visual inspection of the foundations and bearing strata.

The cracking to the bay window brickwork (visible internally and externally) is likely due to the stresses imposed on the masonry as the large tree root grows in diameter. I also suspect the cracking to the front left-hand internal wall in the hallway is also due to the same root causing damage to brickwork and foundations.

The bay structure has been partially rebuilt in the past. However, it does not appear the bay was underpinned as part of this repair work. The previous Structural Engineers report identified tapered stepped cracking on the left and right corners of the bay. Due to the evidence uncovered in the trial pit, the cracking is likely due to subsidence caused by tree roots. I suspect subsidence was the reason the bay was rebuilt years ago. Unfortunately, further movement has occurred, and I suspect is ongoing.

Cracking to the right hand corner masonry caused by the tree root & subsidence. Crack has recently got worst with a brick split, which indicates ongoing movement has occurred.

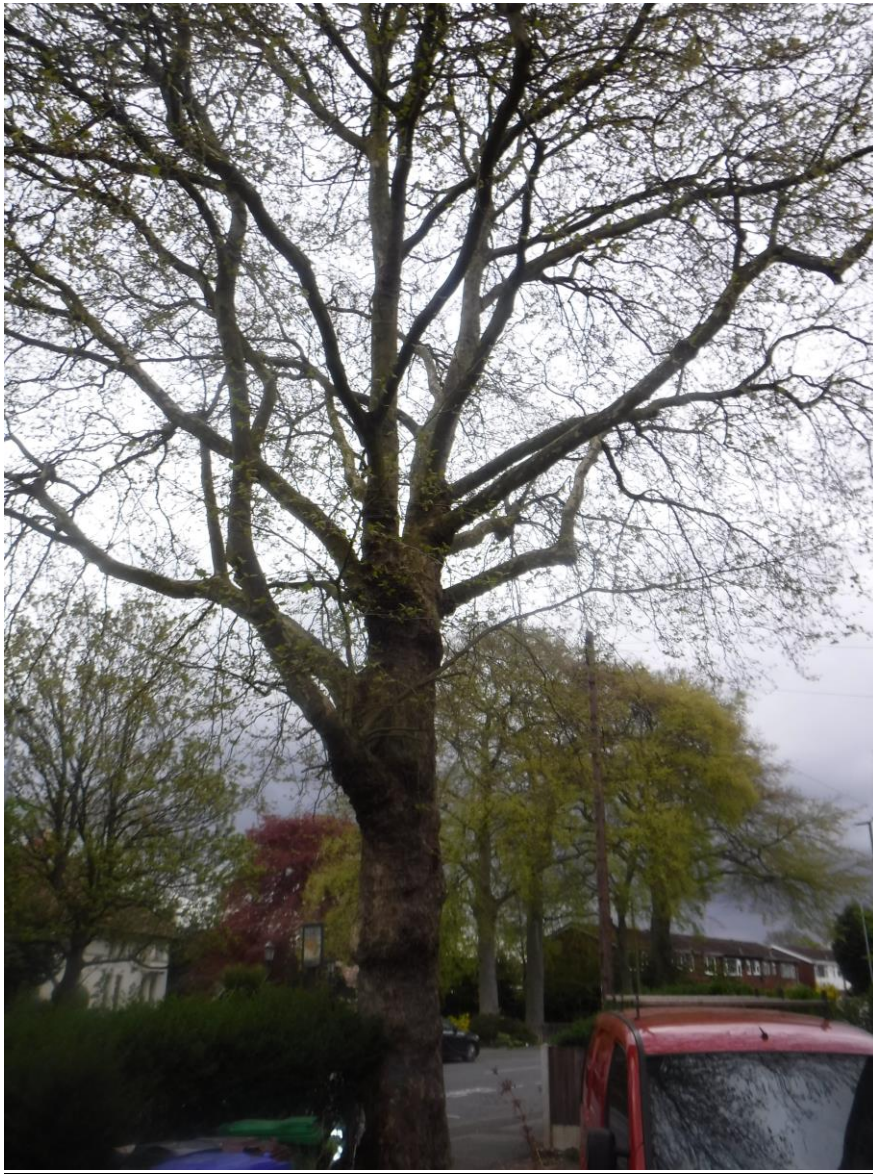
I understand the drains to the front of the property were damaged due to extensive tree root infestation. Although it is possible drainage defects contributed to the subsidence that has occurred to the front bay structure, the prime cause is obviously due to the large tree root causing actual structural damage. There is also indication of subsidence caused by the roots affecting the water content of the clay bearing strata.

Tree located near property

Due to the damage that has and could still occur from the nearby tree, I would strongly recommend the tree be removed. It is obvious the tree is causing significant structural damage and is affecting the properties foundations and drainage system.

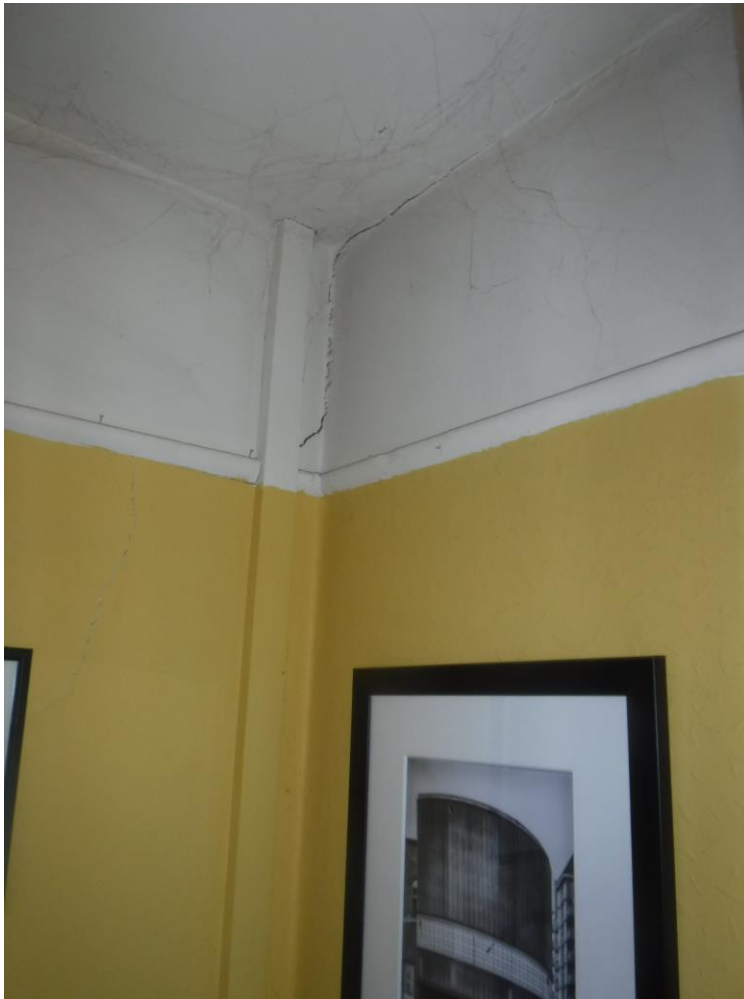
Cracking to internal wall between living room and entrance hall. (noted in 2019 report)  
Opposite side of wall in entrance hall has recently been plastered.

I would also recommend removing a few floorboards in the hallway or living room alongside the left-hand wall in the entrance hall. This is to allow visual examination of the sub floor to determine if the large tree root has caused damage to the internal masonry. The cracking to this wall is also due to subsidence caused by the nearby tree. Therefore subject to findings, underpinning may be required.

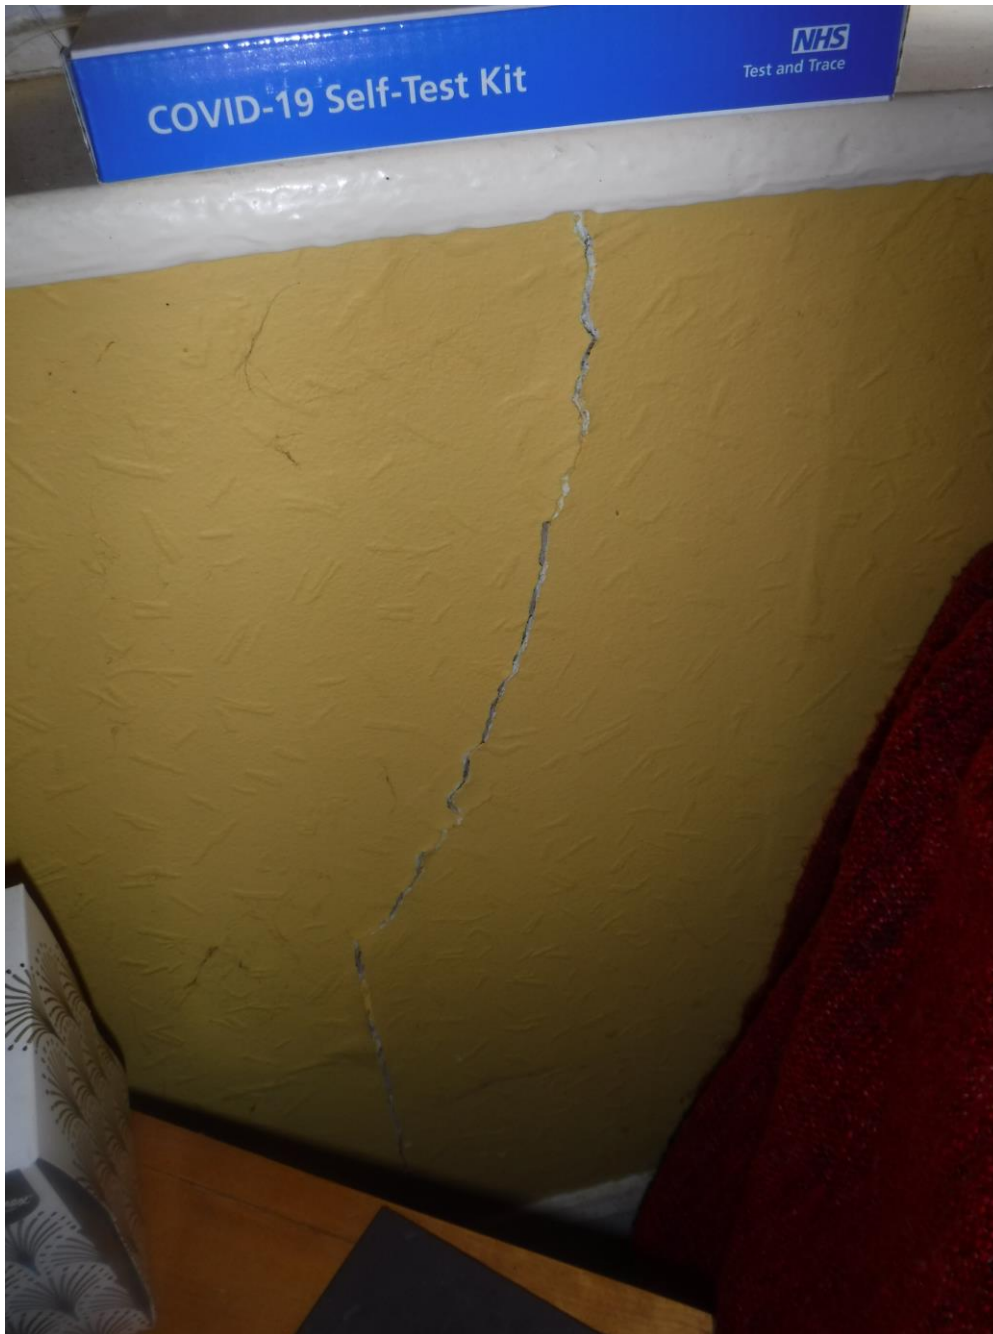
Cracking below the bay window (right hand side).  
Noted in 2019 report, but may have got worst.
