N.B Read in conjunction with drawing 19-143 - CS9 for window Condition Survey and Repair Schedule 19-143 - Sch 1.

# W9 - LG

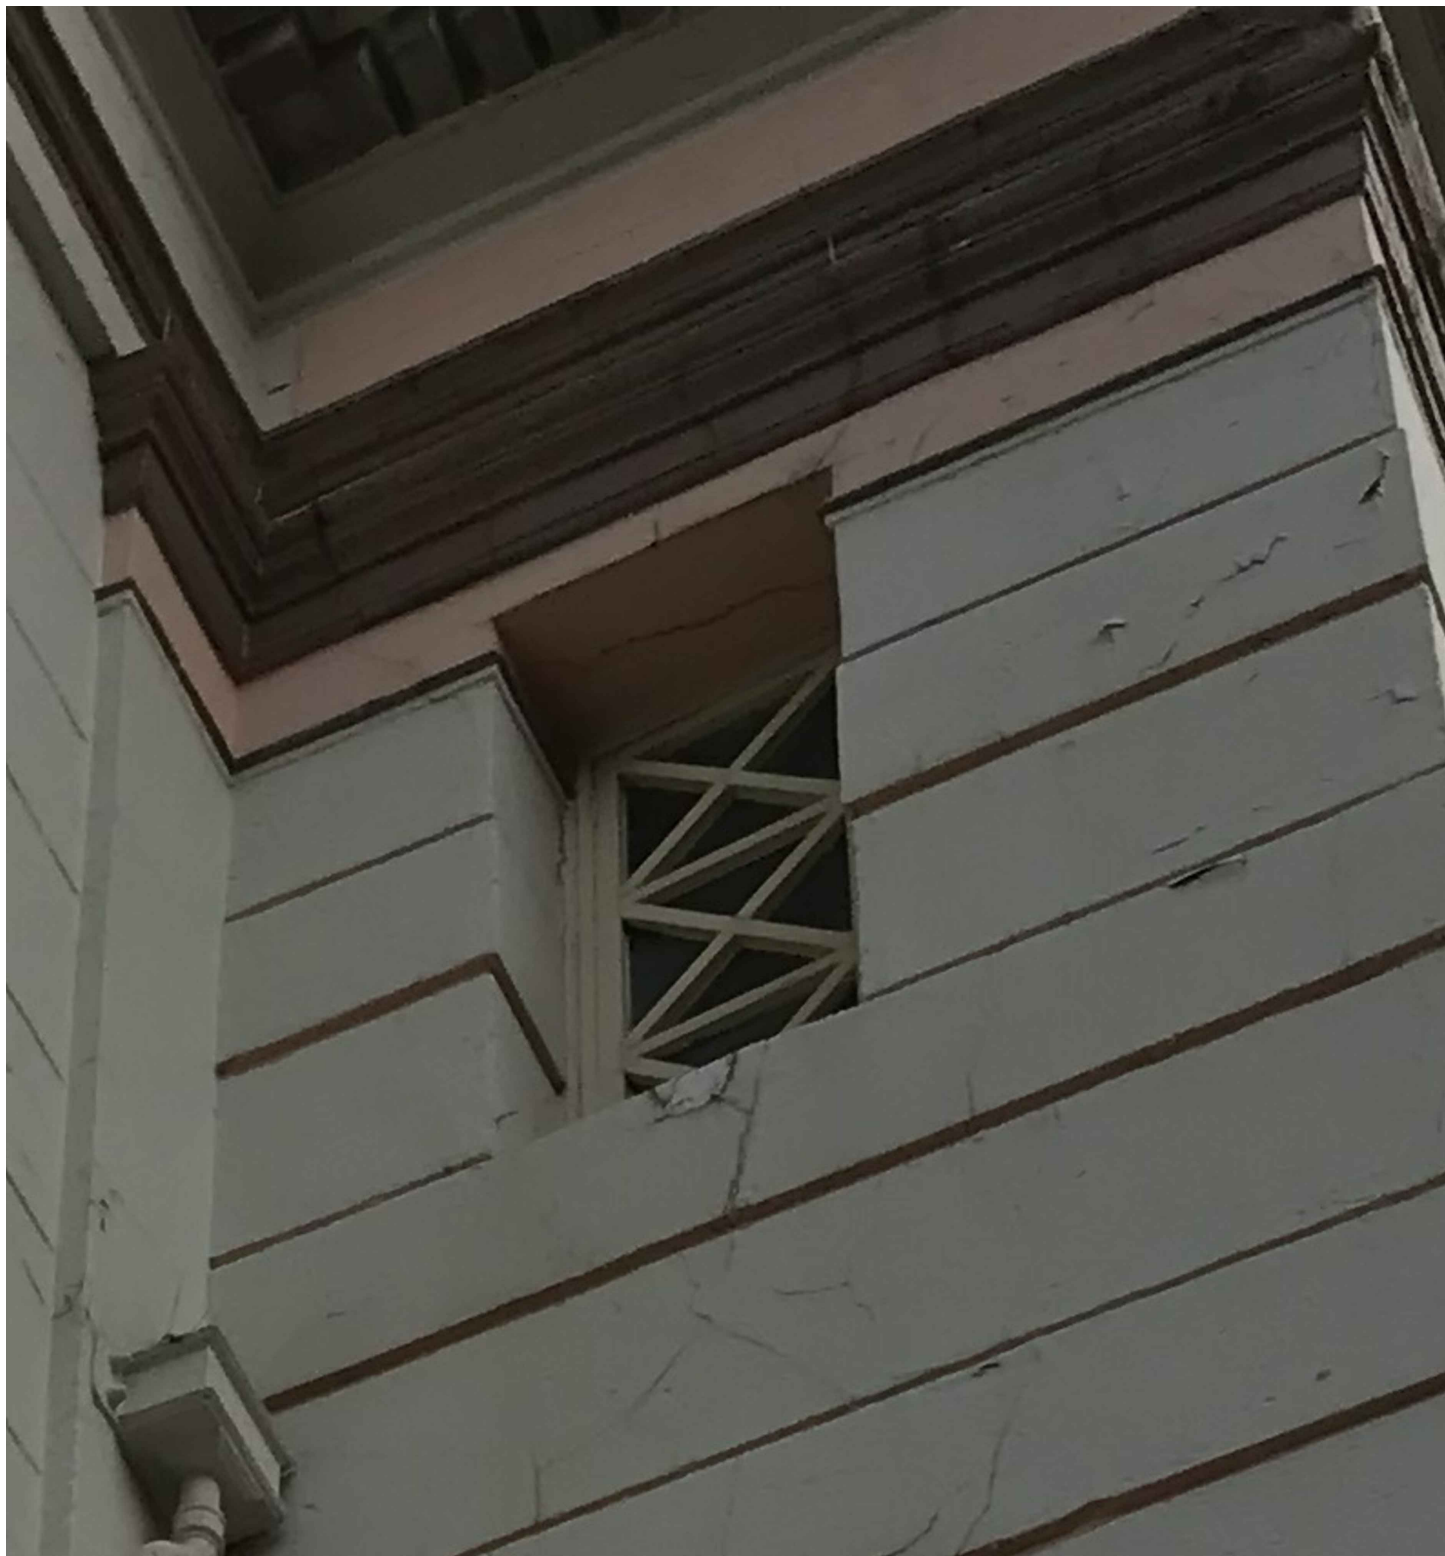
Window W9-LG

Once casement has been removed and the existing frame has been left in-situ, check frame and cill for and damage or rot. Record areas and inform CA.  
N.B Access to window will need to be external.

Where external cills are to be replaced - replicate the profile of the existing cill in a durable hardwood such as oak incorporating a drip detail to the underside. Any new cill parts should be butt jointed below the casement frame. Finish using linseed oil based paint as described above in the colour to match the existing colour.
