| Project | SCIENCE & INDUSTRY MUSEUM<br>1830 WAREHOUSE URW |
| Title | 1830 WAREHOUSE (BASEMENT)<br>PRIMARY BEAM REPAIR |
| Drawing No | 180426-CON-1830-XX-DR-S-4033 |

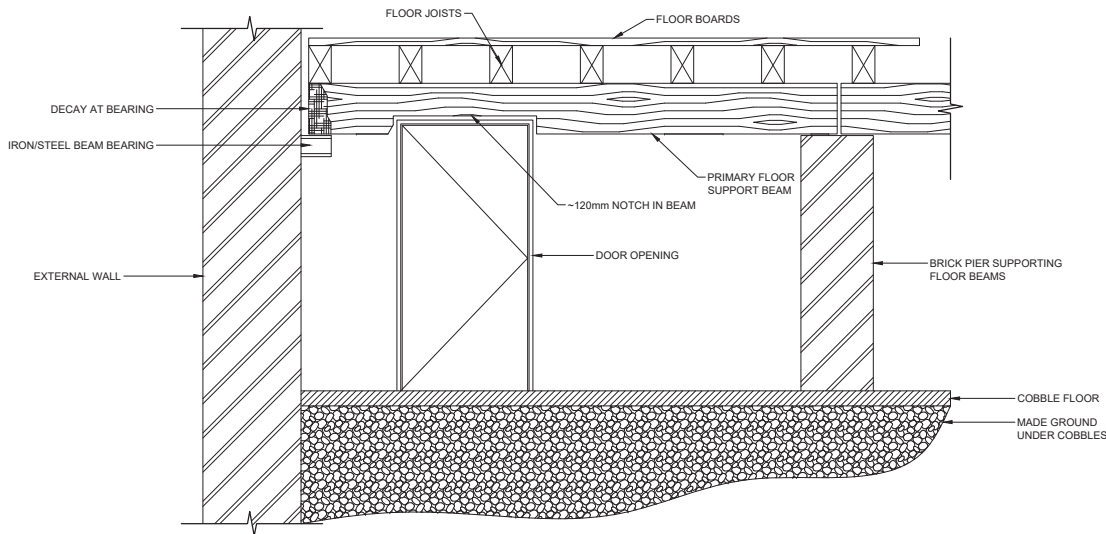
EXISTING BEAM (ELEVATION)  
scale 1:25@A1

1. TIMBER AT THE BEAM BEARING IS HEAVILY DECAYED. THE DECAY DOES NOT EXTEND BEYOND THE BEARING AREA (APPROX 200mm LENGTH).
2. THE BEAM HAS BEEN DEEPLY NOTCHED CLOSE TO THE BEARING FOR INSTALLATION OF A DOOR OPENING. THIS HAS REDUCED STRUCTURAL CAPACITY BELOW THAT EXPECTED FOR MUSEUM/GALLERY LOADING.

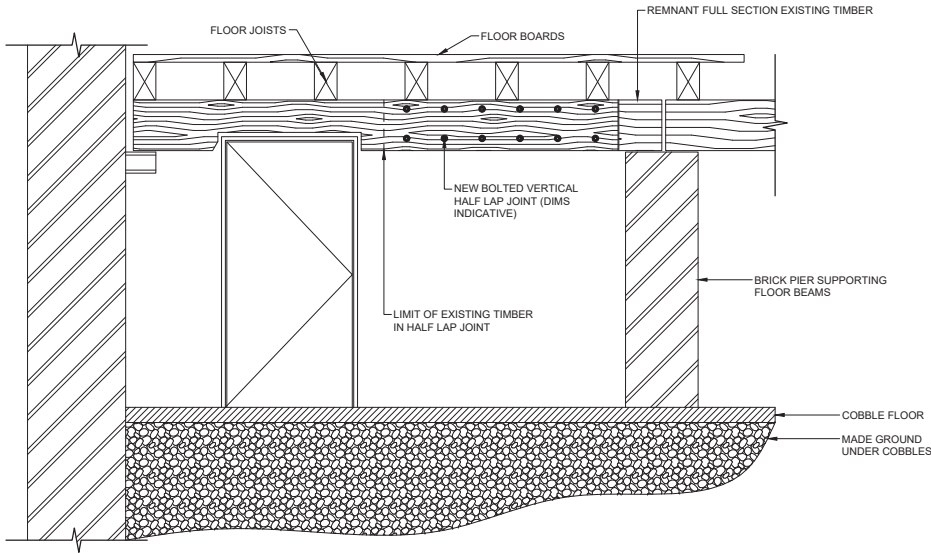
CONSENTED REPAIR METHOD - TRADITIONAL SPLICE  
scale 1:25@A1

1. HIGHLY INVASIVE - MOST OF HISTORIC BALTIC PINE BEAM IS LOST.
2. DOES NOT ADDRESS LOSS OF STRUCTURAL CAPACITY AT NOTCH
3. COULD REQUIRE BOARD LIFTING AND DEMOUNTING OF M&E EQUIPMENT FOR INSTALLATION ACCESS
4. NOT REVERSIBLE

5. THE FLOOR LOADING NECESSITATES A LONG LAP IN THE REPAIR AND WOULD RESULT IN LOSS OF THE MAJORITY OF THE EXISTING HISTORIC BEAM AND NOT ADDRESS THE LOSS OF CAPACITY CREATED BY THE NOTCH.

3. THE CONSENTED REPAIR APPROACH AS PER DR-S-4030 IS TO UNDERTAKE TRADITIONAL BOLTED SPLICE/LAP/SCARF JOINT REPAIRS.
4. IN THIS CASE THE PRESENCE OF THE NOTCH REQUIRES THE GENERIC CONSENTED REPAIR TYPE TO BE LOCATED IN THE FULL DEPTH BEAM SECTION BEYOND.

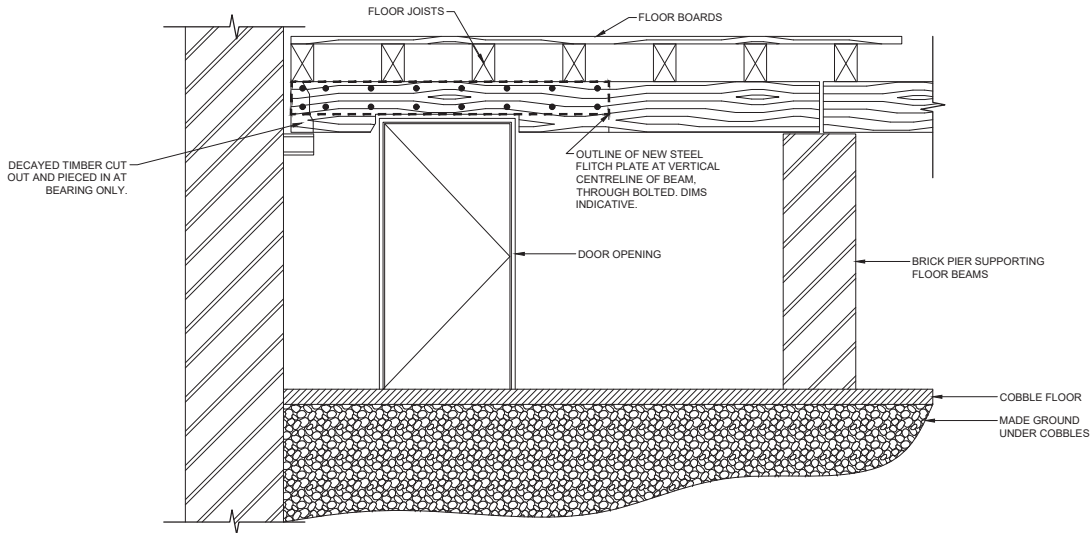
PROPOSED REPAIR OPTION 1 - FLITCH PLATE  
scale 1:25@A1

1. LOW HISTORIC TIMBER LOSS
2. RELATIVELY INCONSPICUOUS
3. ADDRESSES LOSS OF STRUCTURAL CAPACITY AT NOTCH

1. DIFFICULT TO INSTALL - ACCESS FOR BOLTING IS VERY RESTRICTED
2. COULD REQUIRE BOARD LIFTING AND DEMOUNTING OF M&E EQUIPMENT FOR INSTALLATION ACCESS
3. NOT FULLY REVERSIBLE

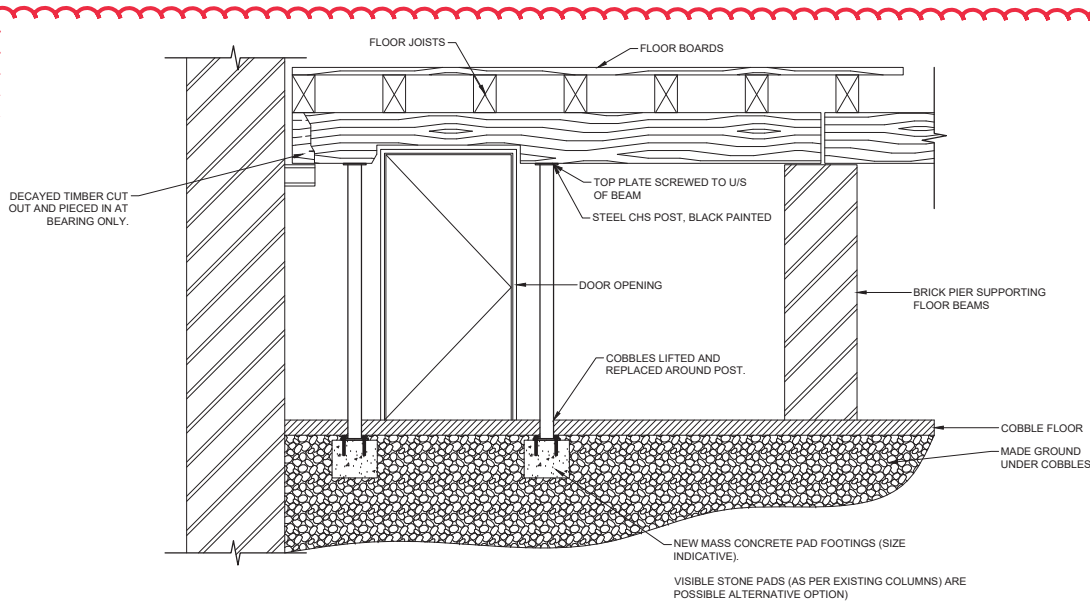
PROPOSED REPAIR OPTION 2 - SUPPORTING POSTS  
scale 1:25@A1

1. MINIMAL HISTORIC TIMBER LOSS
2. NO CHANGE IN APPEARANCE OF BEAM
3. ADDRESSES LOSS OF STRUCTURAL CAPACITY AT NOTCH
4. POSTS HAVE VISUAL SIMILARITY TO EXISTING COLUMNS
5. FULLY REVERSIBLE, NO SIGNIFICANT CHANGE TO COBBLES OR TIMBER.

1. REQUIRES LIFTING AND REINSTATEMENT OF SMALL AREA OF COBBLES
2. POSTS ARE VISIBLE (BUT NOT OUT OF KEEPING)

8. OUR PREFERENCE WOULD BE OPTION 2 TO INSTALL SUPPORT POSTS AS THIS HAS MINIMAL IMPACT ON EXISTING HISTORIC FABRIC IN THE TEMPORARY AND PERMANENT CONDITIONS, AND IS FULLY REVERSIBLE SHOULD THE NEED EVER ARISE.
