### **INSURANCE CLAIM: ENGINEERING APPRAISAL REPORT**

Name of Insured: West Point Medical Centre  
Address of Insured: 167-169, Slade Lane, Manchester, M19 2AF  
Situation of Damage: 167-169, Slade Lane, Manchester, M19 2AF

Date: 07/01/2022

Out Ref: 9377088

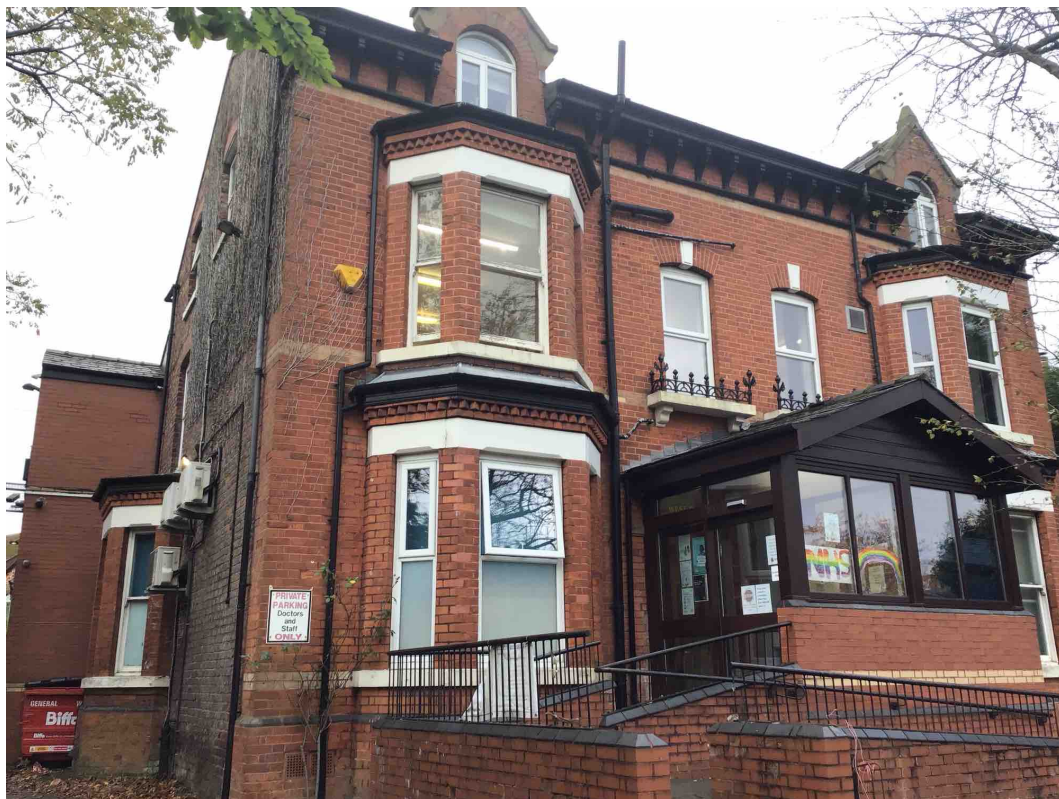
The claim is primarily concerned with damage to the fire escape stairwell. Site record details are attached and all references to the property are as observed facing the front of the building.

The subject property is a pair of semi-detached houses converted to a doctor's surgery constructed in around 1900, in a main road on a plot that is level. There are large single storey extensions at the rear including a two-storey fire escape extension.
