# Proposals for Urgent Repair Works to the 1830 Warehouse, the Science and Industry Museum, Manchester

Listed Building Consent MCC Ref. 124068/LO/2019

Submission for discharge of Condition 6 (structural timber beams, lintels and joists), 1830 URW

CDN/21/0017 Discharge of condition 6 (Timber Beam Repairs) attached to listed building consent reference 124068/LO/2019

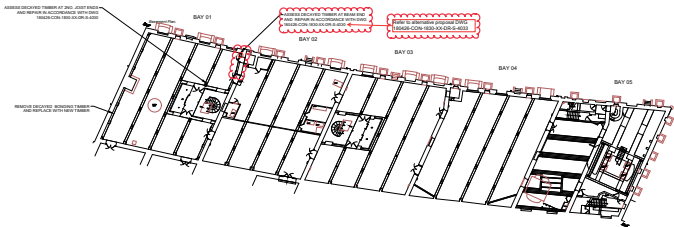
New Drawing - marked-up with location of amended detail for beam end in Bay 1 Basement.

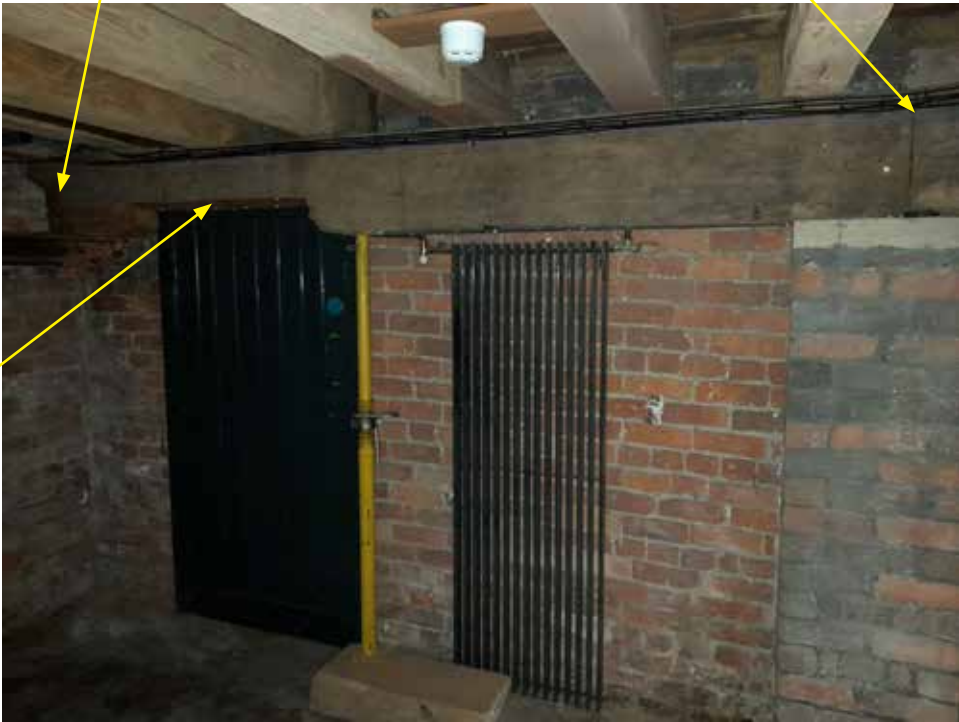
Decayed beam end

Existing joint

Photograph of existing beam in Bay 1 Basement. The decayed beam end is visible to the left hand side, the existing joint showing the extent of the existing beam is visible to the right hand side.

Existing notch in beam for existing door

The drawing 180426-CON-1830-XX-DR-S-4033 illustrates two repair options. Repair Option 1 could require further lifting of floor boards to gain adequate access. Repair Option 2 is preferred as it provides a permanent solution with two minimal steel posts either side of the doorway which will bolt into the existing beam, two small footings below the cobble and only a small number of existing cobbles to be set aside.

Repair Option 2 was discussed on site and agreed in principle on 27/05/21 with Paul Mason.

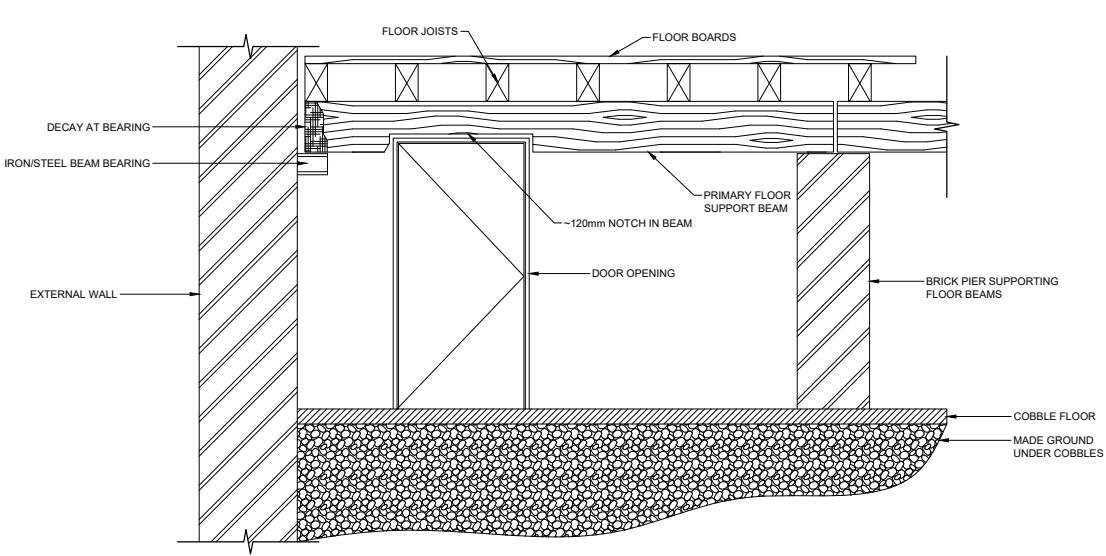
EXISTING BEAM (ELEVATION)  
scale 1:25@A1

1. TIMBER AT THE BEAM BEARING IS HEAVILY DECAYED. THE DECAY DOES NOT EXTEND BEYOND THE BEARING AREA (APPROX 200mm LENGTH).
2. THE BEAM HAS BEEN DEEPLY NOTCHED CLOSE TO THE BEARING FOR INSTALLATION OF A DOOR OPENING. THIS HAS REDUCED STRUCTURAL CAPACITY BELOW THAT EXPECTED FOR MUSEUM/GALLERY LOADING.

5. THE FLOOR LOADING NECESSITATES A LONG LAP IN THE REPAIR AND WOULD RESULT IN LOSS OF THE MAJORITY OF THE EXISTING HISTORIC BEAM AND NOT ADDRESS THE LOSS OF CAPACITY CREATED BY THE NOTCH.

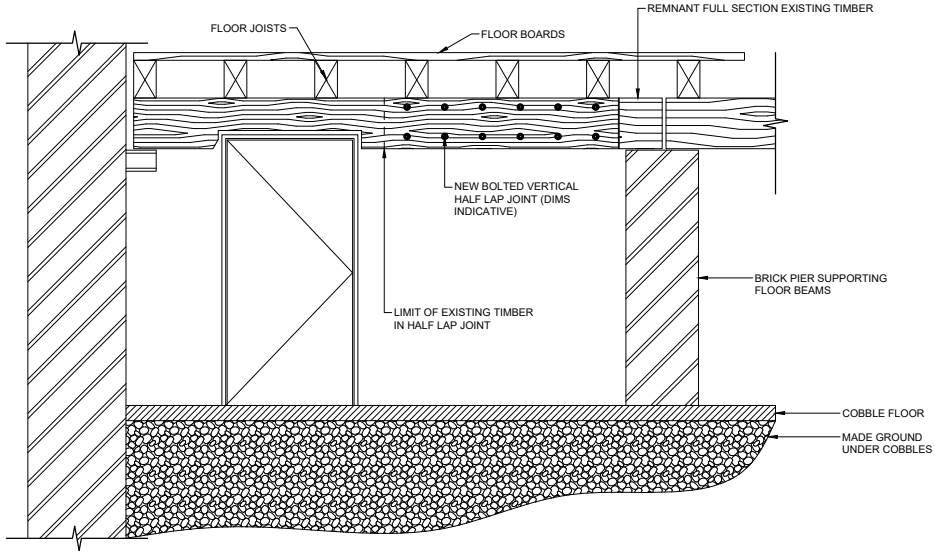
CONSENTED REPAIR METHOD - TRADITIONAL SPLICE  
scale 1:25@A1

3. THE CONSENTED REPAIR APPROACH AS PER DR-S-4030 IS TO UNDERTAKE TRADITIONAL BOLTED SPLICE/LAP/SCARF JOINT REPAIRS.
4. IN THIS CASE THE PRESENCE OF THE NOTCH REQUIRES THE GENERIC CONSENTED REPAIR TYPE TO BE LOCATED IN THE FULL DEPTH BEAM SECTION BEYOND.

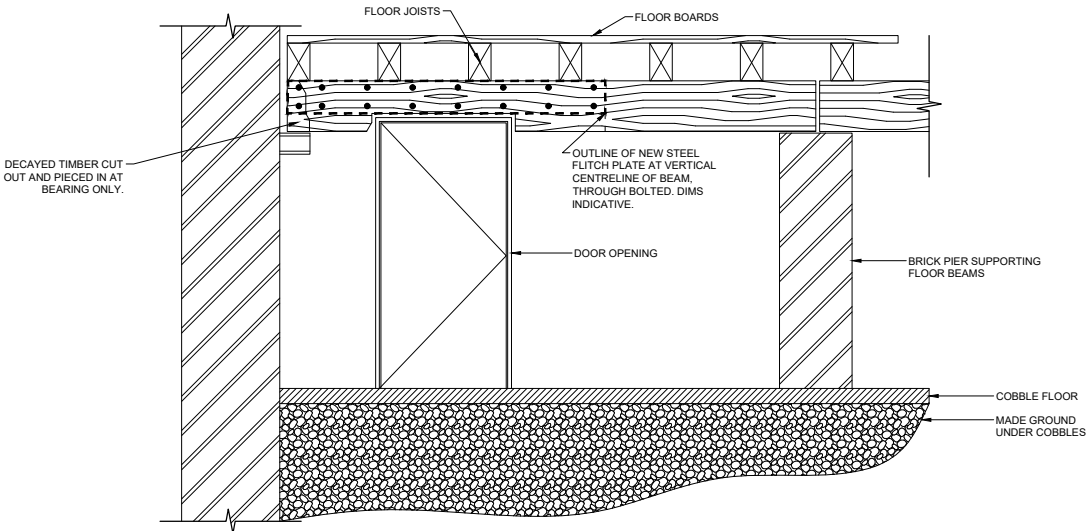
PROPOSED REPAIR OPTION 1 - FLITCH PLATE  
scale 1:25@A1

1. DIFFICULT TO INSTALL - ACCESS FOR BOLTING IS VERY RESTRICTED
2. COULD REQUIRE BOARD LIFTING AND DEMOUNTING OF M&E EQUIPMENT FOR INSTALLATION ACCESS
3. NOT FULLY REVERSIBLE
