Window W6-C

N.B Read in conjunction with drawing 19-143 - CS6 for window Condition Survey and Repair Schedule 19-143 - Sch 1.

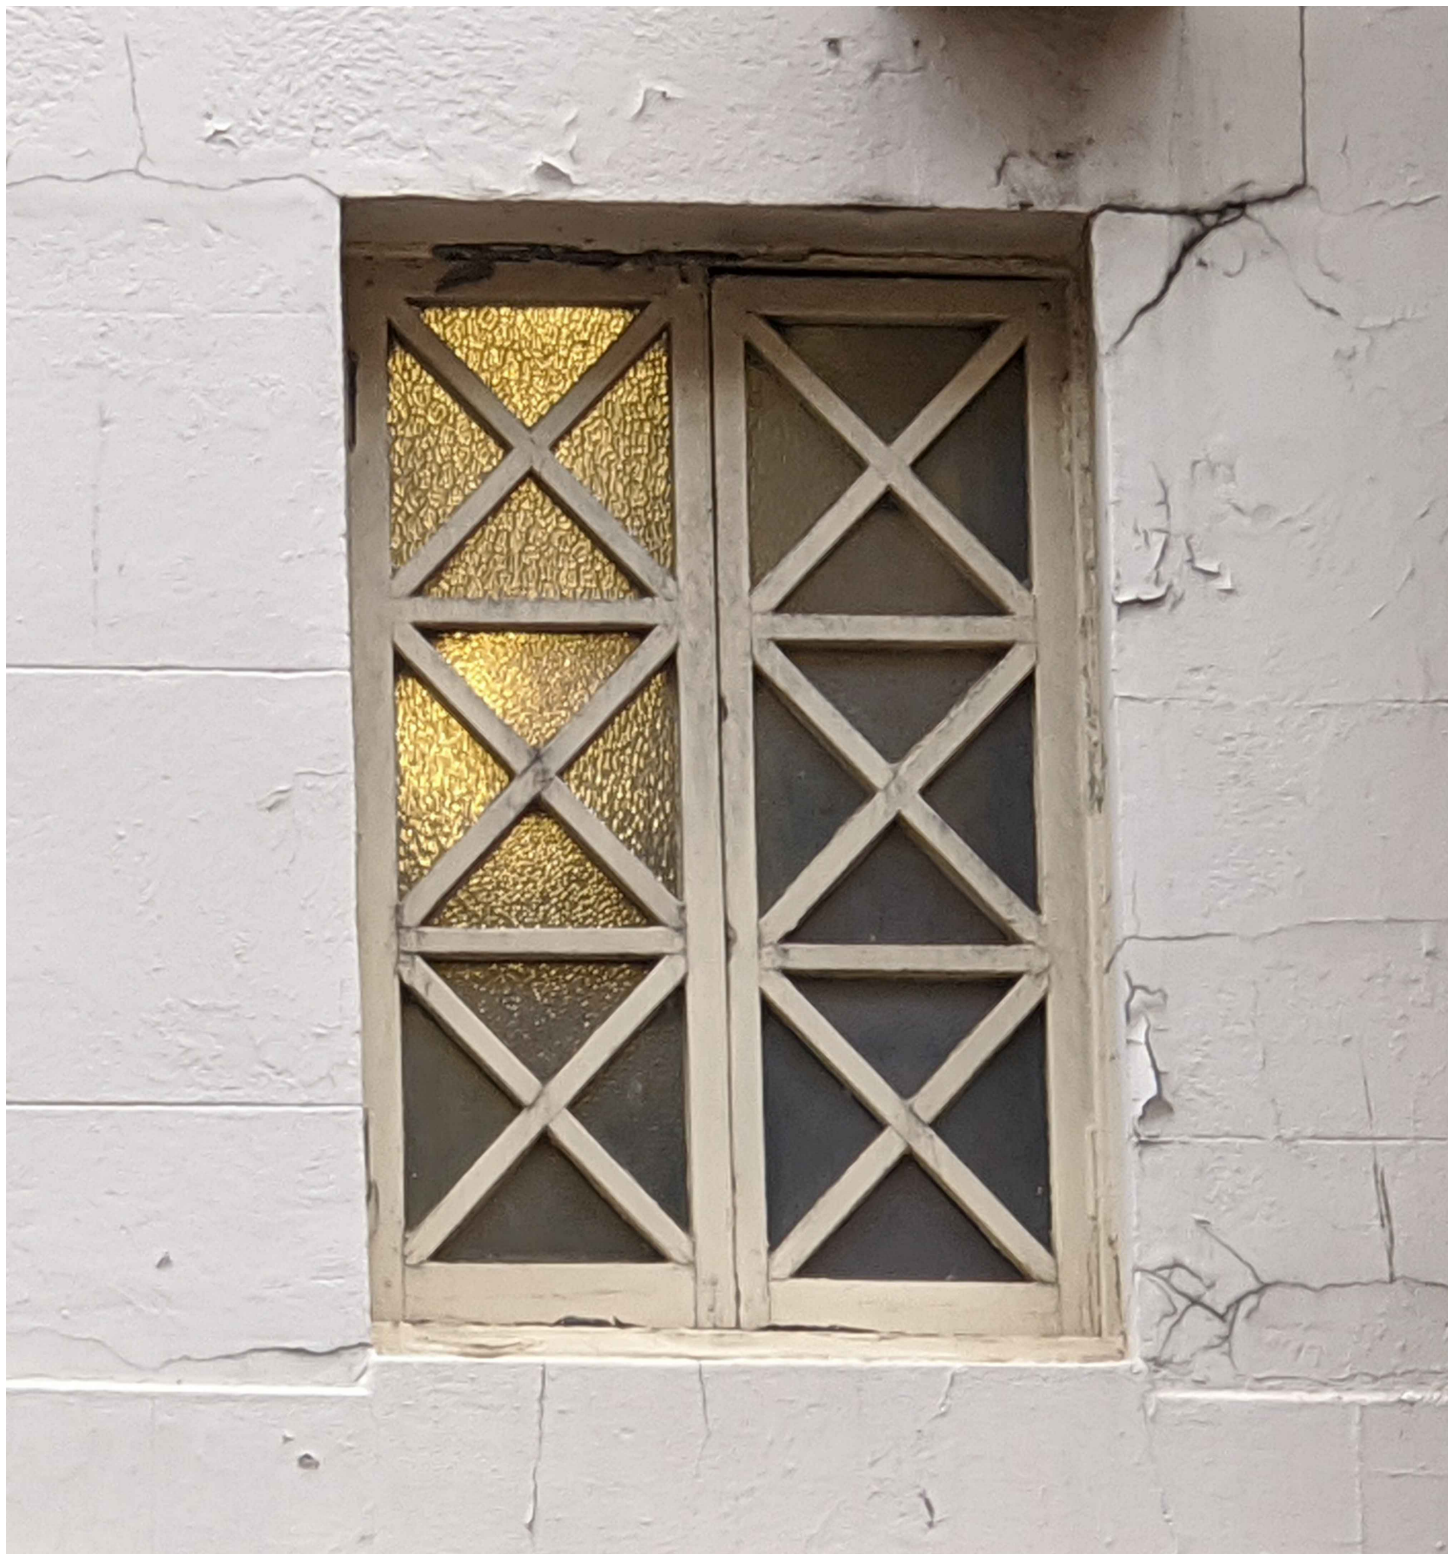
EXTERNAL ELEVATION

Once casement has been removed and the existing frame has been left in-situ, check frame and cill for and damage or rot. Record areas and report to CA.

Where external cills are to be replaced - replicate the profile of the existing cill in a durable hardwood such as oak incorporating a drip detail to the underside. Any new cill parts should be butt jointed below the casement frame. Finish using linseed oil based paint as described above in the colour to match the existing colour.
