Validation Completion Report  
Plots 1-54  
Bowes Street, Manchester

Reference:11-813-R5-2  
Date: May 2022

Plots 1-54  
Former Stagecoach Bus Depot  
Land off Bowes Street  
Manchester

Prepared for:  
**Rowlinson Construction**

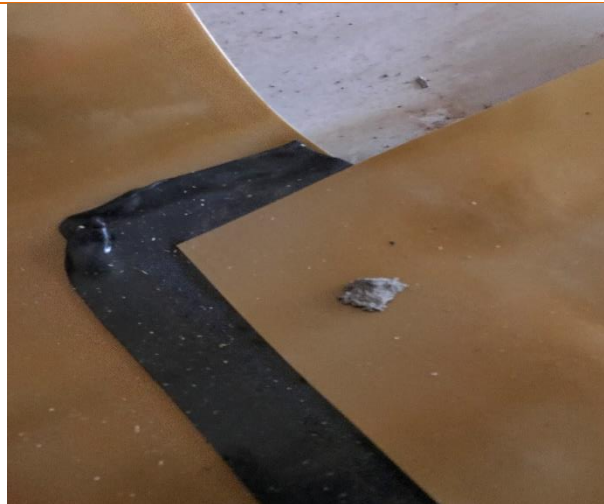
**Verification of Joints and Seals-Good Condition**

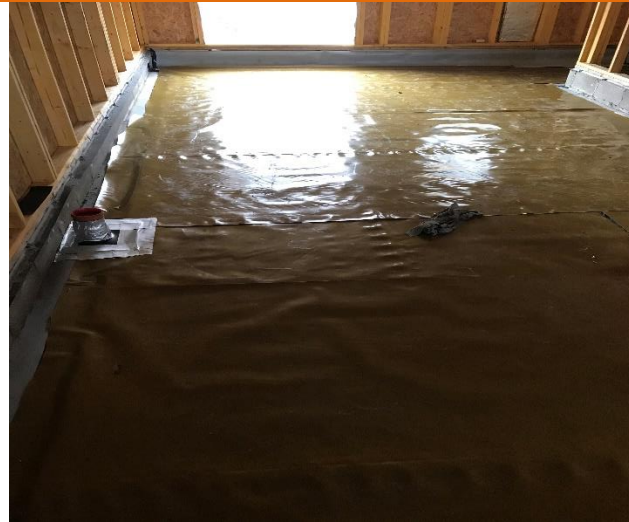
**Plot – 26**

**General Condition of Membrane-Good Condition**

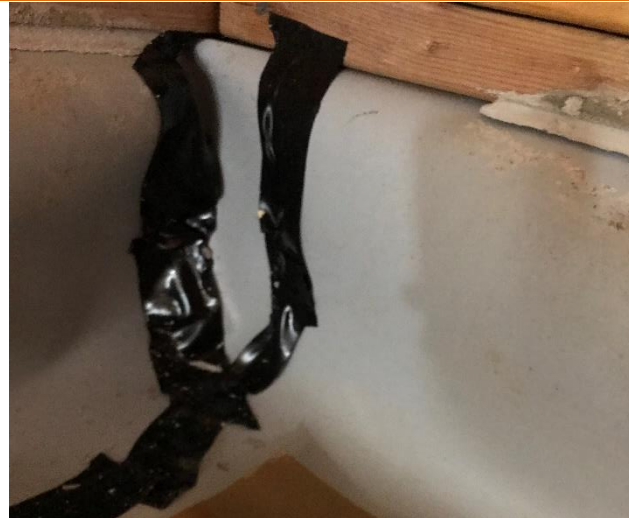
**Verification of Joints and Seals-Good Condition**

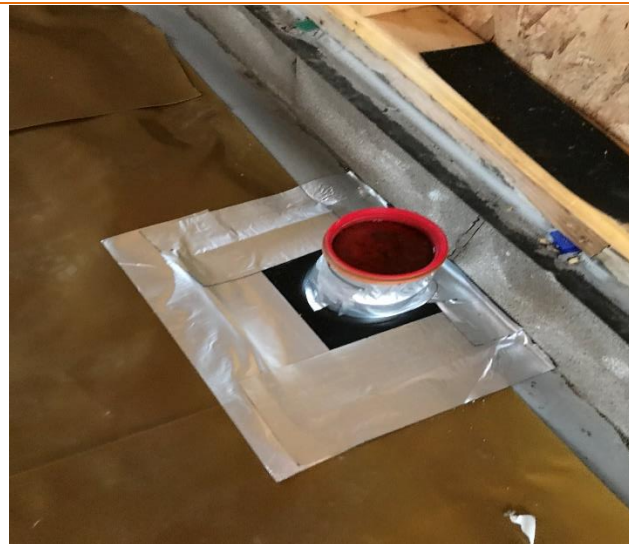
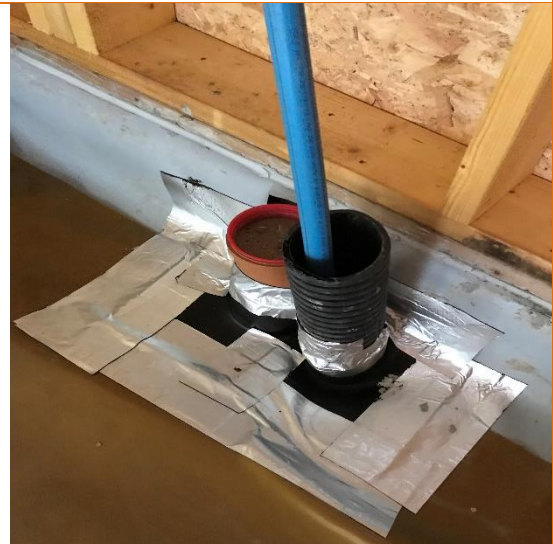
**Verification of Service Penetrations-Good Condition**

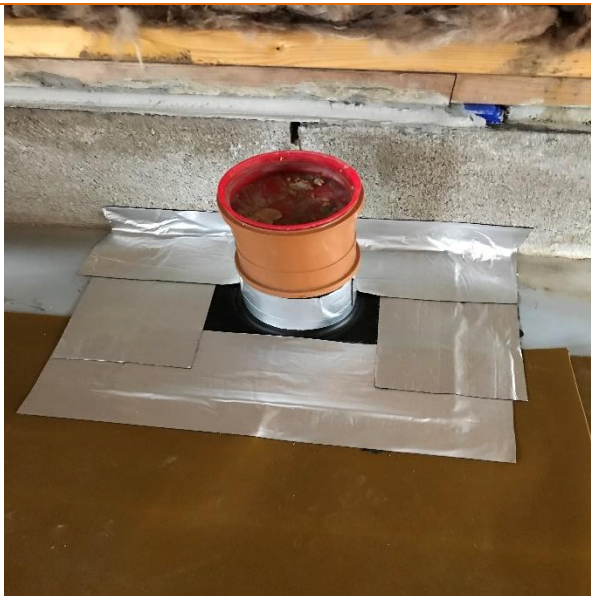
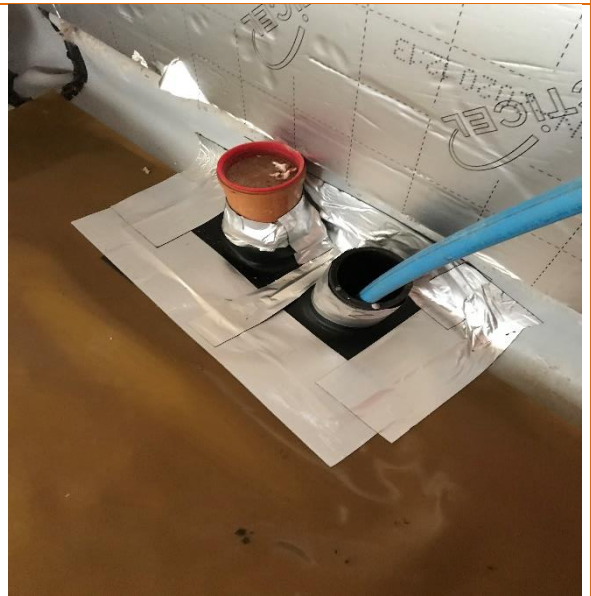
**Plot – 27**

**Verification of Service Penetrations-Good Condition**

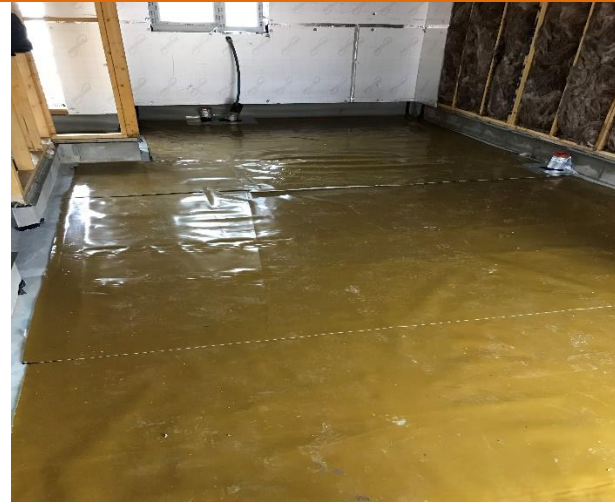
**Plot – 28**

**General Condition of Membrane-Good Condition**

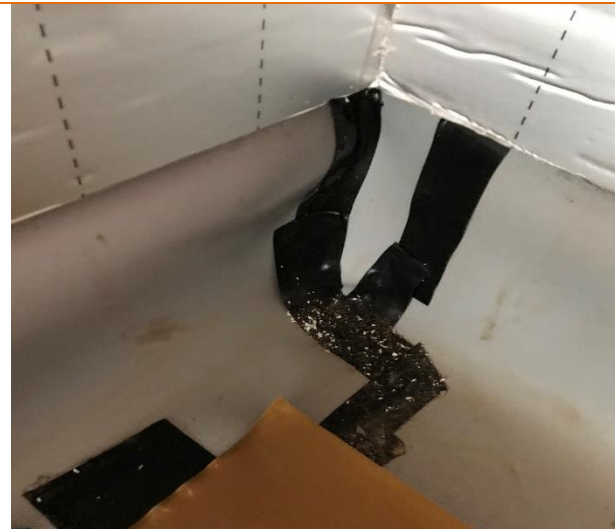
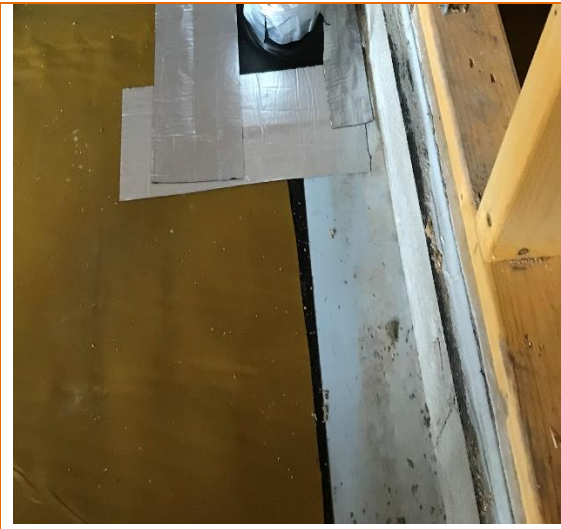
**Verification of Joints and Seals-Good Condition**

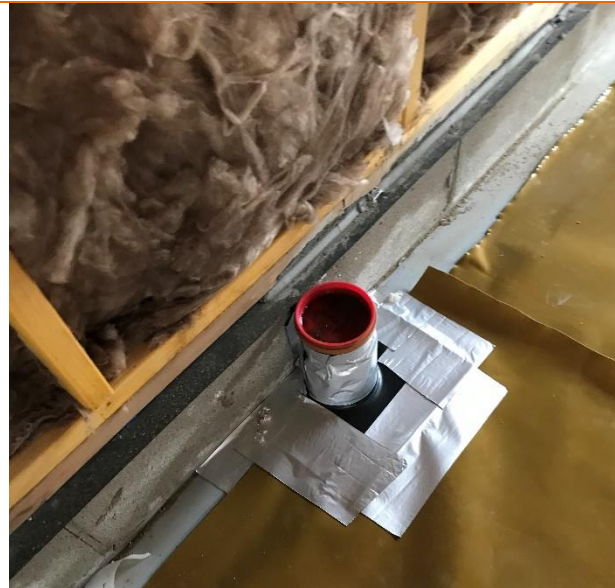
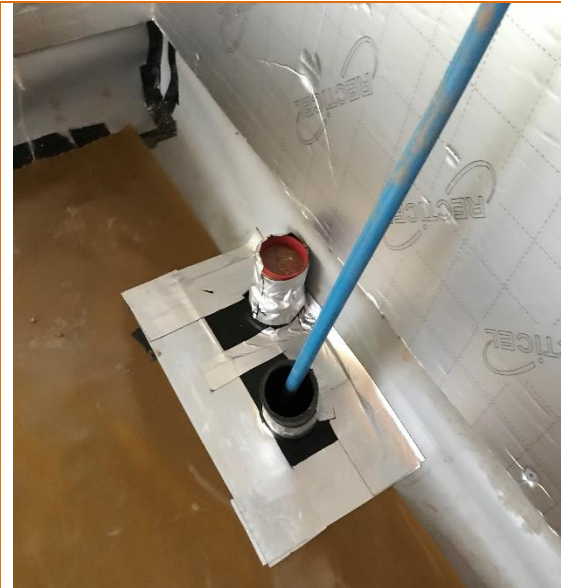
**Verification of Service Penetrations-Good Condition**

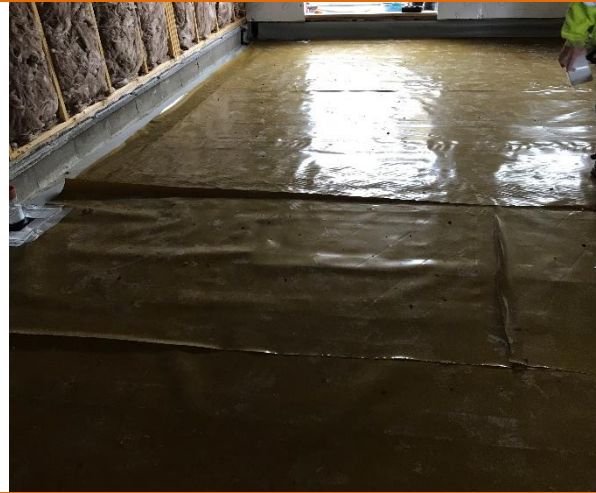
**Plot – 29**

**General Condition of Membrane-Good Condition**

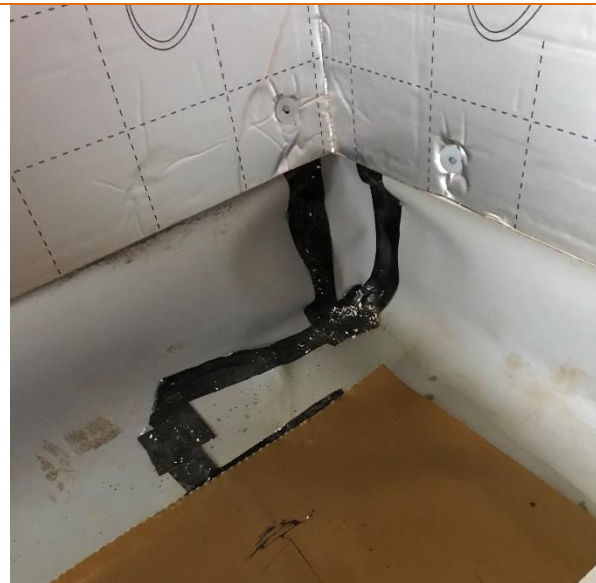
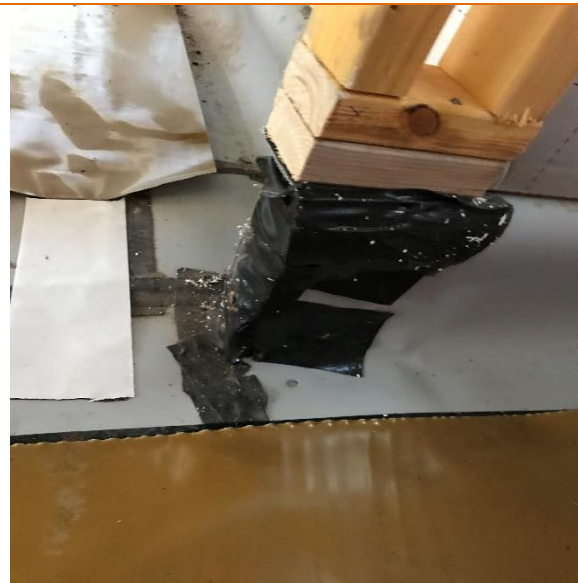
**Verification of Joints and Seals-Good Condition**

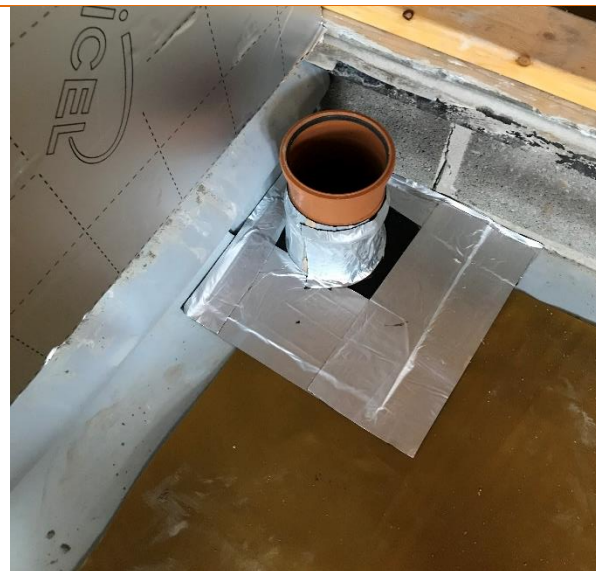
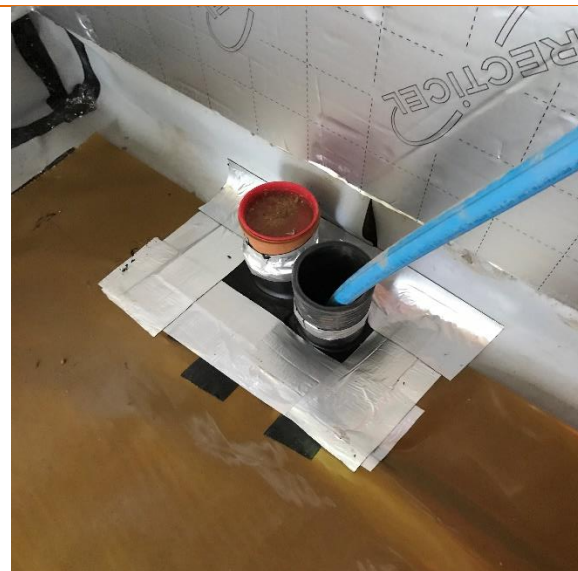
**Verification of Service Penetrations-Good Condition**

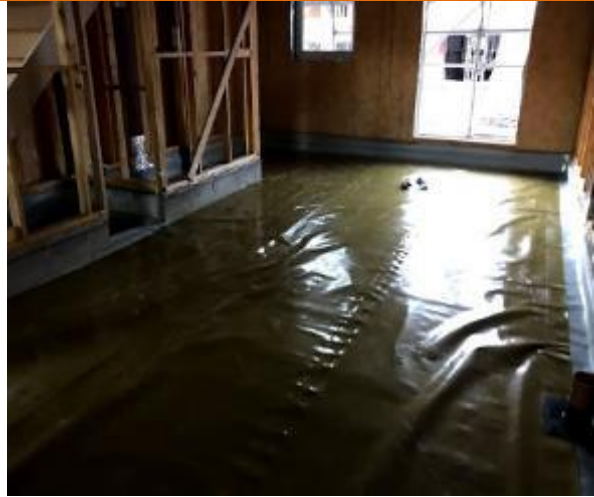
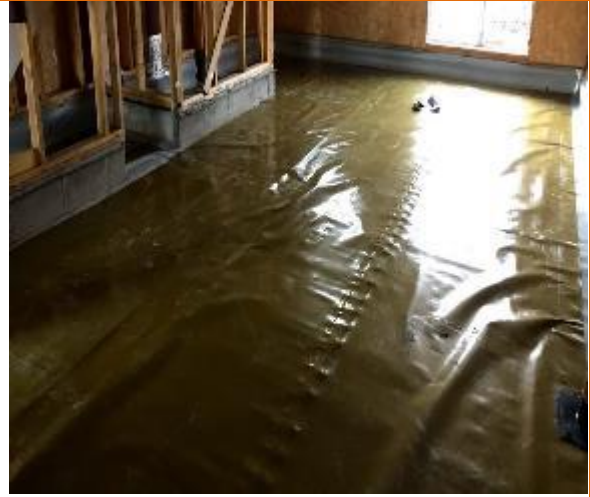
**Plot - 30**

**General Condition of Membrane-Good Condition**

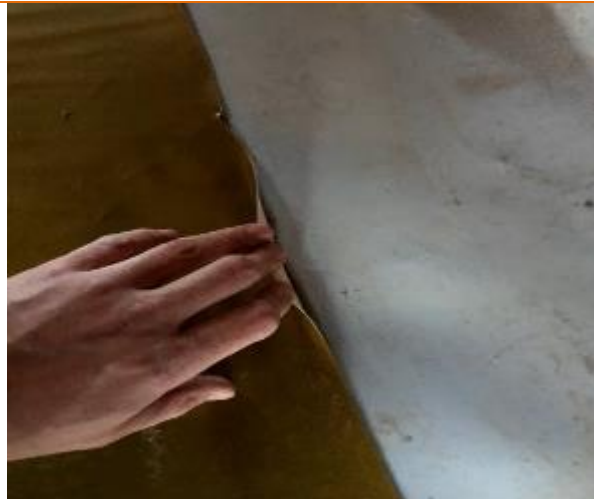
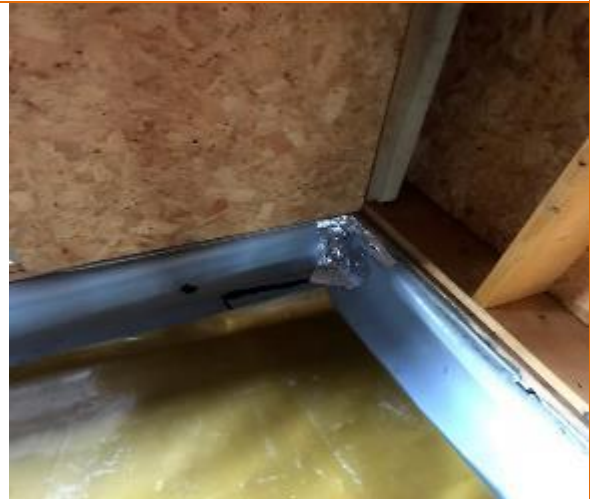
**Verification of Joints and Seals-Good Condition**

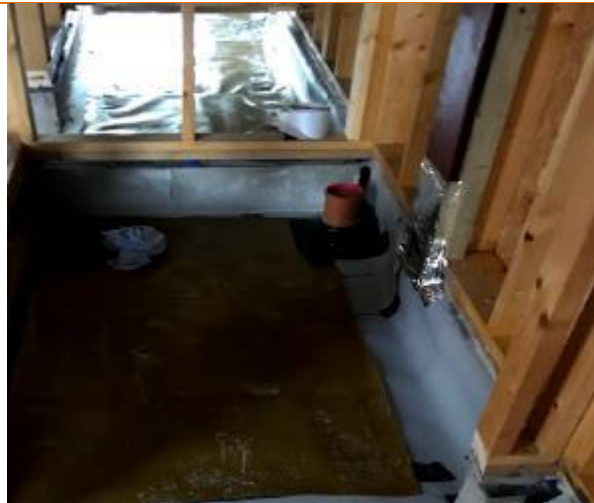
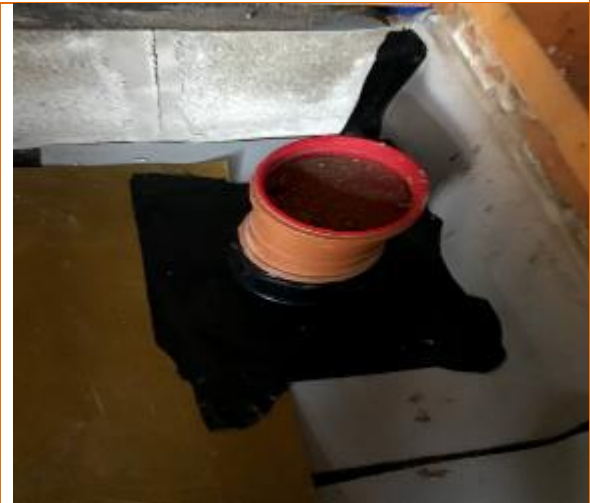
**Verification of Service Penetrations-Good Condition**

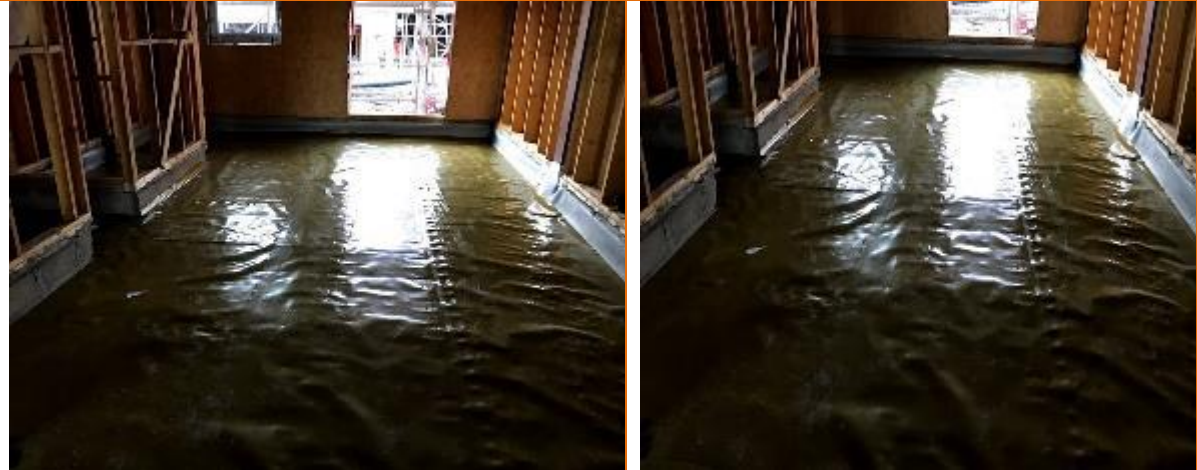
**Plot - 31**

**General Condition of Membrane-Good Condition**

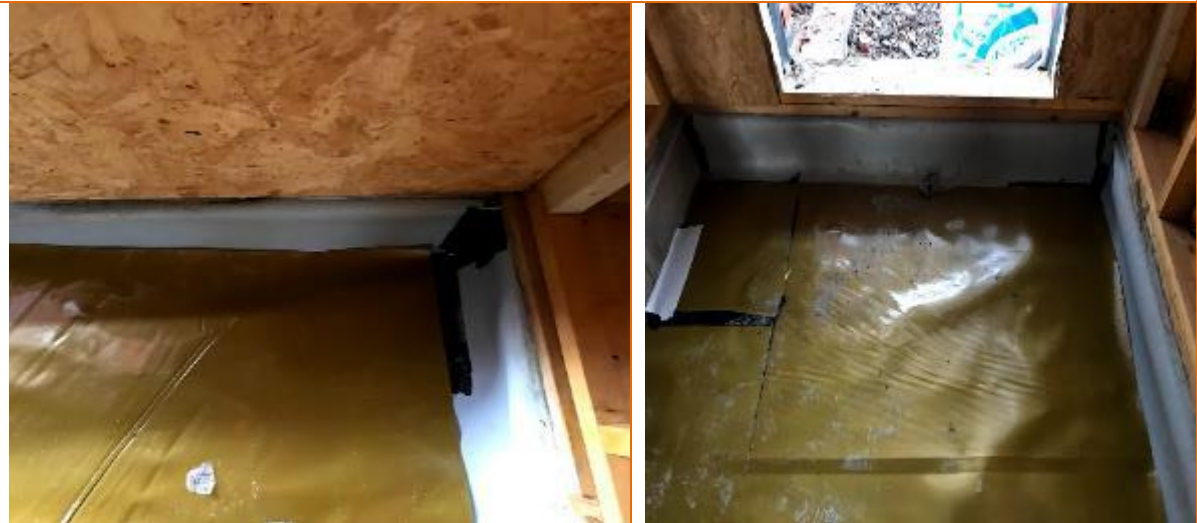
**Verification of Joints and Seals-Good Condition**

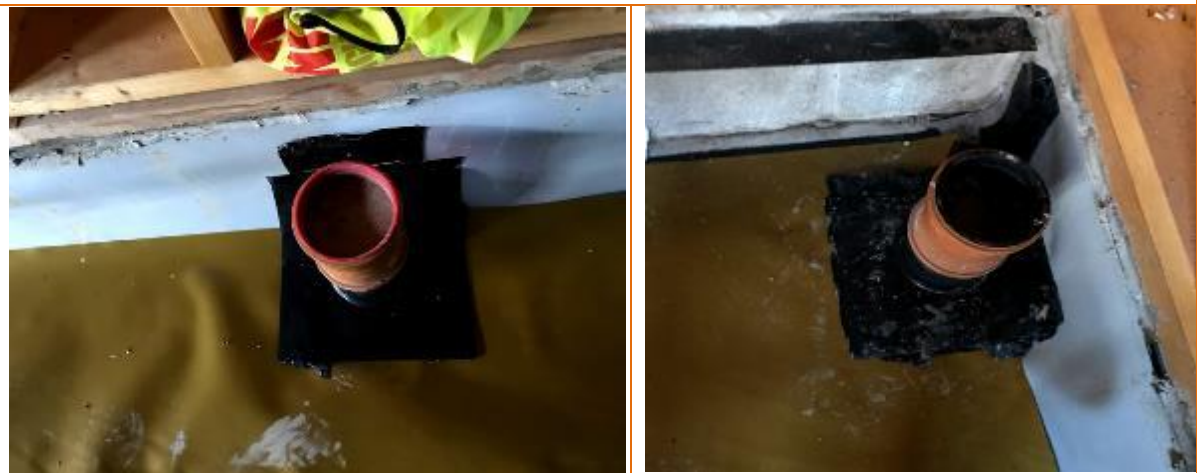
**Verification of Service Penetrations-Good Condition**

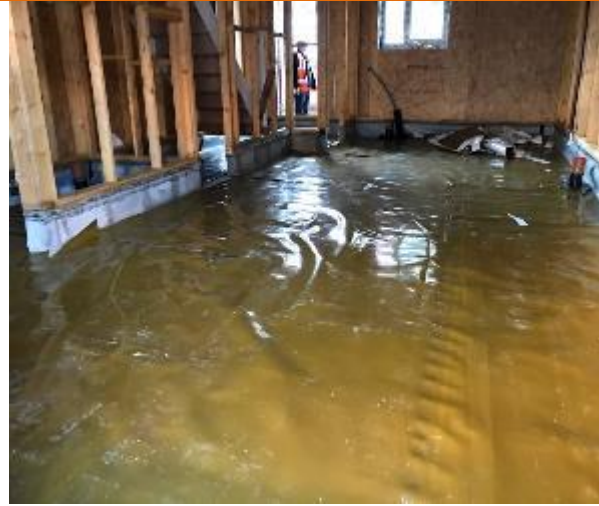
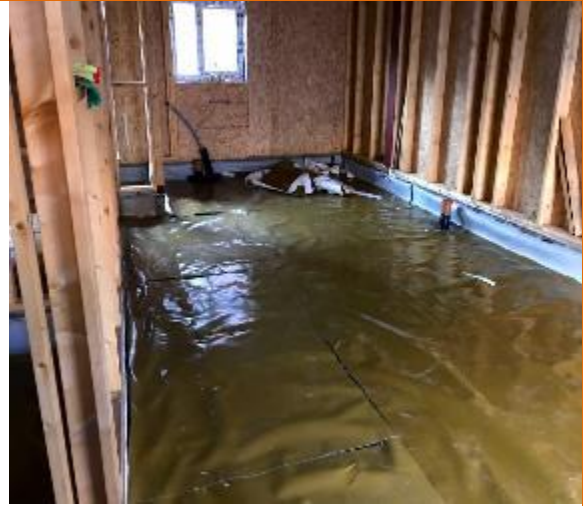
**Plot - 48**

**General Condition of Membrane-Good Condition**

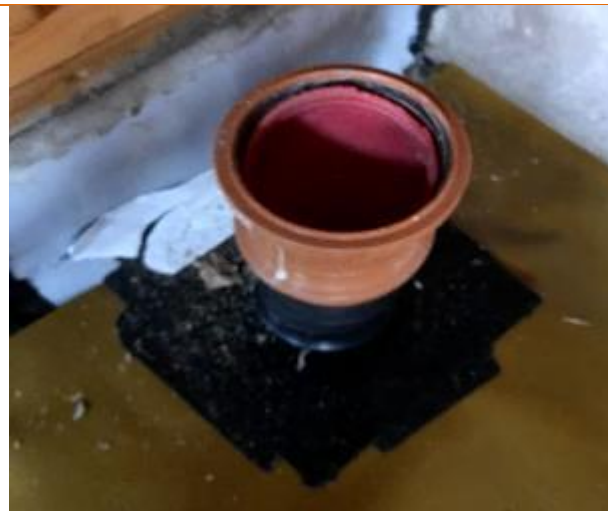
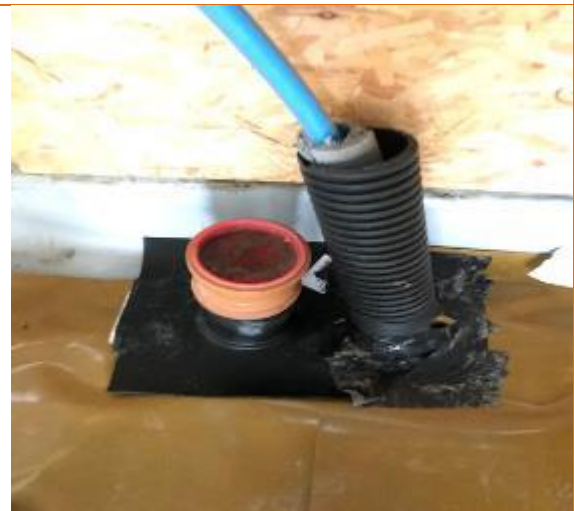
**Verification of Service Penetrations-Good Condition**

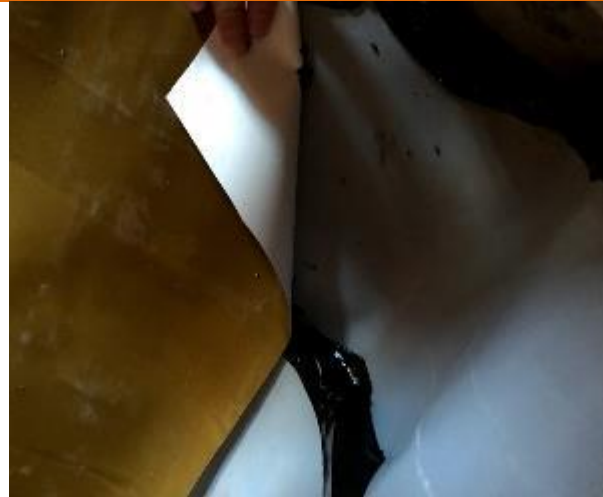
**Plot - 49**

**Verification of Joints and Seals-Good Condition**

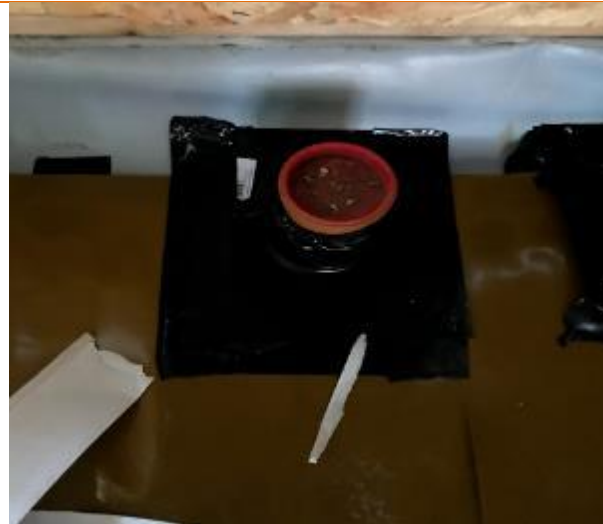
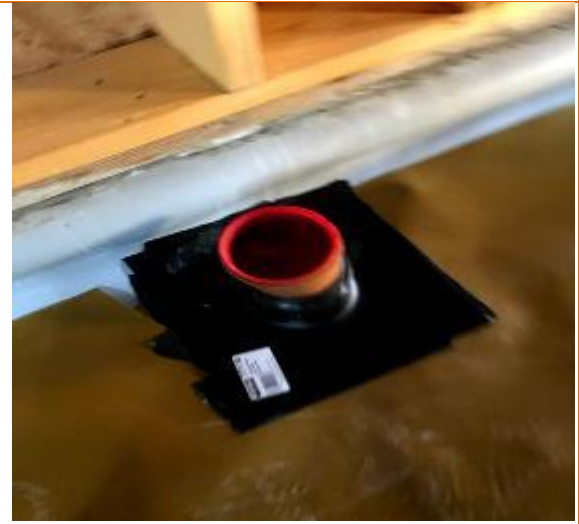
**Verification of Service Penetrations-Good Condition**

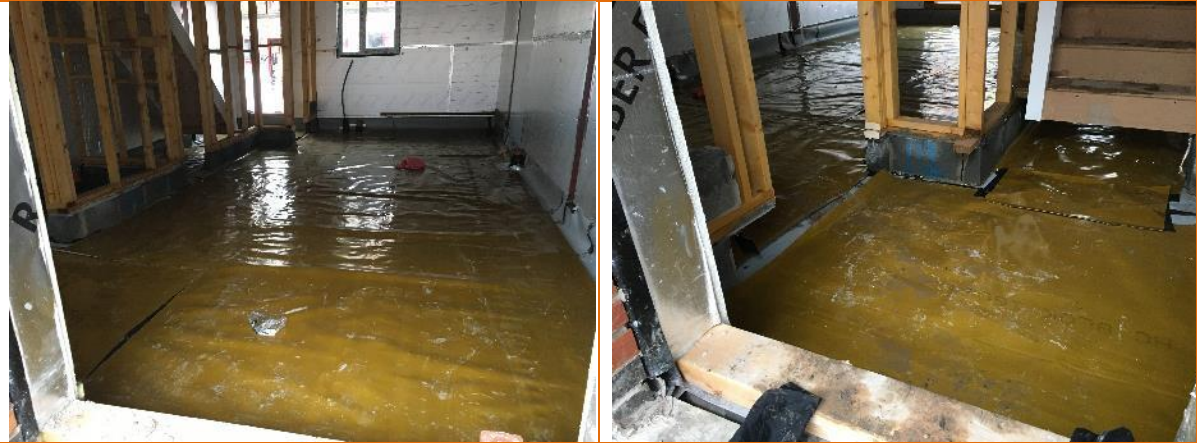
**Plot – 34**

**General Condition of Membrane-Good Condition**

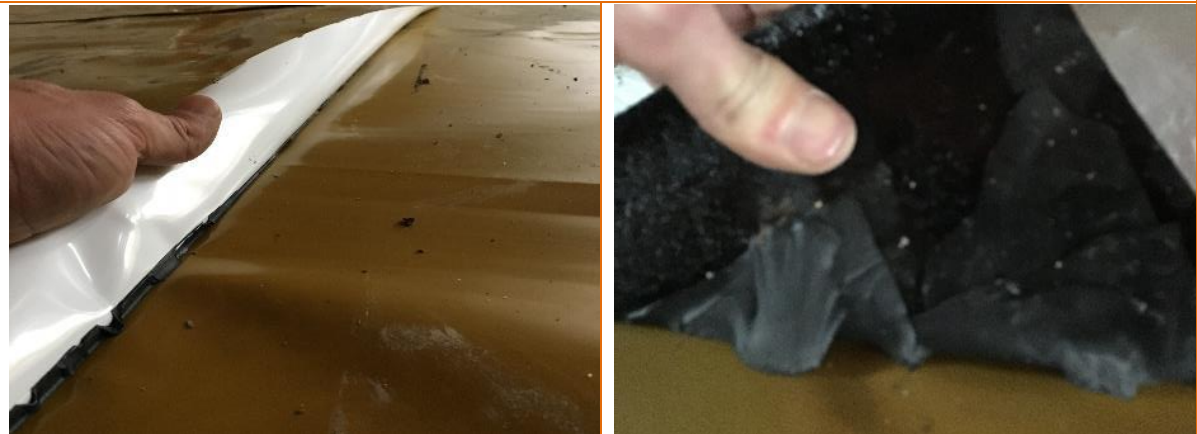
**Verification of Joints and Seals-Good Condition**

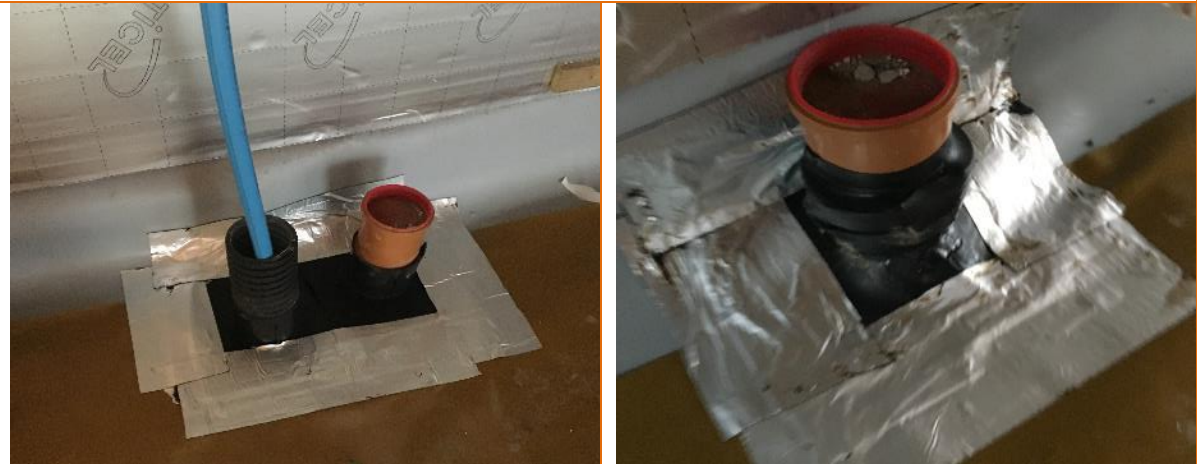
**Verification of Service Penetrations-Good Condition**

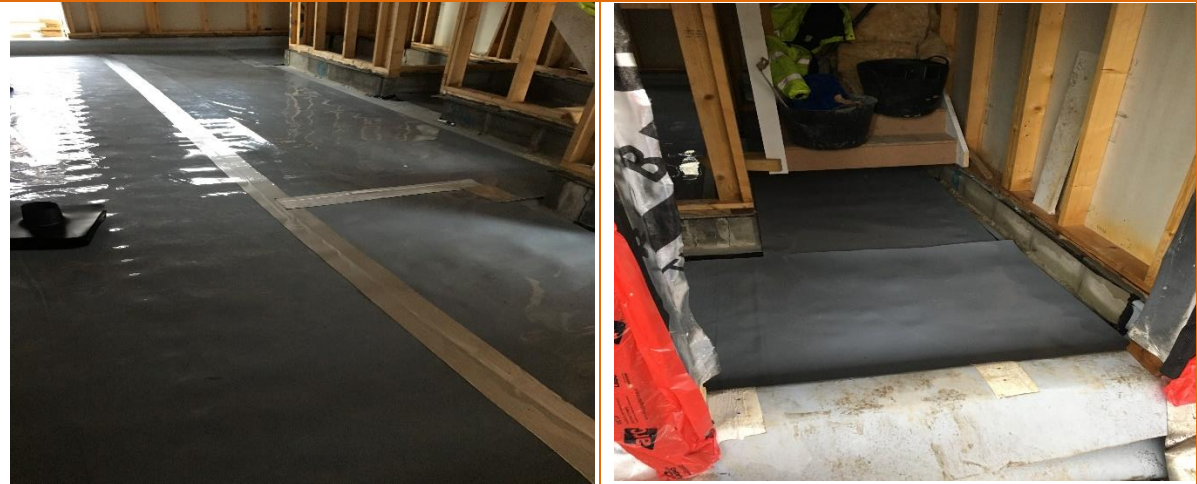
**Plot – 39**

**General Condition of Membrane-Good Condition**

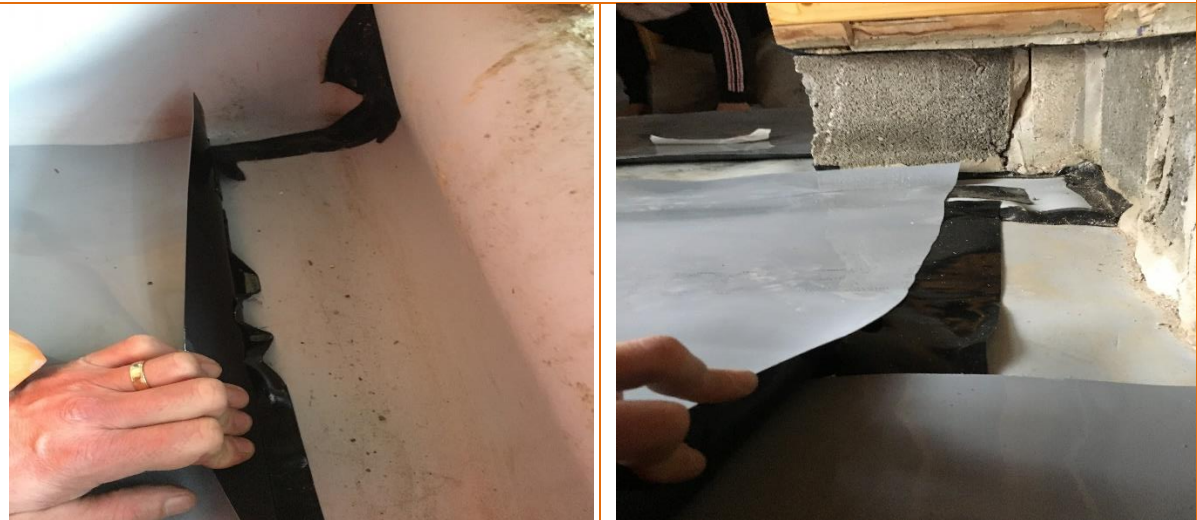
**Verification of Joints and Seals-Good Condition**

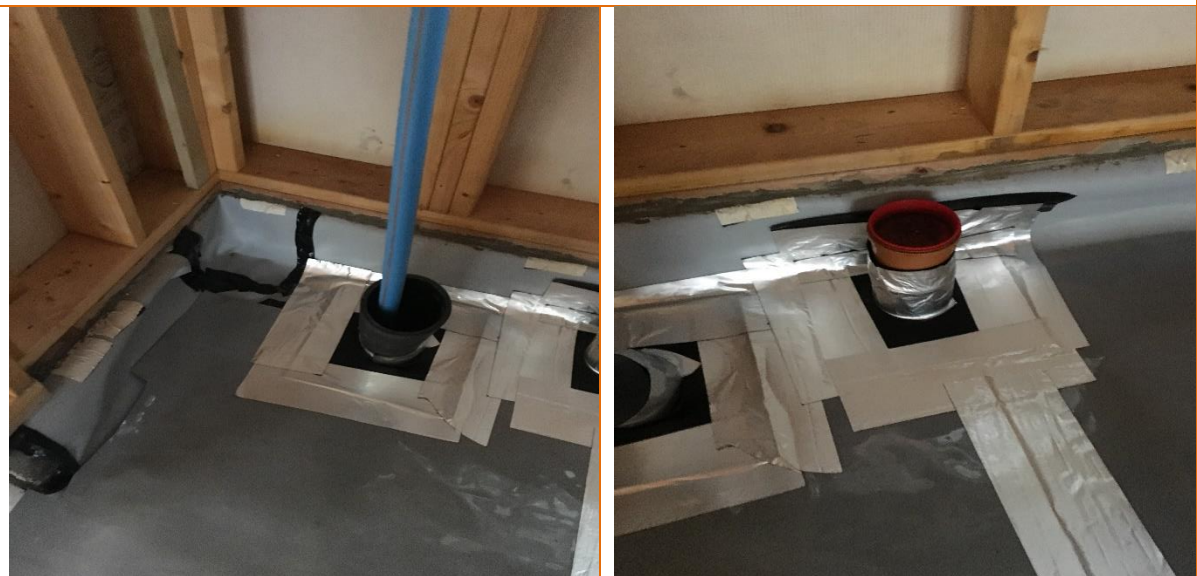
**Verification of Service Penetrations-Good Condition**

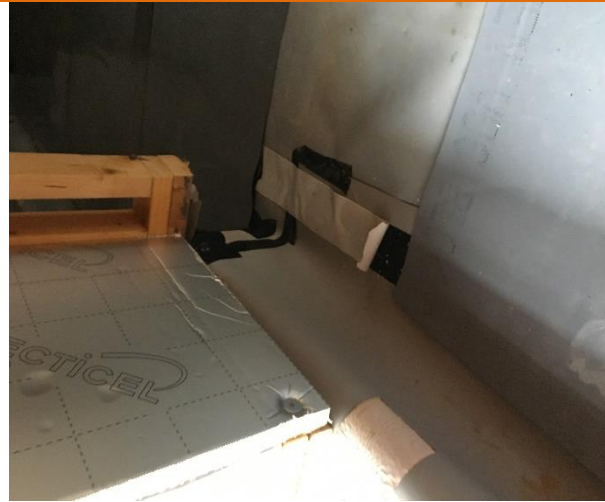
**Plot – 40**

**Verification of Joints and Seals-Good Condition**

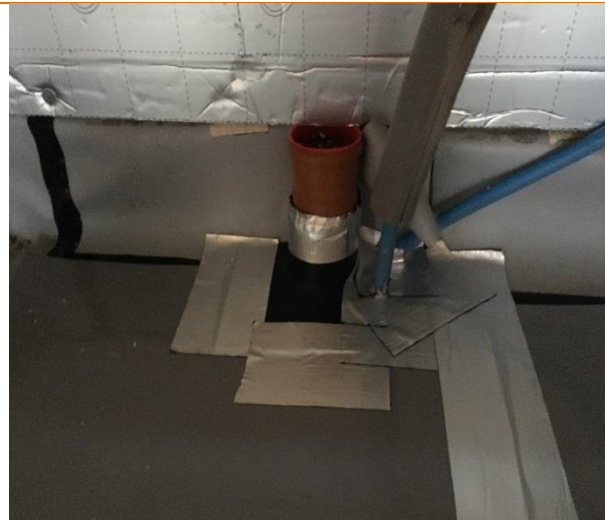
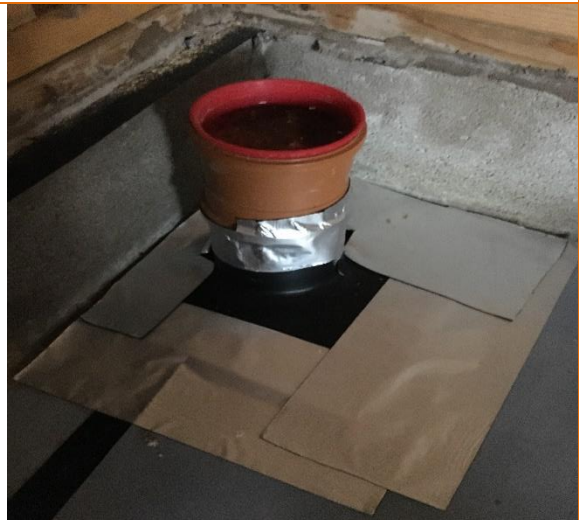
**Verification of Service Penetrations-Good Condition**

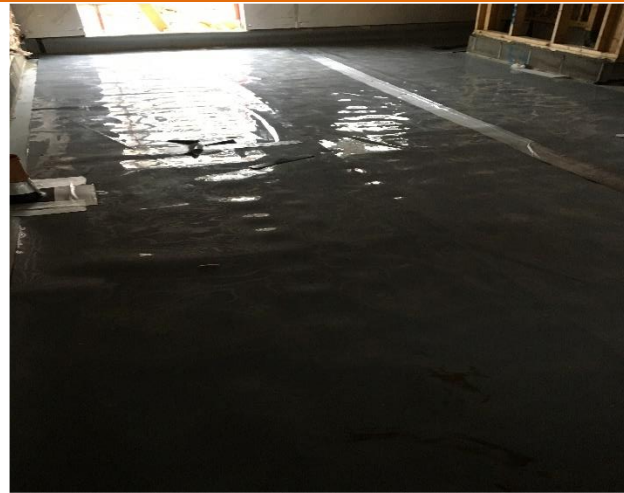
**Plot – 41**

**General Condition of Membrane-Good Condition**

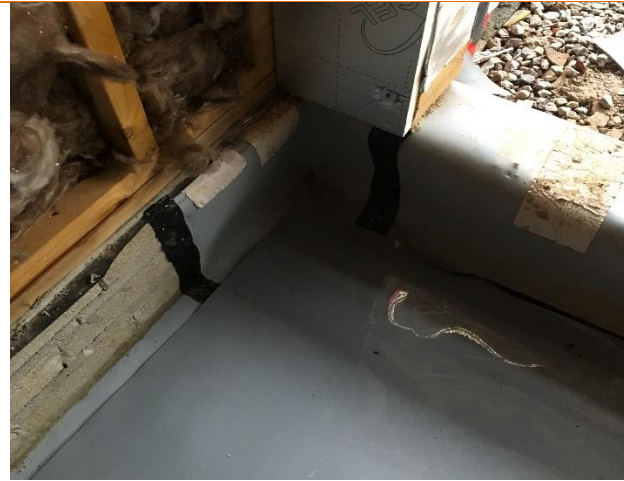
**Verification of Joints and Seals-Good Condition**

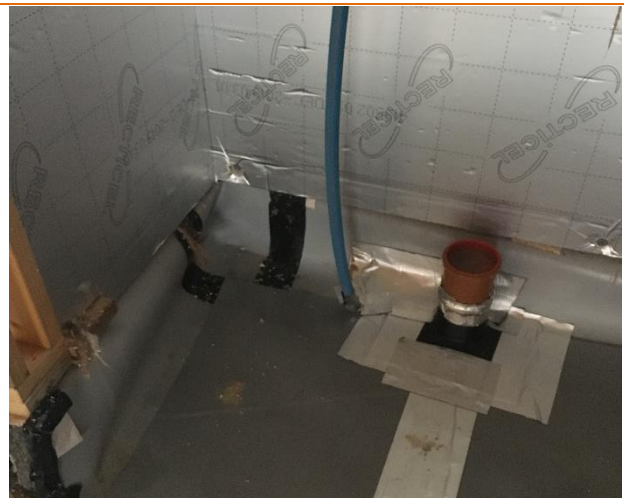
**Verification of Service Penetrations-Good Condition**

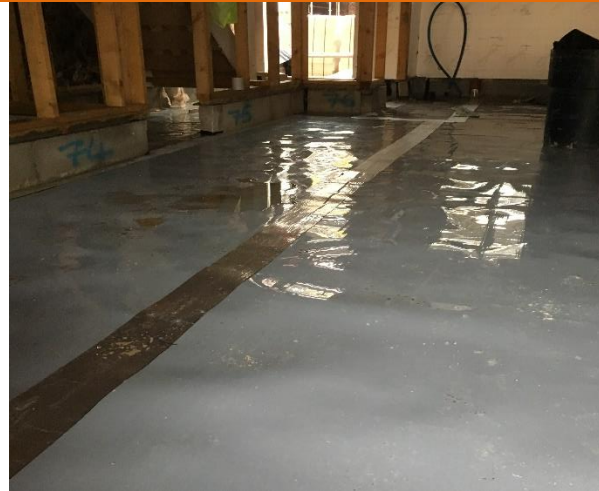
**Plot – 42**

**General Condition of Membrane-Good Condition**

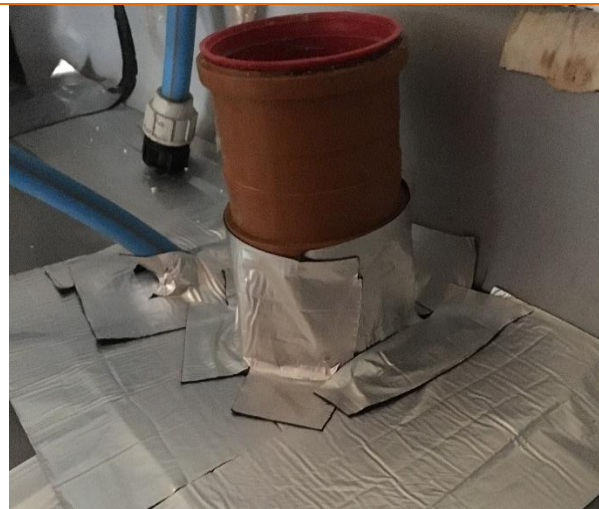
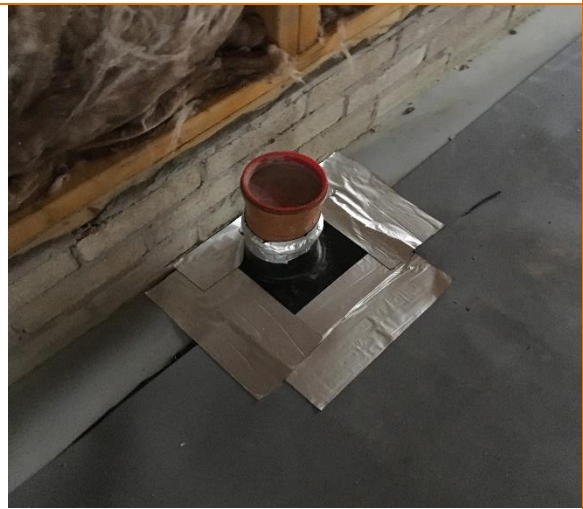
**Verification of Service Penetrations-Good Condition**

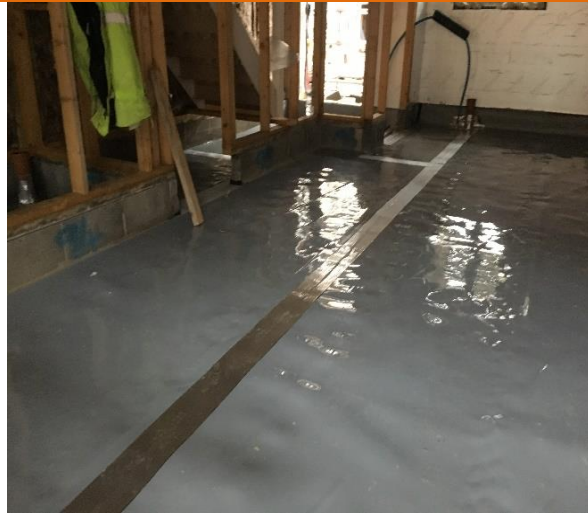
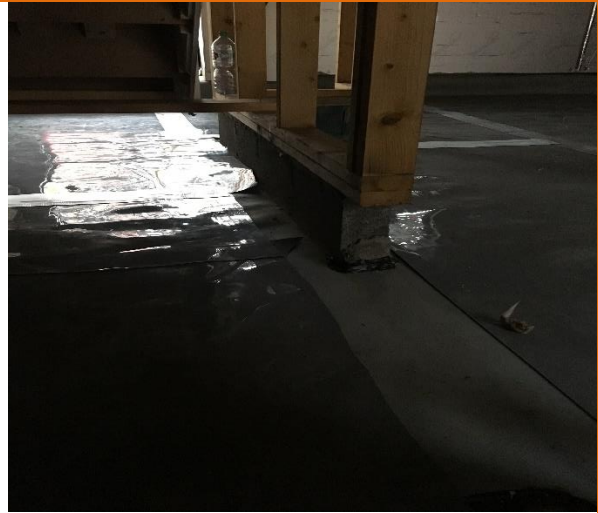
**Plot – 43**

**General Condition of Membrane-Good Condition**

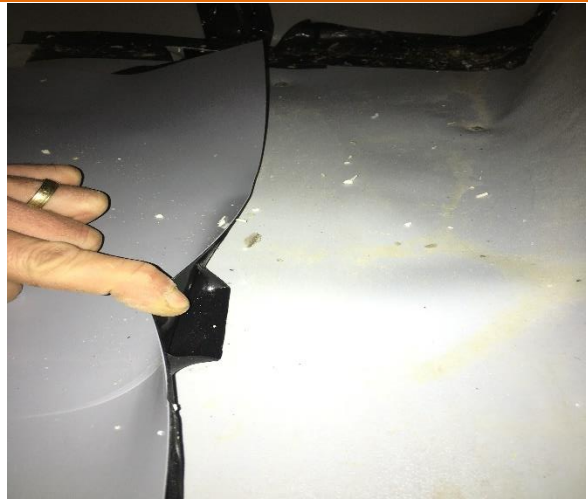
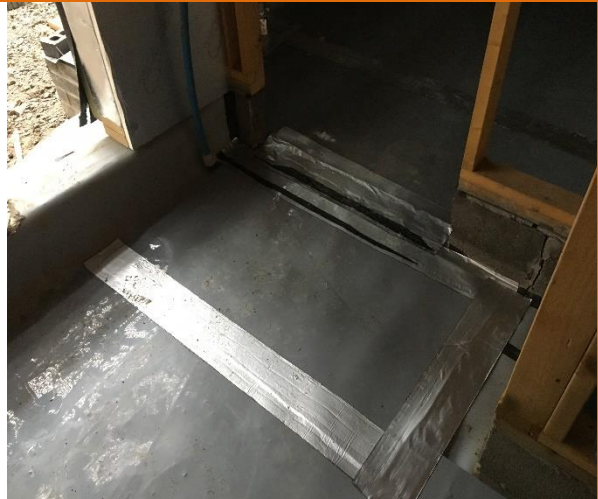
**Verification of Joints and Seals-Good Condition**

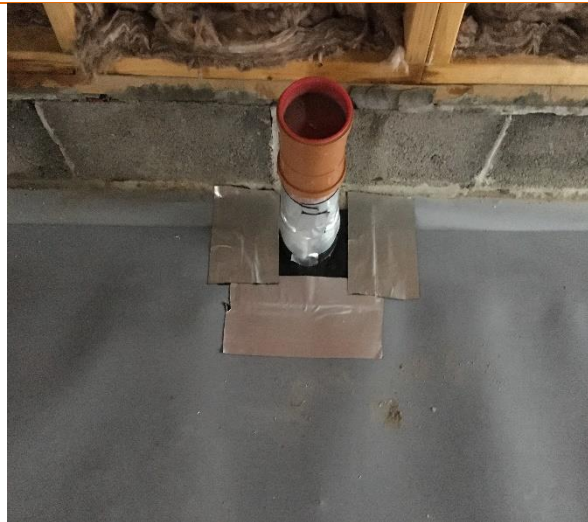
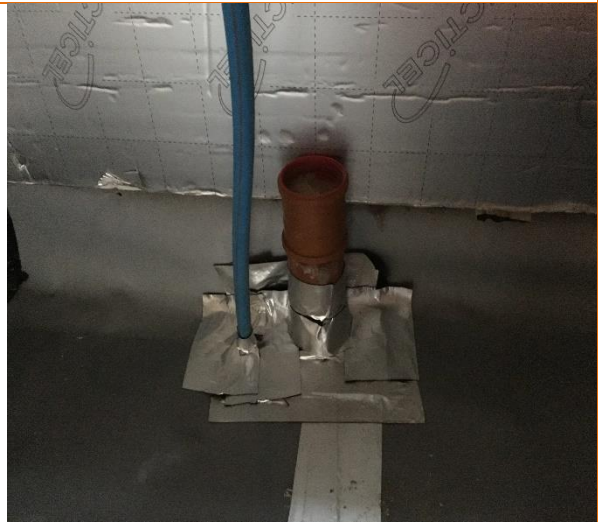
**Verification of Service Penetrations-Good Condition**

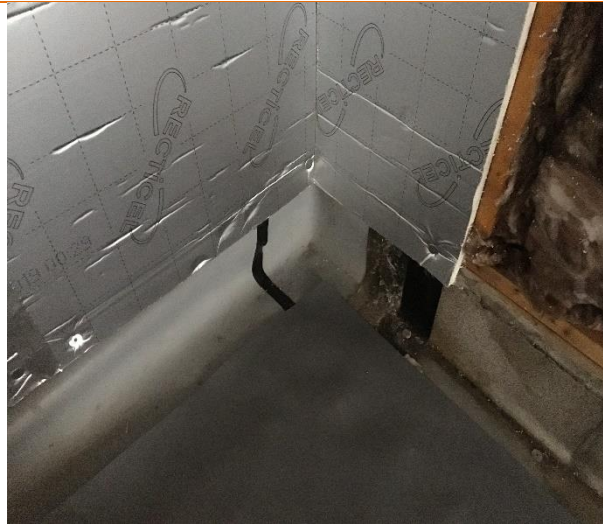
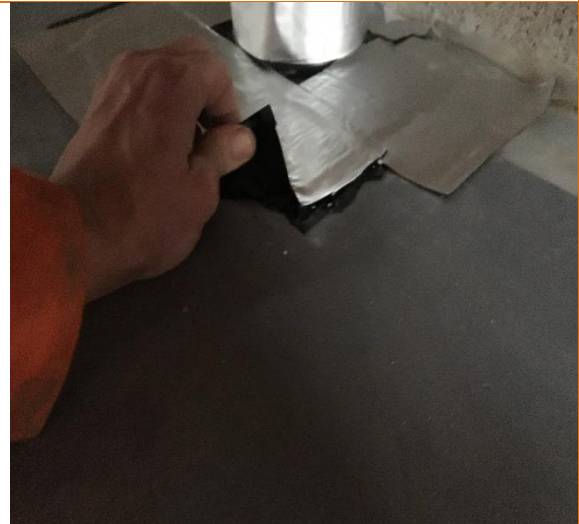
**Plot – 44**

**Verification of Joints and Seals-Good Condition**

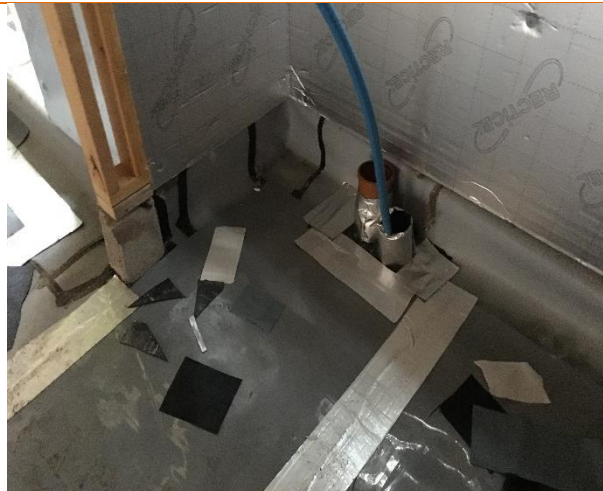
**Verification of Service Penetrations-Good Condition**

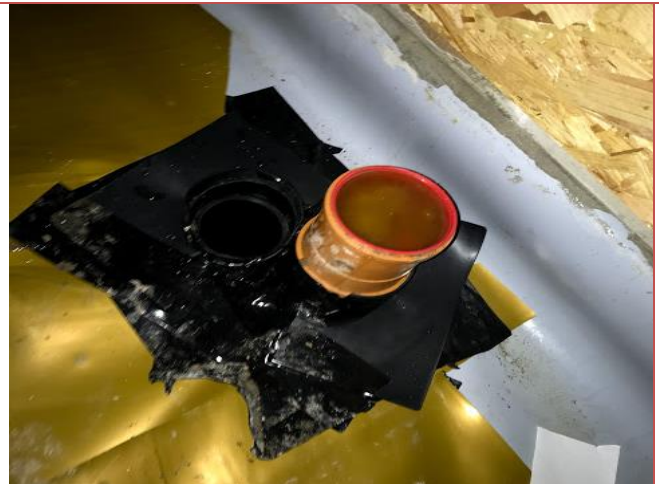
**Verification of Service Penetrations-Good Condition**

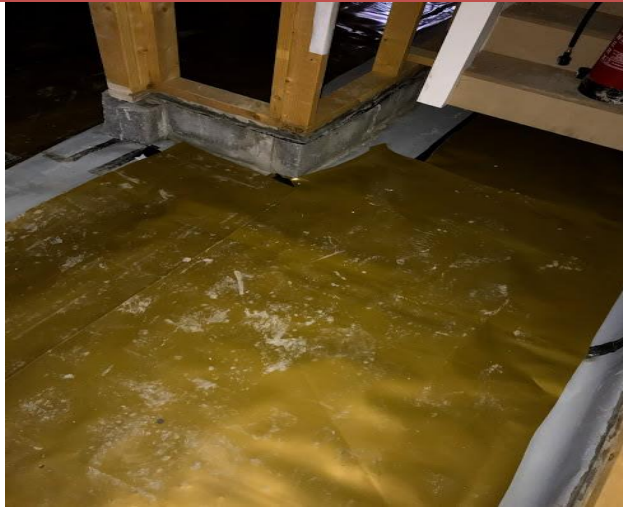
**Plot - 50**

**General Condition of Membrane-Good Condition**

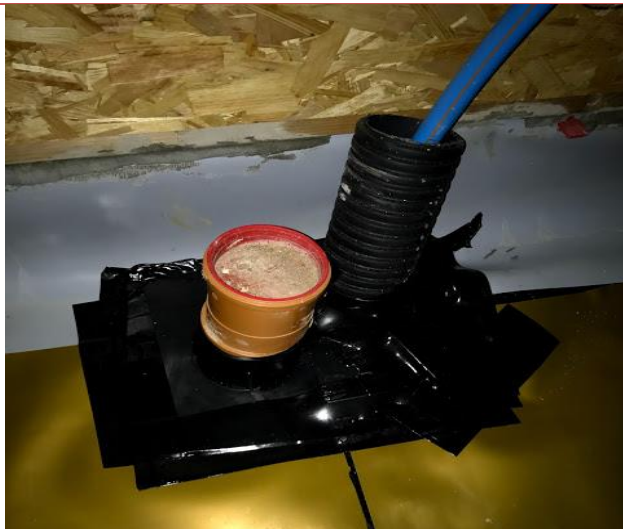
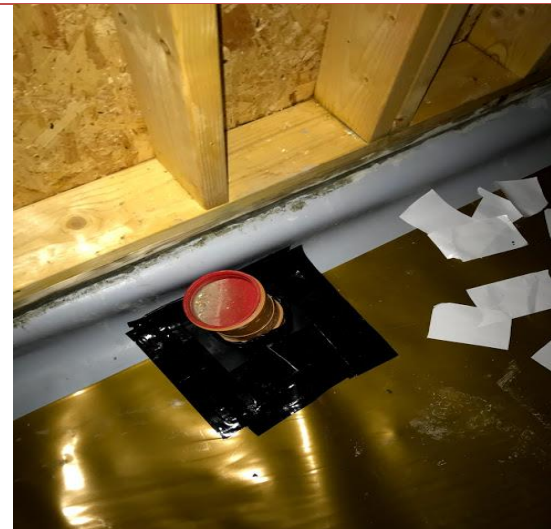
**Verification of Service Penetrations-Good Condition**

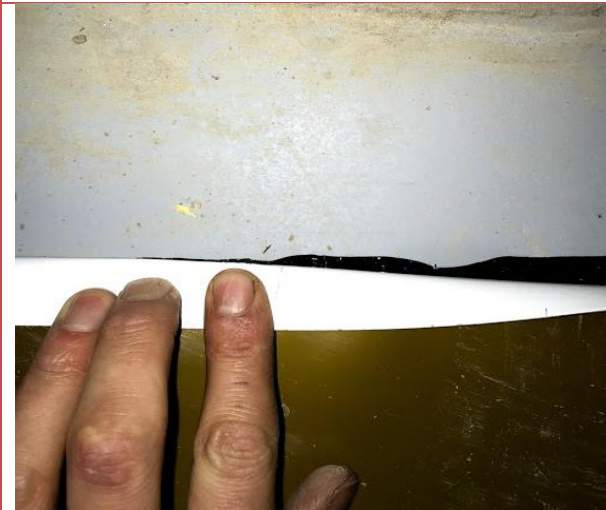
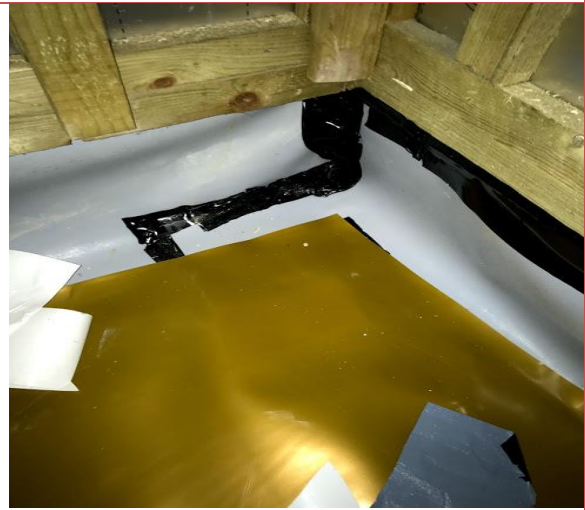
**Plot - 51**

**Verification of Joints and Seals-Good Condition**

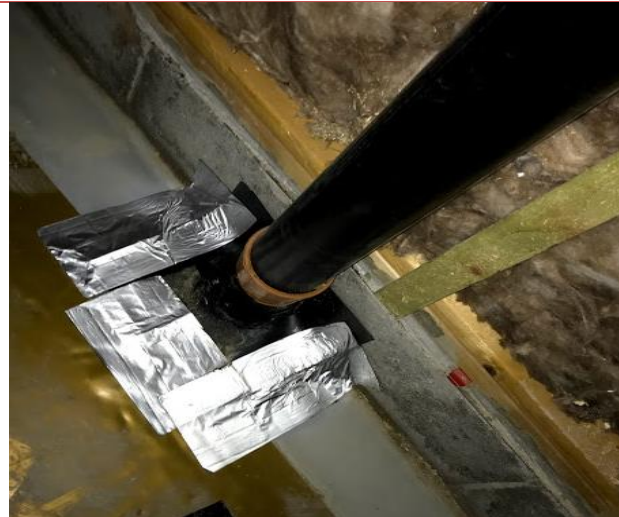
**Verification of Service Penetrations-Good Condition**
