Validation Completion Report  
Plots 1-54  
Bowes Street, Manchester

Reference:11-813-R5-2  
Date: May 2022

Plots 1-54  
Former Stagecoach Bus Depot  
Land off Bowes Street  
Manchester

Prepared for:  
**Rowlinson Construction**

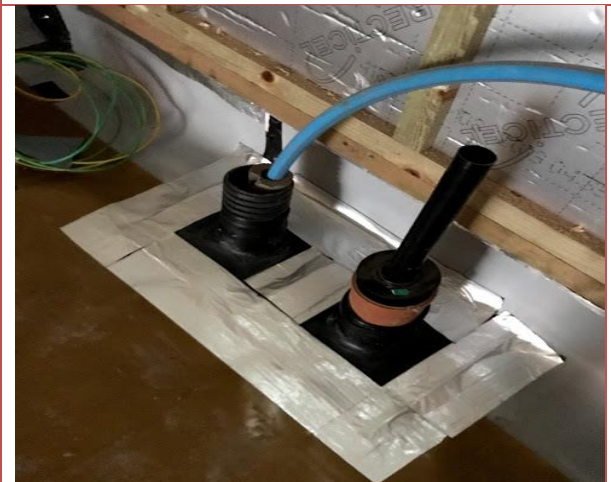
**Verification of Service Penetrations-Good Condition**
