# Ancoats Dispensary Condition Survey

Great Places

**Project number:** P4352

Report Title: Condition Survey

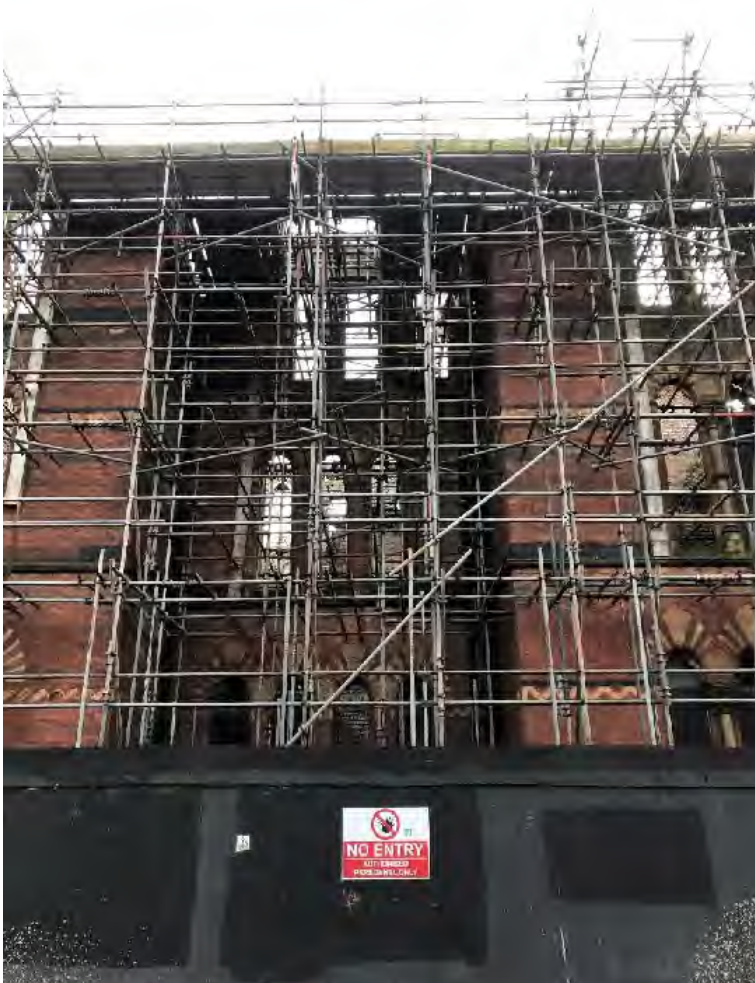
Figure 9

STEPPED CRACK EXTENDING VERTICALLY THROUGH WALL. CRACKING LIKELY CAUSED BY MOVEMENT DURING DEMOLITION AND/OR COLLAPSE. REPEATS ON RETURN CORNER. SEE FIGURES 11 AND 12.

- The significant stepped crack extending vertically through the corner of the north external wall should be repaired using appropriate crack stitch repair products such as Helifix

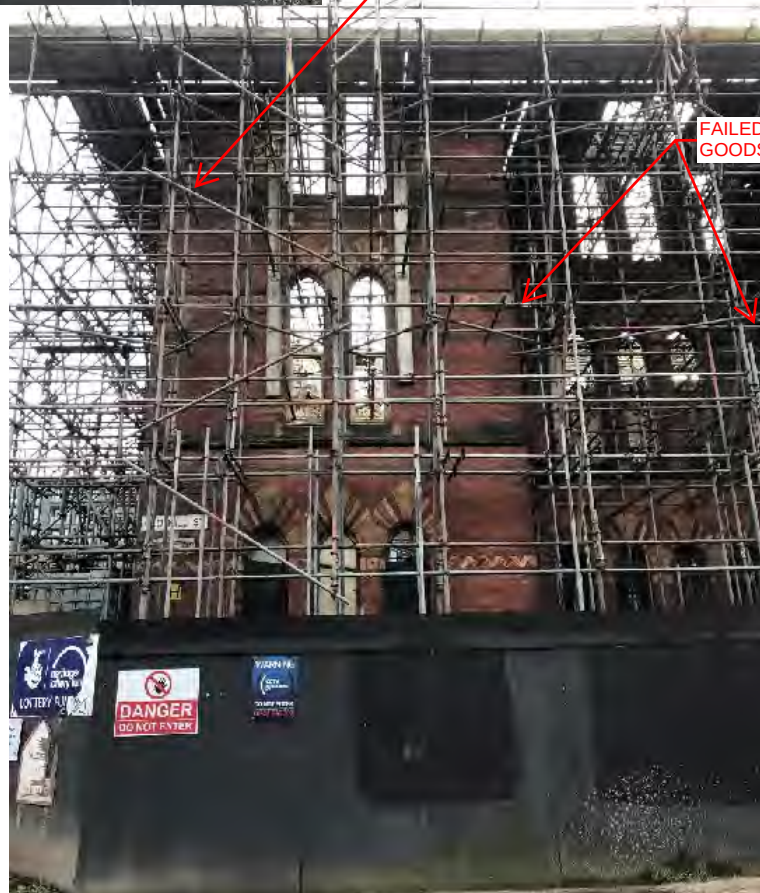
Figure 10

FAILED RAINWATER GOODS AND STAINING

- Rainwater goods should be removed and repaired/replaced with all fixings made good and water staining and damage repaired
- Window heads and mullions require repair internally where frames have collapsed and dislodged and loosened adjacent brickwork

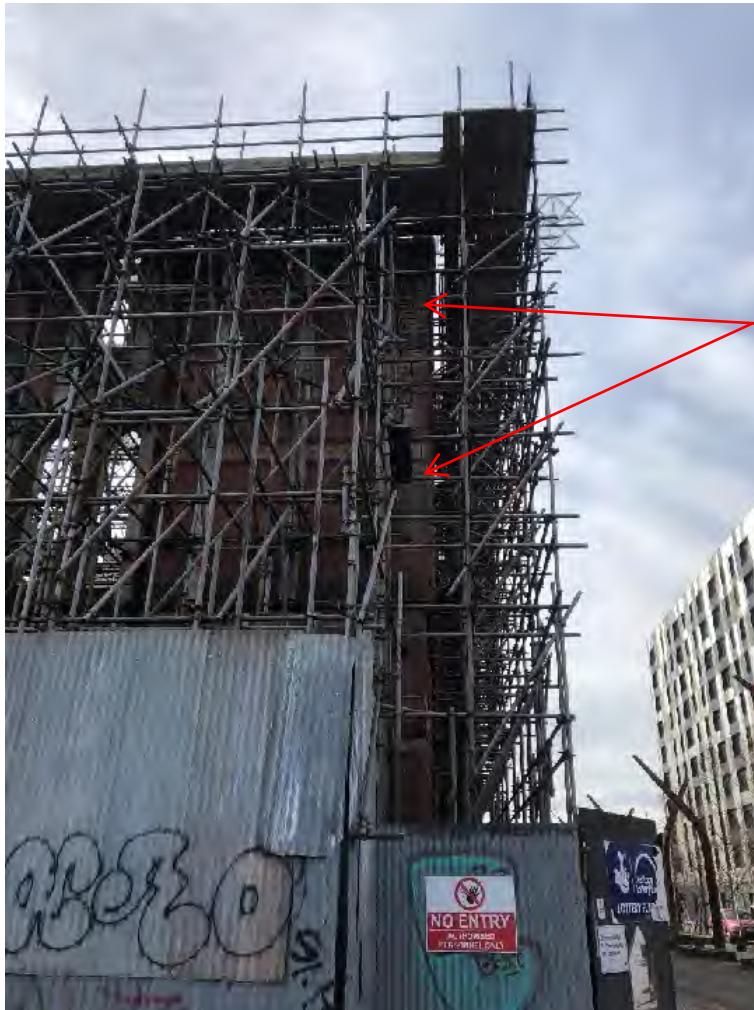
Figure 11

STEPPED CRACK EXTENDING VERTICALLY THROUGH WALL. CRACKING LIKELY CAUSED BY MOVEMENT DURING DEMOLITION AND/OR COLLAPSE. SEE CLOSE UP IN FIGURE 12 BELOW

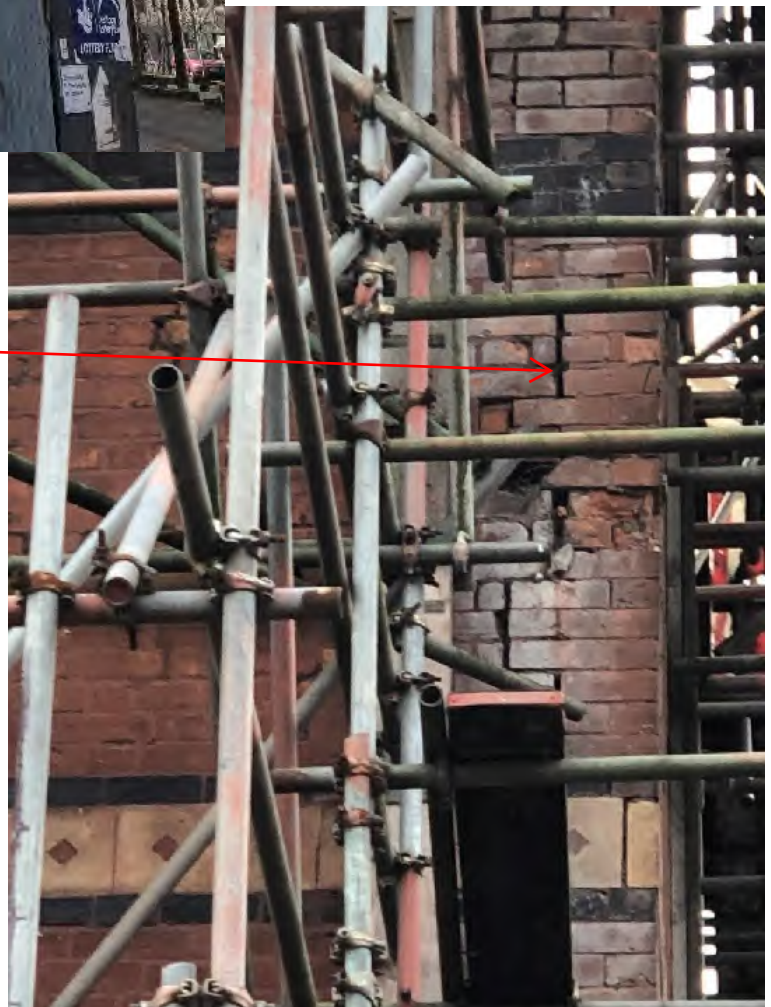
Figure 12

CLOSE UP OF VERTICAL CRACK

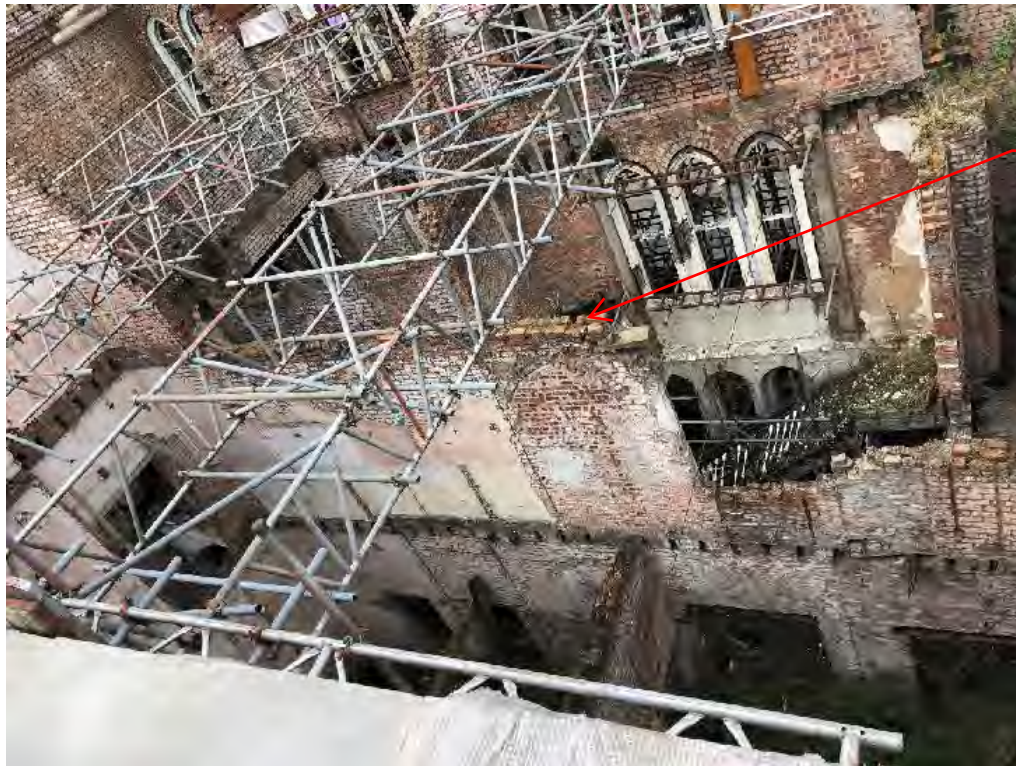
Figure 17

LOOSE BRICKS  
PRESENTING RISK OF  
INJURY TO ANYONE  
ACCESSING THE  
INTERNAL STRUCTURE

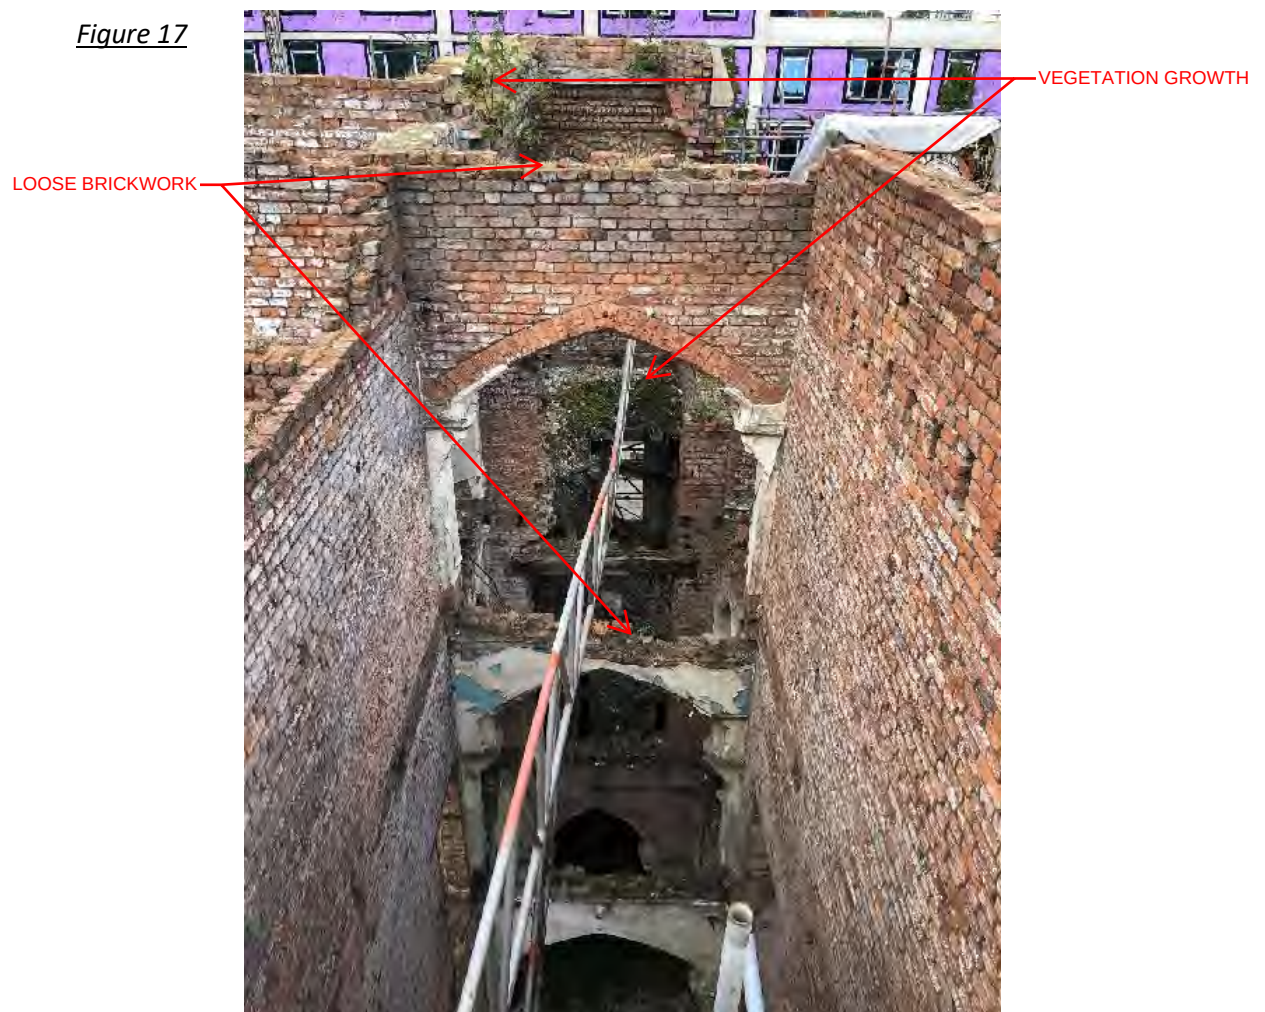
LOOSE BRICKWORK

VEGETATION GROWTH

Figure 18: Internal view through to entrance area

- Remedial cavity ties should be installed through mortar joints to replace any corroded original ties
- Vegetation growth, namely Buddleia, is present numerous areas and should be treated and removed to stop further damage to the masonry. Local repointing/re-bedding of brickwork should be carried out to make good after raking out perished mortar
