**Network Rail NW&C  
Works Delivery (Buildings)**

**Project Title:** Deansgate Station

**Report Title:** Condition Report & Proposals

**Project No:** 169388

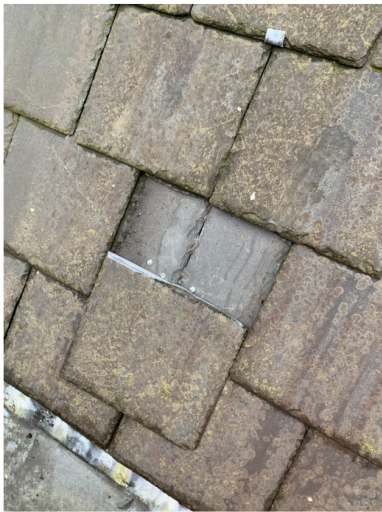
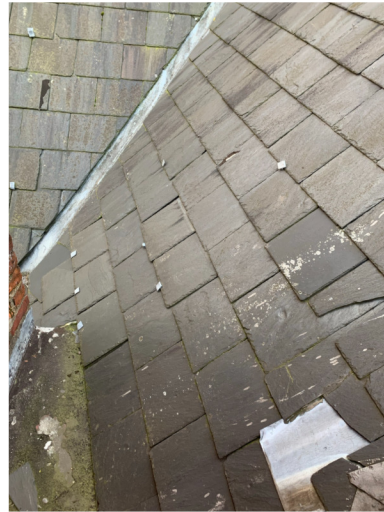
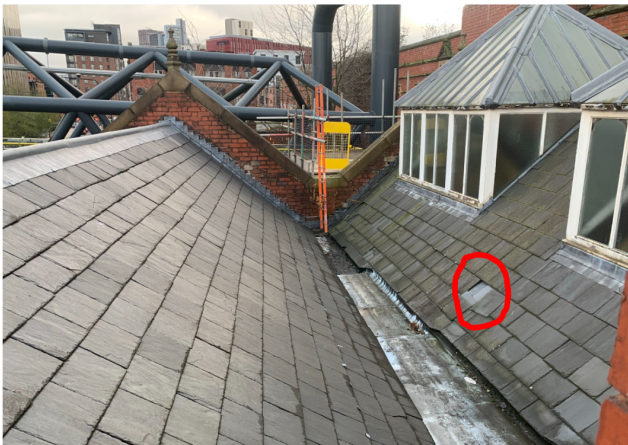
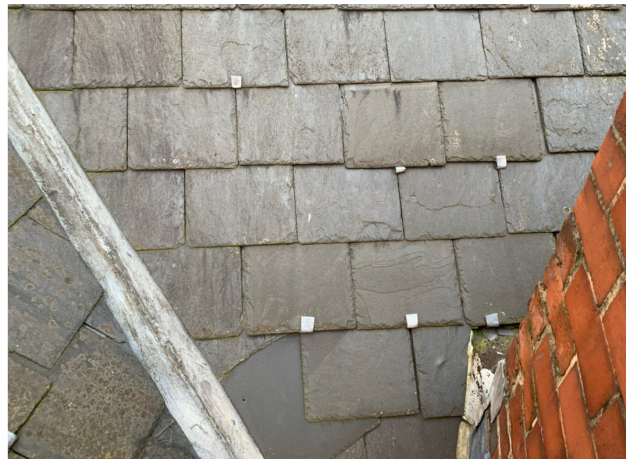
- 5.1.8 Roof Slates: Further damage to the roof slates was identified in the November 2021 survey, with missing slates identified at the intersection between Slope 2 and Slope 5, next to the chimney (see Figure 6 below). Further missing slates were also found on Slope 3, towards Slope 5.

- 6.2.4 Pitched Roof: All slates on each of each of the six slopes are to be replaced on a like-for-like basis with Reclaimed Welsh Slate. Existing slates in good condition are to be reclaimed and reused. Tiles should be fixed using clout or slate nails (these should be either silicon bronze, aluminium to BS 1202-3 or copper to BS 1202-2) fixing should be a minimum of 38mm long and penetrate a minimum of 15mm into battens

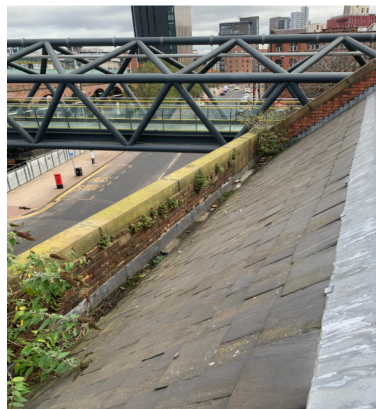
Figure 7

5.1.9 Valleys full of debris: Valleys still full of debris, although not observed to be any fuller since the October 2020 report

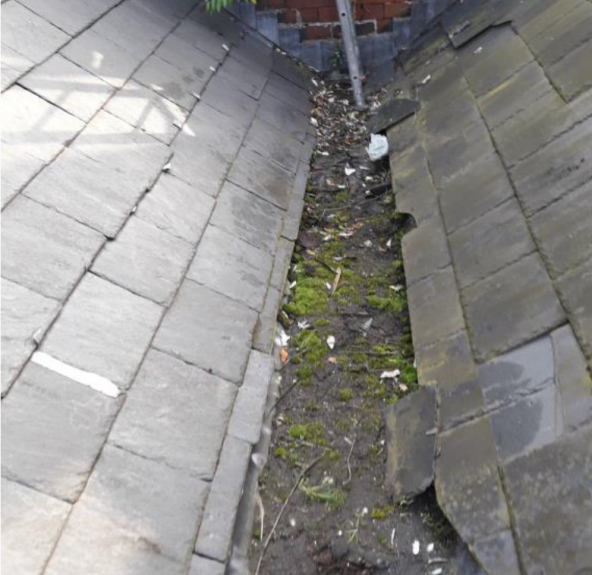
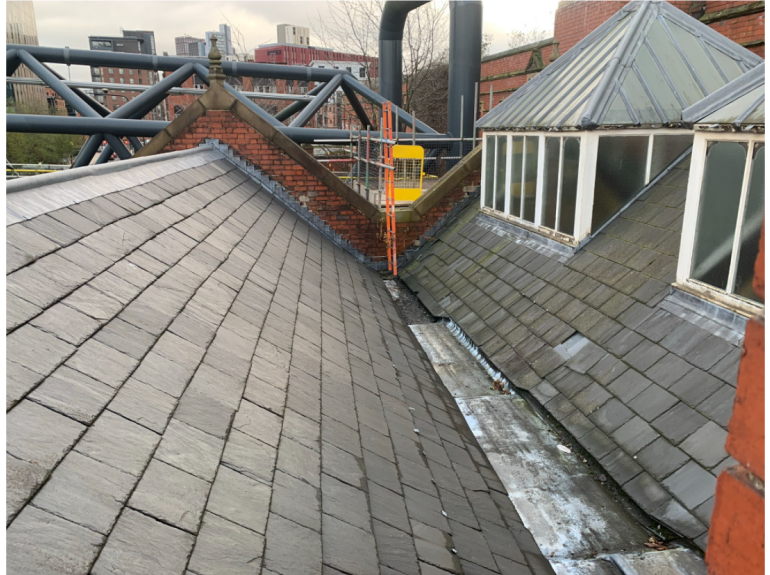
5.1.10 Blocked downpipe: Valley 2, which was previously full of dirt and debris, appears to have been cleaned out and drainage assumed to be in good working order as a result.

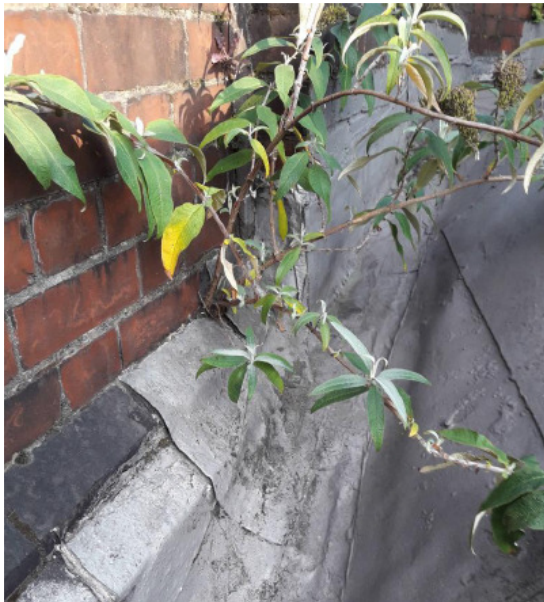
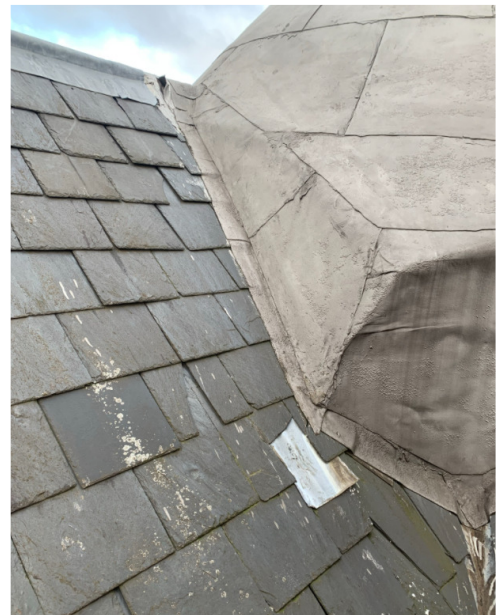
5.1.11 Poor roof detailing: Same observation as the 2020 report. No further deterioration in the system but it is not fulfilling its purpose.

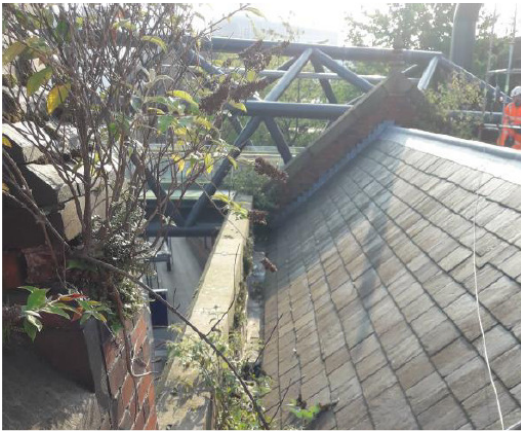
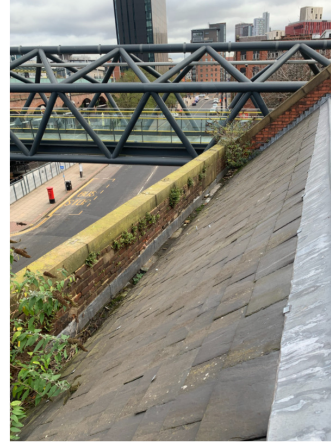
5.1.12 Vegetation Growth: No further vegetation growth was identified in the November 2021 survey.

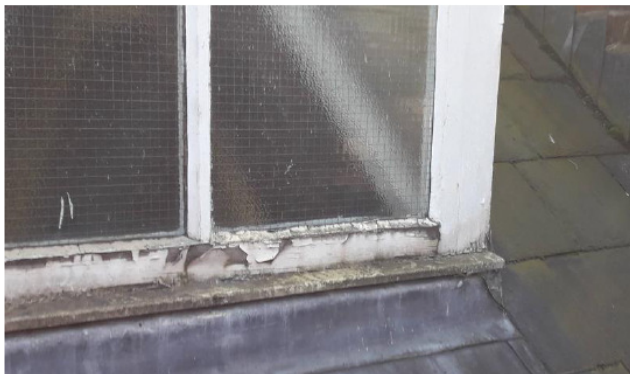
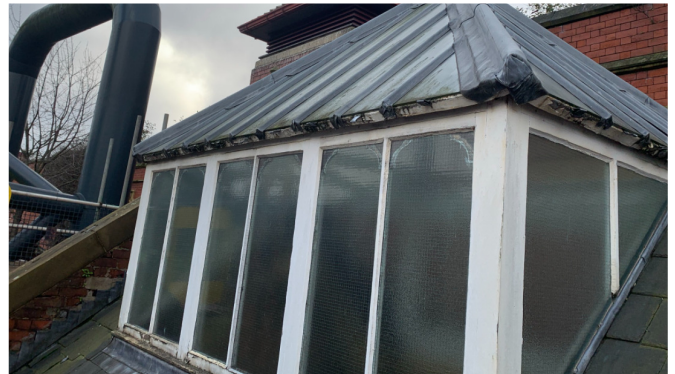
5.1.13 Flaking paint: No further flaking paint was identified in the November 2021 survey

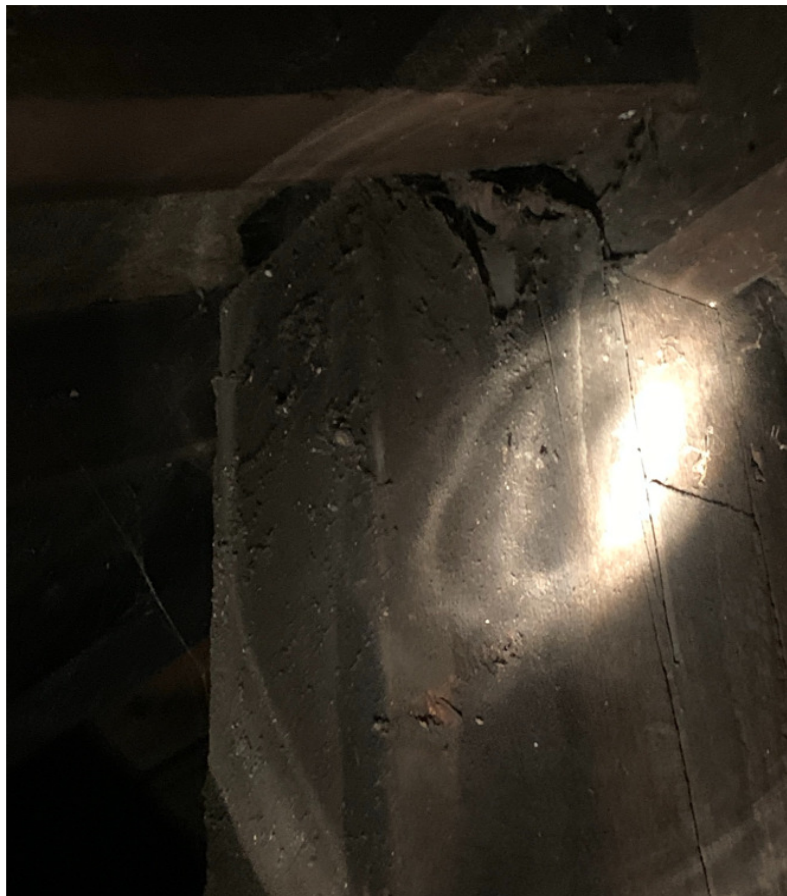
- 5.2.7 The top of the timber column next to Truss 11 has been subjected to rotting (see Figure 16 below)

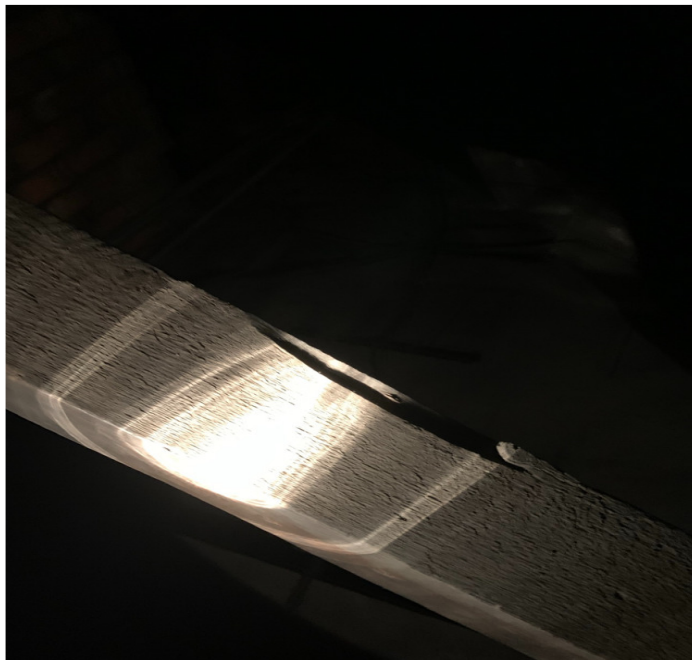
- 5.2.8 Truss 2 has historical split timbers, but does not appear to have been subjected to further damage, aside from splintering of the wood on the top surface of the diagonal member (see Figure 17 below)

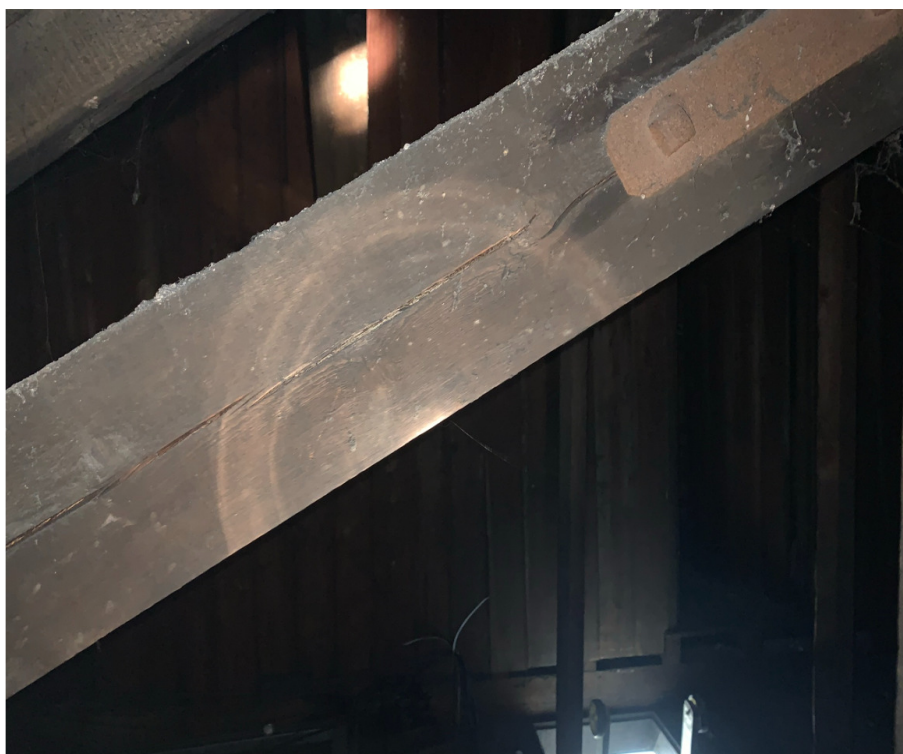
- 5.2.6 Although most marked timbers have been subjected to further splitting, Truss 1 (see Figure 18 below) shows split timber which has not been previously marked.

- 5.2.9 Truss 3 has historical split timbers, but does not appear to have been subjected to further damage (See Figure 18 below)

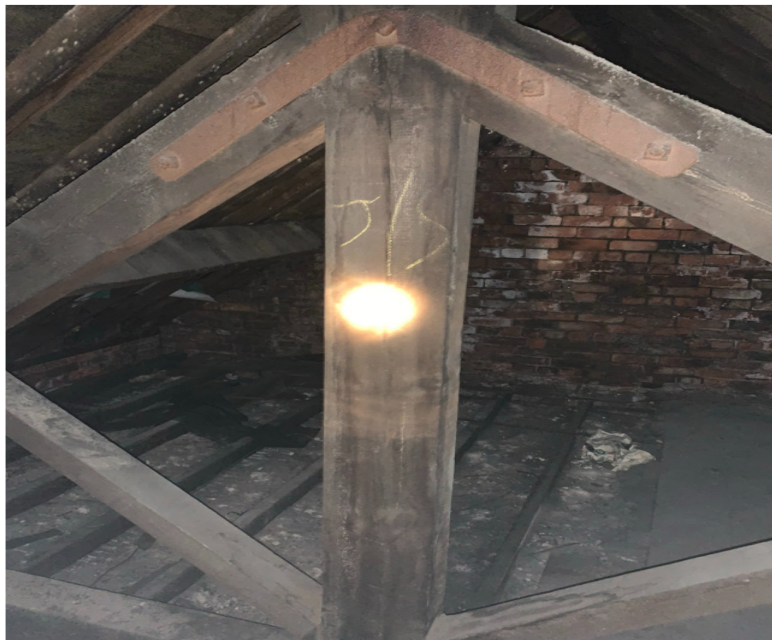
- 5.2.10 Truss 4 has historical split timbers, but does not appear to have been subjected to further damage  
(See Figure 19 below)

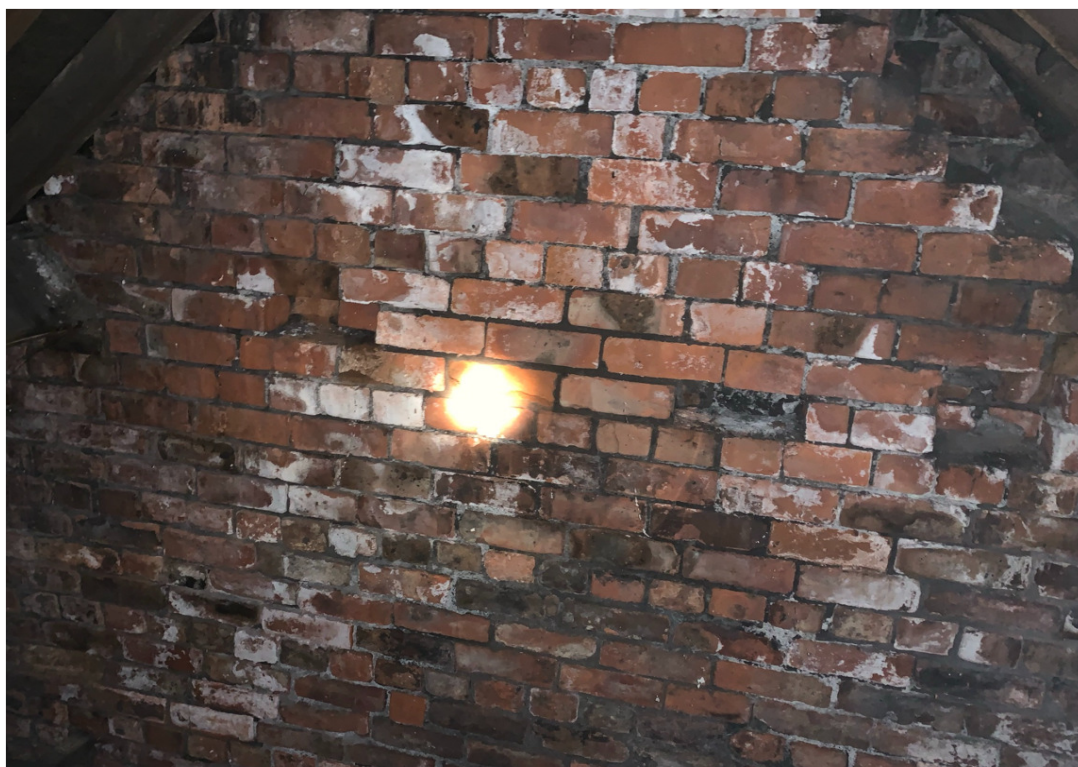
- 5.2.11 The wall at the far (east) end of the roof space has missing brickwork and staining. See Figure 20 below.

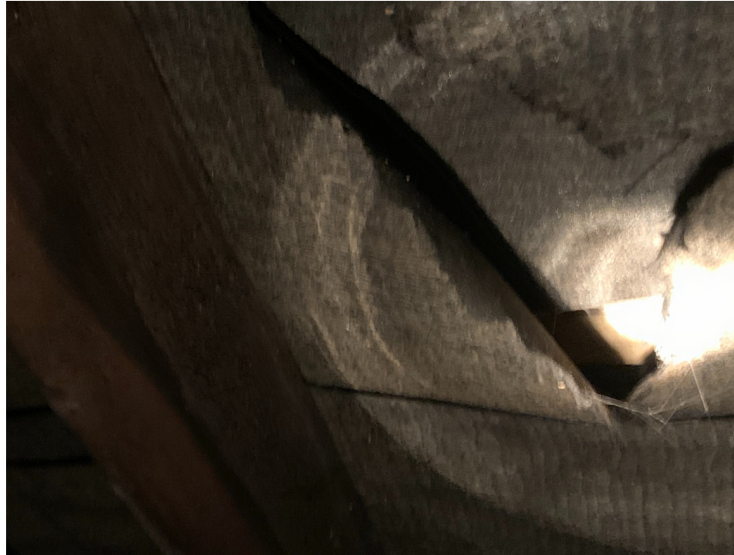
- 5.2.12 The roof felt was observed to be in a reasonable condition throughout aside from a rip between Truss 4 and the east wall however its water resistance could not be commented on. See Figure 21 below.

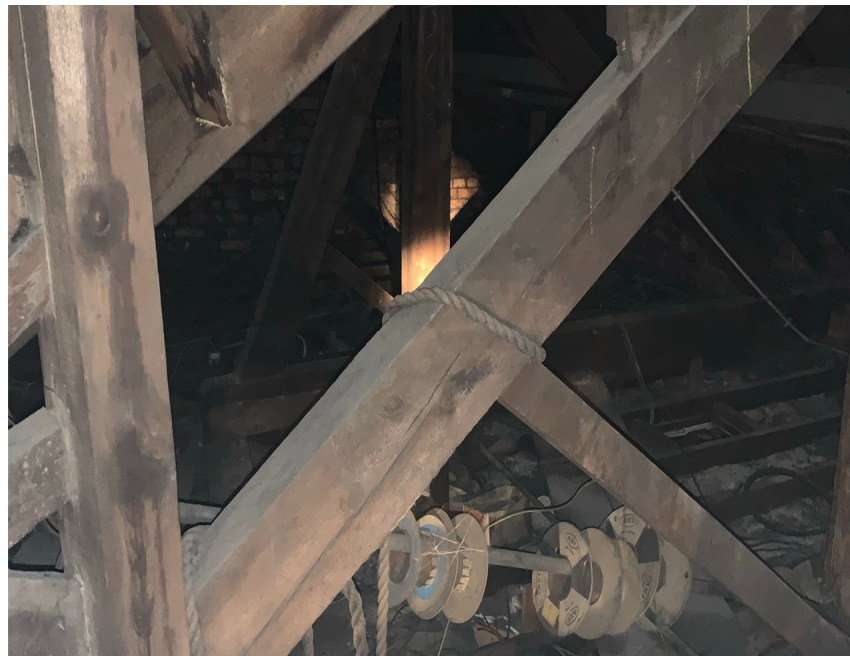
Figure 22

- 5.2.13 The roof space to the south of the cone cupola was inaccessible due to the walkway being blocked by various items. The length was measured to be approximately 5.385m
