## Building Condition Report

32-34 Laystall Street  
Manchester  
M1 2JZ  
UK.

**28th of March 2018**

**BUILDING SURVEY: 32-34 Laystall Street, Manchester.**

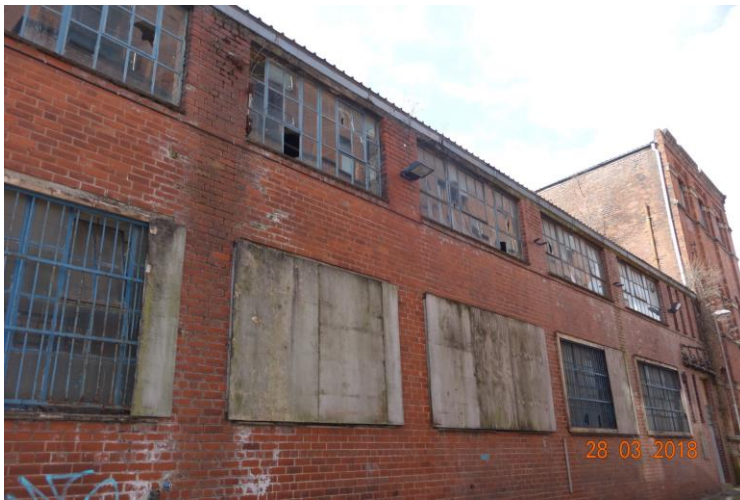
**Photograph No. 1.**

**Photograph No. 1** – Clearly indicates the return area. This photograph highlights the North East elevation of the building.

The proposal is for this element of the structure to be demolished and replaced with a new development.

The proposed works in relation to this element of the building will involve little or no effort apart from salvaging as much brick and timber of the original structure as possible.

This salvage material may need to be re-used as part of the restoration and conservation of the principal structure located on Laystall Street.

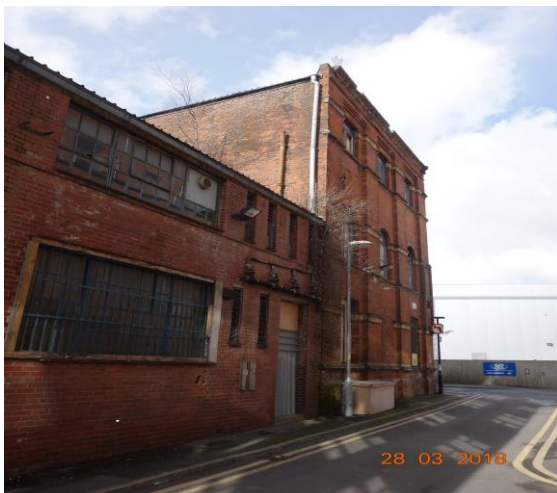
**Photograph No. 2** – Identifies the connection between the two buildings.

During inspection it was noted that there was a significant amount of vegetation and ingress of water as a result of the down pipe not performing its design function.

The immediate reaction in this area should involve the down pipe being cleared and put into working order.

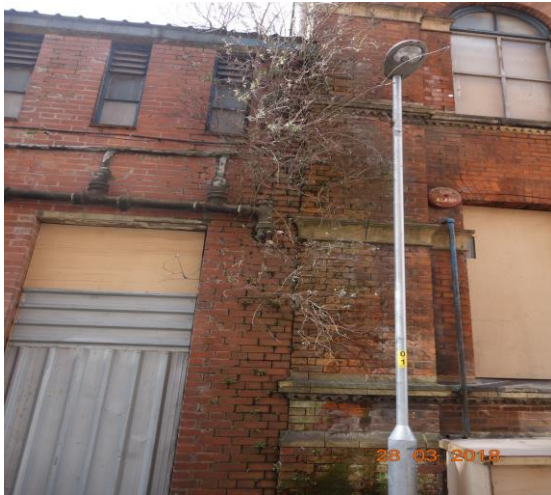
**Photograph No. 3.**

**Photograph No. 3** – Illustrates the presence of heavy vegetation. This vegetation is causing deterioration of the brickwork. The clearing of the down pipes is a priority in this regard.

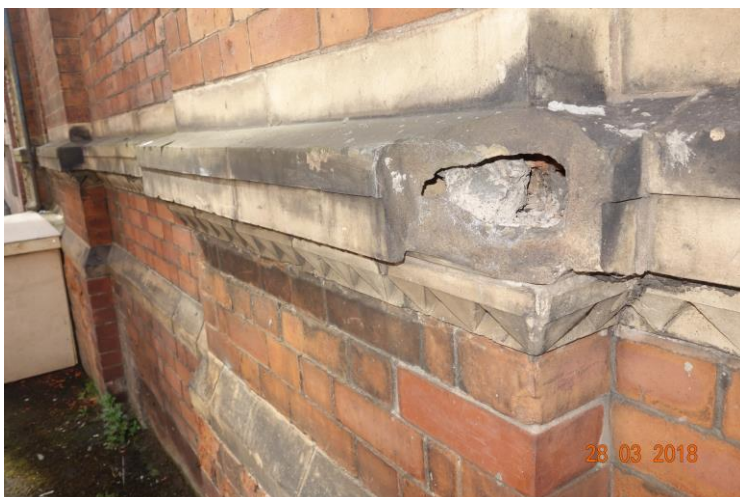
**Photograph No. 4** – Indicates abuse to the building. This damage is most likely as a result of the building being hit by traffic and commercial trucks over the years.

It should be noted that this damage has no relation to ingress of water.

The damage appears to have occurred a number of years ago as the terracotta and cracks are heavily contaminated with city carbon - not a new problem.

In my opinion I would leave these areas as is until such time that we are able to eliminate all the elements which are causing the deterioration to the building.

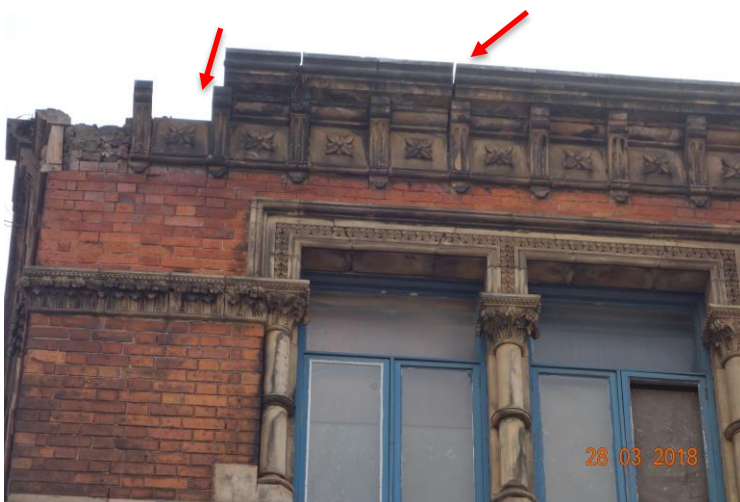
**Photograph No. 6** – Highlights elements of the parapet capping's which have been removed or have deteriorated. Replacements of these will most likely be found from a salvage source. If not, they can be recreated by taking moulds from the original parapet capping's.

During inspection it was also noted that all of the windows oriel round pillars have severe cracking. These cracks are not recent. They appear to have occurred over a long period of time as the cracks themselves are full of city carbon.

As indicated in the photograph, consideration should be given to having all of the horizontal weathering details protected for the short term. This temporary protection should eliminate the ingress of water entering the building and causing damage to the front façade in relation to frost/thaw.

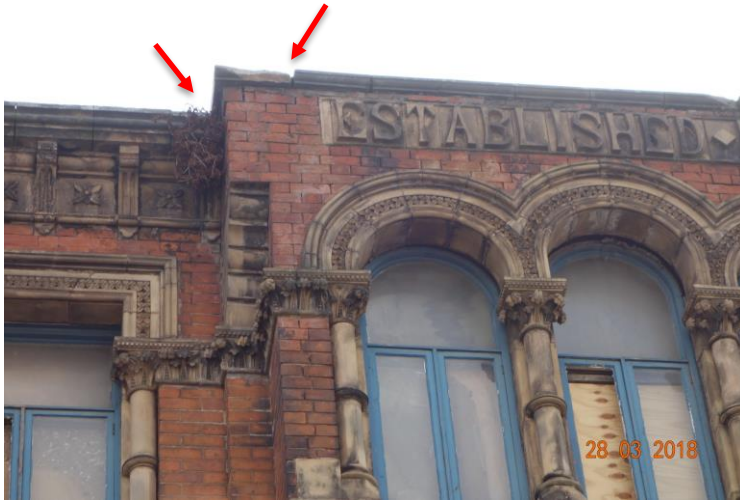
**Photograph No. 7.**

**Photograph No. 7** – Highlights areas where temporary weathering should be undertaken. The pointing of the capping stones could be a consideration to stop any further ingress of water, until such times as full conservation work is undertaken.

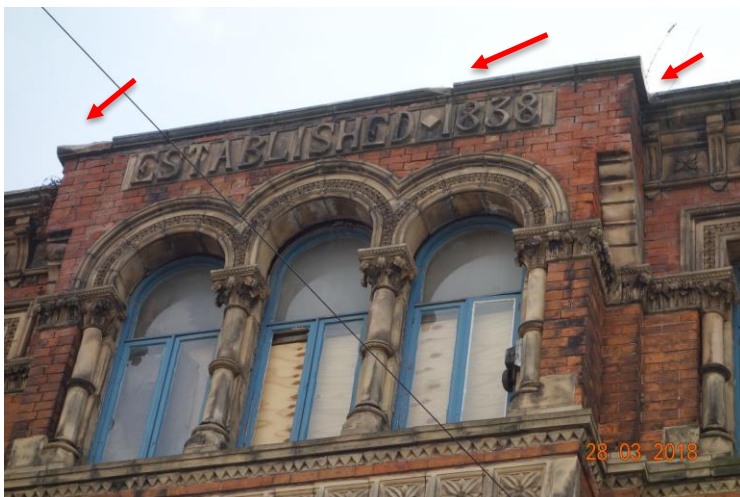
**Photograph No. 8** – Identifies a number of areas where the capping stones require attention.

The main part of the building however although it is very dirty should be left in this state. Only the weathering details i.e. hopper heads, and gutters etc. should be thoroughly cleaned. This will ensure that the rainwater is getting away from the structure and not being retained in the structure.

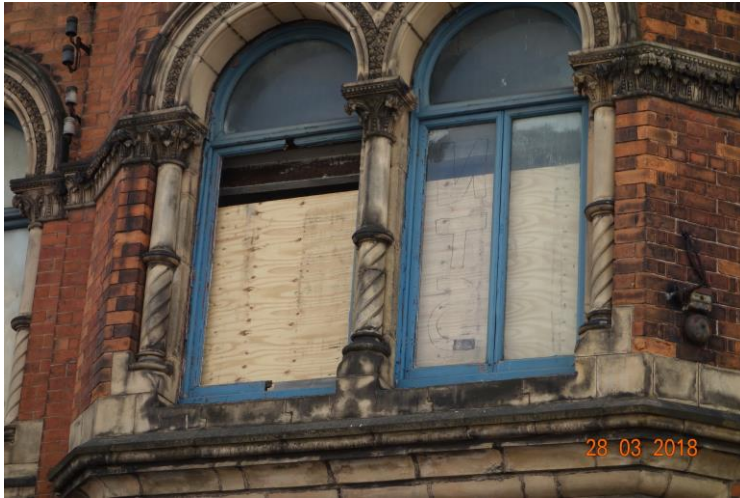
**Photograph No. 9.**

**Photograph No. 9** – This photograph illustrates a close up of the extremely ornate terracotta detail. The curved and fluted pillars around the windows are to be retained. Any cracking is to be filled with a terracotta repair system and stitched with brass dowels.

These remedial works are only required as part of the long term plan. The immediate plan is to eliminate the ingress of water.

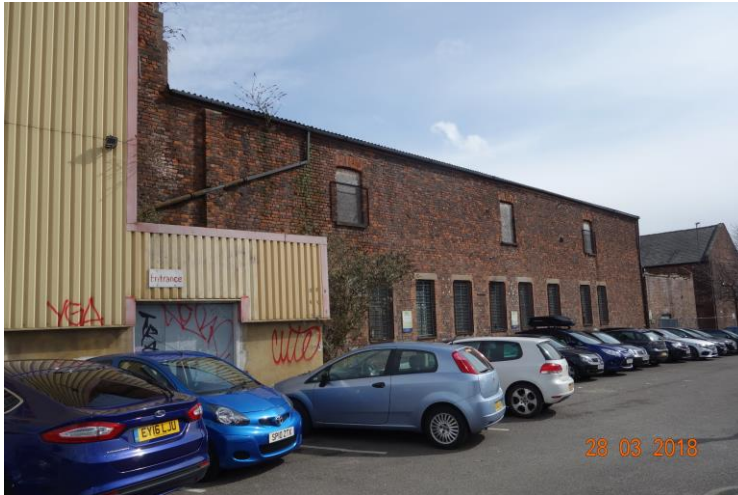
**Photograph No. 11.**

**Photograph No. 11** – This photograph reveals the South West elevation of the return building. This element of the building has no historic value. The proposal is for this structure to be taken down as part of the development going forward.

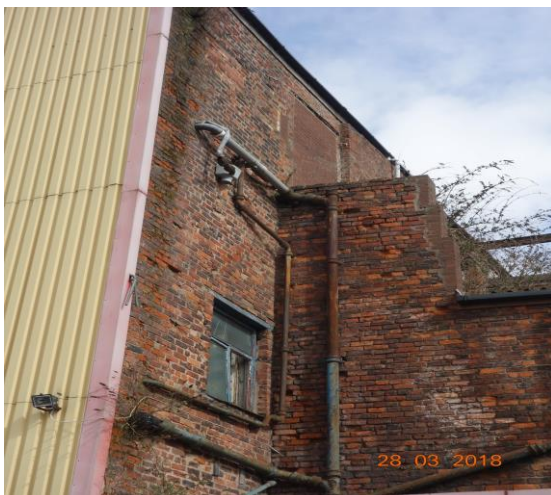
**Photograph No. 12**

**Photograph No.12** – Identifies the area of the rear roof of the main building. The roof of the main building is not original and currently consists of a modern steel roof. Unfortunately this roof has failed in a few areas. Temporary repairs should be undertaken to ensure that no further ingress of water is allowed to enter into the building.

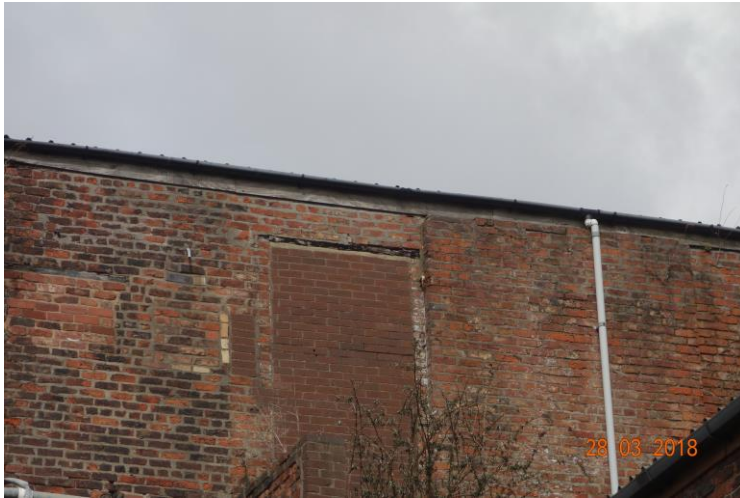
**Photograph No. 13.**

**Photograph No. 13** – This photograph highlights where some of the openings have been built up with modern brick.

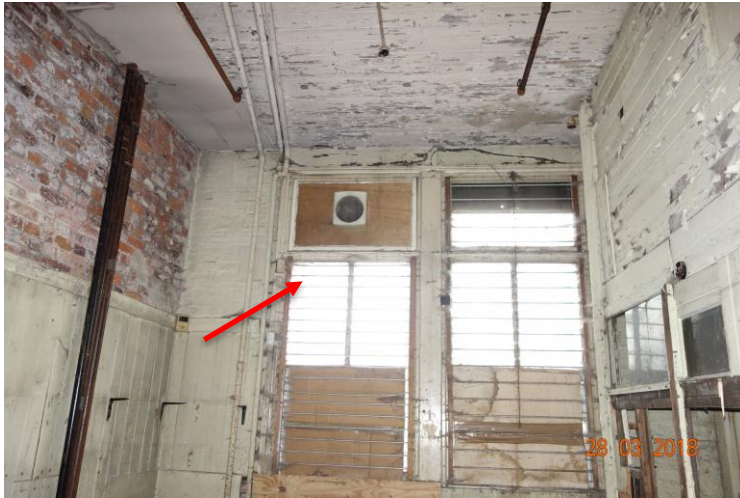
**Photograph No. 15.**

**Photograph No. 15** – Identifies an area located on the ground floor of the building. This photograph identifies that no ingress of water is occurring to this location.

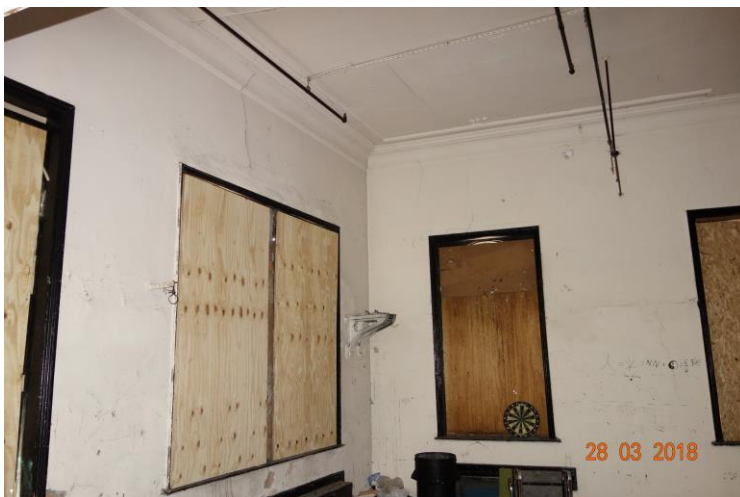
**Photograph No. 16** – This photograph reveals that no damage has occurred to the original cornice. As a result we can retain as much of the original architectural features where possible.

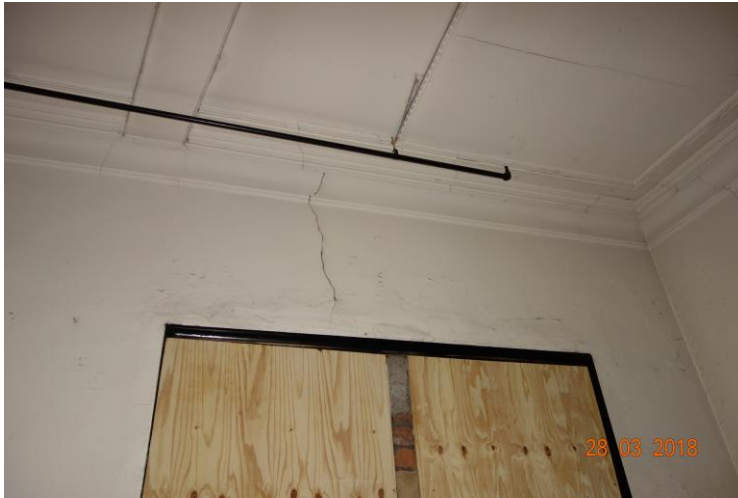
**Photograph No. 17.**

**Photograph No. 17** – This photograph shows that cracking to the front elevation is occurring.

This cracking would have occurred many years ago during the life of the building.

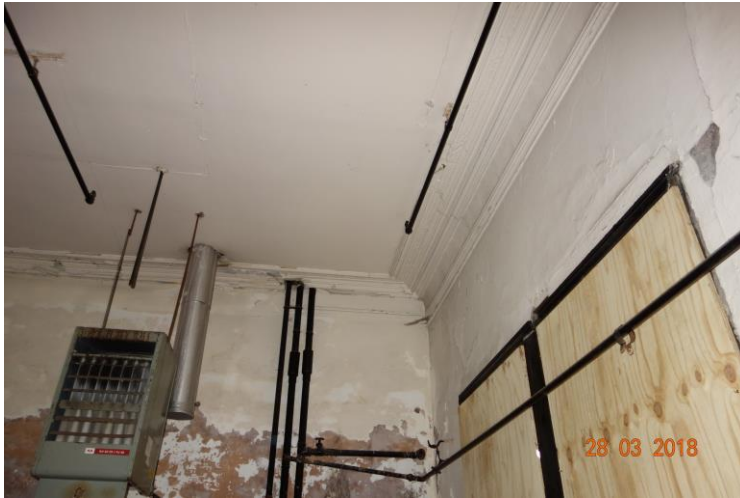
**Photograph No. 19.**

**Photograph No. 19** – Highlights a section of the South West elevation internally. All of the original cornice is in place and no evidence of ingress of water was recorded

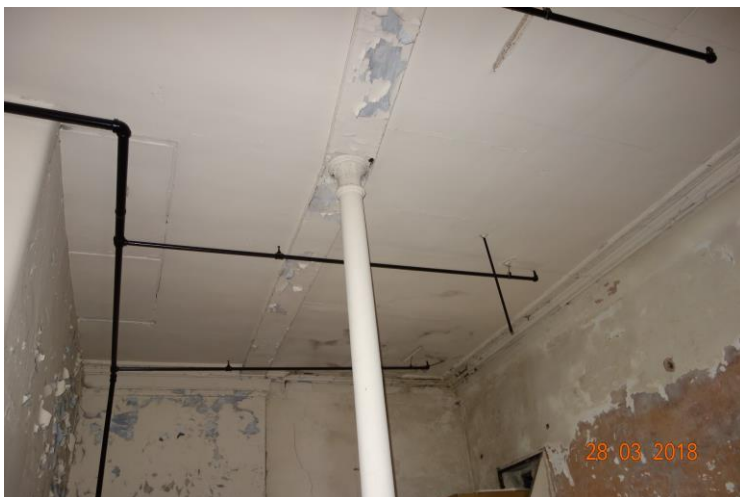
**Photograph No. 20** – This photograph highlights an area located on the 2nd floor level. It was noted that all the original cornice remained in place. However there was some evidence of the ingress of water to the rear of the building – South East elevation. This a localised area where the roof can be temporary repaired until such times as the main contract is undertaken.

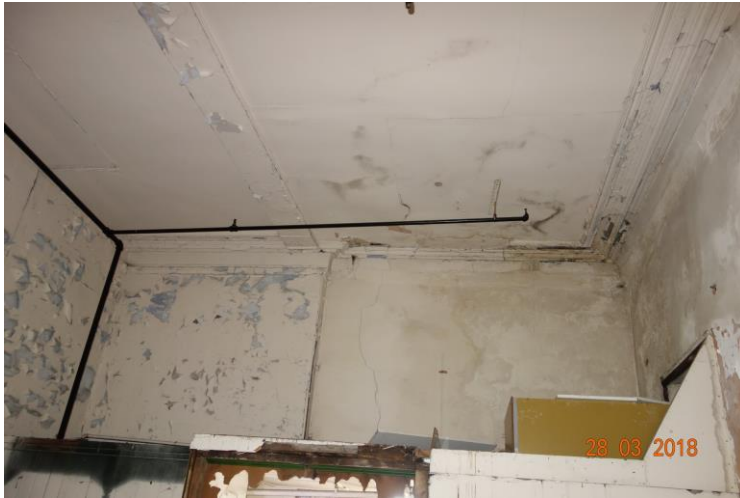
**Photograph No. 21** – Indicates the rear wall of the building – South East elevation. This elevation is in relatively good condition. However there is evidence of the ingress of water.

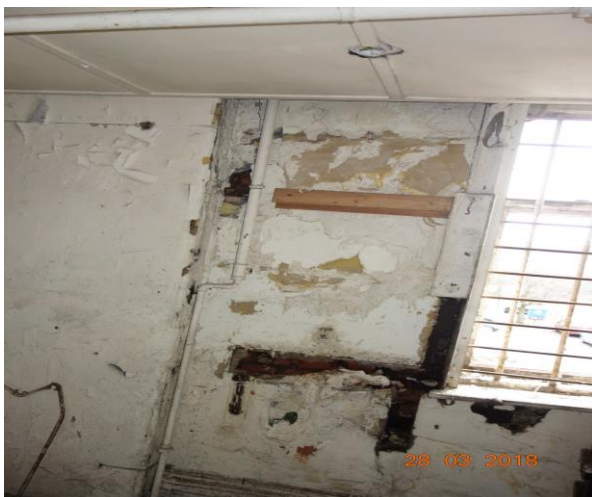
**Photograph No. 22** – This photograph highlights the rear elevation of the building – South East. It is important to point out that there is no original cornice at this location. There is however some evidence of ingress of water. This ingress is to be eliminated. It is a matter of protecting the fabric of the building by eliminating the defective horizontal weathering surfaces.

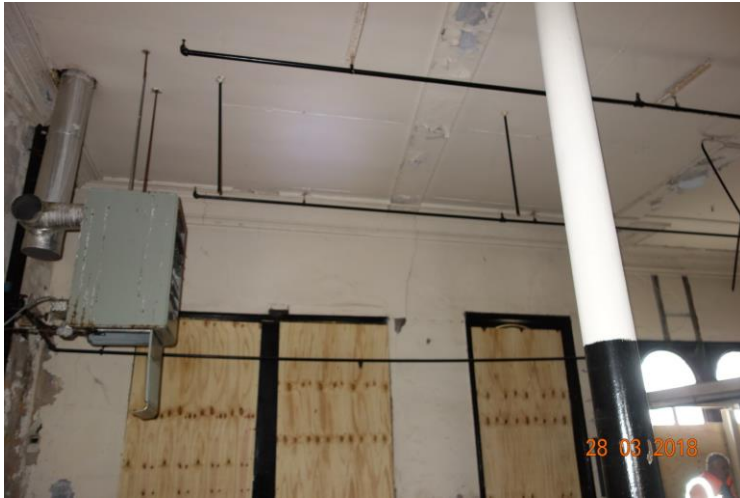
**Photograph No. 23.**

**Photograph No. 23** – This photograph again shows the front elevation of the internal walls. There is no evidence of deterioration. No evidence of existing cornicing in place.

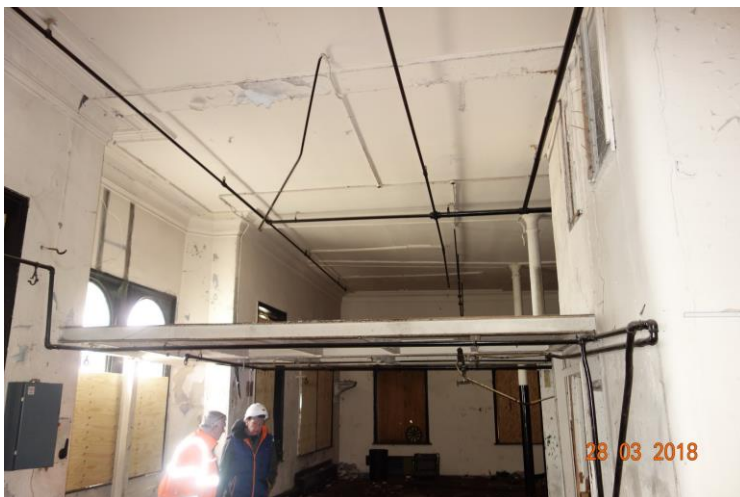
**Photograph No. 24** – This photograph shows the 2nd floor level. This area is in relatively good condition. No evidence of any significant ingress of water was recorded.

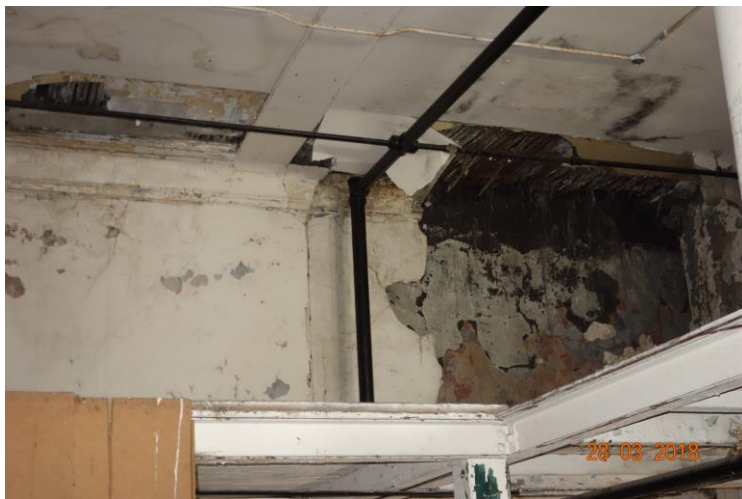
**Photograph No. 25.**

**Photograph No. 25** – This photograph highlights the rear of the building at the back of the mezzanine floor. Significant ingress of water was recorded over a 10 -15 metre length of the wall. This should be rectified as soon as possible in order to reduce the extent of the deterioration of the structure.

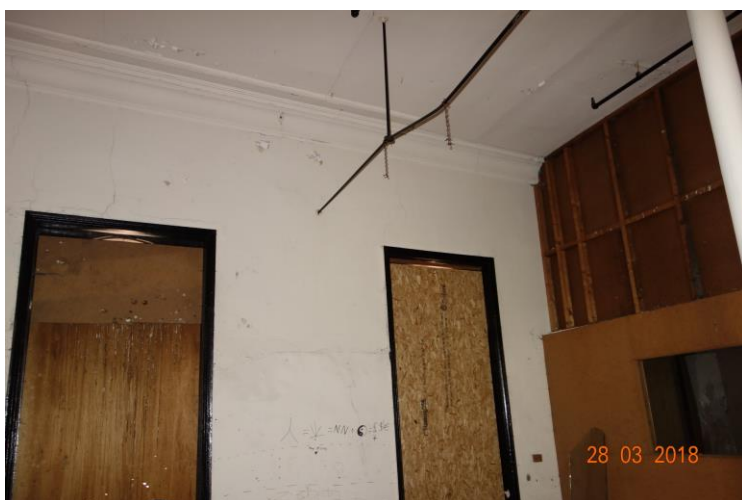
**Photograph No. 26** – Indicates the gable wall of the building. It shows that the cornice is in place. The windows are solidly secured and no evidence of any significant ingress of water.

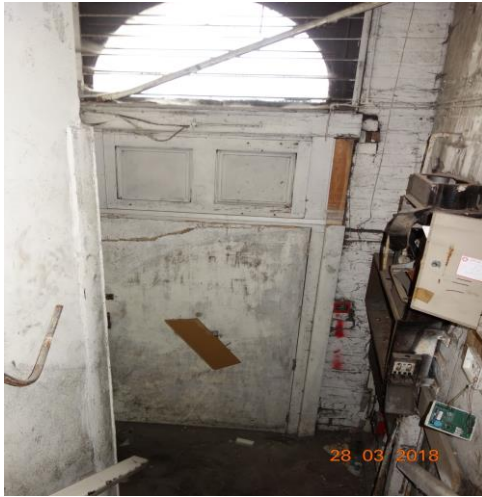
**Photograph No. 27.**

**Photograph No. 27** – This photograph exposes the inside of the front door to the building.

The original door and frame are in poor condition; however the opening appears to be in good condition.

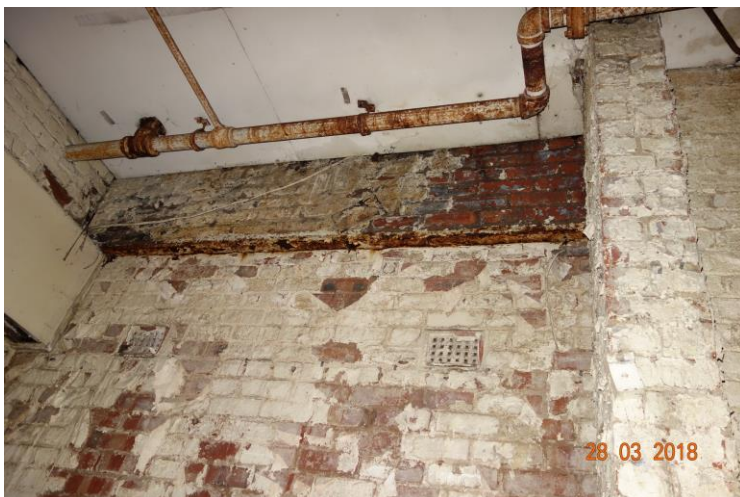
**Photograph No. 28** – This highlights the rear elevation of the wall.

As a result of the ingress of water the brick is starting to deteriorate.

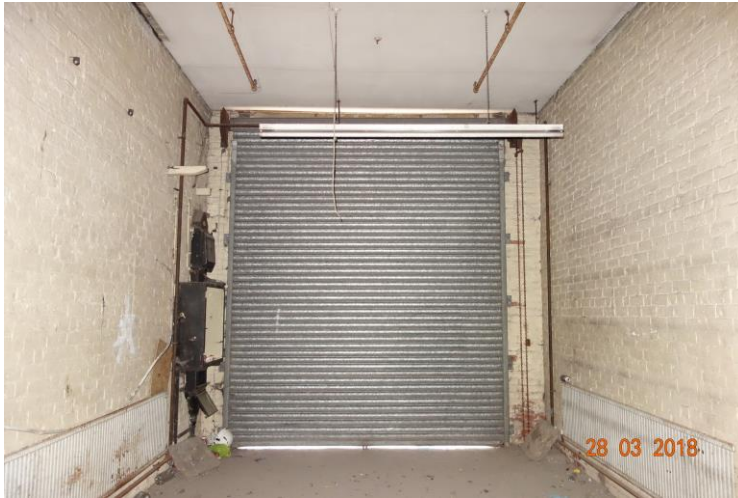
**Photograph No. 29.**

**Photograph No. 29** – Indicates where the large shutter doors are located in the front entrance of the building.

All of this area is in good condition with no significant evidence of deterioration.

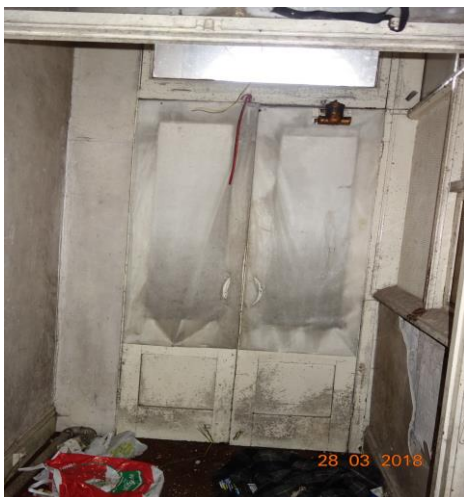
**Photograph No. 30** – This photograph highlights one of the doors adjacent to the main entrance door. This area is in relatively good condition with no evidence of defects recorded.

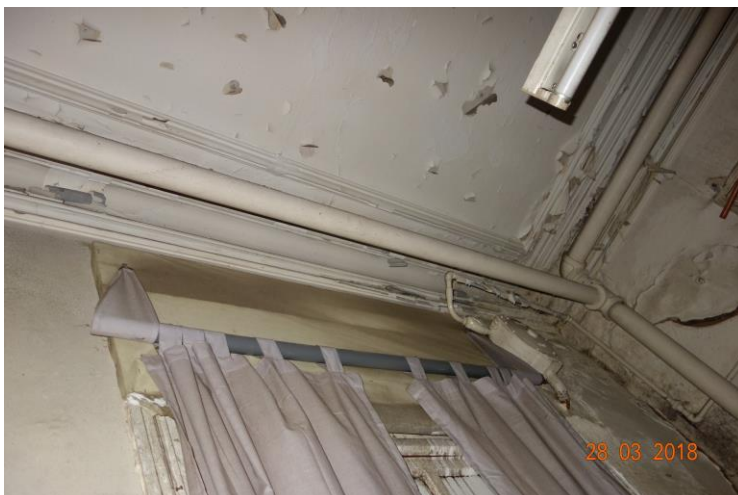
**Photograph No. 32** – This photograph highlights a room to the rear of the ground floor level.

The original cornice is in place and there is no evidence of significant deterioration.

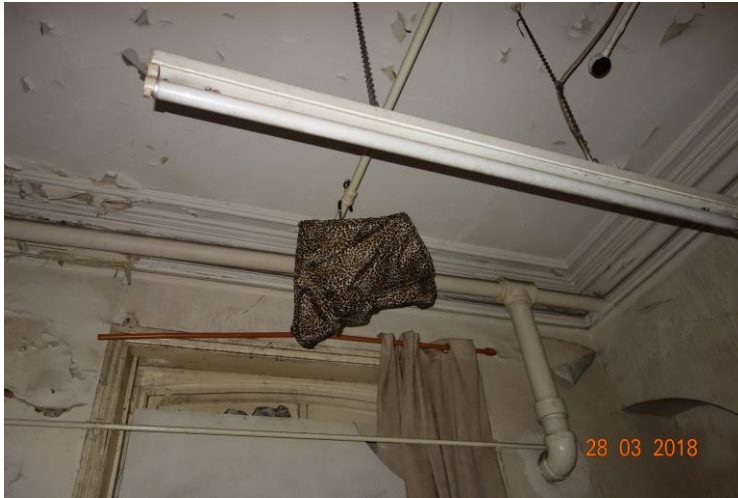
**Photograph No. 33.**

**Photograph No. 33** – This photograph reveals an area where squatters were previous occupying. The original cornice and ceiling are in good condition.

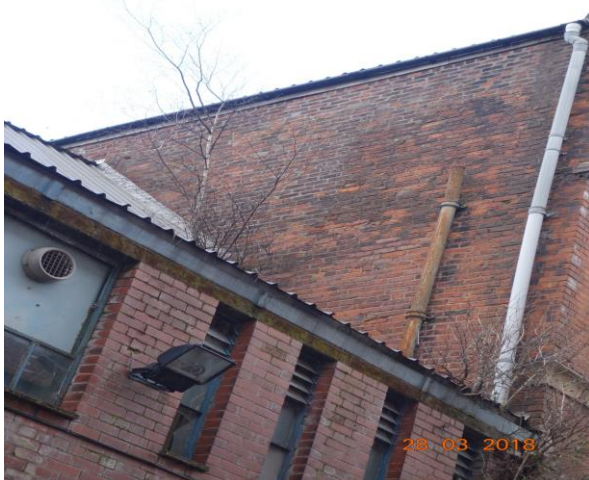
**Photograph No. 34** – This photograph indicates an area of concern. The down pipe is giving problems to the external wall.

- We would strongly recommend that temporary repairs of any areas of the roof that are not performing to their designed function should be carried out.
- This work will include the cleaning of all down pipes ensuring that the building is draining rainwater adequately away.

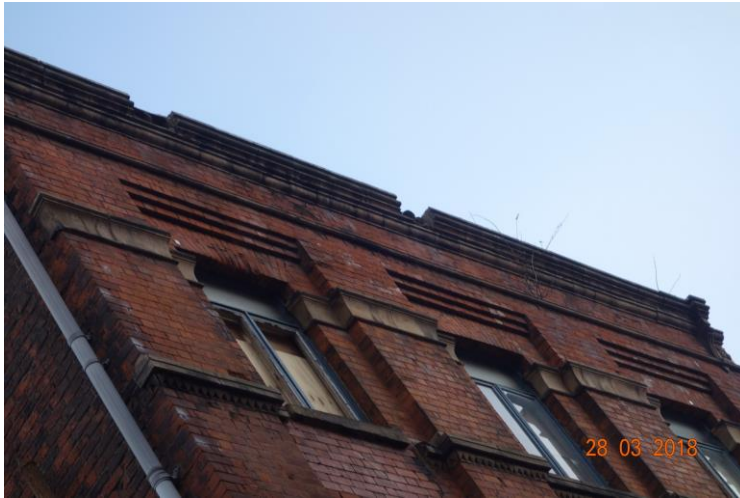
**Photograph No. 35.**

**Photograph No. 35** – This photograph reveals a close up of where areas of cornice and capping need to be weathered on a temporary basis.

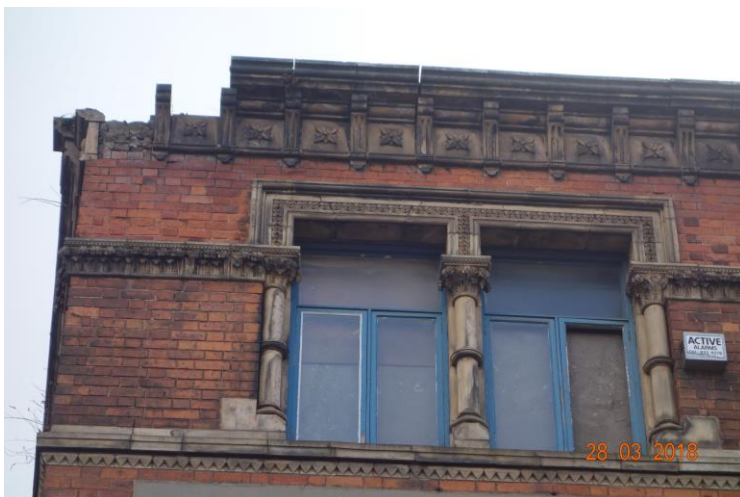
**Photograph No. 36.**

**Photograph No. 36** – Identifies a further close up of front parapet capping that requires detailed weathering on a temporary basis.

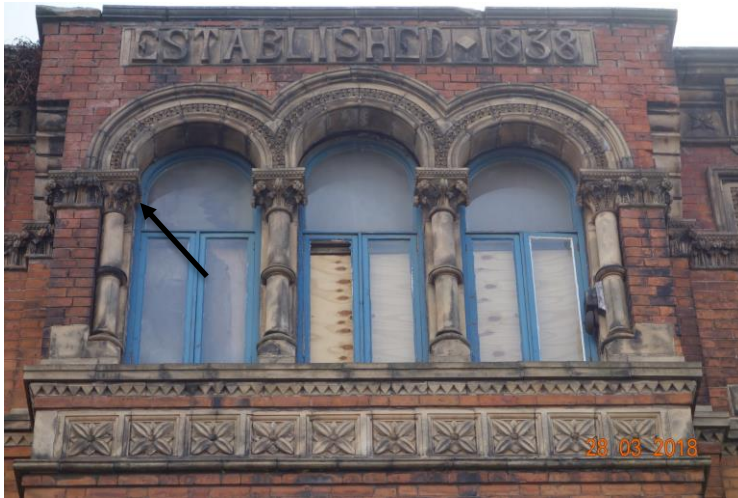
**Photograph No. 37.**

**Photograph No. 37** – This photograph highlights that repairs to the horizontal weathering details are required on a temporary basis.

All of the horizontal weathering surfaces will be repaired and upgraded where necessary, with lead details to be applied in strict accordance with the Lead Sheet Association Guidelines.

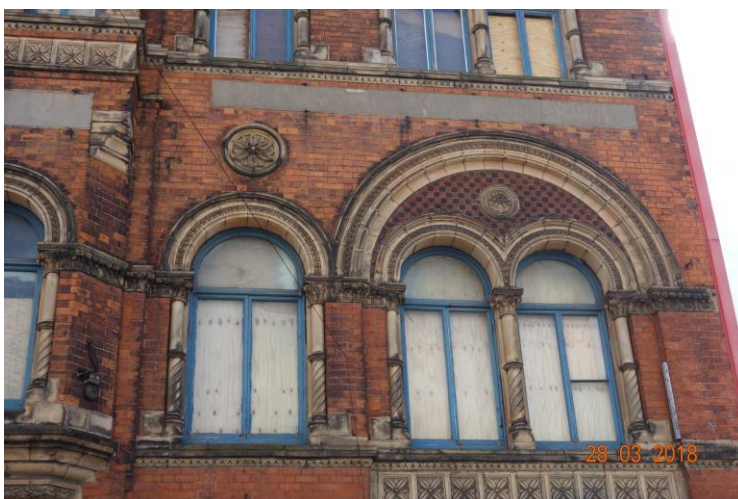
**Photograph No. 38.**

**Photograph No. 38** – This photograph reveals a section of the ornate details and unique brickwork. It is of the utmost importance that these bricks are protected until such times until the building is restored.

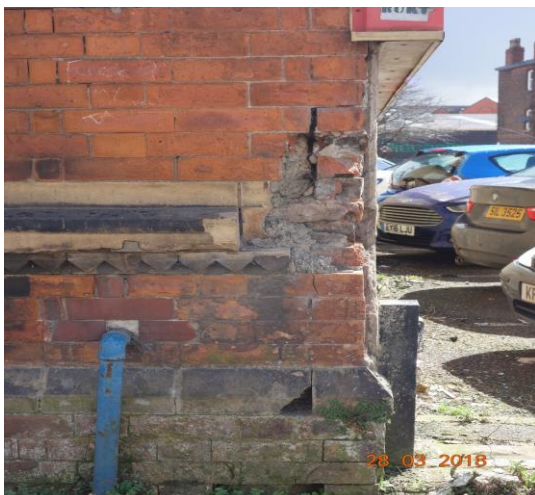
**Photograph No. 40.**

**Photograph No. 40** – This photograph exposes past evidence where the building appears to have been struck by a vehicle.

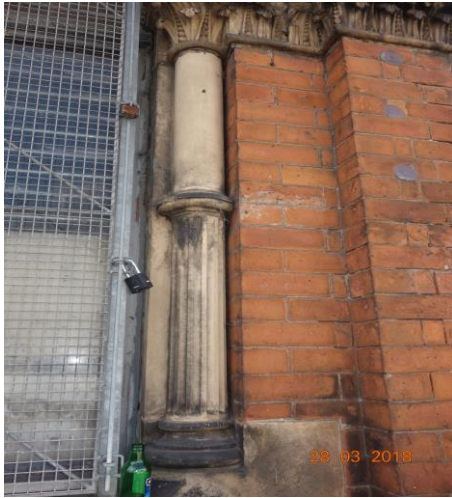
**Photograph No. 41.**

**Photograph No. 41** – Reveals a close up view of a round ornate terracotta pillar. It also highlights the level of deterioration present.

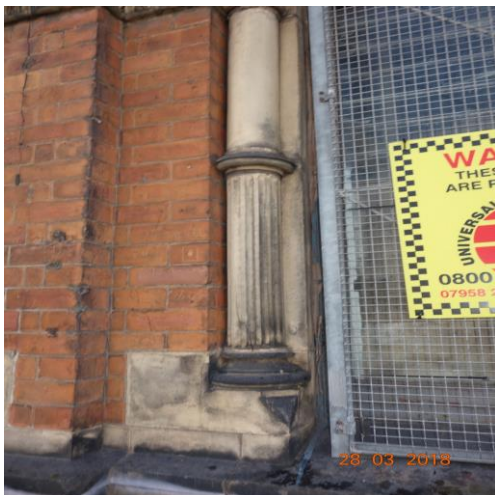
**Photograph No. 42.**

**Photograph No. 42** – This photograph highlights the level of deterioration present on the external façade of the building.

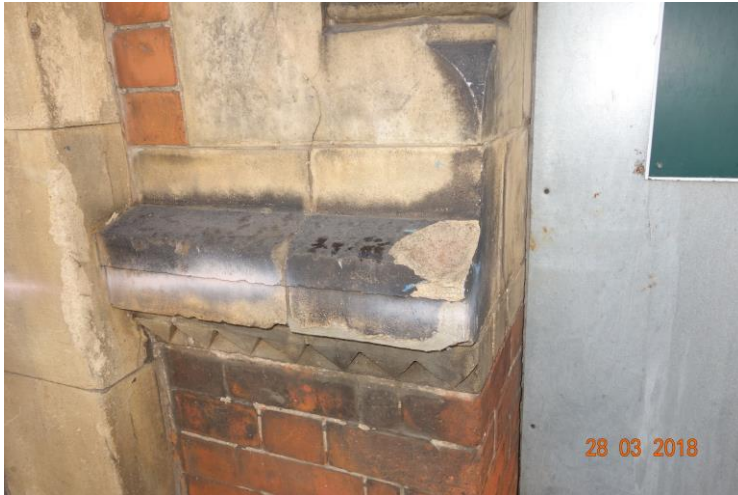
**Photograph No. 43.**

**Photograph No. 43** – This photograph illustrates a close up view of the past damage to the horizontal sills.

This can be repaired as part of the temporary works by applying an appropriate clear weather proofing system.

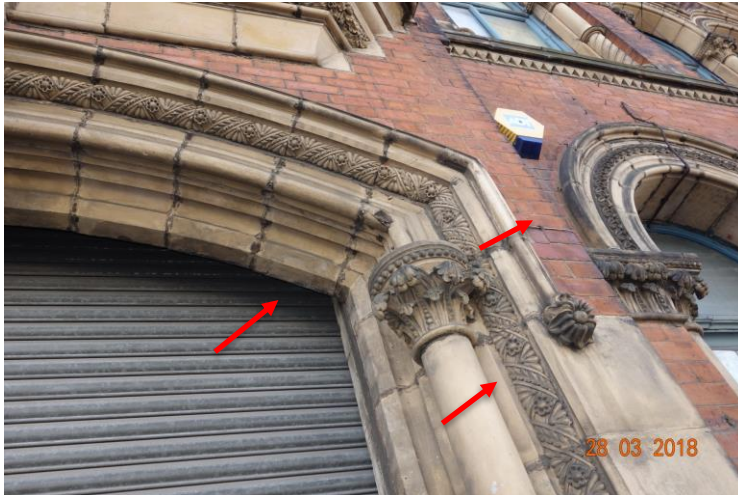
**Photograph No. 45.**

**Photograph No. 45** – This photograph highlights the extent of cracking on the building.

This is a result of the past ingress of water. At the time of my survey I found very little evidence of ingress of water in particular to the front façade.

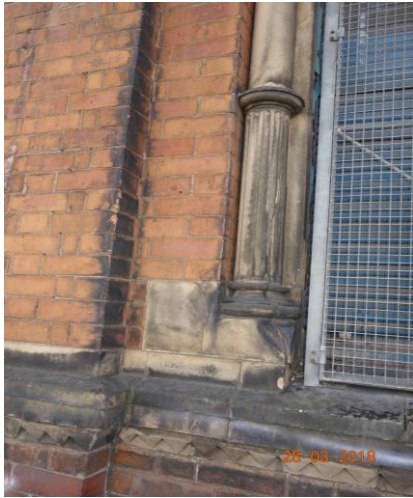
**Photograph No. 47.**

**Photograph No. 47** – Highlights the cracking to a round pillar and also the extent of carbon on the buff brick.

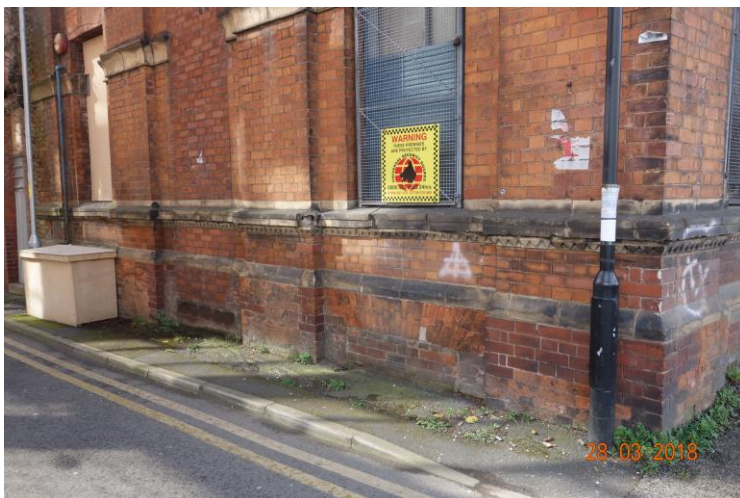
**Photograph No. 48.**

**Photograph No. 48** – This photograph illustrates a global view revealing the extent of various deteriorations to the brick work.
