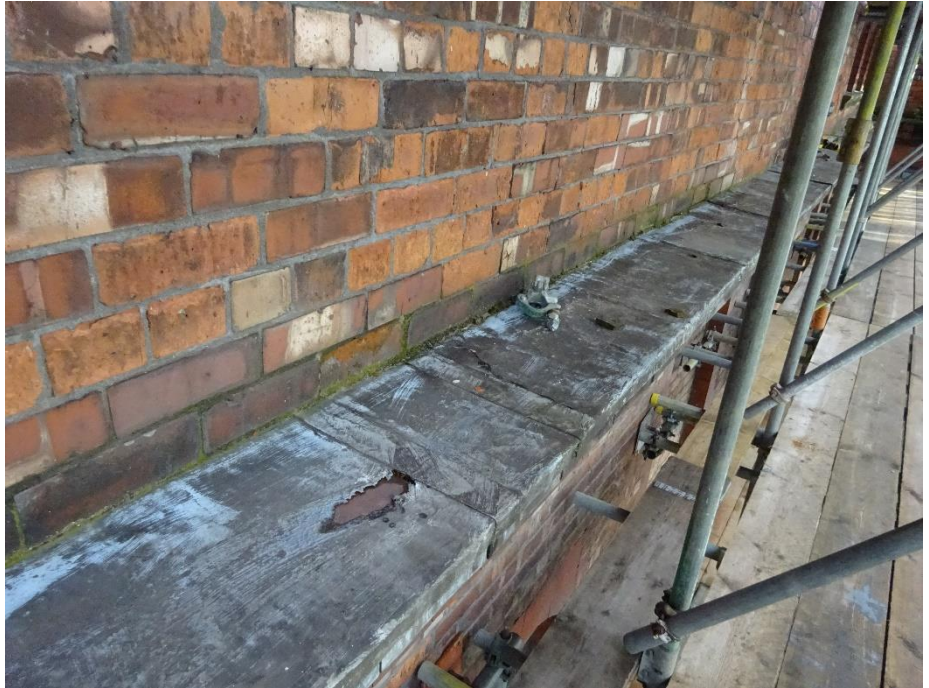
Photograph 1

View of damage to the lead projecting cornice to the West elevation.

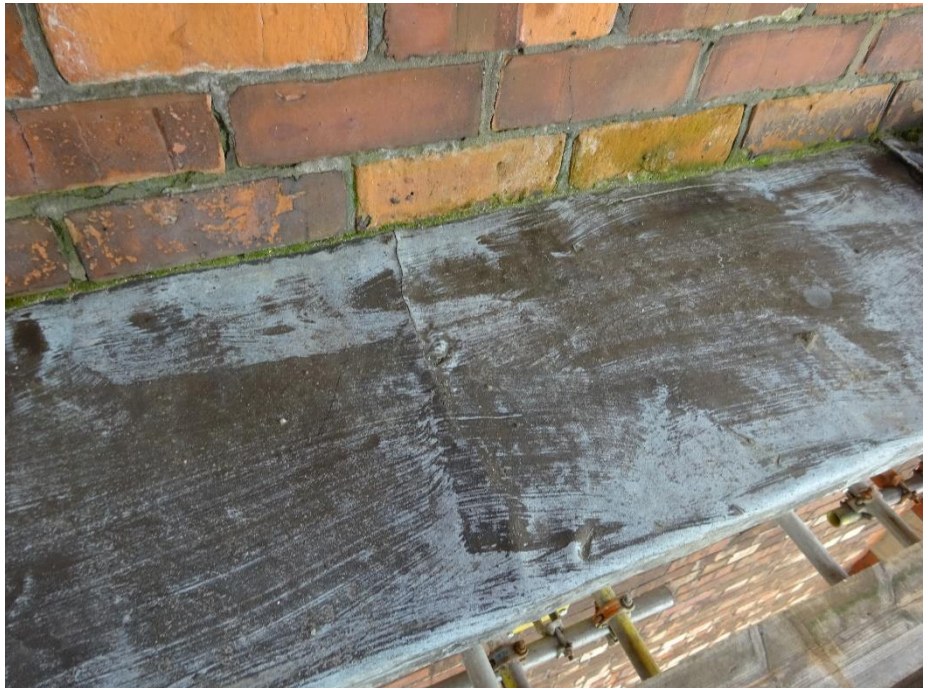
Photograph 2

View of damage to the lead projecting cornice to the West elevation.

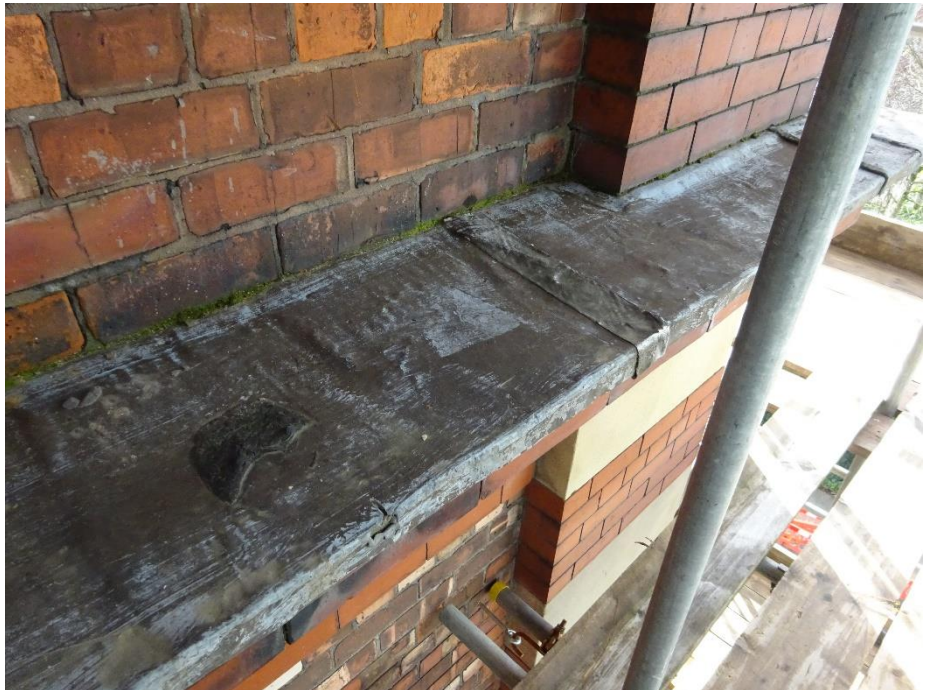
Photograph 3

View of damage to the lead projecting cornice to the West elevation.

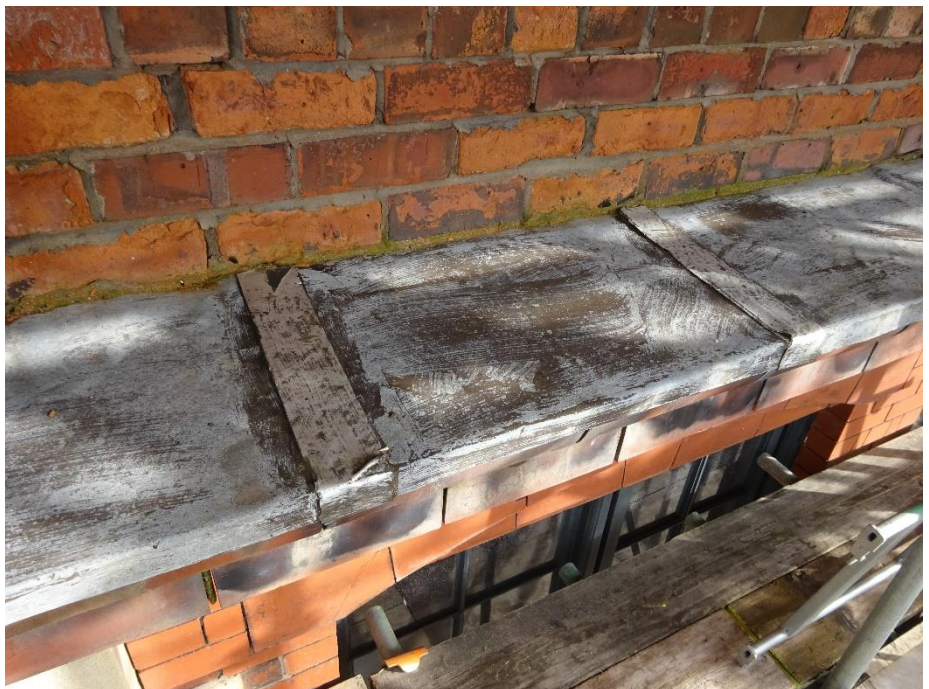
Photograph 4

View of patch repairs to the lead projecting cornice to the South elevation.

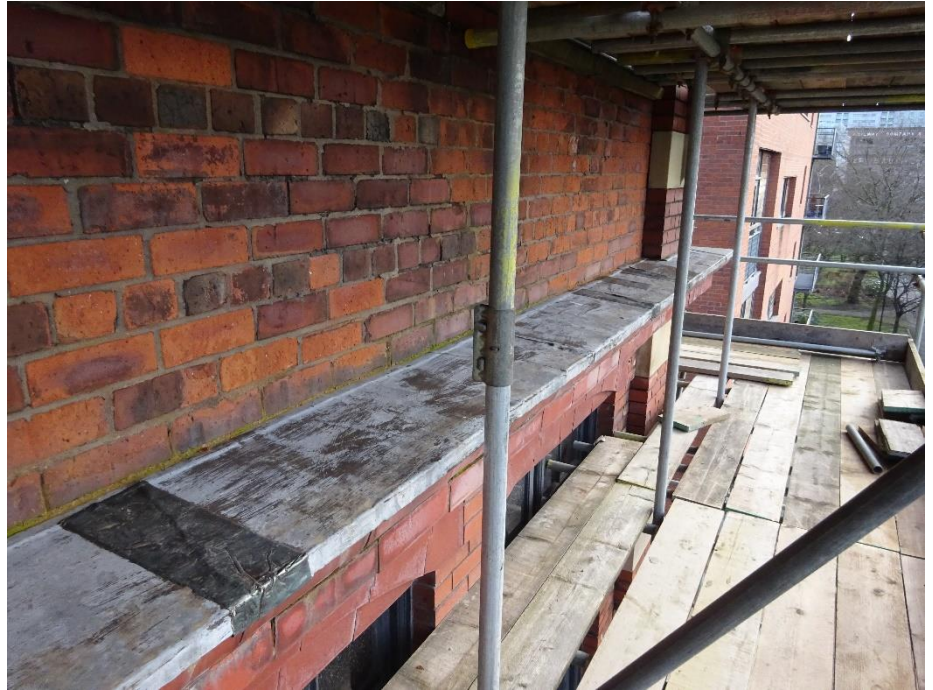
Photograph 5

View of patch repairs to the lead projecting cornice to the South elevation.

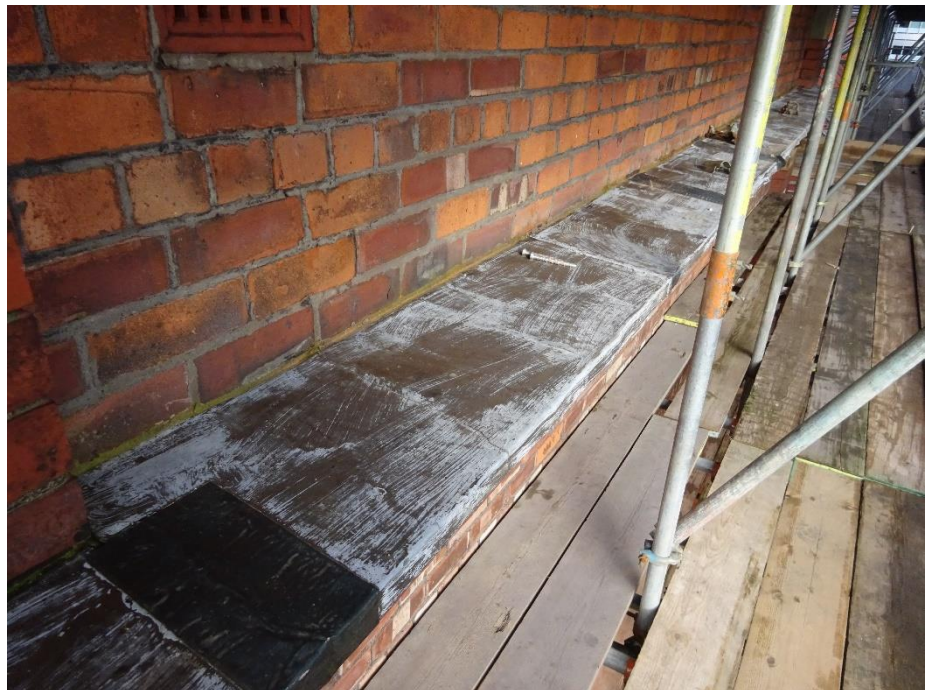
Photograph 6

View of patch repairs and a crack to the lead projecting cornice to the East elevation.

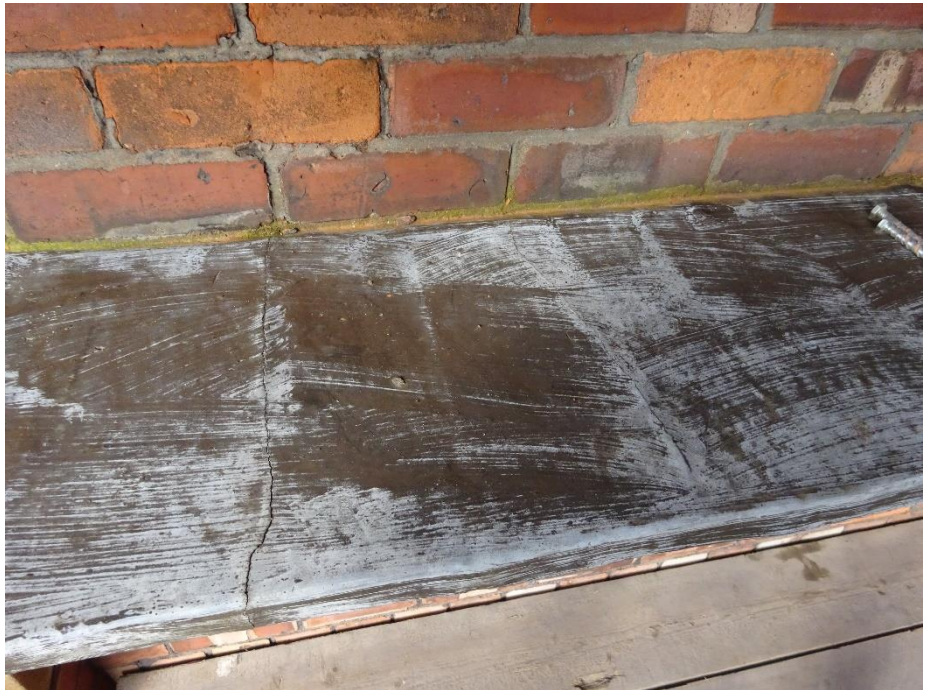
Photograph 7

View of crack in lead projecting cornice, East elevation.

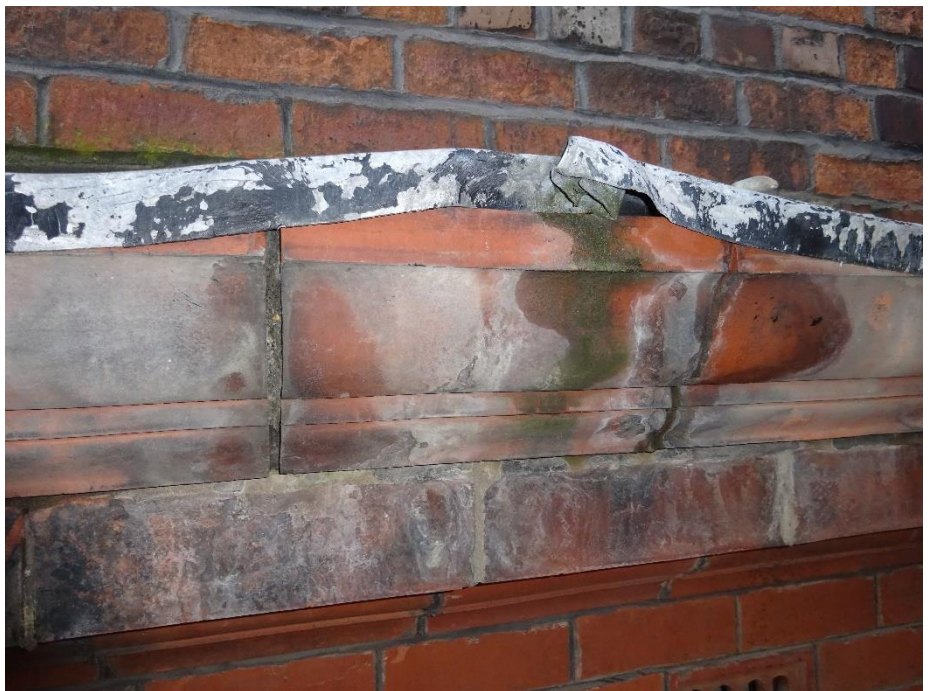
Photograph 8

View of a damaged lead projecting cornice to the East elevation.

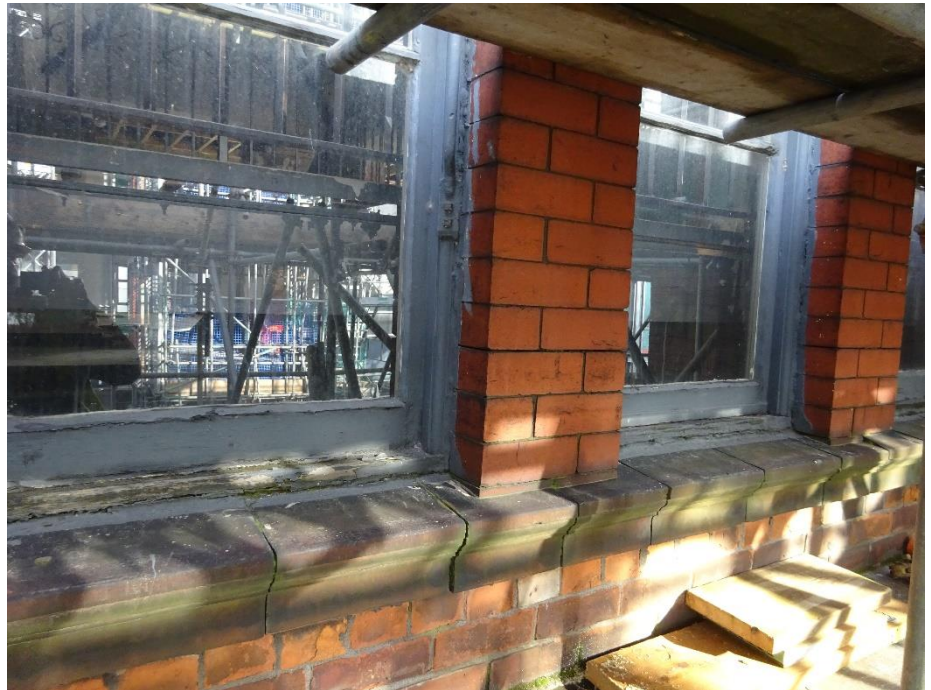
Photograph 9

View of rotten window cills, West elevation, 3<sup>rd</sup> floor level.

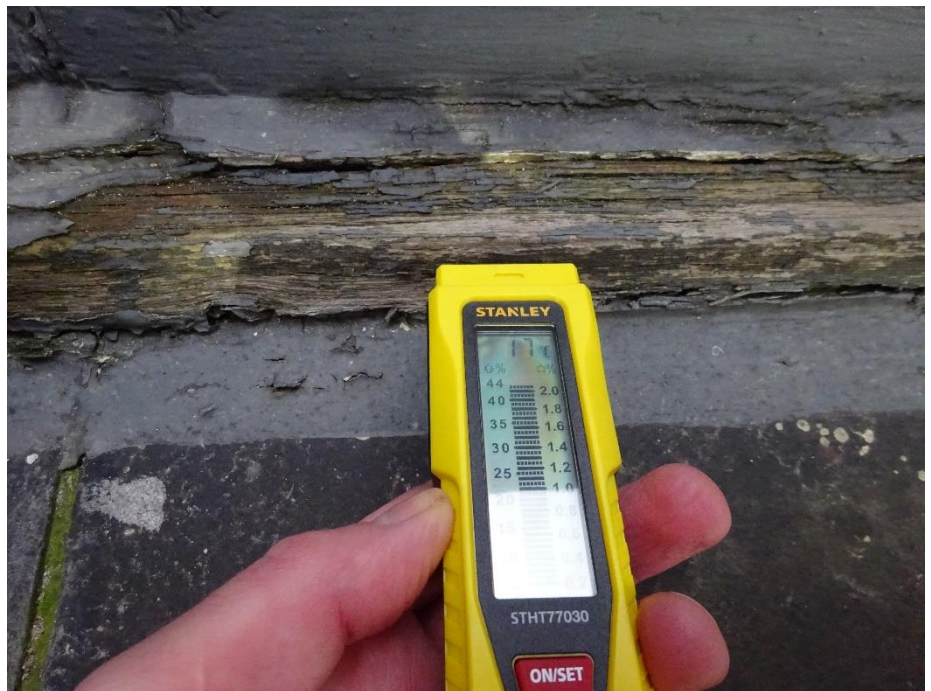
Photograph 10

Moisture reading or damp/rotten windows to West elevation, 3<sup>rd</sup> floor level.

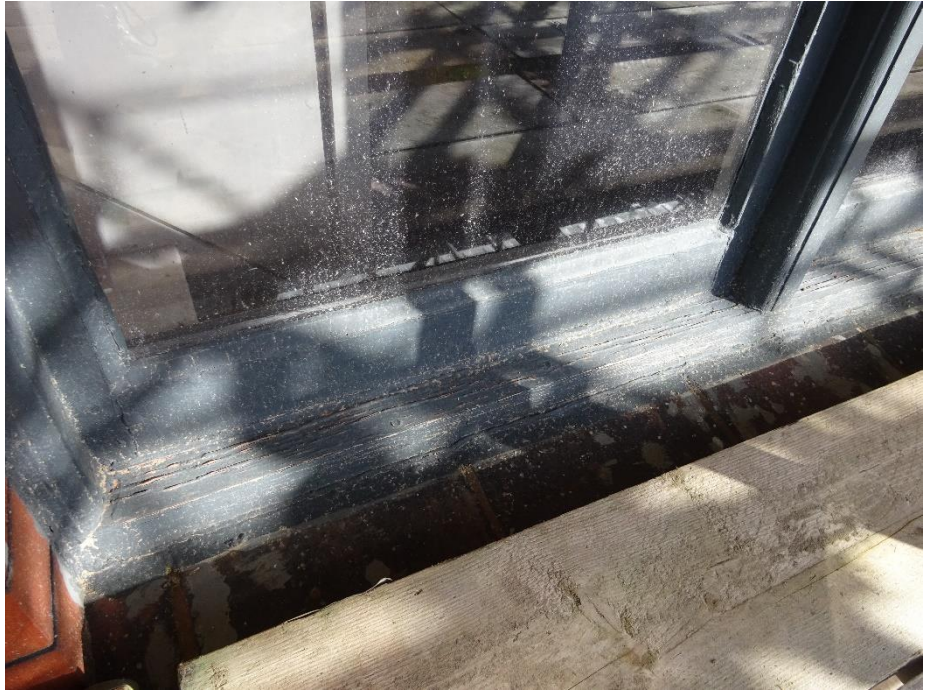
Photograph 11

View of weathered and cracking paint to windows to South elevation.

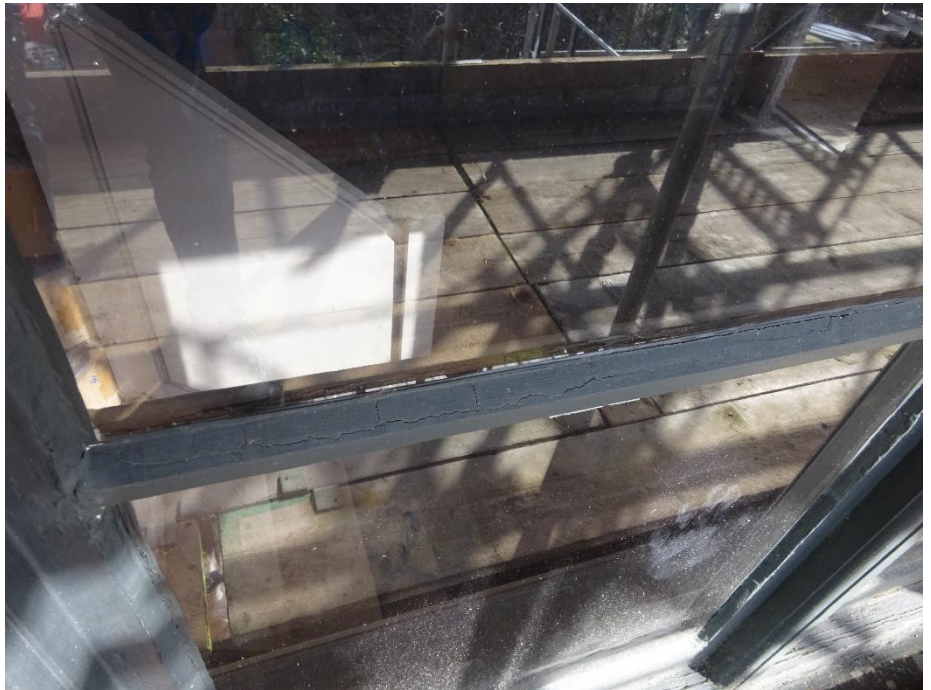
Photograph 12

View of brittle and cracked paint and timber to window to South elevation.

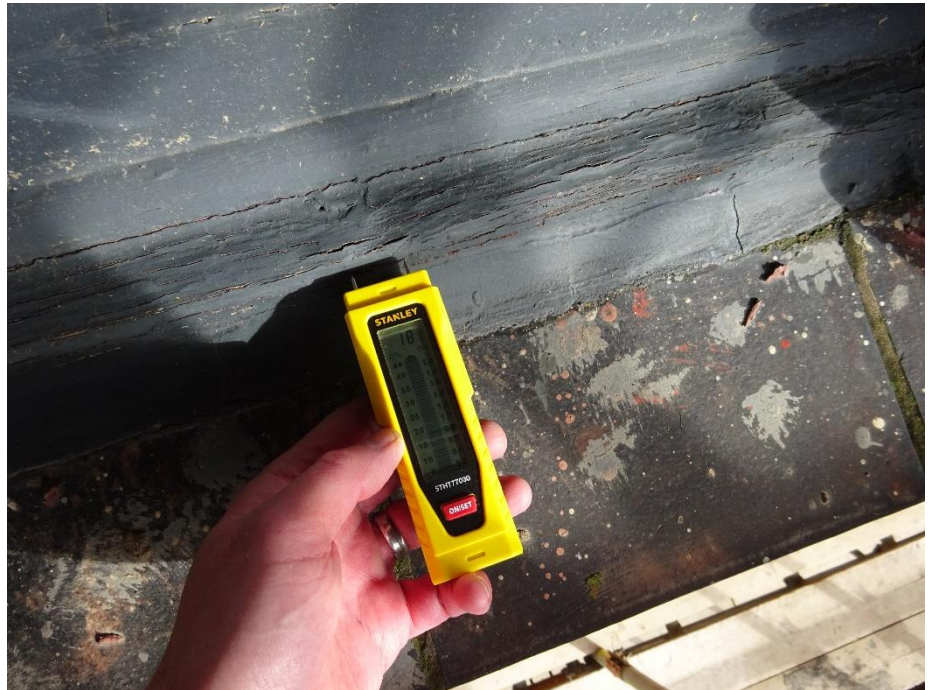
Photograph 13

Moisture reading or damp/rotten windows to South elevation, 2<sup>nd</sup> floor level.

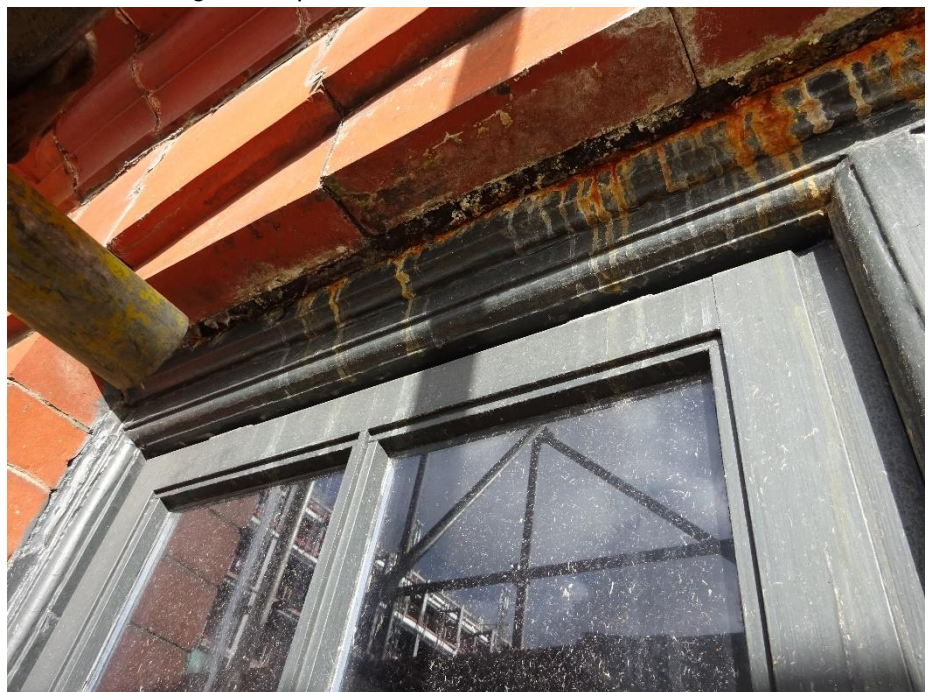
Photograph 14

View of heavily soiled windows and repointing/new sealant required to window on South elevation.

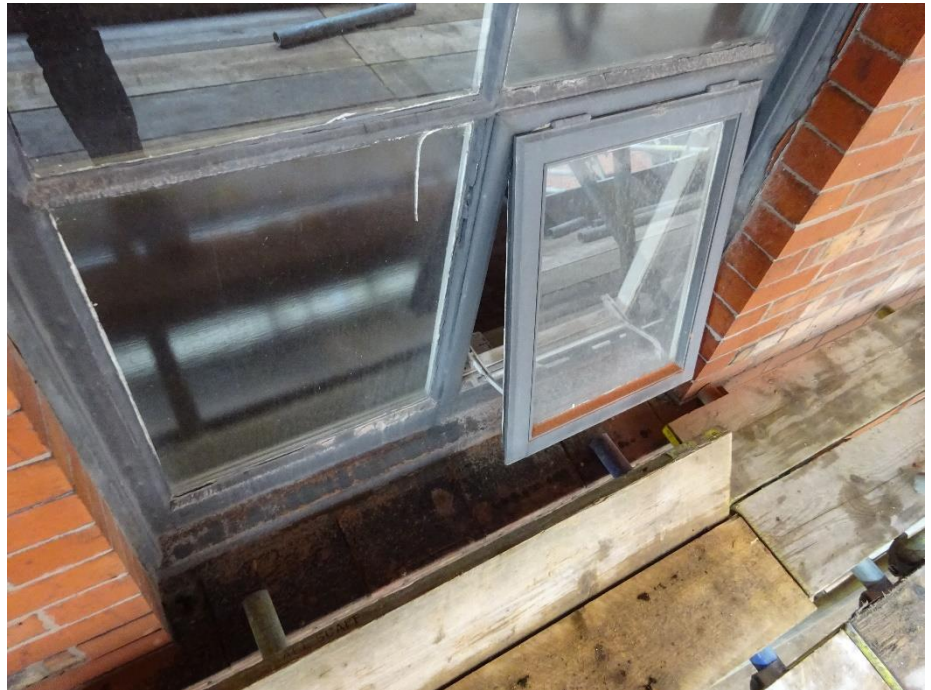
Photograph 15

View of peeling paint to 2<sup>nd</sup> floor window, East elevation.

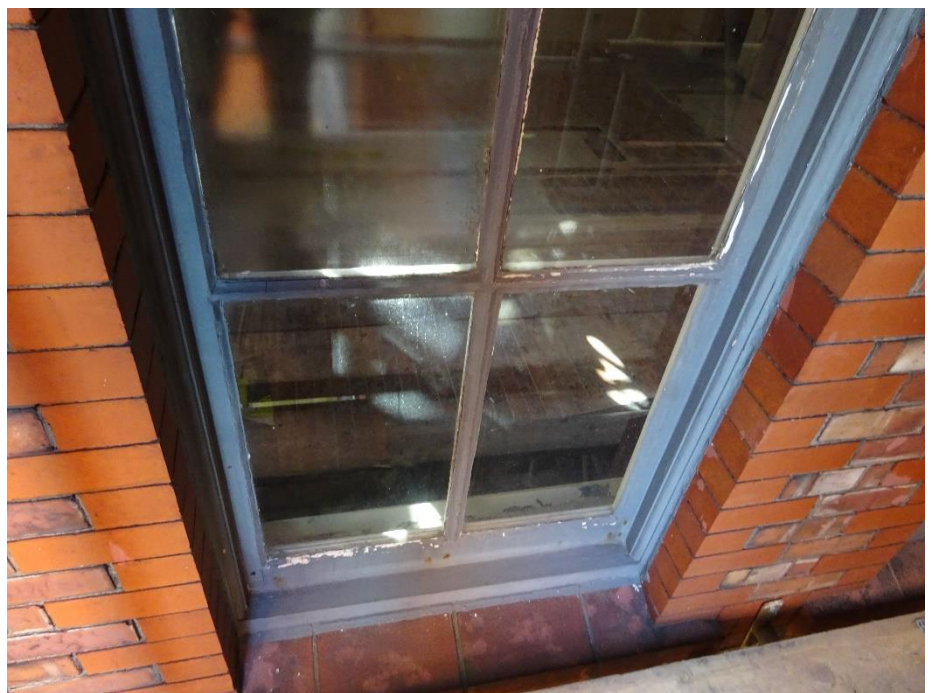
Photograph 16

View of peeling paint to 2<sup>nd</sup> floor window, North elevation.

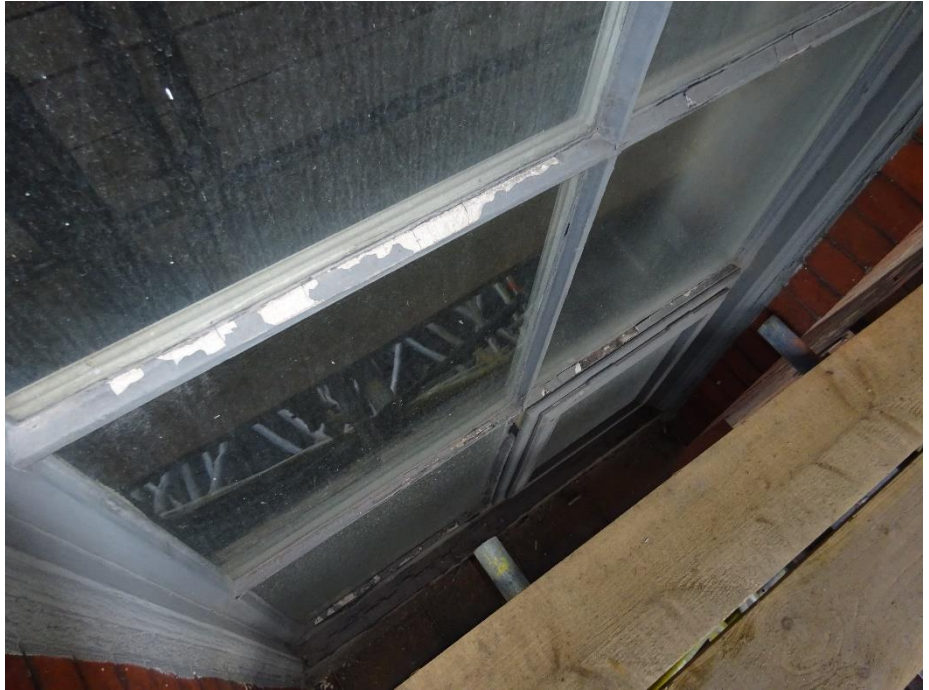
Photograph 17

View of peeling paint to 1st floor window, south elevation.

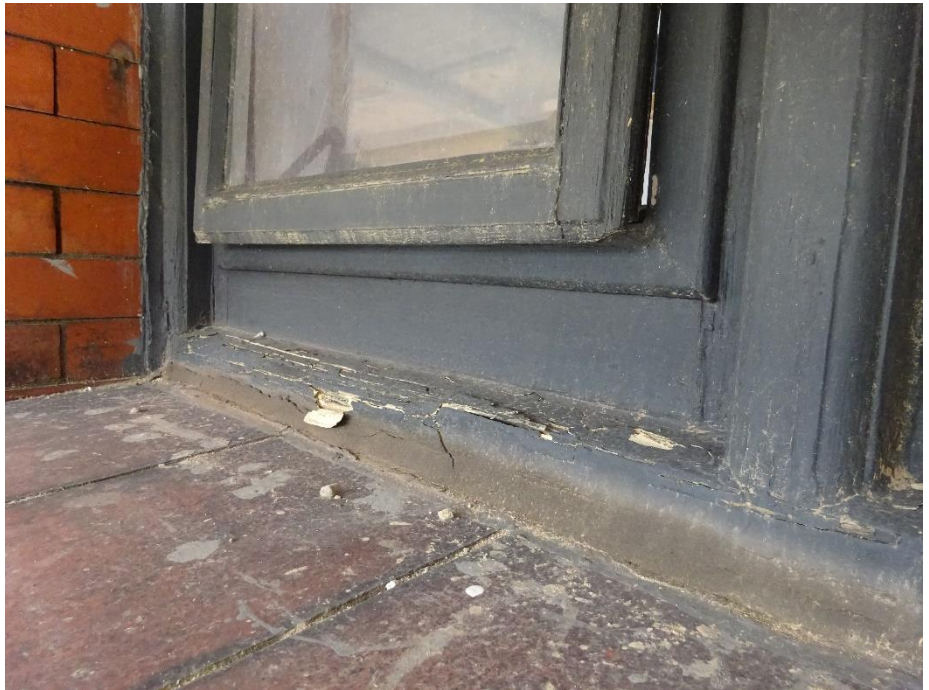
Photograph 18

View of peeling paint to 1st floor window, south elevation.

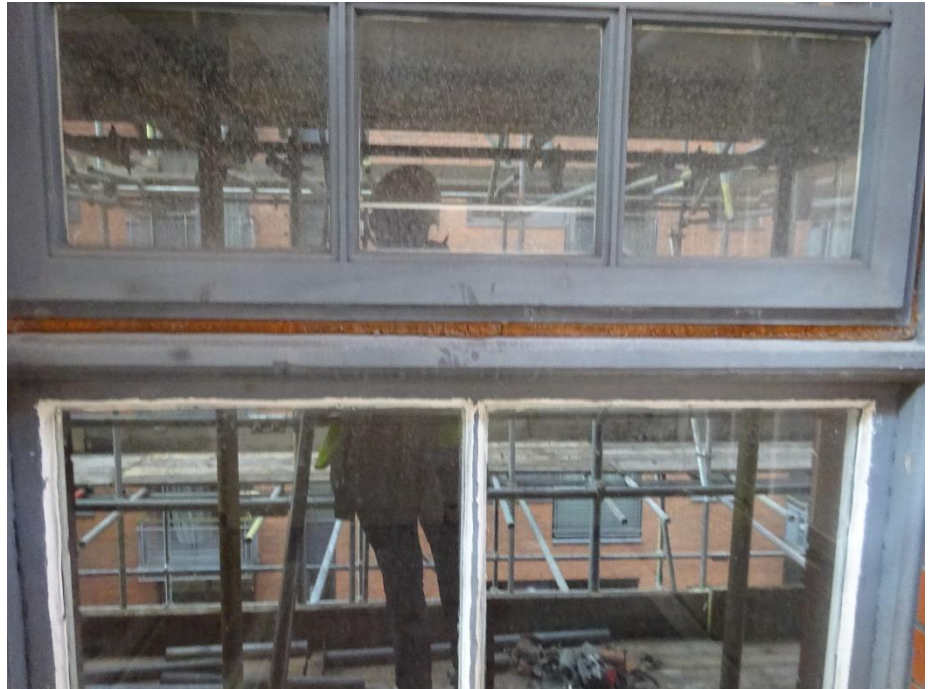
Photograph 19

Foam insulation in window frame, East elevation.

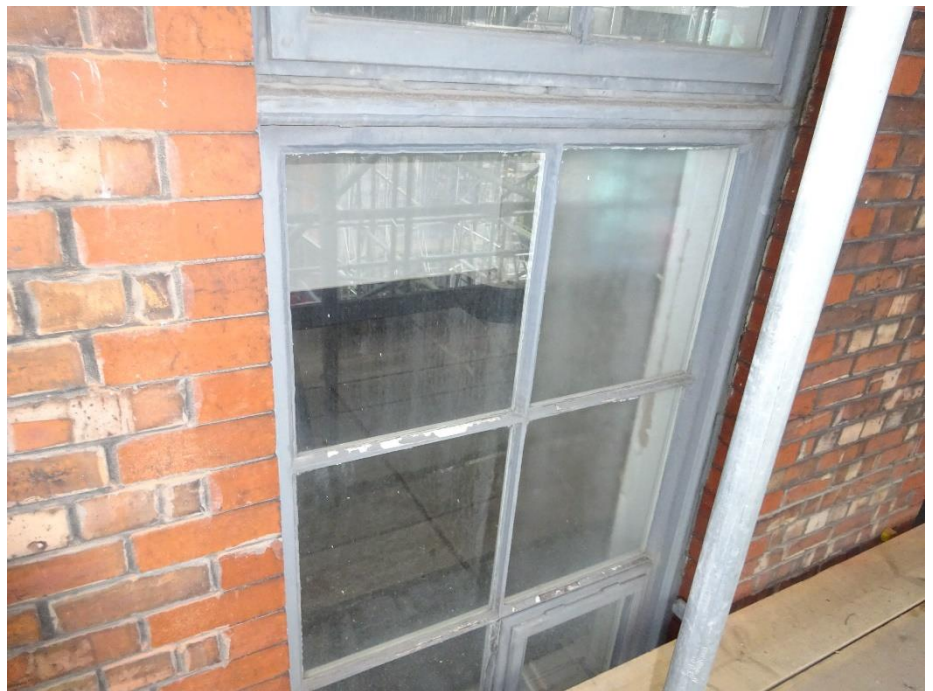
Photograph 20

Foam insulation in window frame, South elevation.

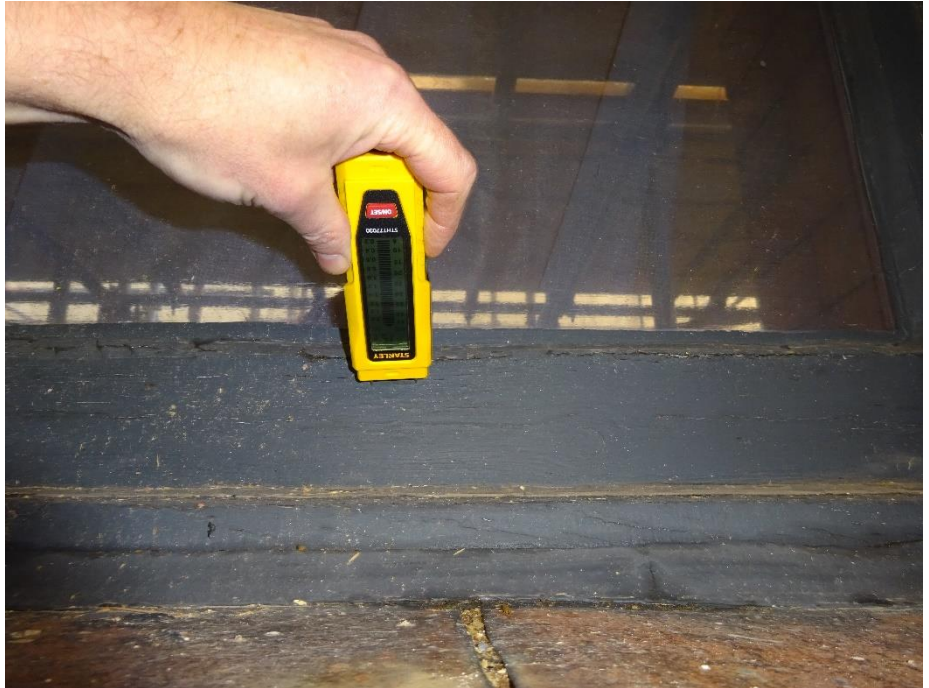
Photograph 21

Moisture reading or damp/rotten windows to South elevation, ground floor.

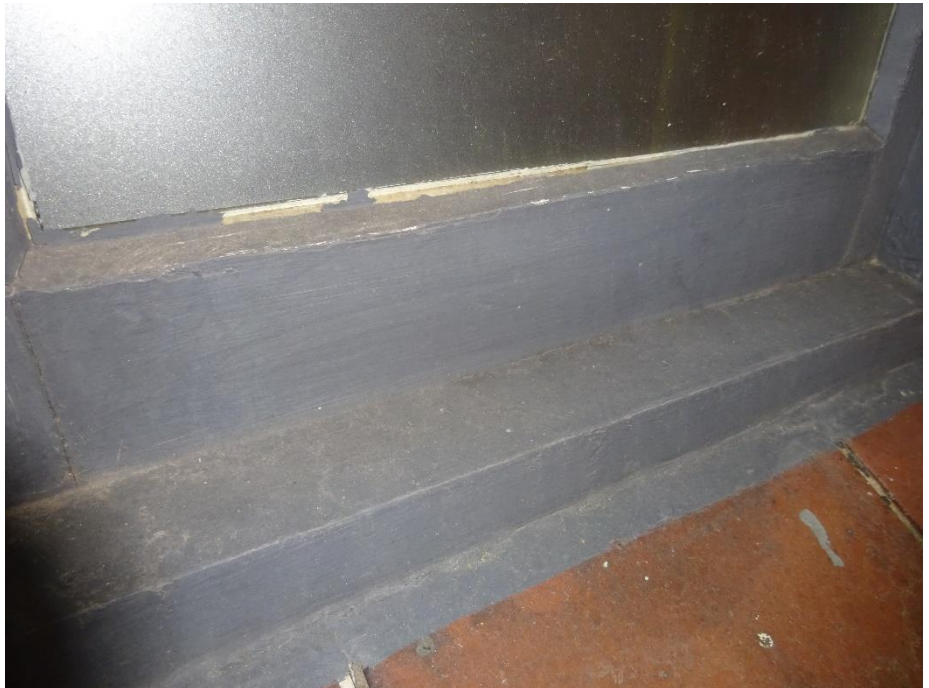
Photograph 22

View of peeling paint to ground floor window, North elevation.
