# W14-LG

**OSBORNES**CHARTEREDARCHITECTS  
The Balconies • Hanley Swan • Malvern • Worcestershire • WR8 0DN  
T: 01484 311303 E: architecture@osbornesarchitects.com F: 01484311255 W: osbornesarchitects.com  
CLIENT AMBASSADOR THEATRE GROUP  
PROJECT MANCHESTER OPERA HOUSE  
TITLE WINDOW REPAIR - W14-LG  
SCALE 1:5; NTS @ A1  
DATE MAR 2020  
DRAWN AML DRAWING NUMBER 19-143- WR14

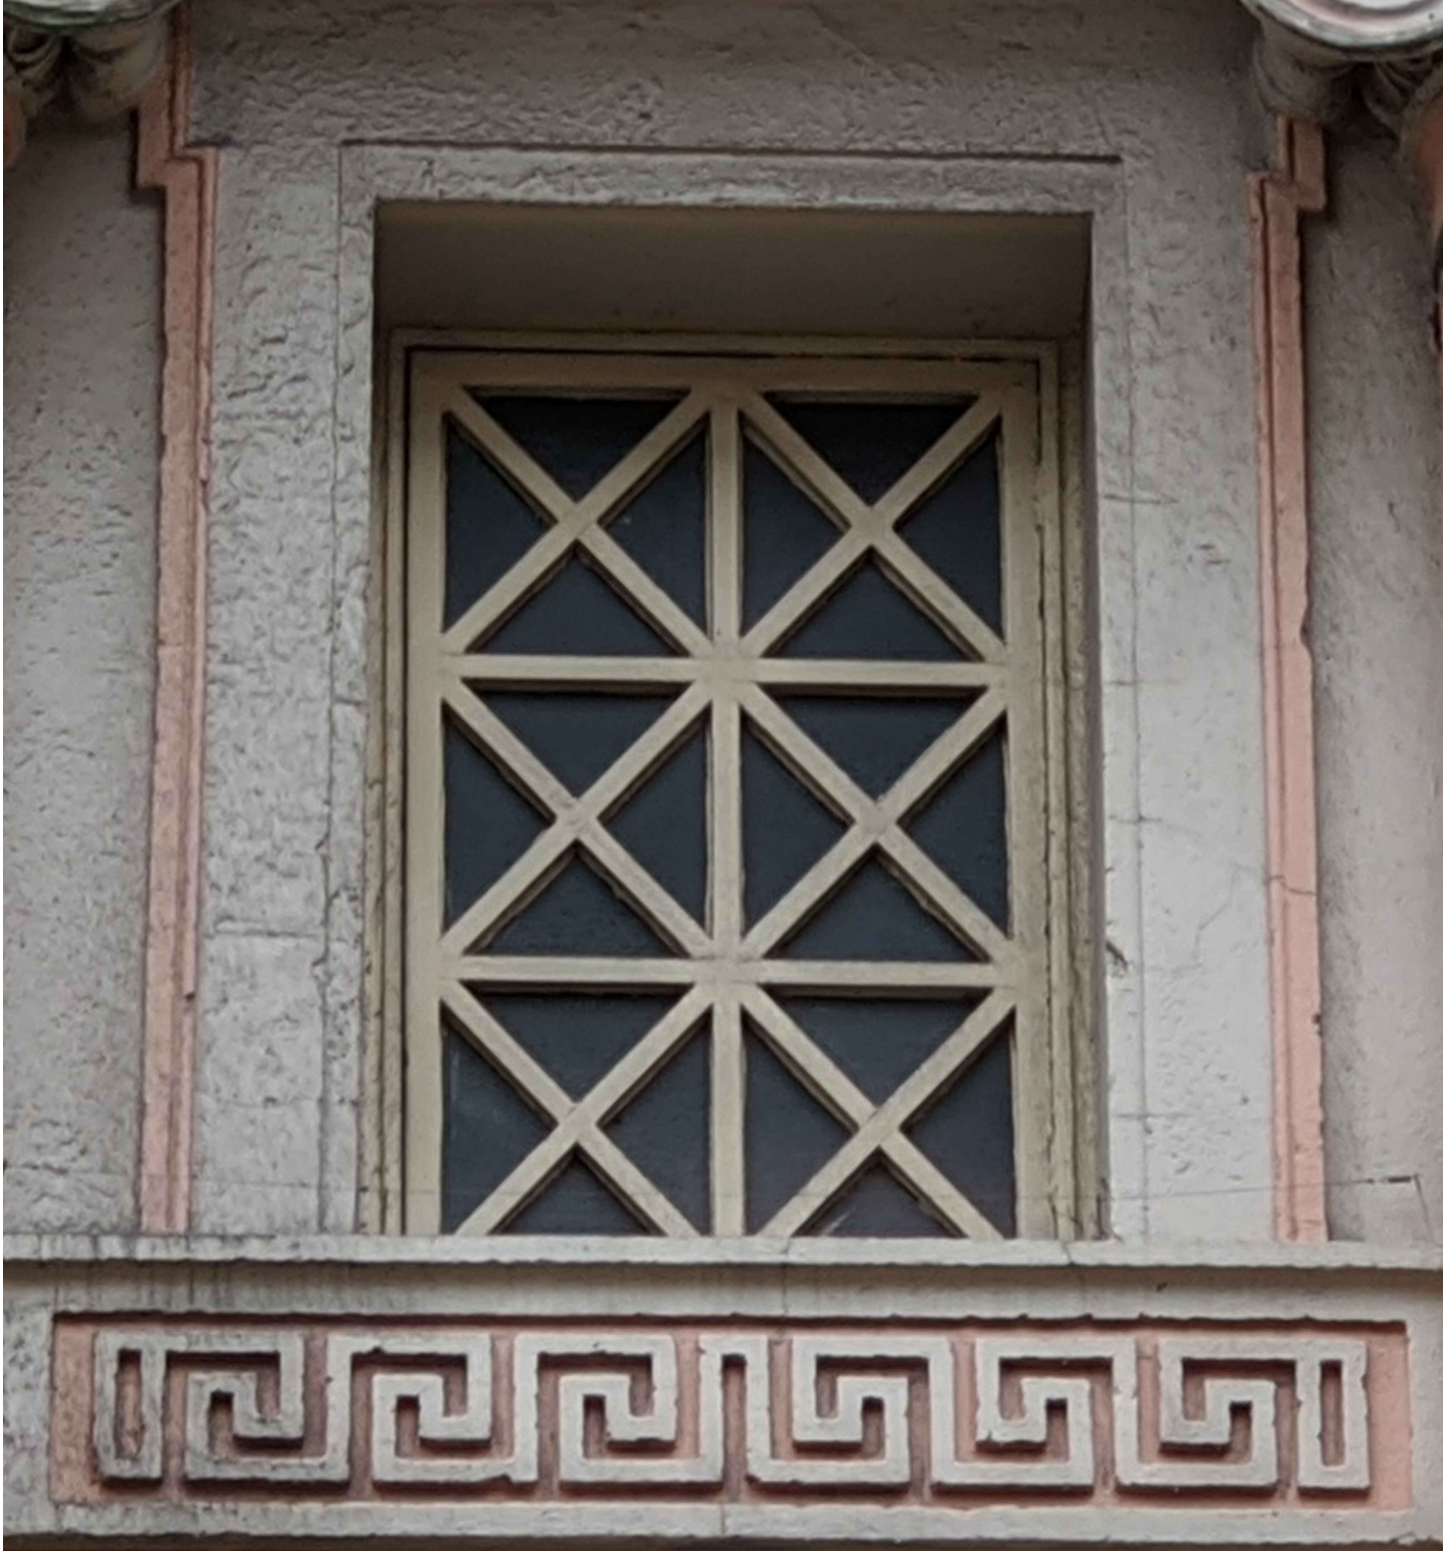
#### EXTERNAL ELEVATION

Once casement has been removed and the existing frame has been left in-situ, check frame and cill for and damage or rot. Record areas and inform CA.

Where external cills are to be replaced - replicate the profile of the existing cill in a durable hardwood such as oak incorporating a drip detail to the underside. Any new cill parts should be butt jointed below the casement frame. Finish using linseed oil based paint as described above in the colour to match the existing colour.
