**Report No. DJ210324A**  
**Asbestos Refurb/Demo Survey**

**1 Snell Street, Manchester M4 7EL**

**Date of survey:** 24/03/21

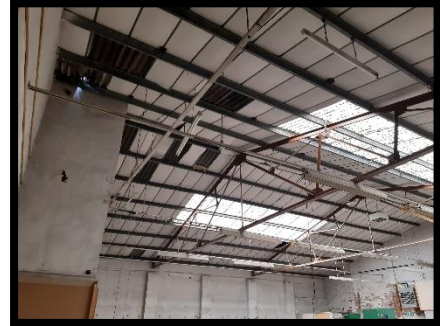
The **roof sheets** to the building are asbestos cement. Asbestos cement is a non-licensed low risk material. However, given the large area involved, we recommend using the services of a HSE-licensed contractor for removal of this item.

**Sample no:** 01  
**Room no:** 0/01  
**Location:** main roof  
**Item:** roof sheets  
**Accessibility:** at height  
**Sample Taken:** Yes  
**Lab Result:** chrysotile asbestos  
**Quantity:** 400sq.m  
**Surface Treatment:** cement  
**Areas of Damage:** none

**Comments:** Asbestos material. The roof sheets to the building are asbestos cement. Asbestos cement is a non-licensed low risk material that may usually be removed by a suitably trained general contractor wearing appropriate RPE/PPE and following HSE guidance work methods. However, given the large area involved, we recommend using the services of a HSE-licensed contractor for removal of this item. Once removed, dispose as hazardous waste. The roof sheets are boarded with plasterboard to the underside.

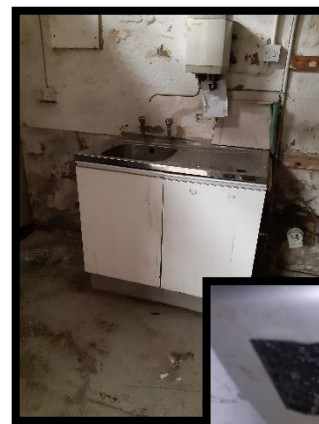
**Sample no:** 02  
**Room no:** 0/04  
**Location:** kitchen  
**Item:** sink pad  
**Accessibility:** easy  
**Sample Taken:** Yes  
**Lab Result:** non-asbestos  
**Quantity:** N/A  
**Surface Treatment:** N/A  
**Areas of Damage:** N/A

**Comments:** Non-asbestos material.

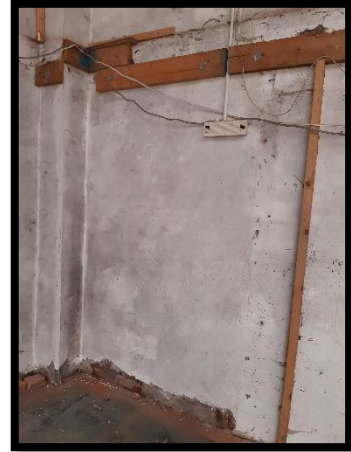
Sample no: 03  
Room no: 0/01  
Location: main warehouse  
Item: textured wall coating  
Accessibility: easy  
Sample Taken: Yes  
Lab Result: non-asbestos  
Quantity: N/A  
Surface Treatment: N/A  
Areas of Damage: N/A

Comments: Non-asbestos material.

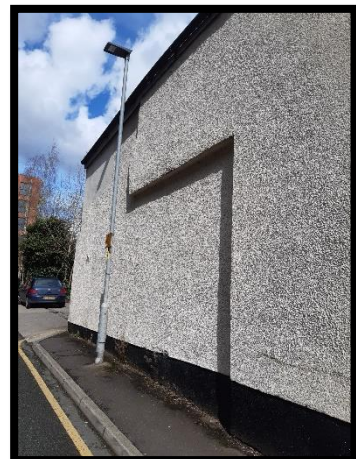
Sample no: 04  
Room no: external  
Location: external walls  
Item: wall coating  
Accessibility: easy  
Sample Taken: Yes  
Lab Result: non-asbestos  
Quantity: N/A  
Surface Treatment: N/A  
Areas of Damage: N/A

Comments: Non-asbestos material.
