**Project Name:** Caddick Construction Limited - Openshaw Campus - PJ372741  
**Project Number:** PJ372741  
**Project Date:** 11/06/2020  
**Inspection Standard:** MSCC4 Sewers & Drainage GB (SRM4 Scoring)

**Lanes**  
Group Plc

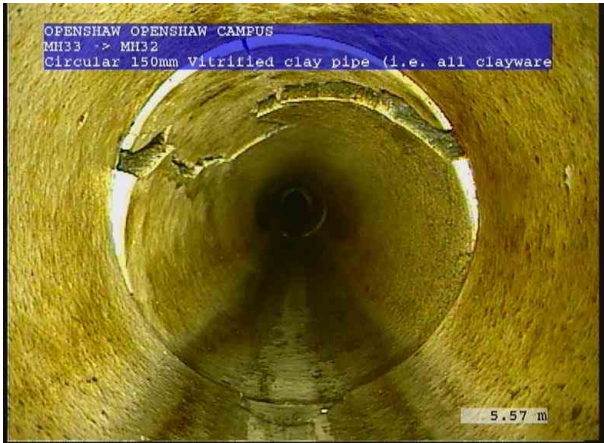
<table><tr><td>MH</td><td>Start node type, manhole, reference number: MH33</td><td></td></tr><tr><td>BJ</td><td>Broken pipe at joint from 10 o'clock to 2 o'clock ,</td><td>4</td></tr></table>

MH33X\_569ac2a5-a267-488a-b279-9629dcb790c9\_2020061  
1\_125731\_866.jpg, 00:00:53, 5.57 m  
Broken pipe at joint from 10 o'clock to 2 o'clock ,

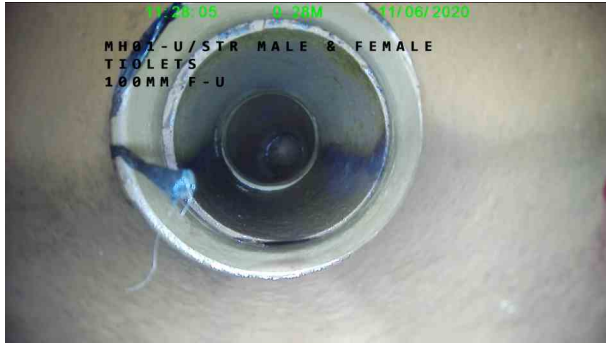
U\_STAIR  
WCX\_c975292b-a33a-4537-ad00-ec4c8870aa13\_20200611\_  
152938\_605.jpg, 00:00:16, 0.28 m

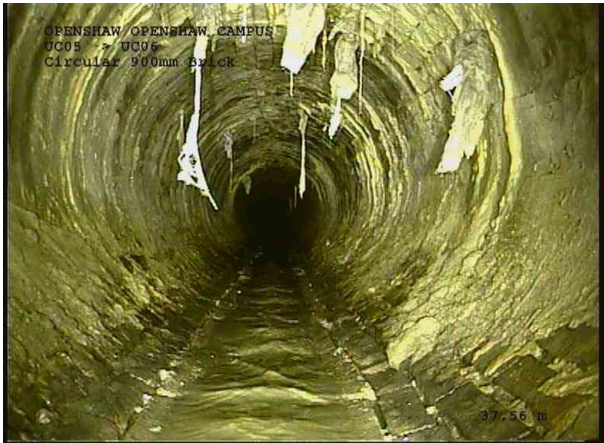
UC05X\_f57ceeea-3490-4ac7-894e-edc87a541434\_20200612\_115413\_741.jpg, 00:06:04, 37.55 m  
Infiltration, dripping from 12 o'clock to 1 o'clock

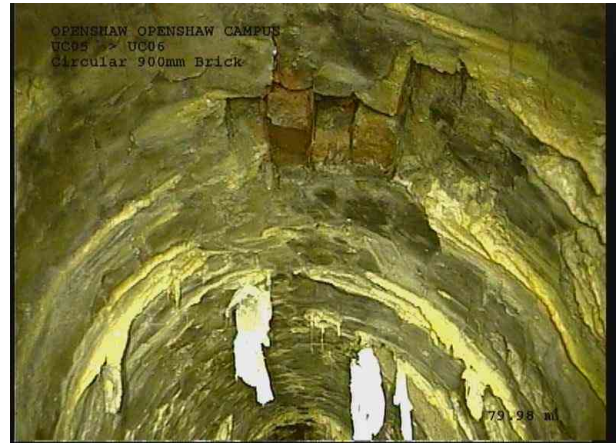
| | 79.98 | MB | Missing bricks at 12 o'clock | 4 |

UC05X\_4bbd8acb-7a18-400f-8141-a86006ade5ca\_20200612\_120429\_867.jpg, 00:13:50, 79.98 m  
Missing bricks at 12 o'clock

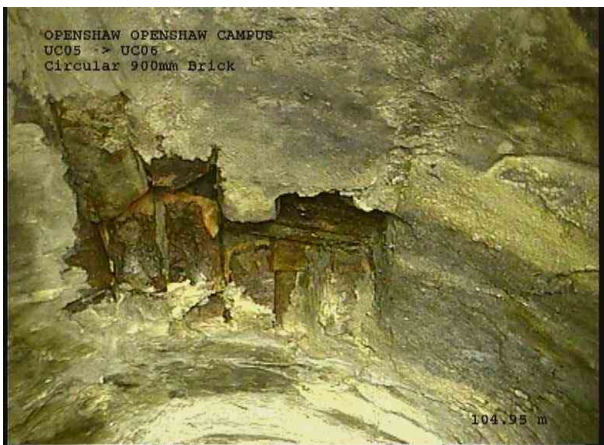
| | 104.95 | MB | Missing bricks from 1 o'clock to 2 o'clock | 4 |

UC05X\_3a7e4e4e-80cf-46fa-b935-b415f066d653\_20200612\_120931\_208.jpg, 00:18:36, 104.95 m  
Missing bricks from 1 o'clock to 2 o'clock
