## CCTV Drainage Survey

DYSE  
16 Saxton Street  
Manchester, M40 7BY

CCTV DRAINAGE SURVEY REPORT

**Project Name**  
16 SAXON STREET

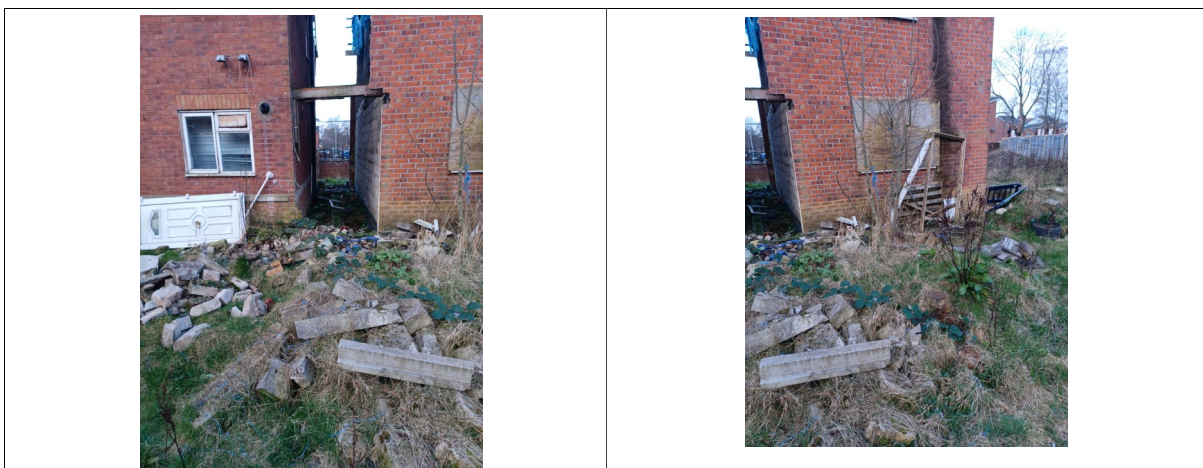
| Remarks: Buried under heavy debris |

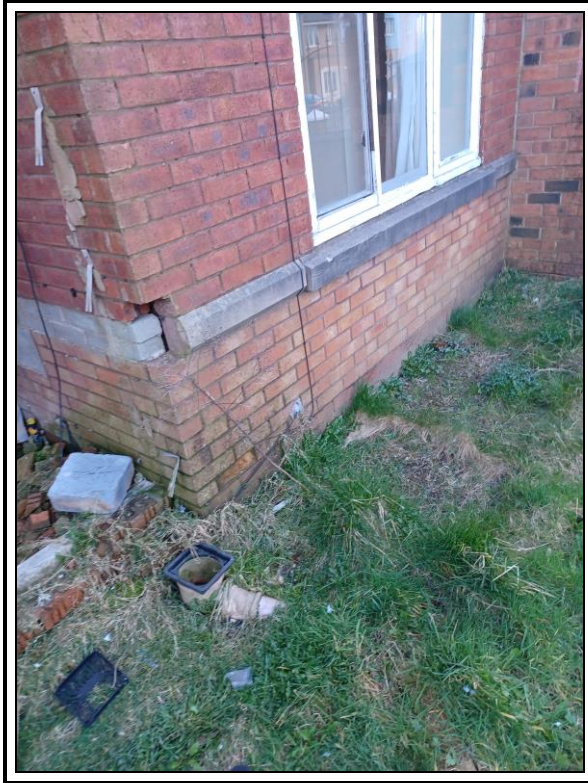
Photo 1, GY 1 LOCATION

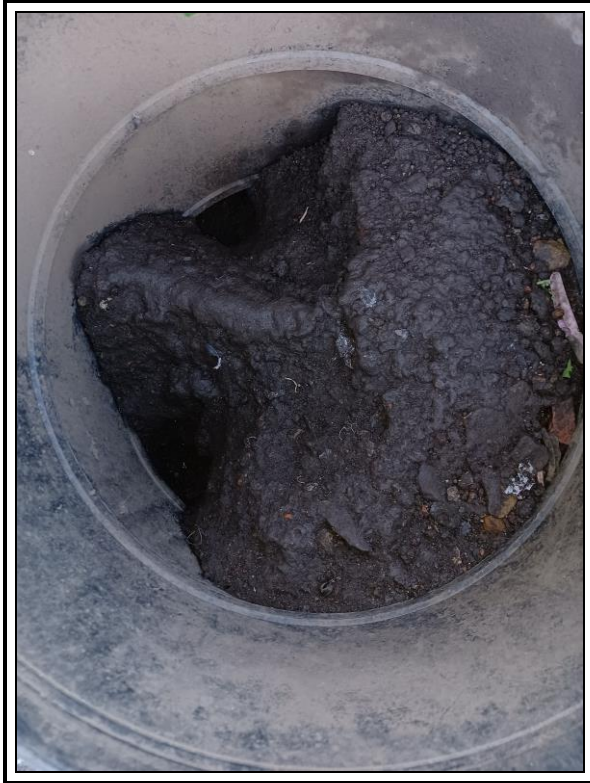
Photo 3, MH 1 SILTED AND AMOUNT REMOVED

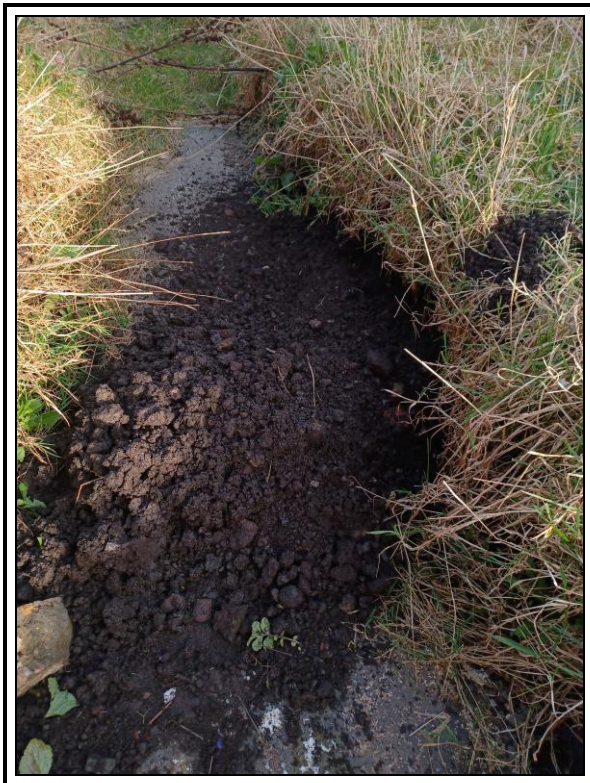
Photo 4, MH 1 SILTED AND AMOUNT REMOVED

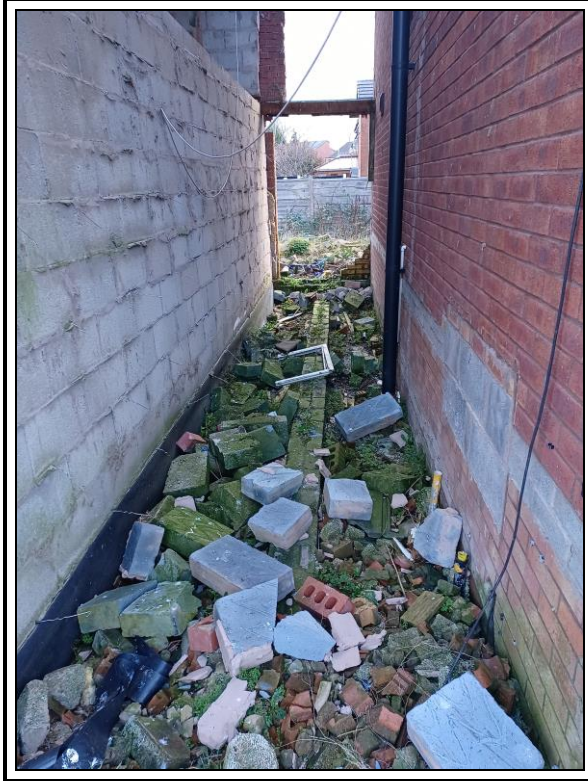
Photo 5, DEBRIS LEVELS ON SITE

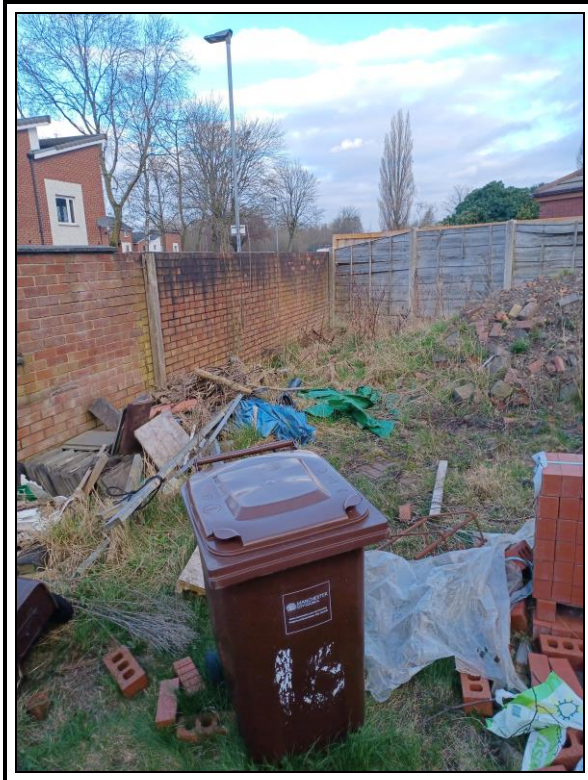
Photo 6, DEBRIS LEVELS ON SITE

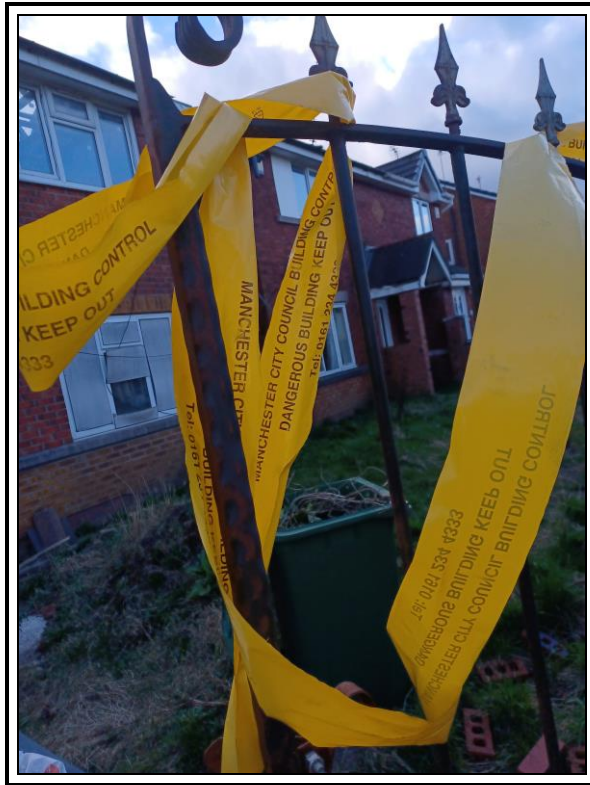
Photo 7, DEBRIS LEVELS ON SITE AND COUNCIL DANGER WARNING TAPE

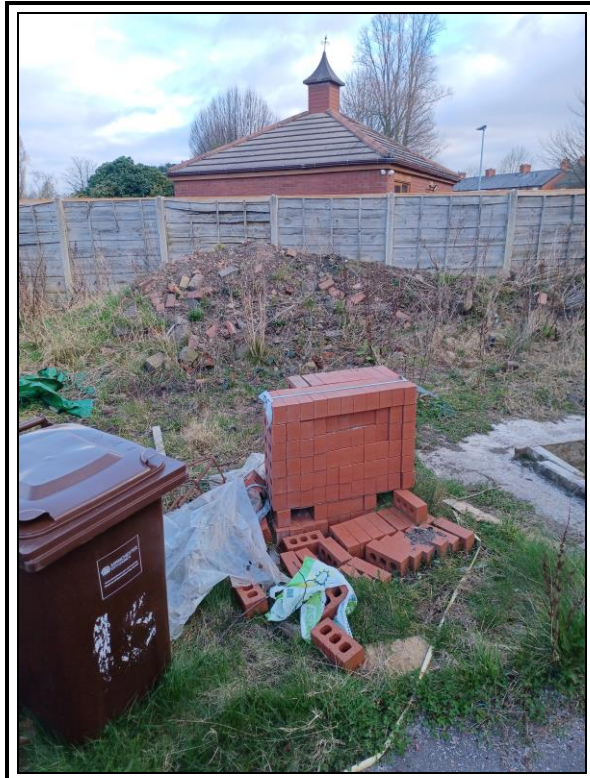
Photo 8, DEBRIS LEVELS ON SITE

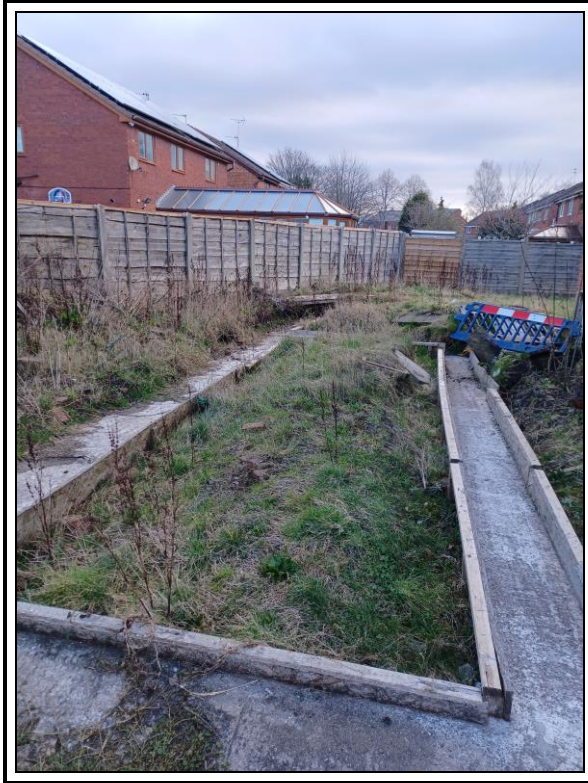
Photo 9, DEBRIS LEVELS ON SITE

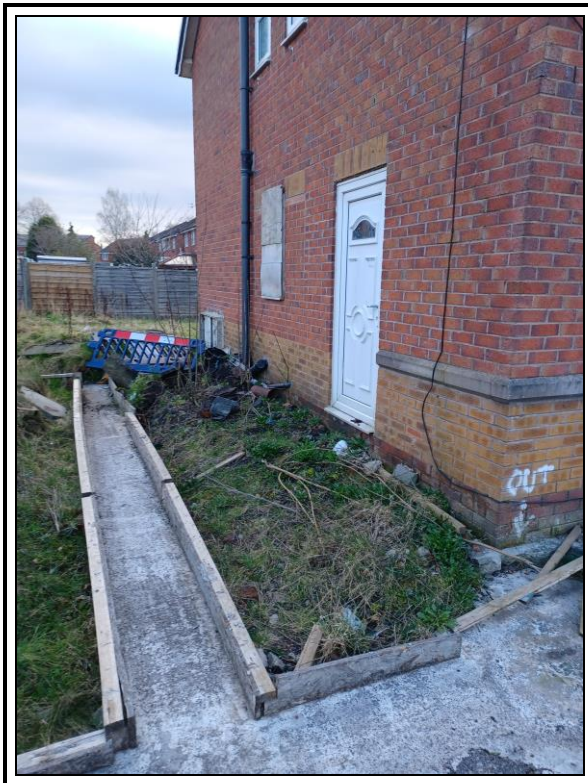
Photo 10, DEBRIS LEVELS ON SITE

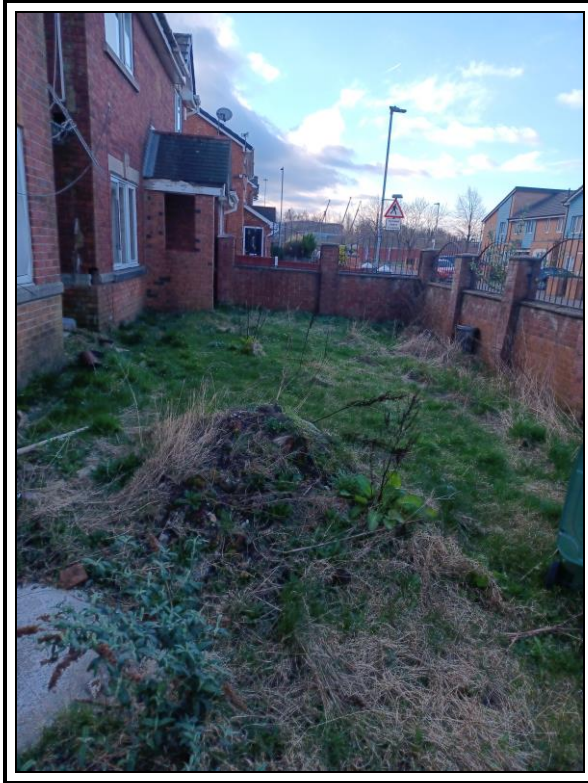
Photo 11, DEBRIS LEVELS ON SITE

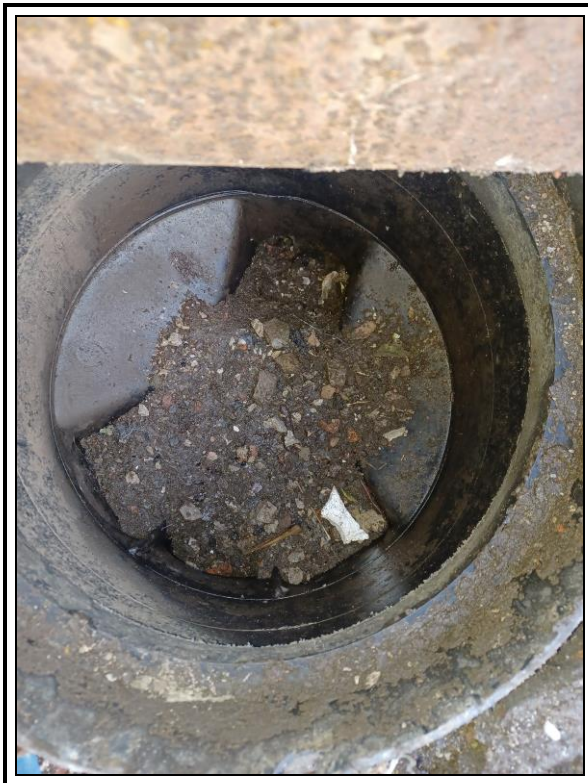
Photo 12, MH2 Silt before removal
