## Inspection report

| Place :<br>Road :<br>Location<br>Inspection | <b>BELLE VUE</b><br><b>BELLE VUE DOG TRACK</b><br><b>Road</b><br><b>MH1 (D/S) D/STREAM</b> | Location details:<br>Catchment:<br>Tape number :<br>Pipe Length | <br><br><br>0.30 m | U/S MH :<br>U/S Depth :<br>D/S MH :<br>D/S Depth : | <b>MH1</b><br><b>3.57</b><br><b>D/STREAM</b><br><b>0</b> |

Place :  
**BELLE VUE**

Road :  
**BELLE VUE DOG TRACK**

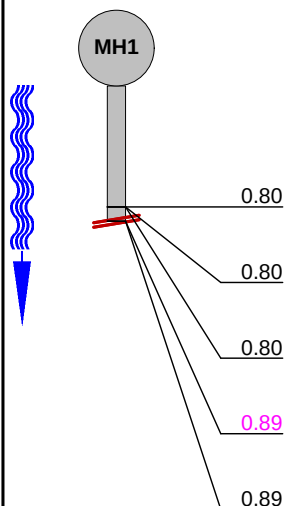
| DEX | Settled deposits, other, 30% cross-sectional area<br>loss Remarks: BRICK | 4 |
| SA | Survey abandoned DEBRIS BRICK Remarks:<br>DEX BRICK | 0 |

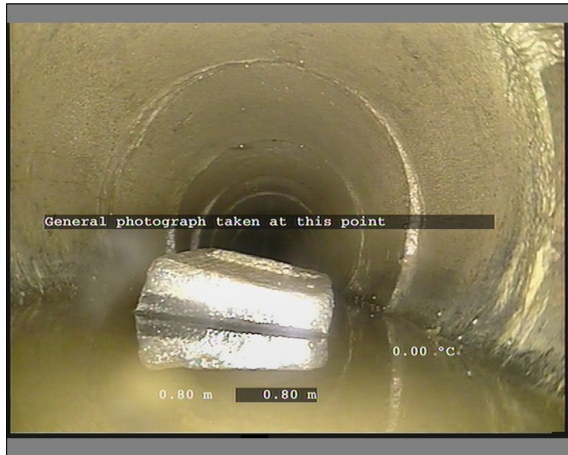
Photo: 3\_3\_11\_A.JPG  
0.8m, General photograph taken at this point
