Project name :  
**BELLE VUE TRACK**

## Inspection report

| Place :<br>Road :<br>Location<br>Inspection | <b>BELLE VUE<br/>BELLE VUE DOG TRACK<br/>Road<br/>MH1 (U/S) UP/ST</b> | Location details:<br>Catchment:<br>Tape number :<br>Pipe Length | U/S MH :<br>U/S Depth :<br>D/S MH :<br>D/S Depth : | <b>UP/ST<br/>0<br/>MH1<br/>3.57</b> |

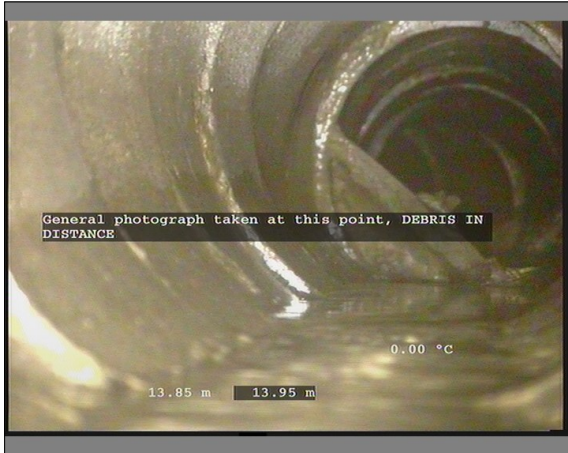
Photo: 1\_1\_6\_A.JPG

13.85m, General photograph taken at this point Remarks:  
DEBRIS IN DISTANCE
