**PROJECT NO. AMP-44787/1****MCC M&E CONDITION SURVEY****PROJECT Name: Building Fabric Repairs**

Document No: AMP-44787/1-ME

Mechanical Works Survey in relation to External Fabric cladding repairs

January 2021

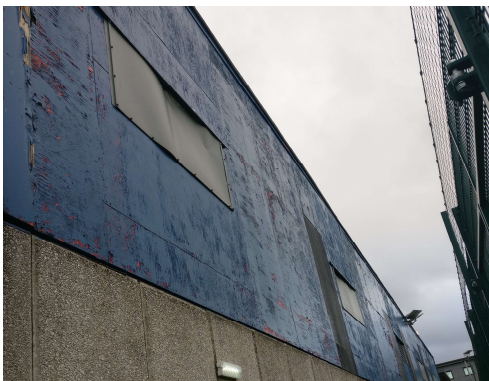
The ventilation within the sports hall has not been maintained. The mechanically operated louvres are assumed to be non-functioning and their winding mechanisms are inaccessible and most of them are broken. Externally three of these louvres on the side facing the astro turf pitches have been covered with what is assumed powder coated steel sheets, from historical images this seems to be the case for at least the last decade. Although the original reason for covering these louvres is unknown it is assumed that they became damaged and non functioning, then instead of a costly repair they were covered.

External covered louvre showing evidence of ongoing physical damage

The louvres should have work undertaken on them to bring them back into use. It is suggested that this includes a full clean, fixing of any broken mechanisms, removal of external cladding where it exits, and a replacement actuation system with mechanical controls at an accessible level (such as 2m to keep them out of). These control points should be protected from accidental damage using a stiff wire cage or similar (as used on other fixtures in the hall). The handle actuator should be removable to allow trained staff use only to minimise damage to the mechanism or over opening and closing of the louvres. Additionally, a study mesh cage should be affixed internally around and over the louvres to protect them from accidental physical damage and externally weatherproof mesh.

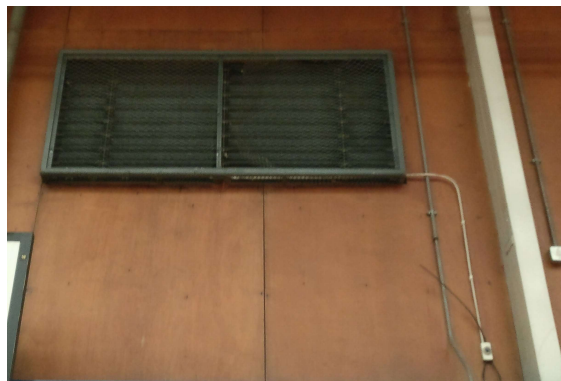
Internally the mechanical actuators for these louvres are inaccessible. The handles to operate them are mounted at a height approximately 3m above the floor. Furthermore 7 out of the 9 handles are visibly missing or damaged. It is assumed that these actuators are only mechanically operated by these handles, however it is possible that they are motorised through CO2 and/or temperature sensors.

Internal louvre showing evidence of physical damage and missing actuator handle

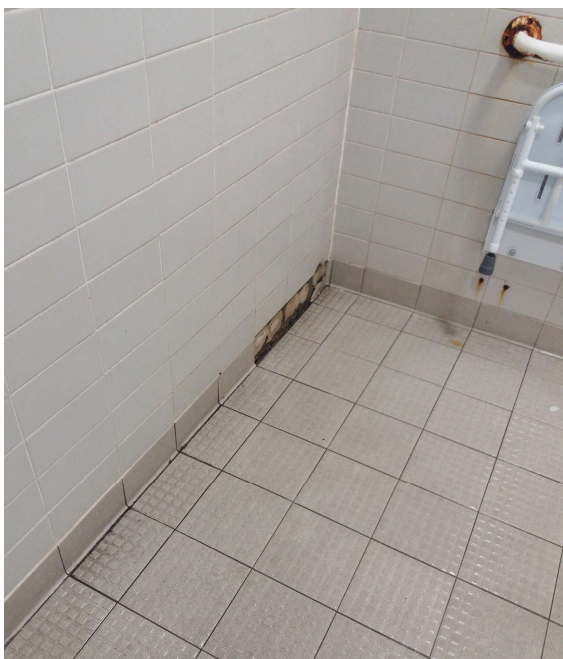
As noted in other reports a significant portion of the centre would benefit from refurbishment. This includes areas causing maintenance issues such as in public changing rooms and shower areas. In these areas there are reports of mould and damage have been made. It is expected that mould growth is due to insufficient ventilation/surface damage rather than water ingress from outside.

Evidence of internal damage and rusting within changing rooms (image from Nov 2019)

Areas which are damaged, such as missing tiles and degraded sealant should be rectified. The mould growth is expected to be due to insufficient ventilation rather than water ingress from outside or an internal leak. Therefore, in the first instance the mechanical ventilation system should be cleaned and maintained to ensure it is working as designed. Any natural ventilation grilles should also be cleaned of a build-up of detritus.

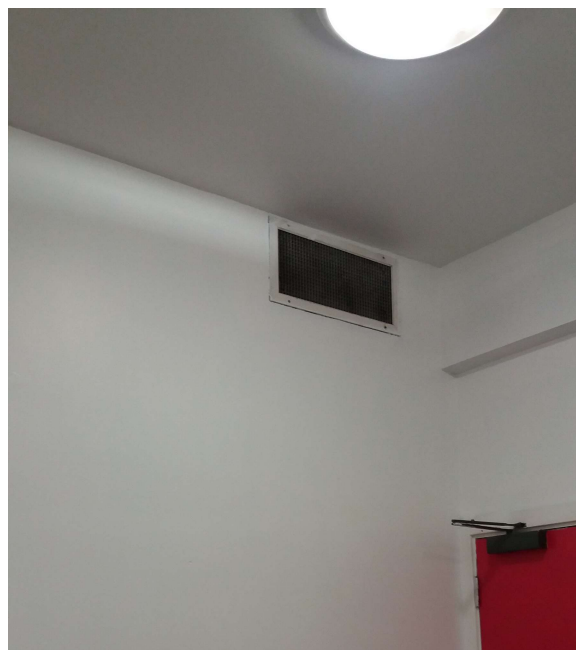
Mechanical Ventilation Grille serving a changing room (image from Nov 2019)

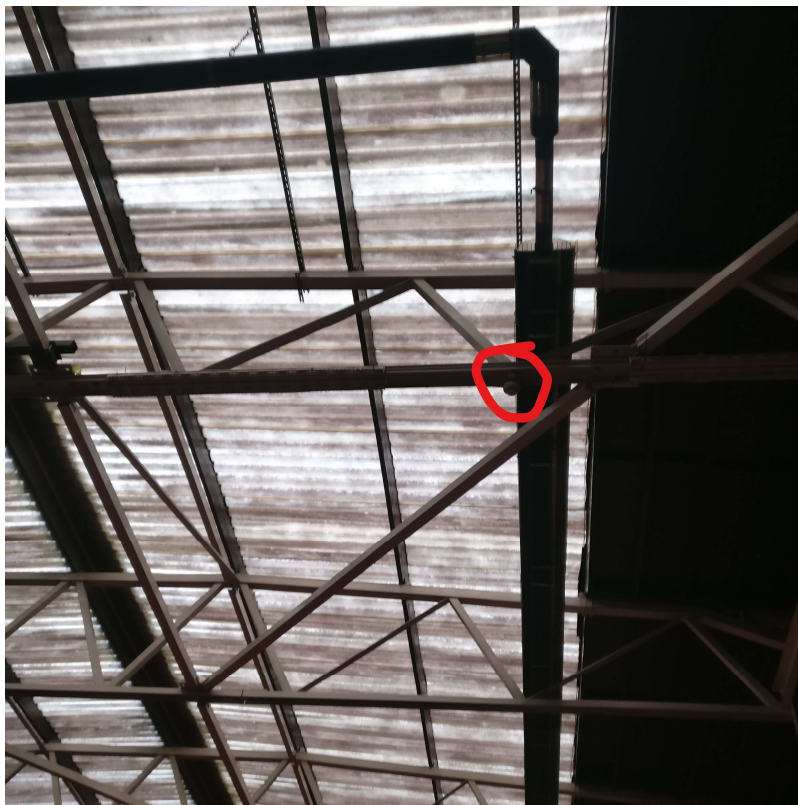
It appears that the smoke detectors within the sports hall are too low for current regulation compliance. Although not my primary area of expertise it would appear from looking from floor level that the position of the detectors is outside that of 600mm from the pitch as stated in BS 5839-1 (2017).

An example of the smoke detector on a lower cross beam seemingly more than 600mm from the apex
