**Report No:** LTM0240.ADDR.01

**Project:** 32 Hampton Road  
Chorlton-Cum-Hardy  
M21 9LA

# Advanced Decay Detection Report

- VALID - Validator
  - Professional Member of the Consulting Arborist Society
  - Professional member of the Arboricultural Association
- 1.0.3 I was instructed by Mr Marcus Redmond with reference to the potential decay within the tree at the front of the property at 12 Wellington Road in Timperley.  
Tree Number: T1  
Species: Hybrid Black Poplar (Populus Nigra)

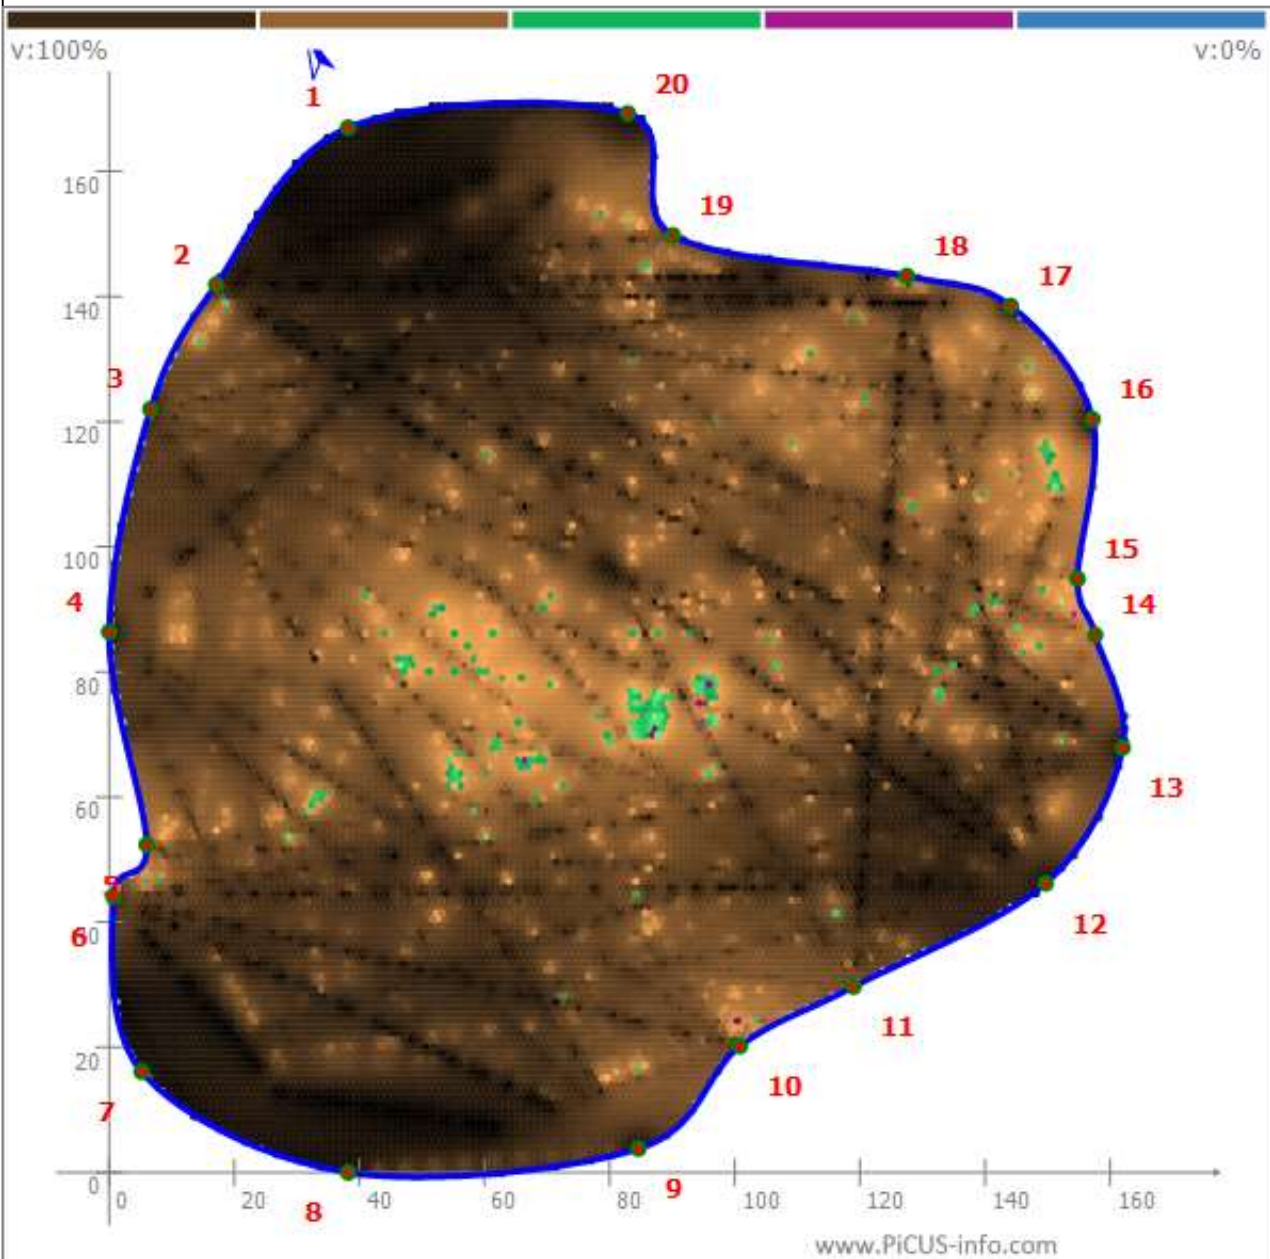
## Picus: Manchester Chorlton Cum Hardy

- 5.0.1 The results of the Picus test clearly show that there is not extensive decay levels within the main stem at 20cm. There is, however, evidence of early degradation of the wood but this is of little concern at this time. A cavity is present at 3m on the main stem which will require further investigation.
- 5.0.2 The PiCUS Image can be found below:

Some areas within the centre of the tree are undergoing minor changes but this is of little concern at this time. A cavity is present at approximately 3m. Further inspection of this cavity is required.

- 6.0.1 It is recommended that the epicormic growths are removed from the main stem from ground level up to a height of 4m to enable access to investigate the extent of the cavity at 3m within a 6 month time frame.
- 6.0.2 Inspect cavity at 3m and perform a PiCUS test to ascertain level of decay in the area within 6 months.

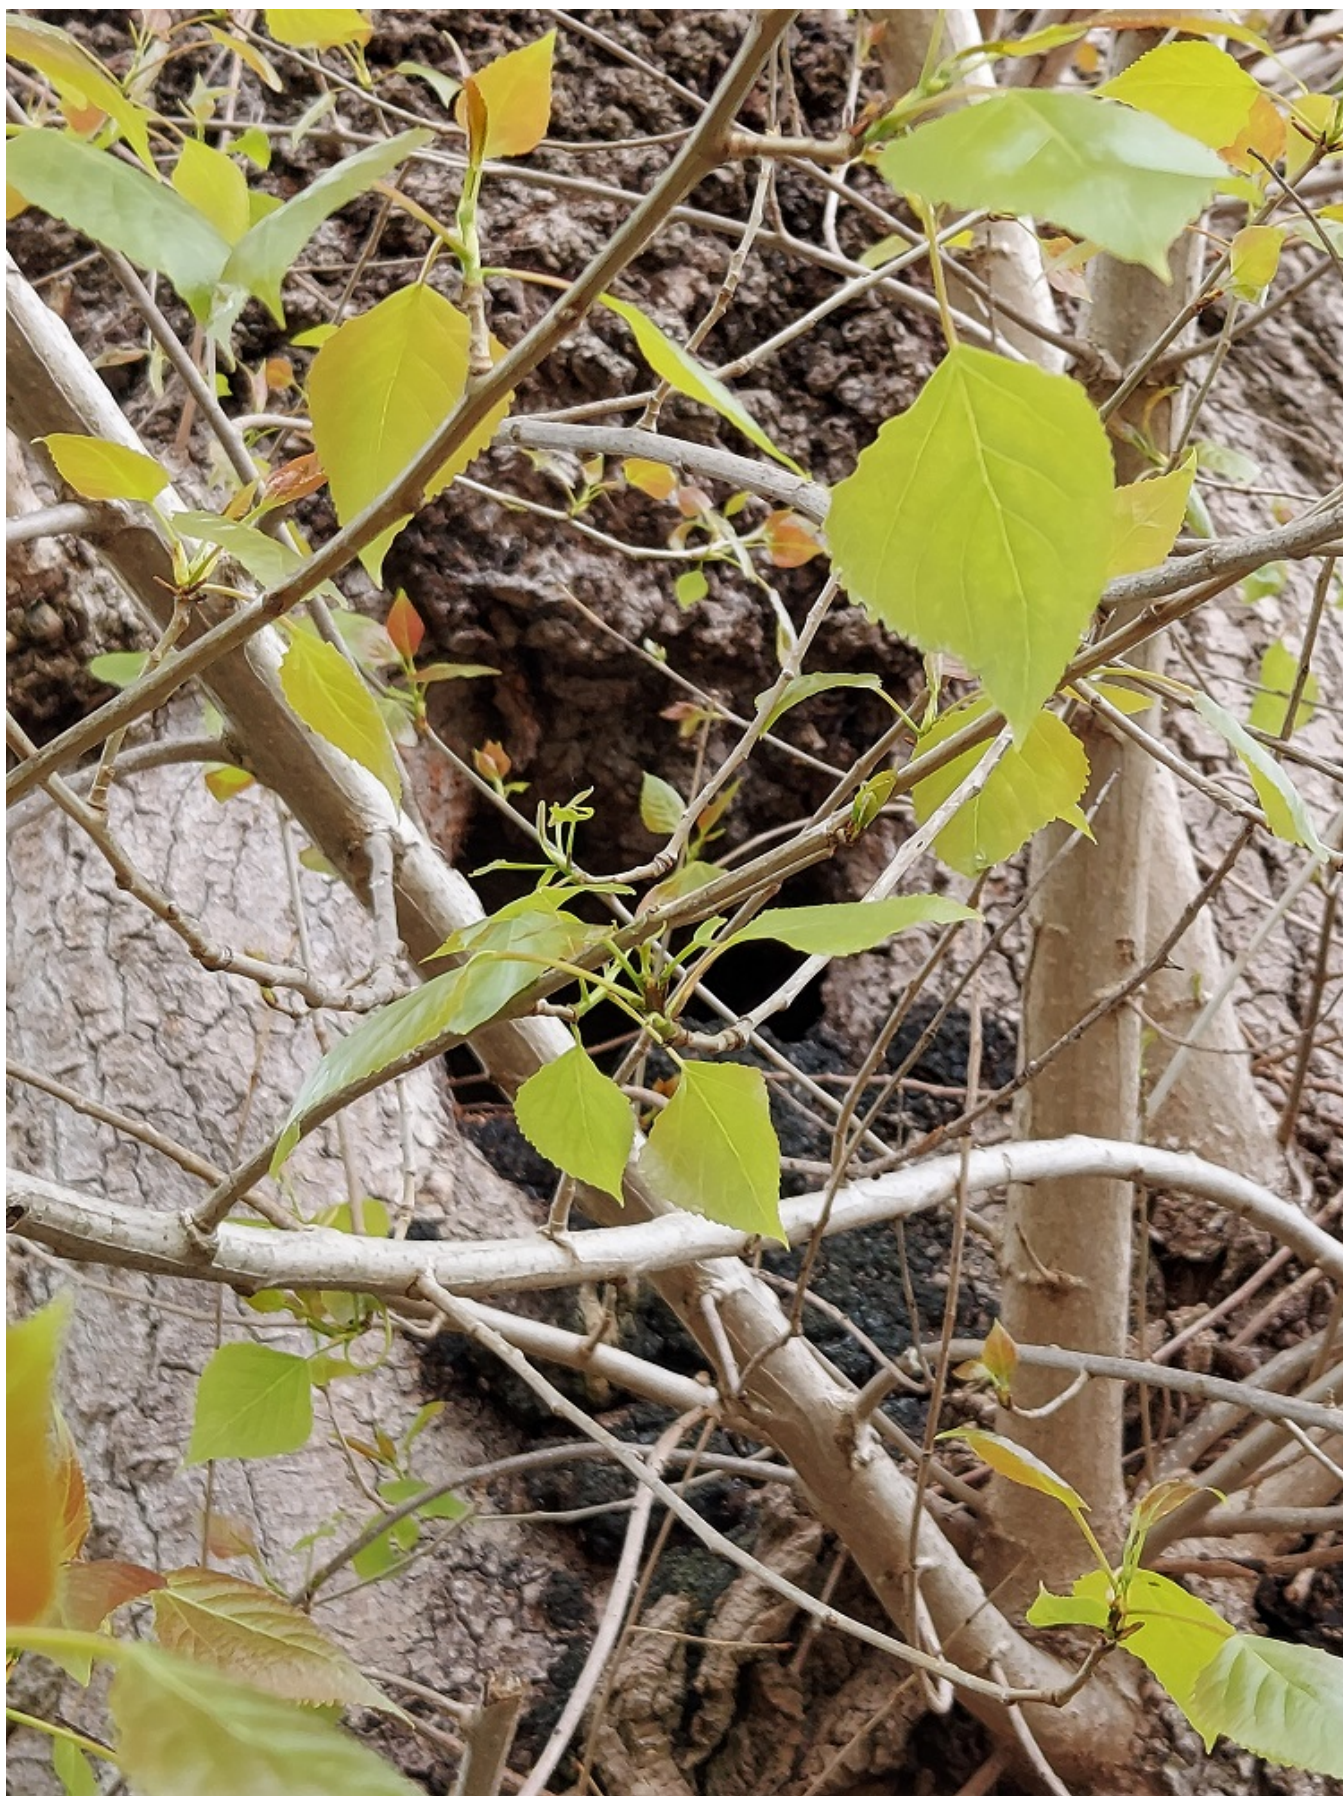
Figure 1. Cavity present at 3m

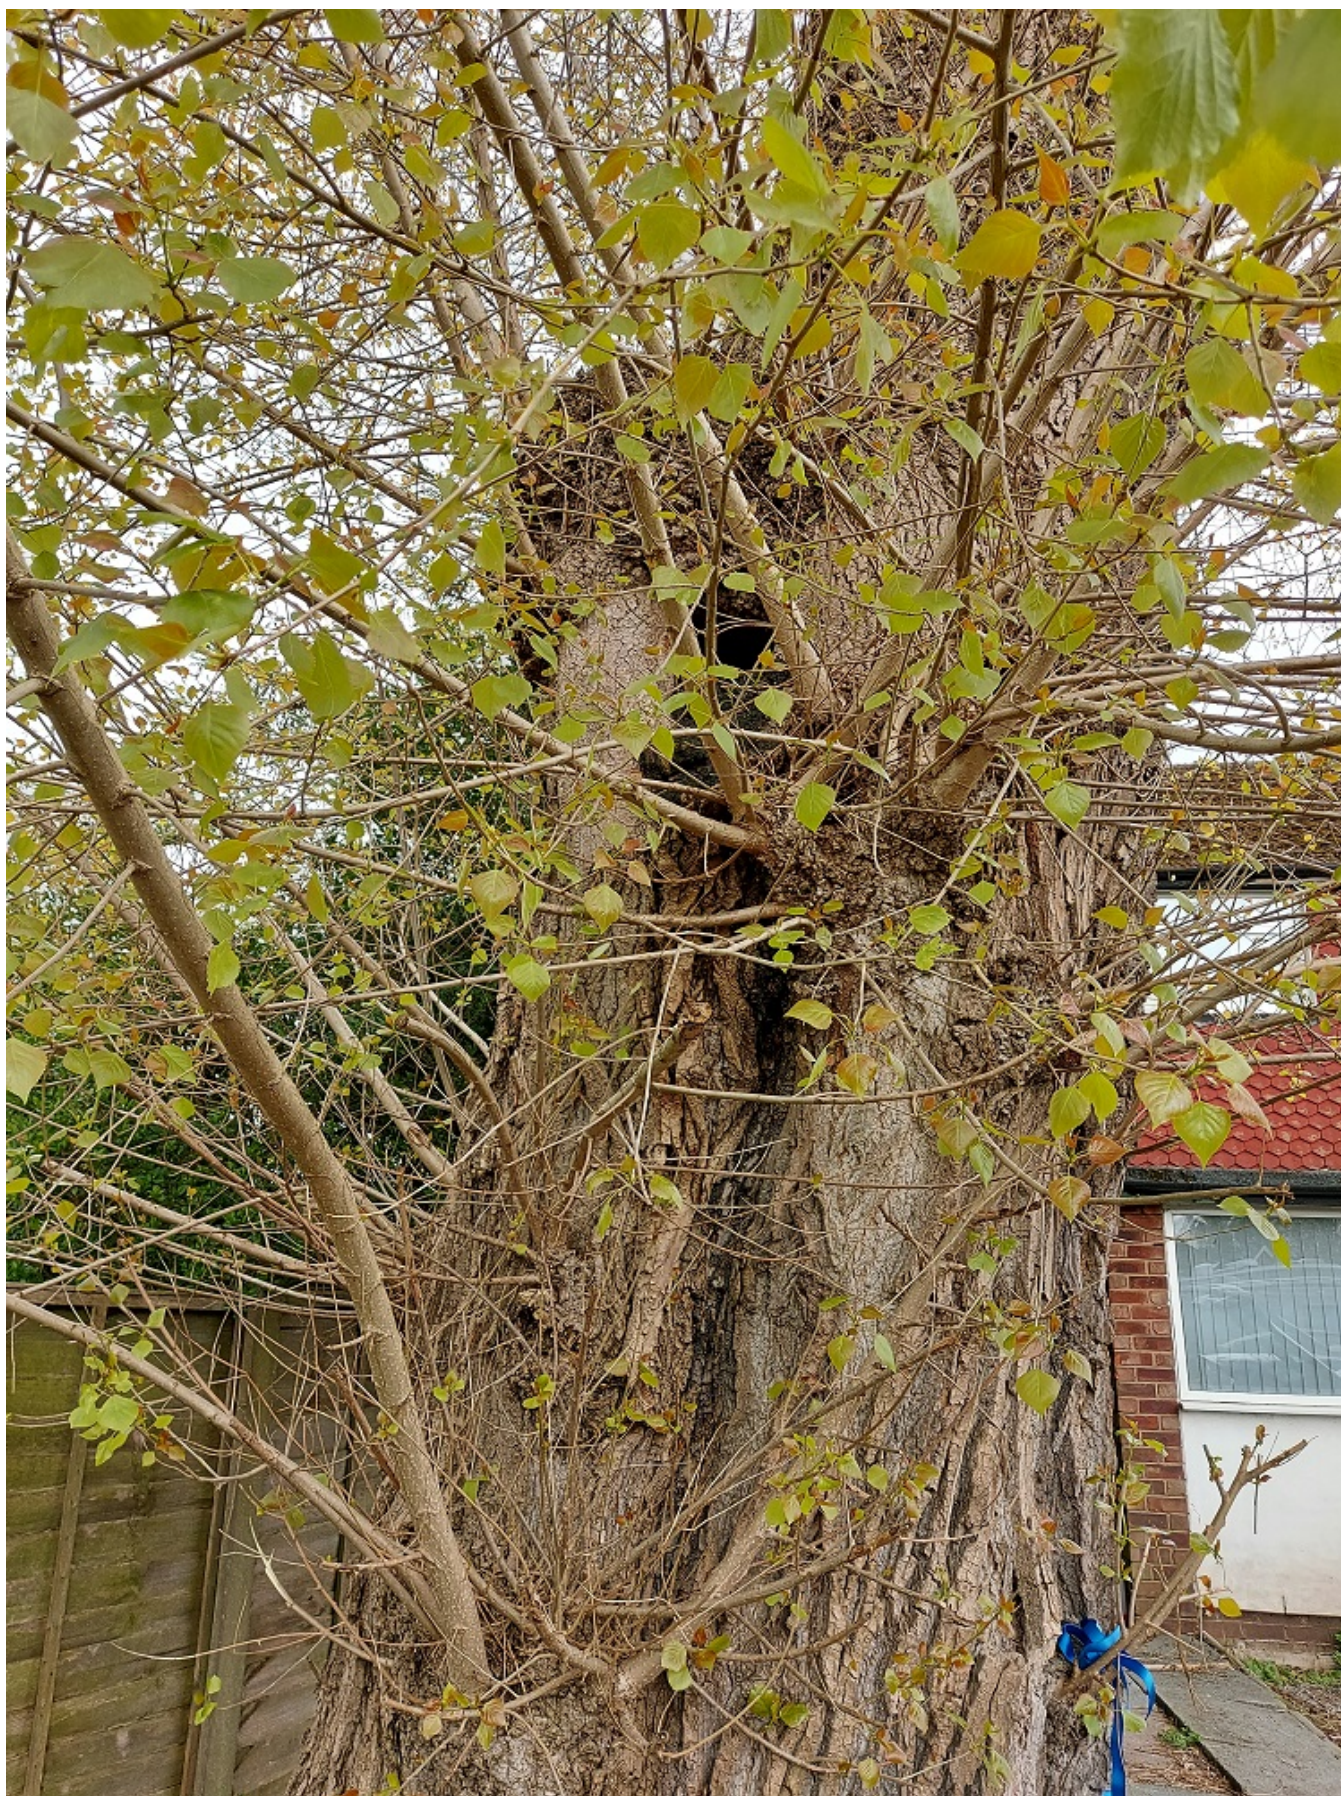
*Figure 2. Epicormic growth on main stem preventing a detailed inspection of the cavity.*

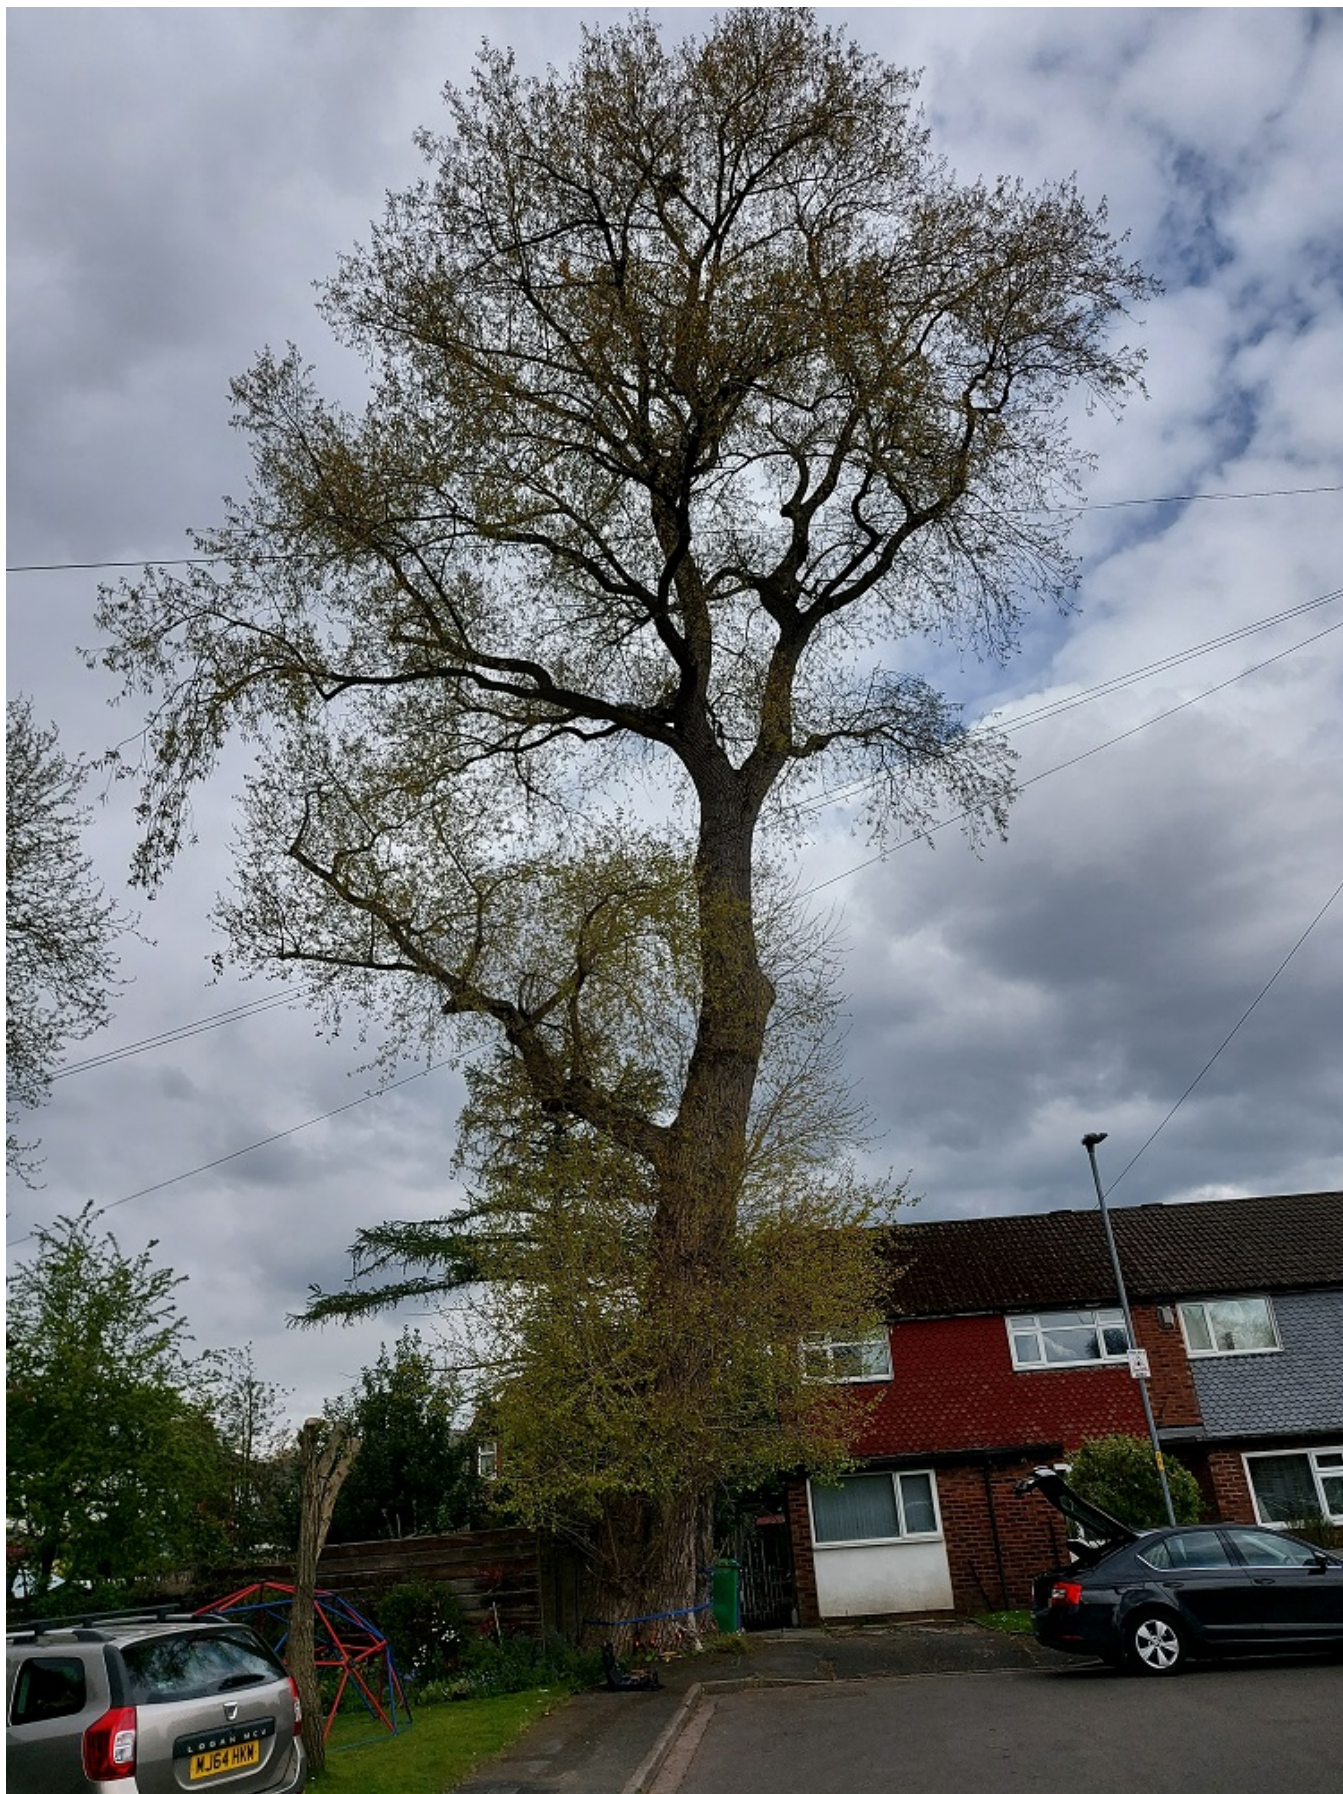
*Figure 3. Tree is located at front of property.*
