## CIS Tower Refurbishment.

Recording Strategy and Photographic Audit of internal & external features.

# APPENDIX 5 – LEVEL 00 INTERNAL.

Planning Permission ref: 126118/FO/2020. Condition 29.

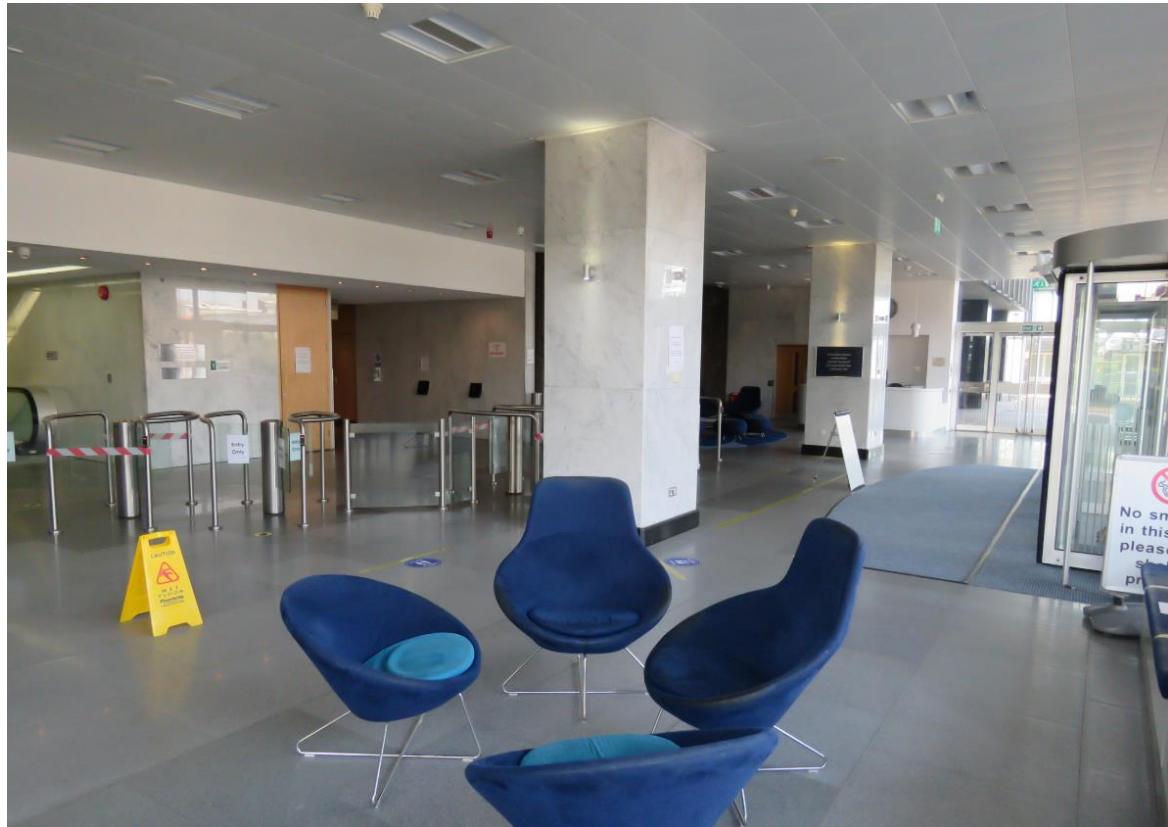
**00-04** Looking south-west across the reception hall showing the inserted ceiling and column cladding.

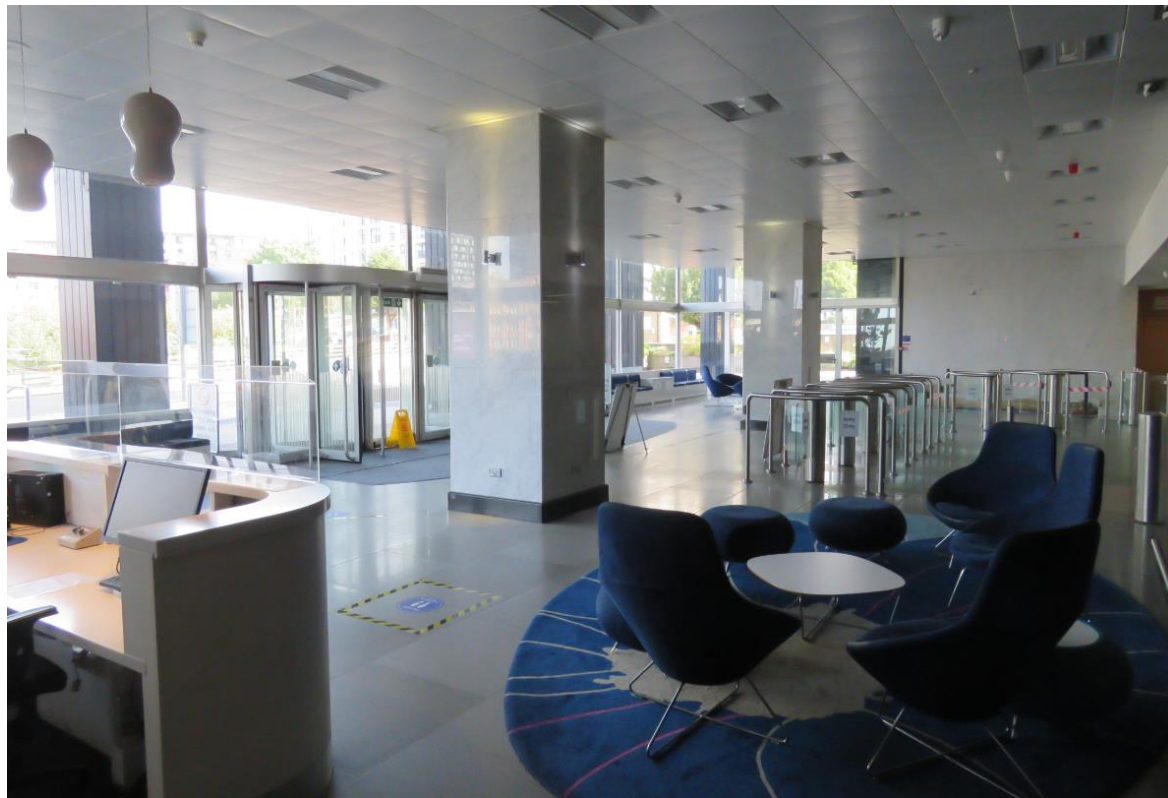
**00-05** Looking north-east from the entrance to the post room showing the replacement ceiling.

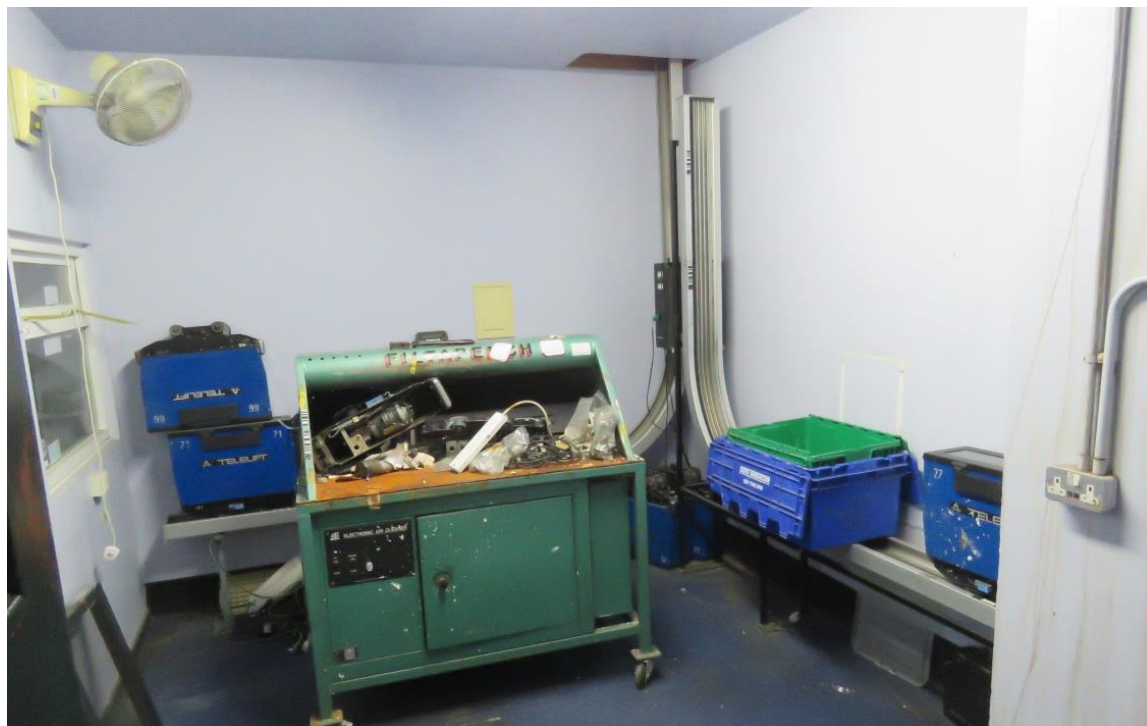
**00-15** Detail of the decommissioned Telelift system.
