## 3.4 Mosaics | Refurbishment Vs Replacement

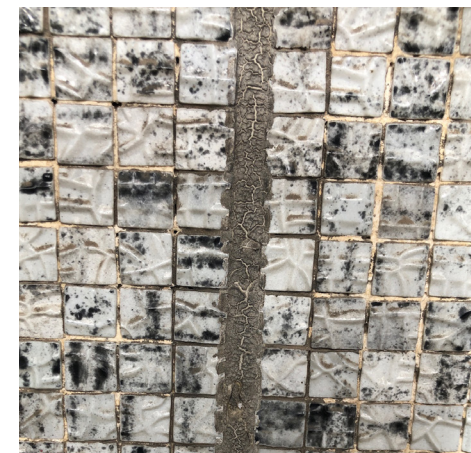
Original grey coloured movement joint between precast panels.

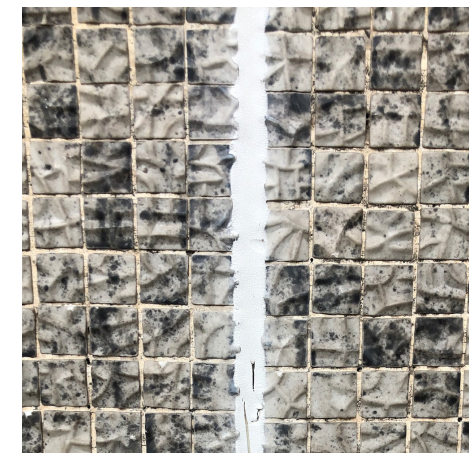
Non-original white coloured movement joint.

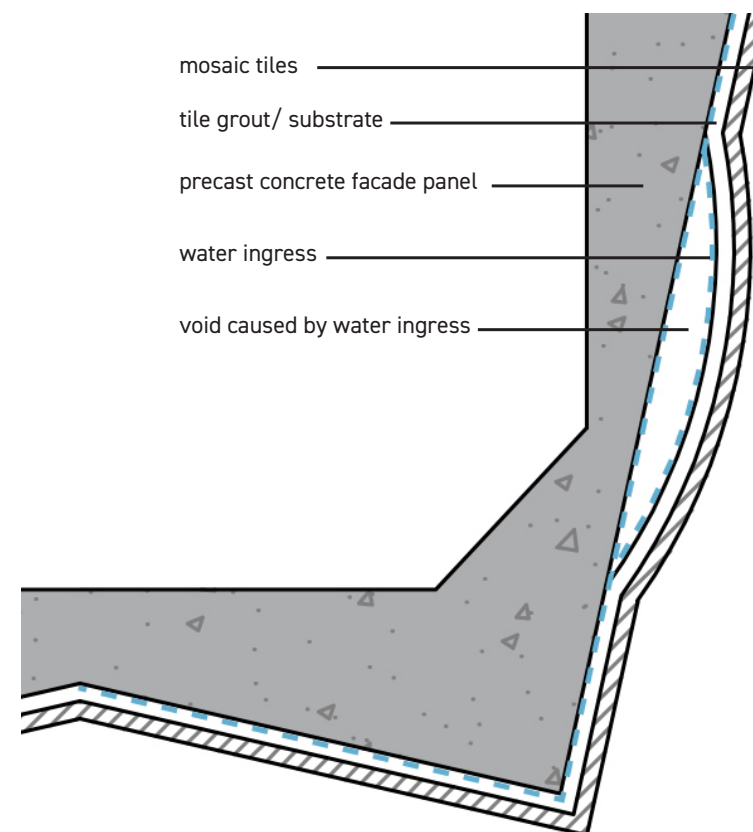
Diagram: indicative plan detail showing the cause of delamination.

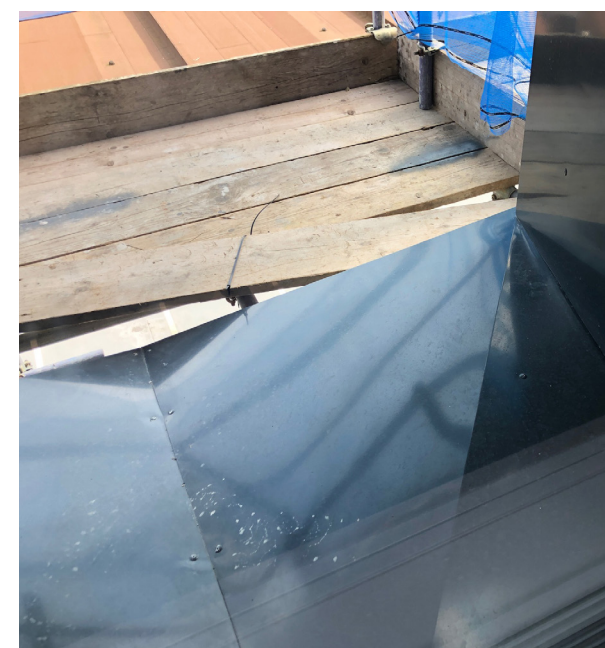
Overcladding in sheet metal (test) on site to 1 window: not a long term solution or cost effective sepcification / installaion method for the entire building

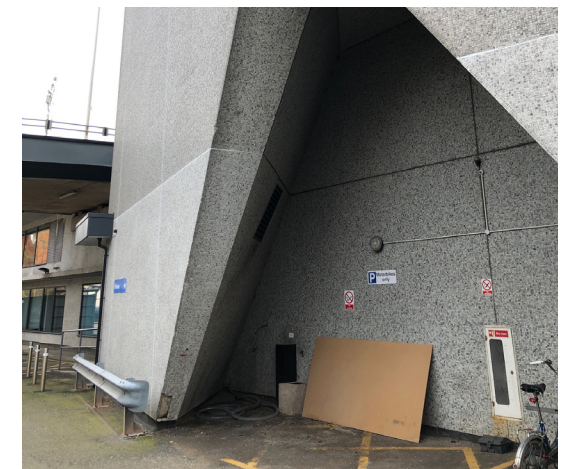
Replacement tiles and white movement joints disrupt the facade uniformity.

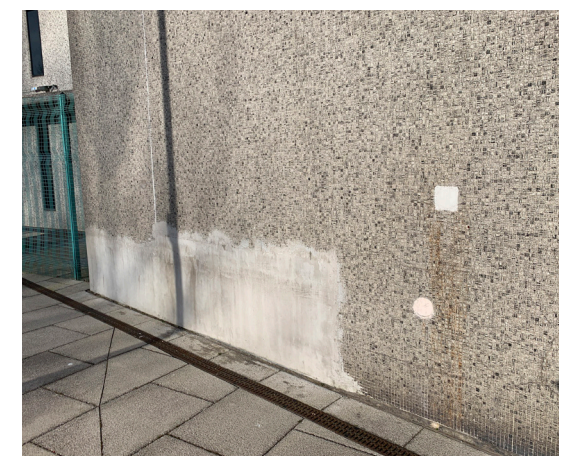
Replacement cladding panels to area of delamination

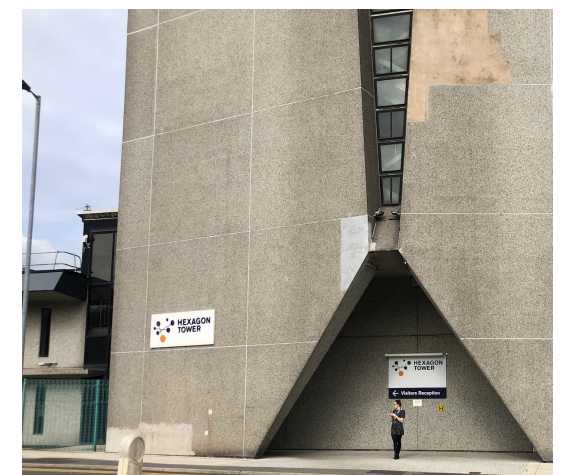
'Bookend' elevation where new tiles and white joints are apparent.
