# DAYTIME BAT SURVEY OF 65 PRINCESS STREET, MANCHESTER

MARCH 2020

**RACHEL HACKING ECOLOGY**

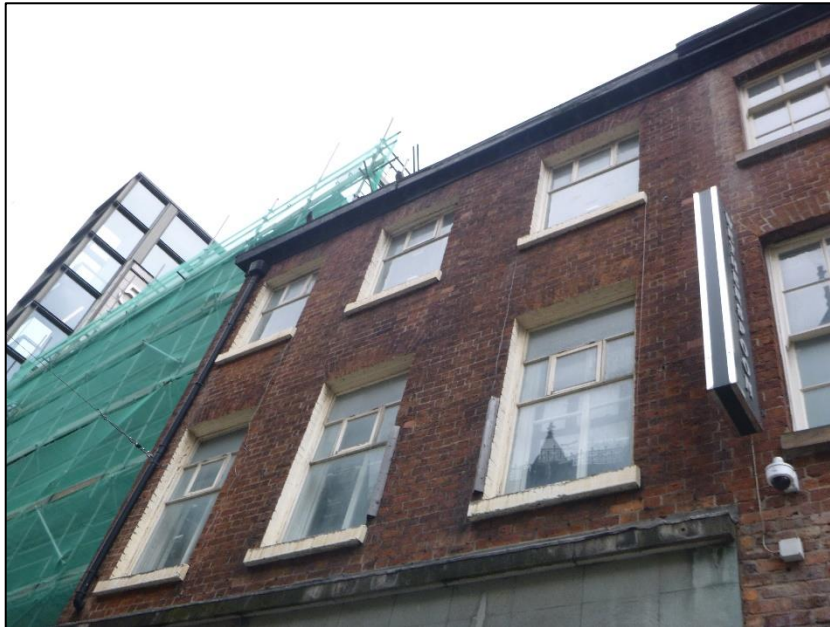
- 3.1 The property is constructed from brick and has a pitched, tiled roof. The external brickwork is complete and intact on the front elevation, with no significantly damaged bricks or recessed mortar. The wooden window frames are flush to the surrounding masonry (see Photograph 1). The brick lintels are complete and intact. The ground floor has a large shop window, which is sealed to the brickwork.

**Photograph 1 showing the front elevation of the property**

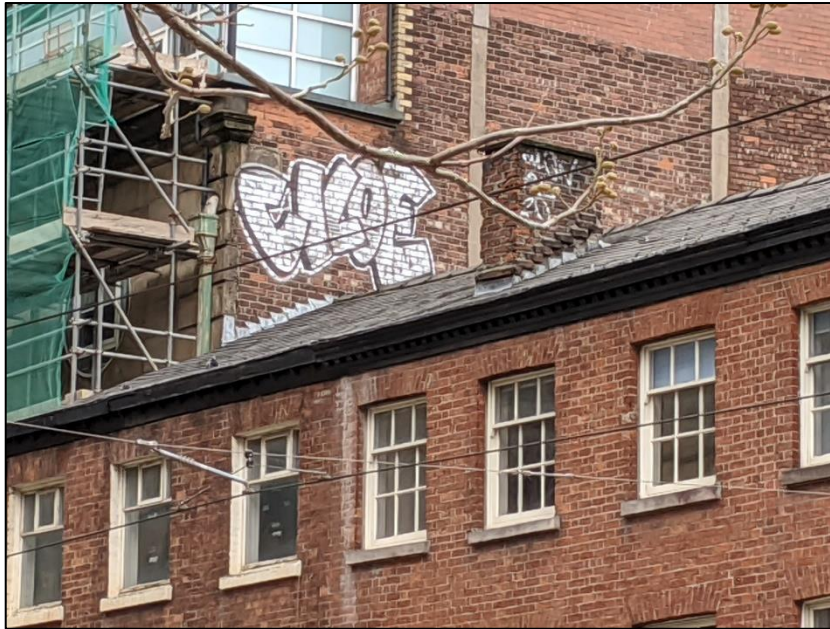
- 3.2 The roof is pitched and tiled with slate tiles (see Photograph 2). The roof tiles are all in position and flush to one another, with no slipped or broken tiles. The ridge tiles are complete and intact. The brick chimney stacks are complete, with no damaged bricks present. Lead flashing occurs at the base of the chimney stack and where the roof meets the brick walls of the adjacent building. The lead flashing is flat and does not provide a suitable bat roosting cavity. The property has wooden bargeboards present at the roof edges, and these are flush to the upper brick courses.

**Photograph 2 showing the roof of the property**

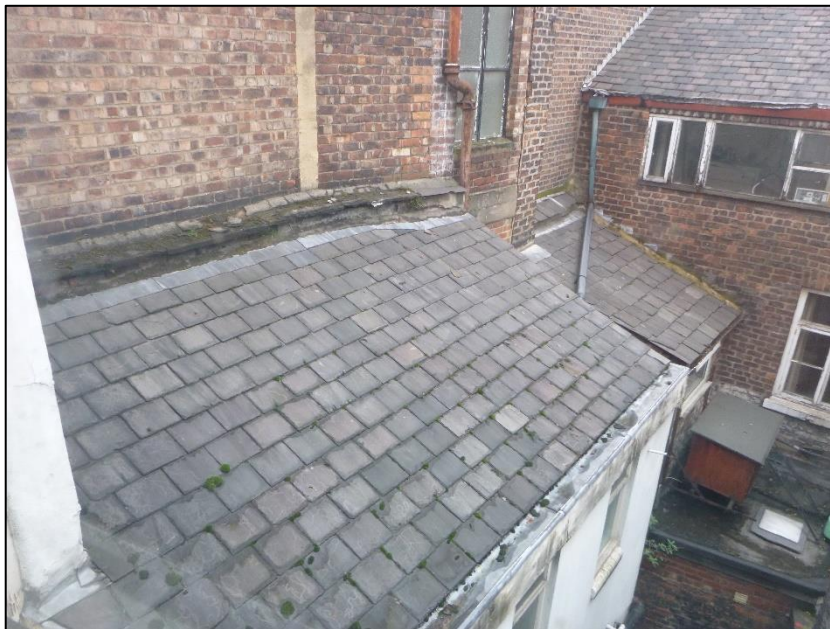
- 3.3 An extension occurs at the rear of the property (see Photograph 3). The extension is rendered, with no cracks or gaps in the render. The roof is pitched, with all of the slate tiles in position and flush to one another.

**Photograph 3 showing the roof of the rear extension**

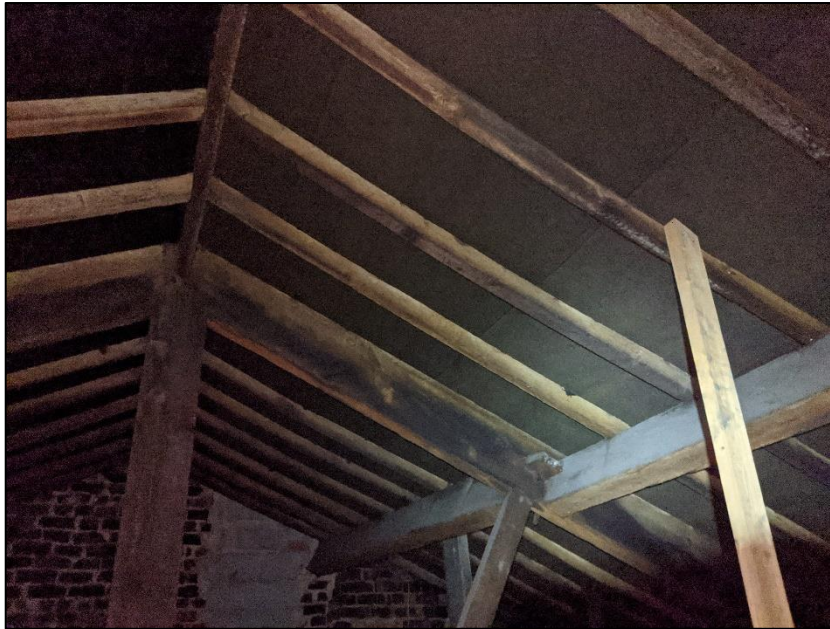
- 3.4 The interior of the property is split over several floors and is currently unoccupied. The ground floors and most of the remaining floors offer no suitable bat roosting habitat. A large, open roof void exists, covering the expanse of the roof. The wooden roof joists are complete and without gaps or cracks for bats to exploit (see Photograph 4). The roof is lined throughout, with no major tears or rips in the lining.

**Photograph 4 showing the roof structure of the upper floor**

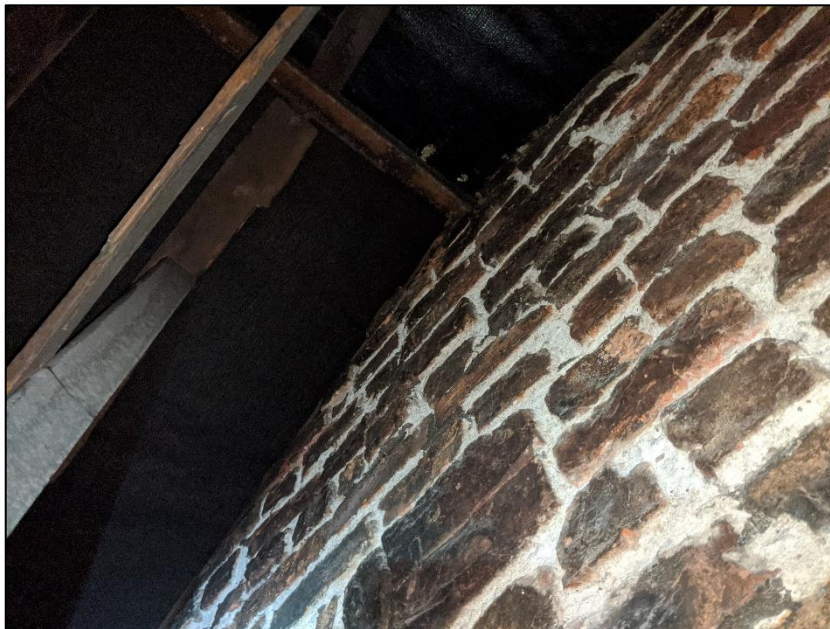
- 3.5 The internal brickwork is complete and intact, offering no damaged bricks or recessed mortar for crevice-dwelling bat species to occupy (see Photograph 5). The roof void is well-sealed internally, with no daylight present at the roof edges. The roof void is dusty and cobwebbed throughout, suggesting no recent bat access. No evidence of bat activity, such as bat droppings, could be located in the roof void.

**Photograph 5 showing the internal brickwork**

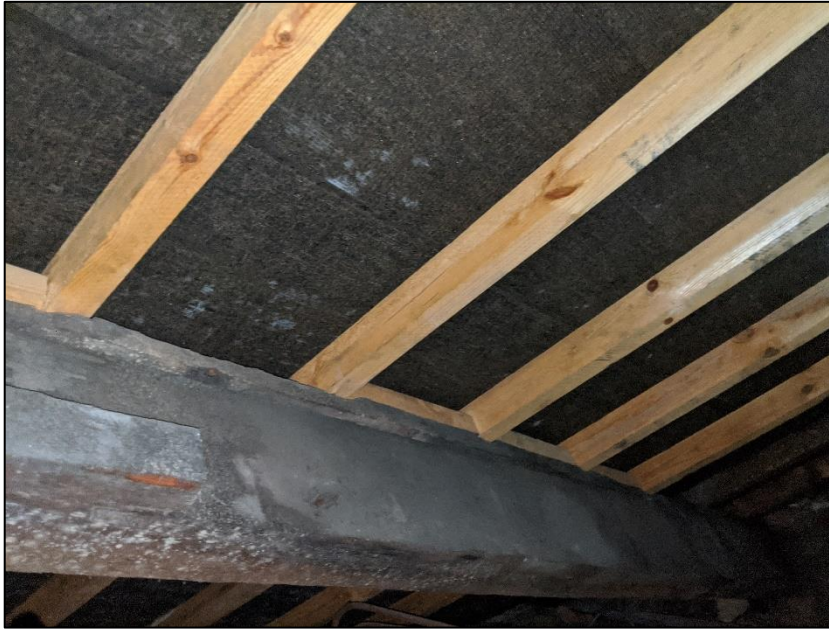
- 3.6 The rear extension has a small, shallow roof void. This is a constricted space. The wooden roof joists are complete and without gaps or cracks to exploit (see Photograph 6). The roof lining is intact, with no major rips or tears. The roof void is well-sealed. No evidence of bat activity was found in the extension roof void.

**Photograph 6 showing the small, shallow roof void above the extension**

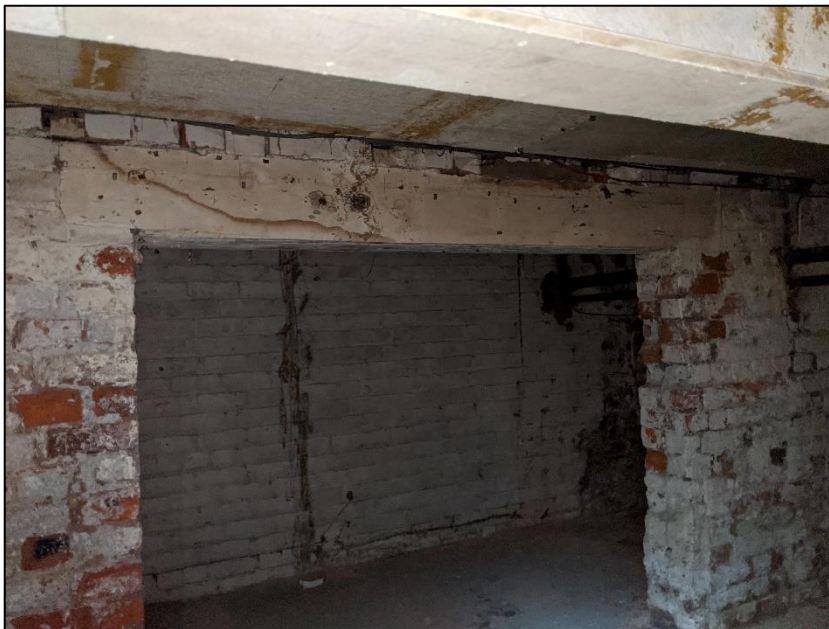
- 3.7 The property has an extensive cellar space (see Photograph 7). The space offers no suitable bat roosting spaces. The brick walls are complete. No evidence of bat activity was located in the cellar space.

**Photograph 7 showing the cellar space**
