Gas Membrane Installation  
Validation Report  
Keepmoat  
Royce Road  
Manchester  
Blocks 1, 2 & 3

### Verification of gas protection measures

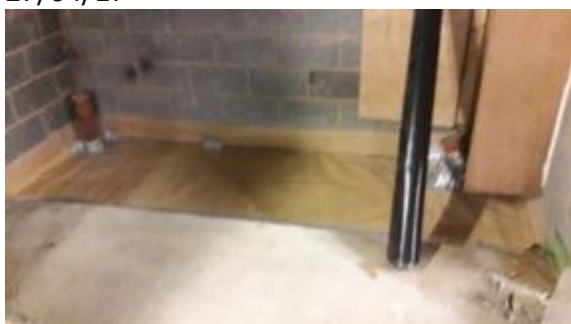
\* Contractor supplied repair photos

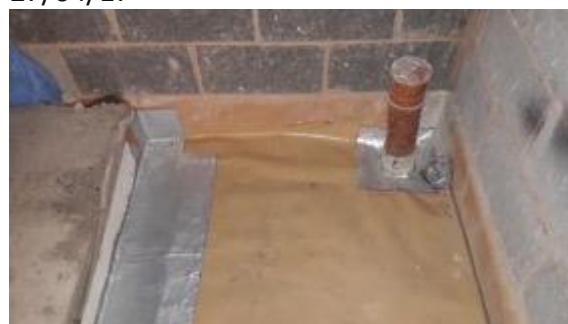
\* Contractor supplied repair photos

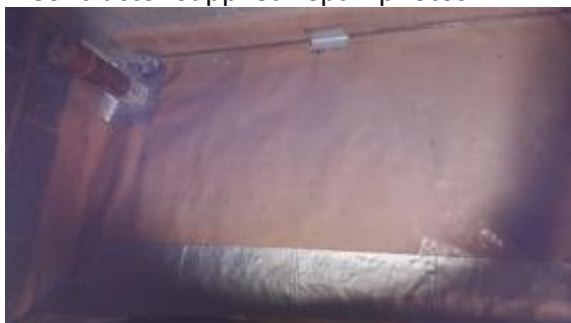
\* Contractor supplied repair photos

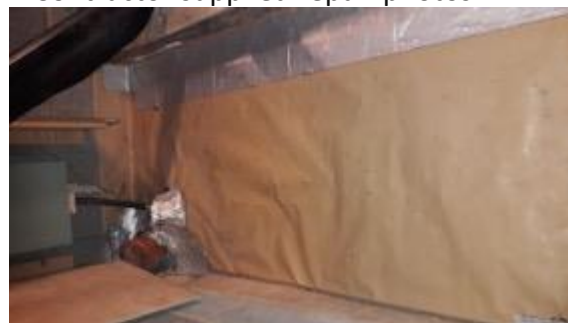
\* Contractor supplied repair photos
