The following report describes works carried out to existing windows at Avro.

**Urbansplash  
Construct Report**

# Existing Window Works

Completion Report

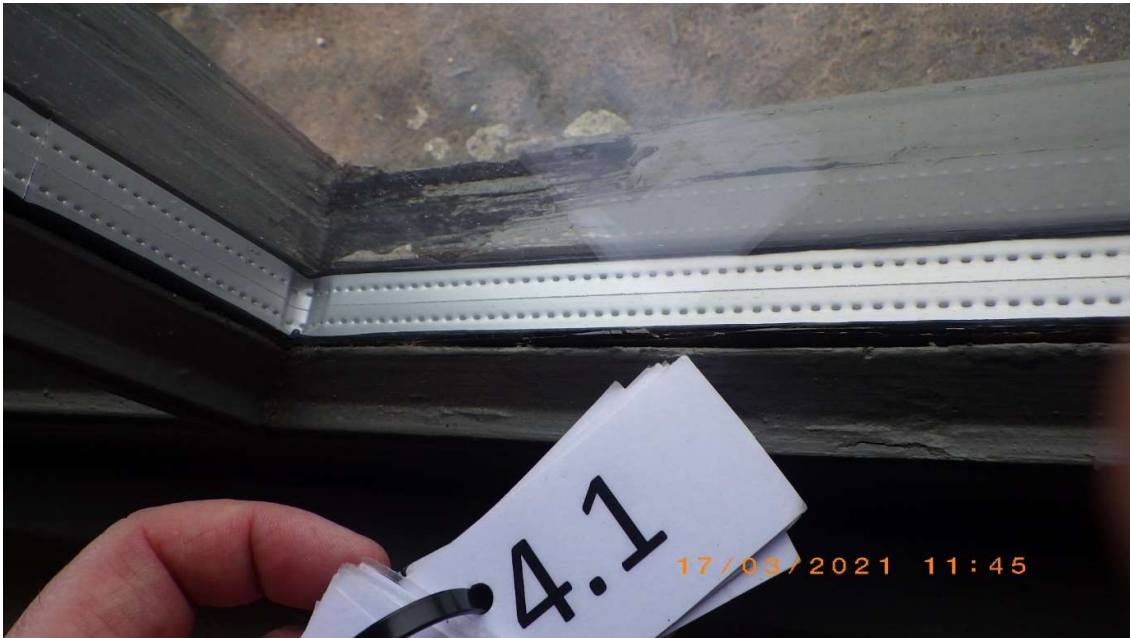
During the construction phase, some localised areas of decay in the existing windows became apparent. This effected various elements of the window including transoms, rails, beading and mullions. USC procured new like for like timber sections to match the existing and replaced them where required.

*Figure 1 Example of localised decay in window opening light*

- Cut out old rotting timber and spliced with new timber to match existing.
- Beading taken out and new beading pinned back in place.

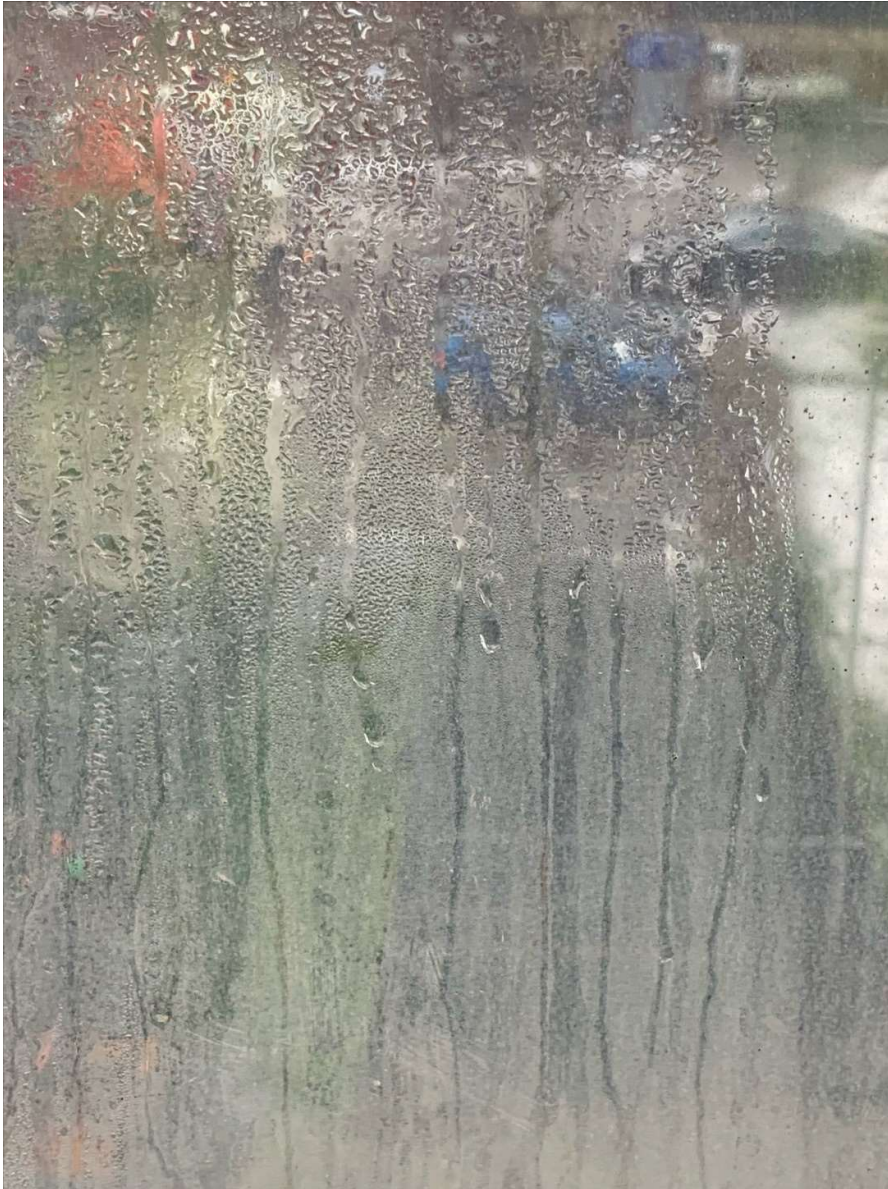
During the construction phase, USC highlighted that several existing glazing units were failing (Condensation building up within the double-glazed units). To rectify this issue, USC sub-contracted a further scope of works to carry out the procurement and installation of like for like glazing units to existing windows.

*Figure 2 Example of failed existing glazing unit*

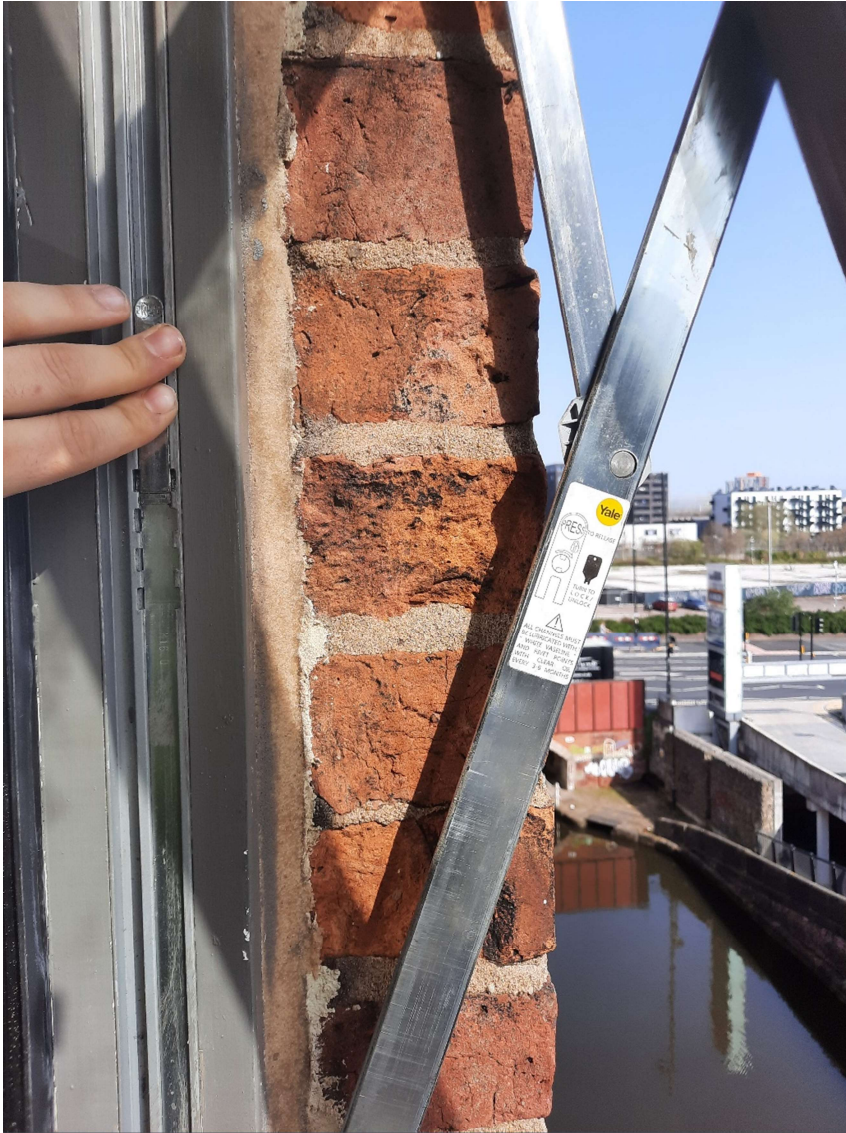
Whilst refurbishing the existing windows it was discovered that some of the existing hinges were failing. Further investigation determined that the hinge did not have enough capacity to carry the weight of the window. This led to the conclusion that the existing hinges were too unsafe to keep in place.

*Figure 3 Example of new hinge installed and Burnt Sand Mastic*

As a result, USC sub-contracted a further updated scope of works. This included the removal of window sashes to enable the replacement of the hinges. The existing hinges were changed in line with the Construction Drawings detailed in Section 2.

In line with conservation requirements and manufacturers recommendation, USC Sub-contracted works that involved the application of Burnt Sand Mastic Mortar to the external gaps of the windows.

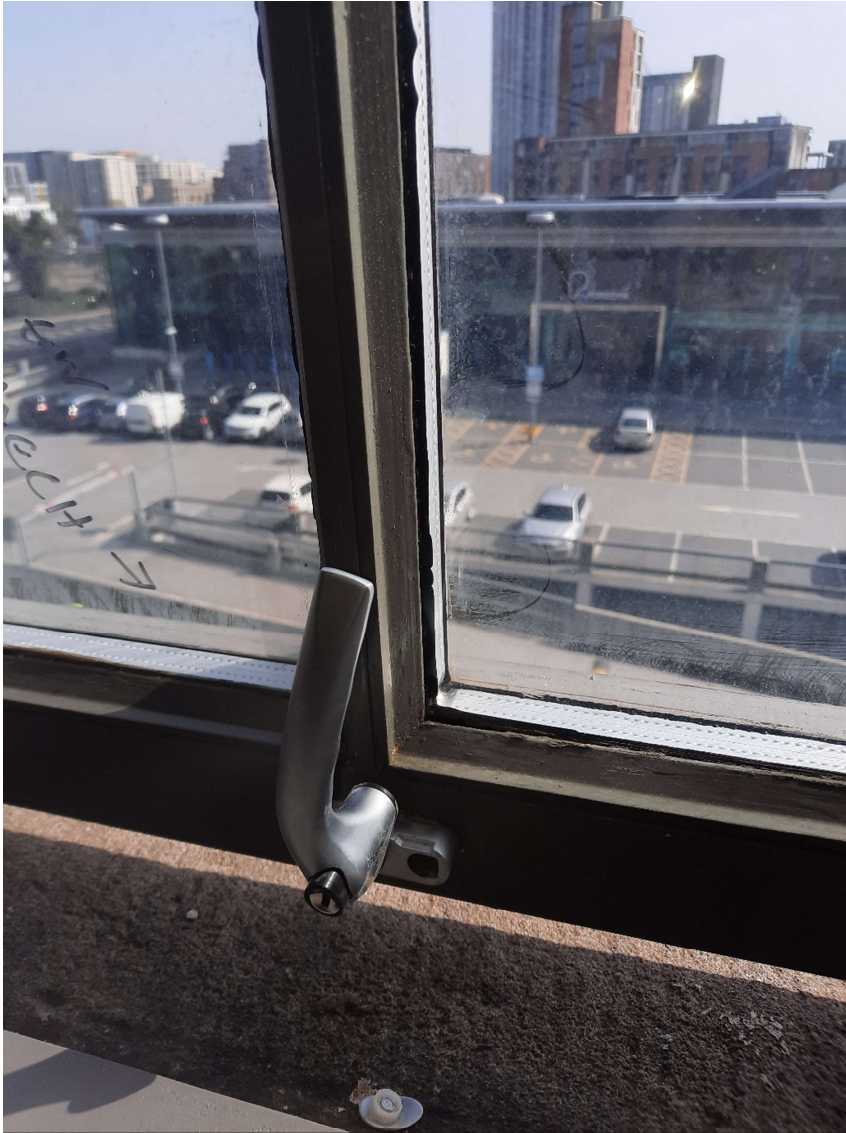
Following the renewal of existing windows, it was noted that most of the window handles did not function and/or had keys missing. Therefore, they were not fit for purpose. In response to this, USC sub-contracted a further updated scope of works to install new internal window handles to all existing windows.

*Figure 4 Example of new window handle installed to match existing*

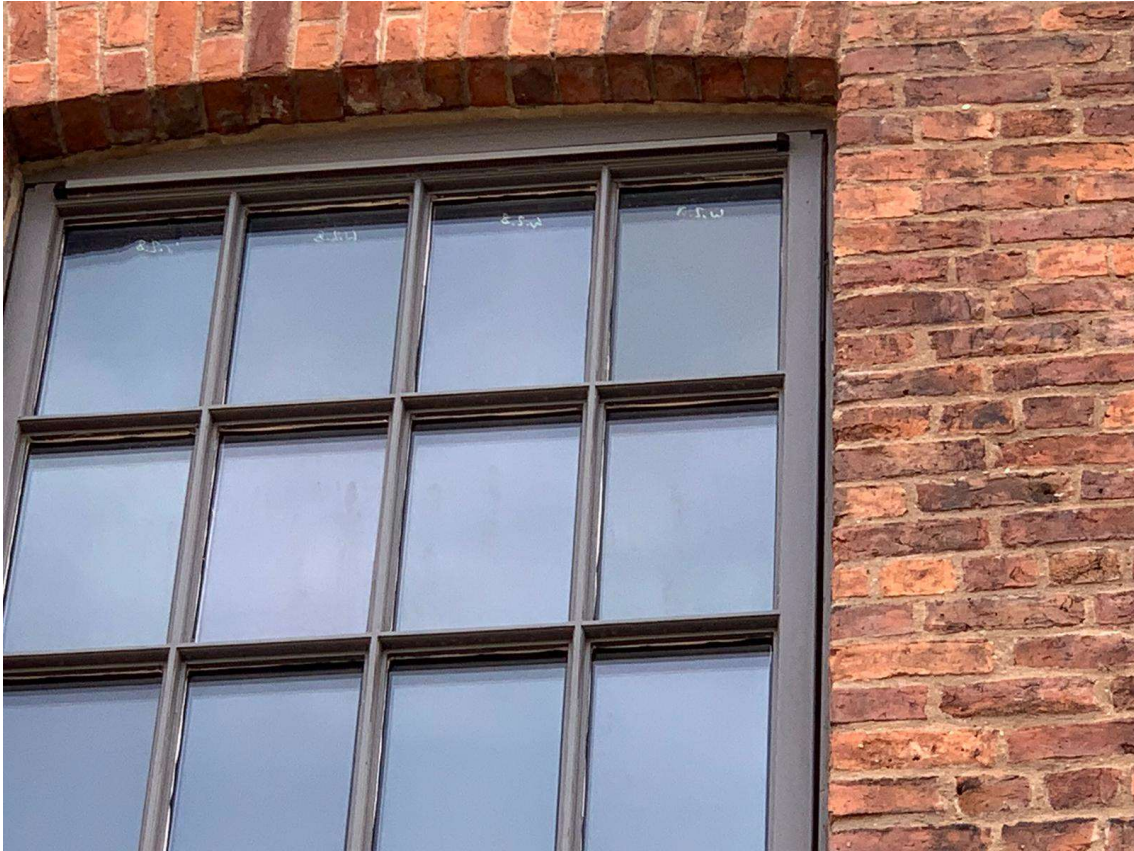
*Figure 5 Example of window with trickle vent installed, windows repairs carried out, new glazing and painting.*

USC subcontracted a scope of works in line with the Construction Drawings detailed in section 2. The works involved installing Triton V75/V50 trickle vents to specified windows. A frame-wide cover cap was installed the external side of the window to ensure visual uniformity.

- Router out slot for trickle vent, fix in place bedded on silicone

Windows are primed with a water-based Dulux primer. Then 2 topcoats of quick dry weather seal satin paint. (RAL 7039). The timber is also filled and sanded in-between coats.

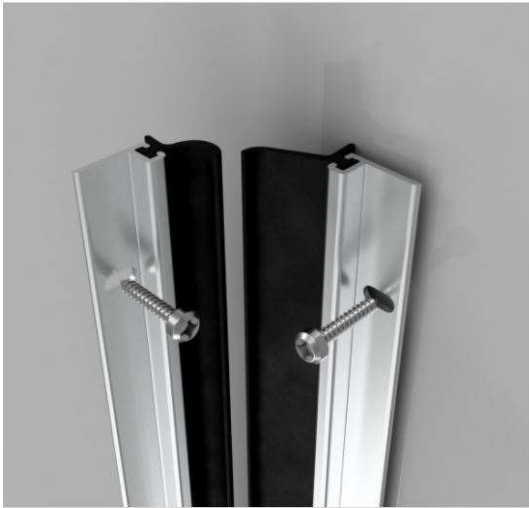
Figure 6 Additional Internal proprietary seal product

To meet the requirements of dBx Acoustics report and recommendations, perimeter seals to the existing windows have been replaced and additional internal proprietary seals installed to improve general sealing and acoustic performance.

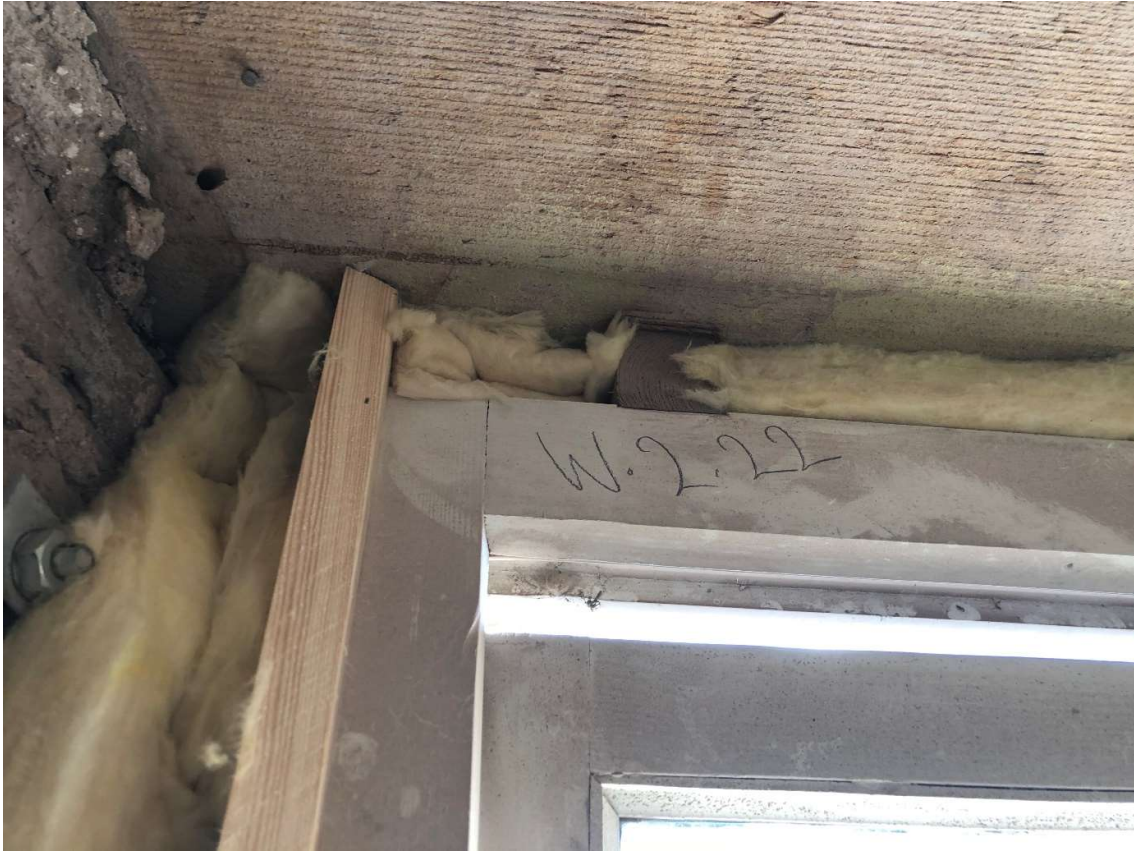
*Figure 7 Internal window reveals pre-boarded*

Around the perimeter of the window frame where the timber meets the brick wall, USC subcontracted a scope of works out that included the installation of an MDF boxing around the window that was mineral wool insulation. This was in line with the Construction Drawings. Please note here that this enabled the retention of existing window fixings.

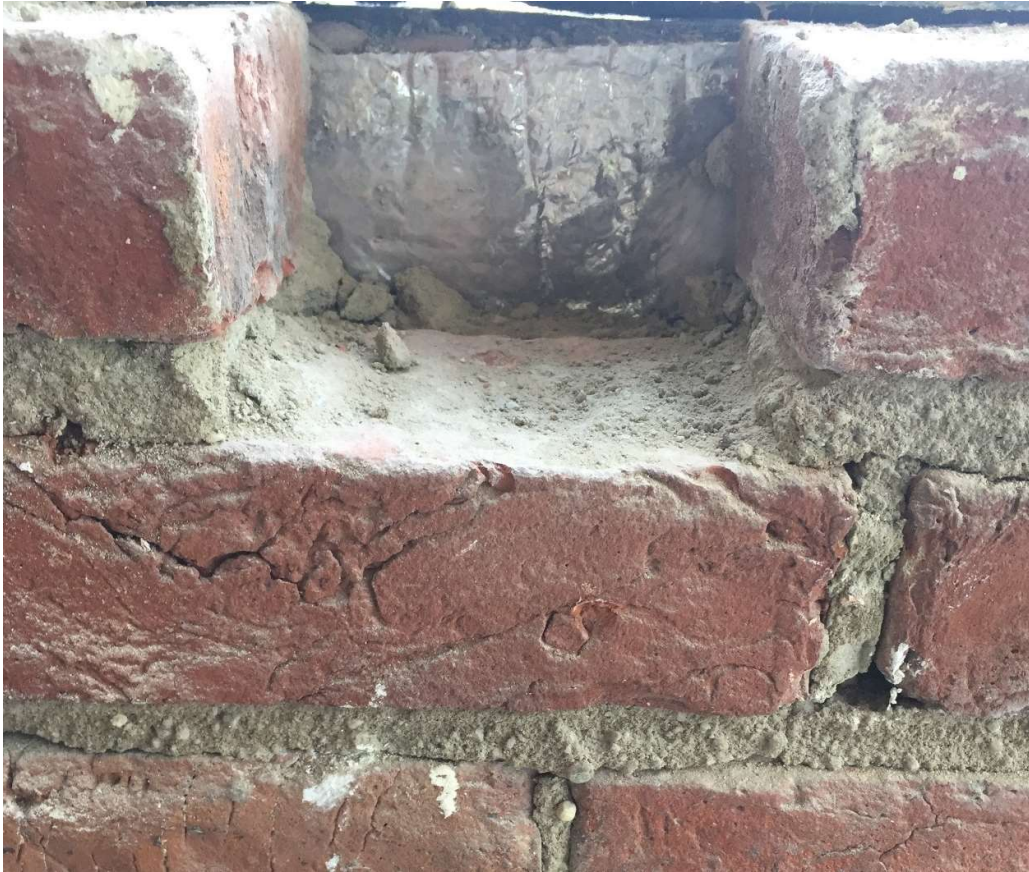
*Figure 8 Internal cill repairs*

In line with the Construction Drawings, USC Sub-contracted a scope of works that included the renewal of the existing brickwork cills. This involved installed matching brick work to the cills, sat on Airguard and pointed with conservation approved mortar.

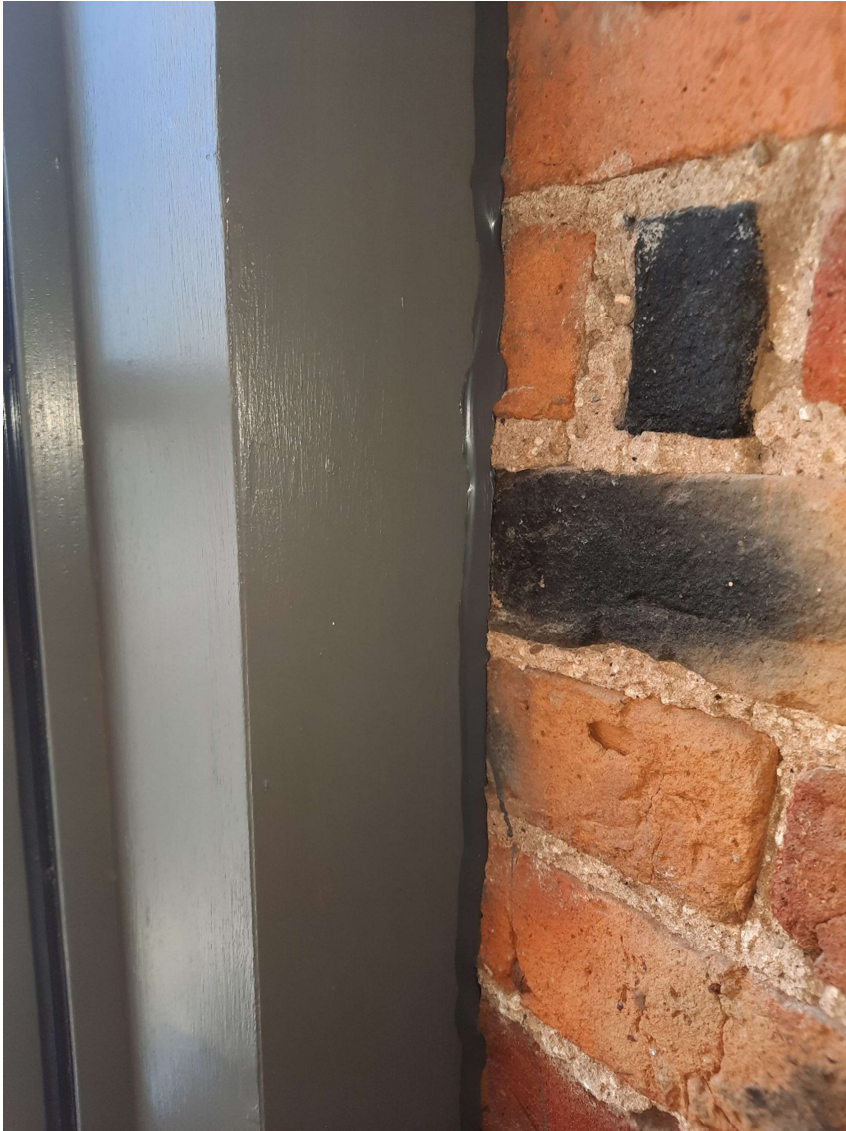
*Figure 9 Window reveal painted and sealant applied internal*

Internally, USC subcontracted a scope of works that involved the application of a Grey silicone sealant to fill gaps between the timber reveals and the brickwork.
