Heritage defect repair specification and methodology

1-3 Back Turner Street,  
Manchester M4 1FR

Date: 02 February 2021

Reference: 91420/38/JPC/LAP

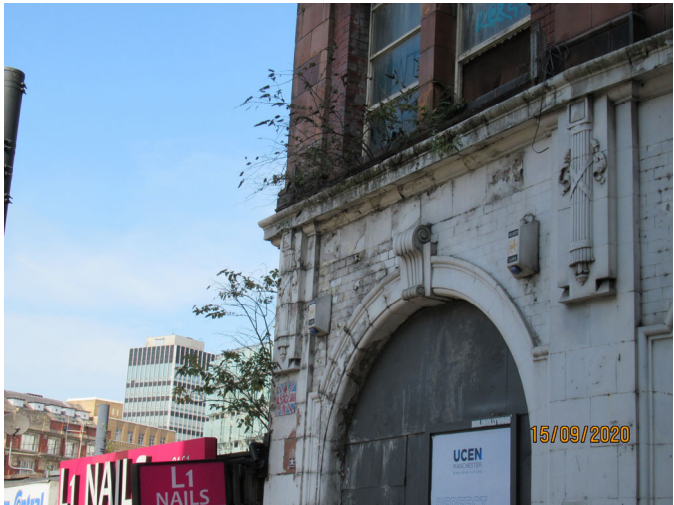
| <p>4.</p> | <p>Typical view of vegetation growth to the elevation.</p> | |

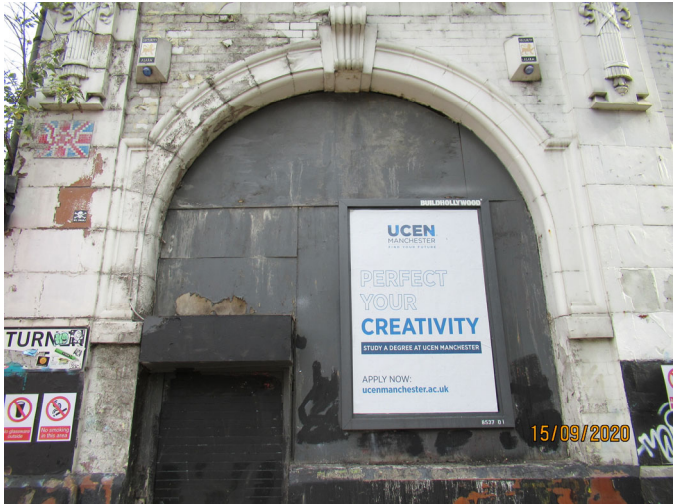
| <p>5.</p> | <p>General view of carbon sulphation, degraded paintwork and biological staining to arch and brickwork.</p> | |

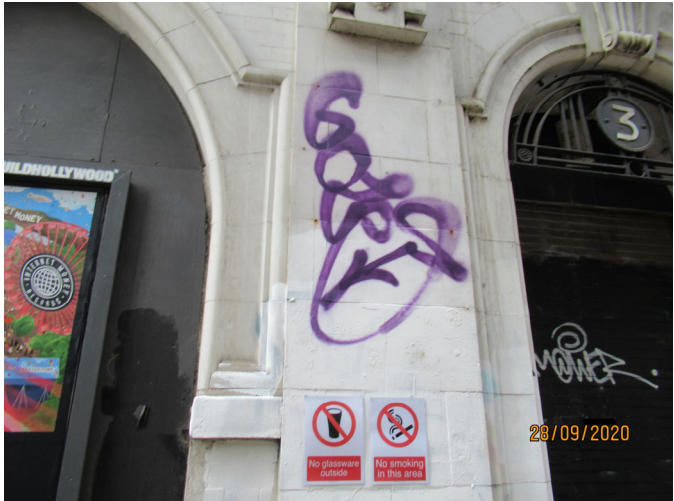
| <p>6.</p> | <p>Typical view of aerosol graffiti to the painted terracotta pilaster.</p> | |

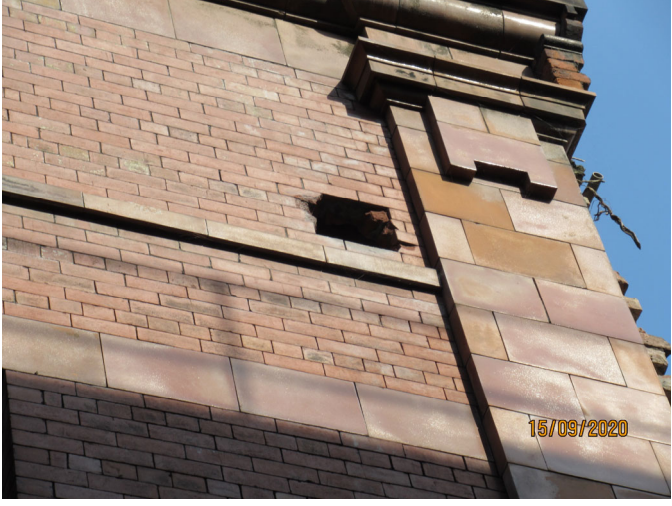
| 8. | View of missing brickwork to the front elevation. | |

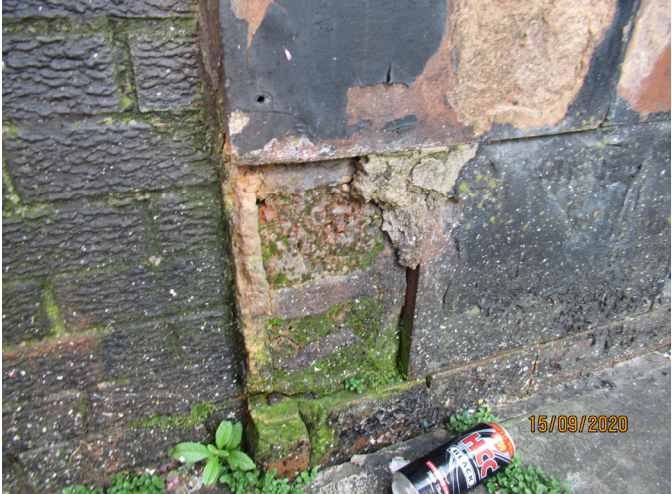
| 9. | View of delaminated sandstone pilaster base to the front elevation. | |

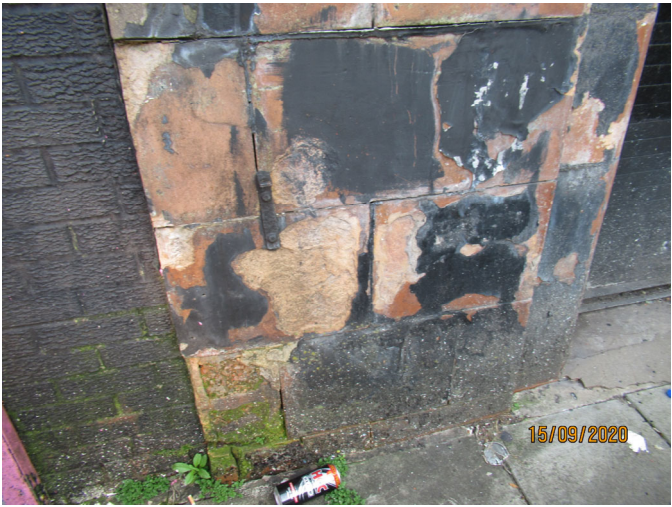
| 10. | View of delaminated sandstone pilaster base to the front elevation. | <p>15/09/2020</p> |

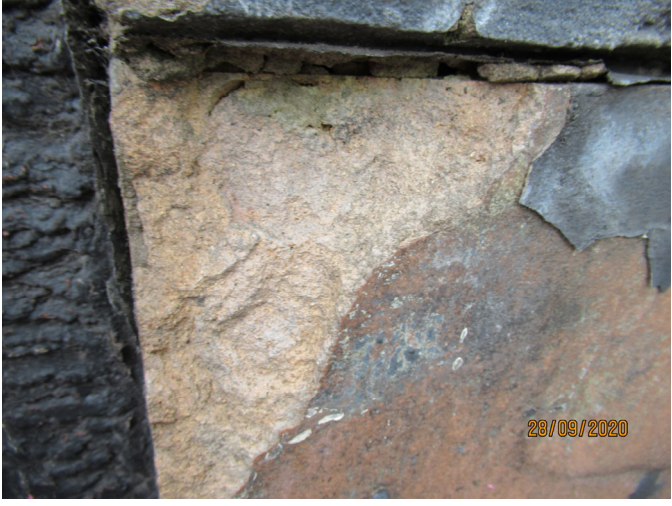
| 11. | View of chipped exposed sandstone stone to pilaster base to the front elevation. | <p>28/09/2020</p> |

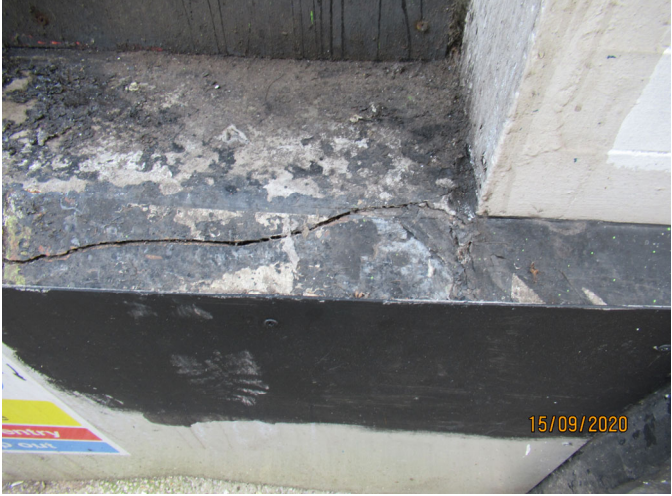
| 12. | View of cracking to the sandstone wall base plinth to the front elevation. | <p>15/09/2020</p> |

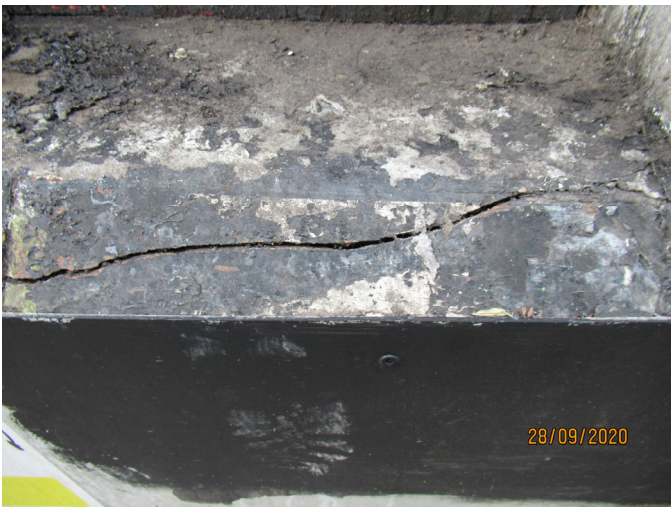
| 13. | View of cracking to the sandstone wall base plinth to the front elevation. | |

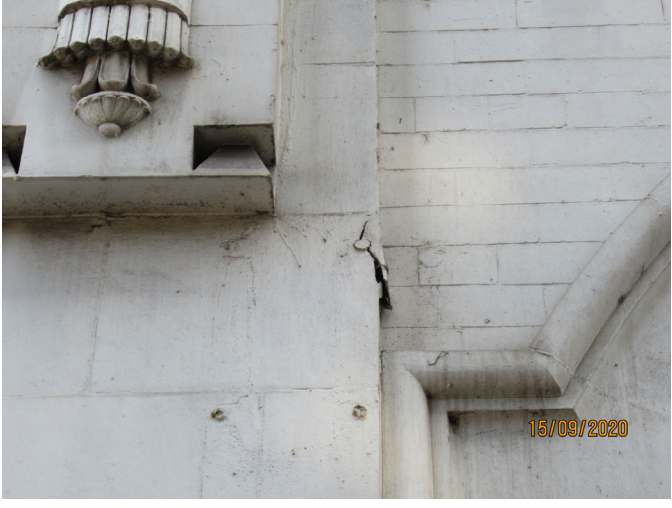
| 14. | View of corroded iron work and delaminated stone work to the front elevation. | |

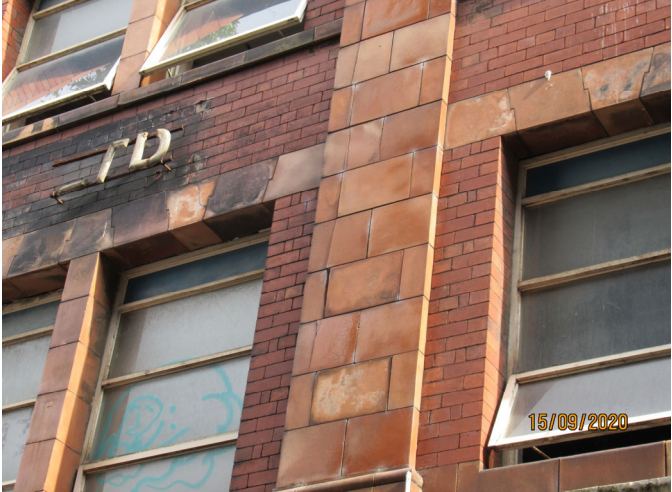
| 15. | Typical view of cracking to terracotta pilaster. | |

- 1.4.2 Given recent experience on previous jobs and based on internal investigations, we anticipate blast cleaning and paint protecting of the embedded steel columns may be required to prevent further damage to the terracotta piers. If left unprotected we are likely to face an ongoing maintenance issue with further cracking, however at this stage this is speculative, and the extent of works required can be confirmed following localised external investigations.

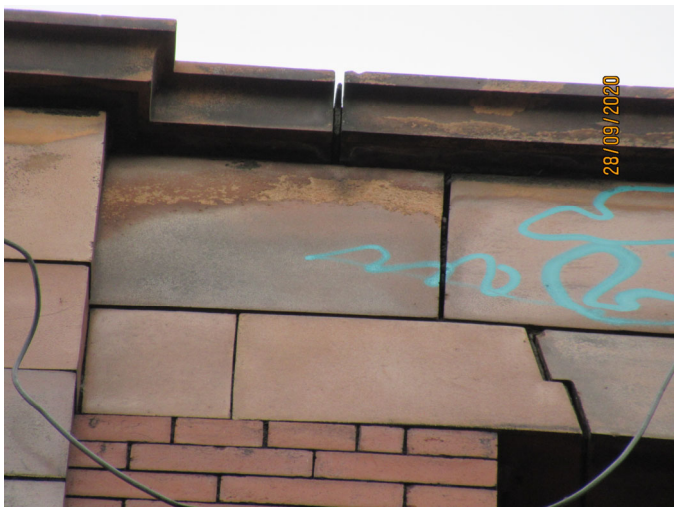
| 16. | Typical view of defective pointing to coping stones. | |

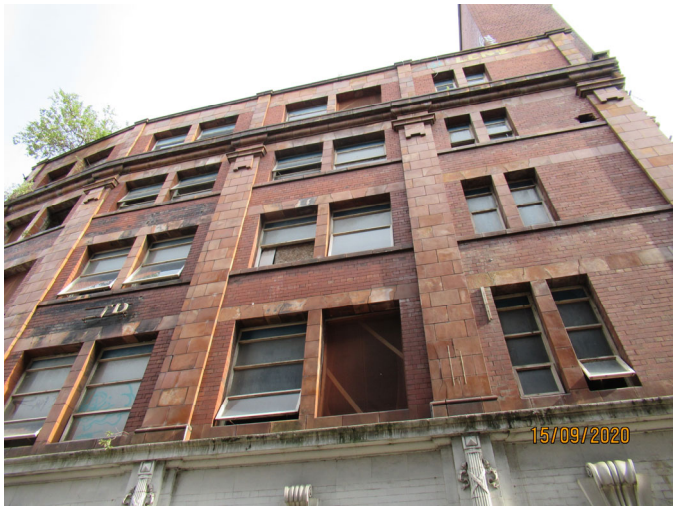
| 17. | Typical view of missing windows to front elevation. | |

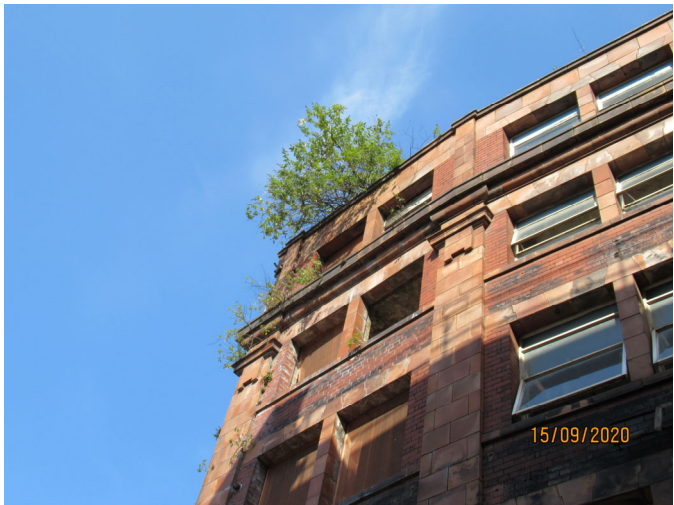
| 18. | Typical view of missing windows to front elevation. | |

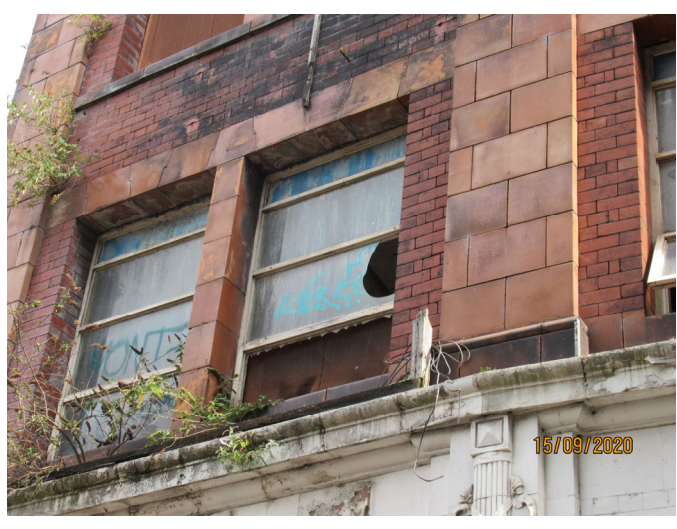
| 19. | Typical view of cracked modern retrofitted timber window to front elevation. | <p>A photograph showing a close-up of a modern retrofitted timber window set into a brick wall. The window frame is made of dark wood and shows signs of wear and cracking. The glass is multi-paned and has some blue graffiti on it. The surrounding brickwork is red and shows some weathering. A date stamp '15/09/2020' is visible in the bottom right corner of the image.</p> |

- 1.4.10 We propose to remove the existing arched windows (windows 5, 6 & 7) and replace with a structural glazed curtain wall, with a polyester powder coated aluminium frame (sympathetic colour TBC and approved) and double glazed units. Window proposals, detail drawings and colours can be submitted to the Conservation officer for approval if required.

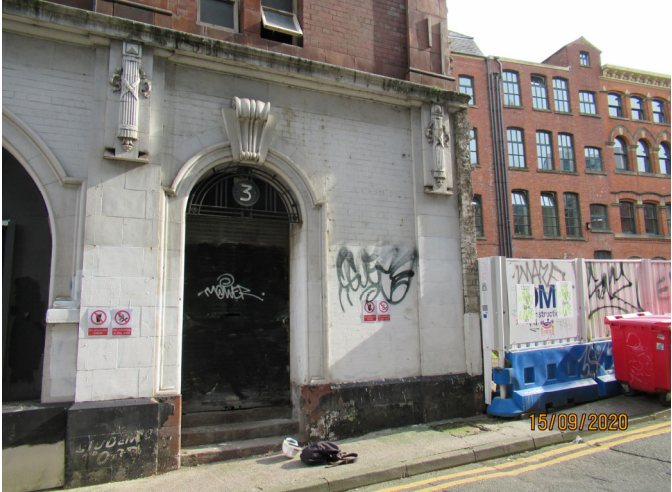
- 1.3.10 The external doors are generally in poor condition. The retrofitted external roller shutters to both entrances are severely corroded and will require replacement in the short term.
- 1.3.11 Low-light levels made it difficult to assess the condition of the internal entrance doors, and access was not afforded during our second site visit. We will update our schedule when power can be enabled on-site recording the condition and schedule any itemised repairs.
- 1.3.12 The tables below identify the location, element, description of defect and proposed remedial works.

| 24. | Typical view of corroded roller shutter to entrance door. | |

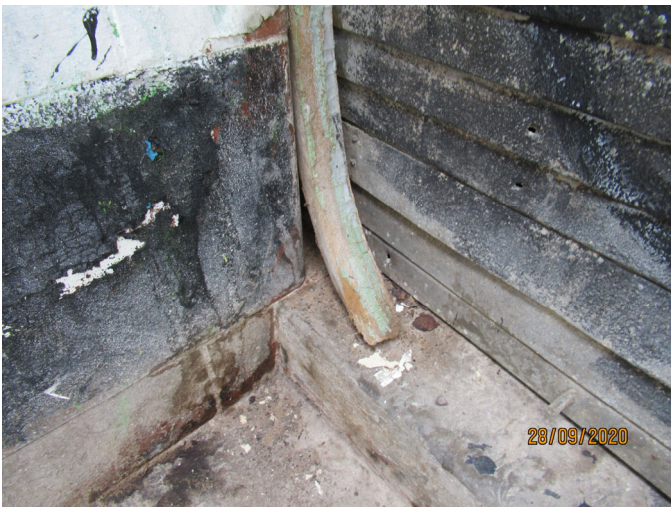
| 25. | Typical view of corroded roller shutter to entrance door. | |

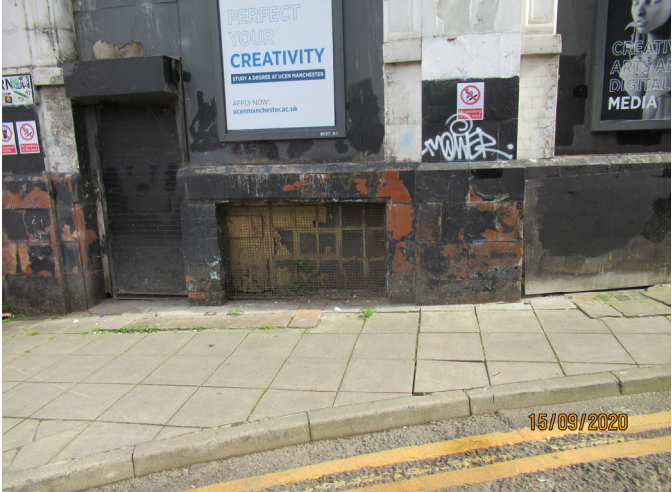
- 1.3.7 Following further investigation of the basement windows (windows 1, 2 & 3), we noted the frames were in fair condition commensurate their age, however, have been previously heavily overpainted, and we could not determine the age or originality of the windows. We noted the glazing has previously been replaced with modern Georgian wire glazing panes, which were in poor condition and impact damaged throughout. We could not obtain a view of window 1 as it was concealed by wall panelling, however, all surveyed windows to the basement were sequential and consistent in style and condition.

| 27. | Typical view of painted basement windows. | |

- Elevation – Soap Street.
- 1.4.9 We propose to infill the basement windows (windows 1, 2 & 3) using matching bricks, in a header course brick bond arrangement to match the front elevation. The introduction of the brick infill, including pointing, will be undertaken in line with the Heritage Surveyors recommendation, as documented in Appendix A – A6 & A7.

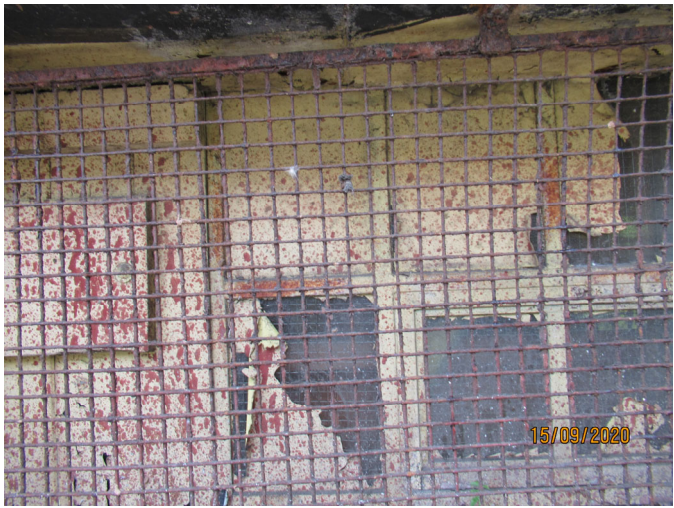
| 29. | Typical view of painted basement windows. | |

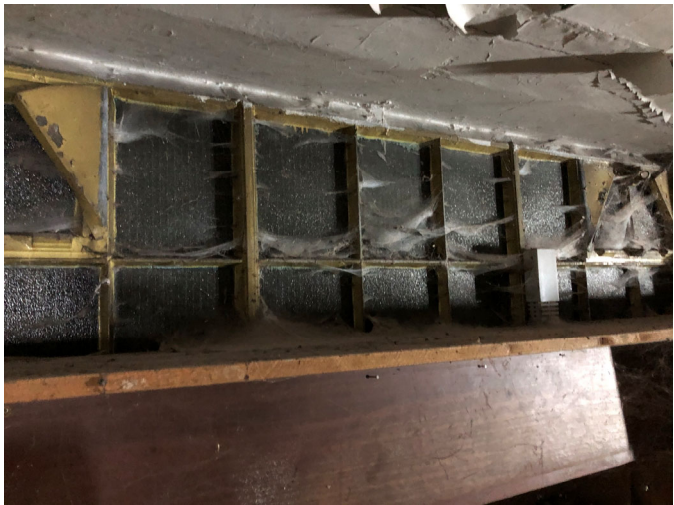
| 30. | Internal view of painted basement windows. | |

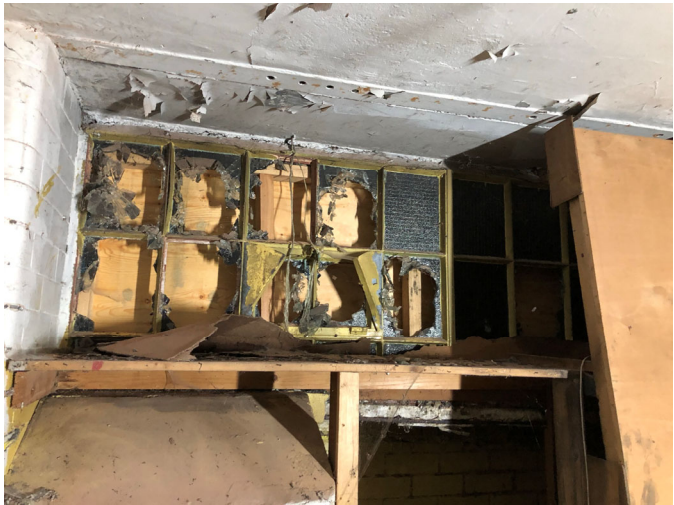
| Item | Location | Element | Number (from left side to right) | Condition/proposed repair method |
|---|---|---|---|---|
| 2. | Back Turner Street Elevation | Windows – Basement | 2 | Poor condition – overpainted and several impact damaged glazing panes. |
| 3. | Back Turner Street Elevation | Windows – Basement | 3 | Poor condition – overpainted and several impact damaged glazing panes. |

| 31. | Typical view of painted basement windows with impact damaged glazing. | A photograph showing a set of painted basement windows. The glazing is severely damaged, with many panes shattered or missing, revealing the internal wooden frame. The surrounding walls are painted white and show signs of peeling paint and debris. |

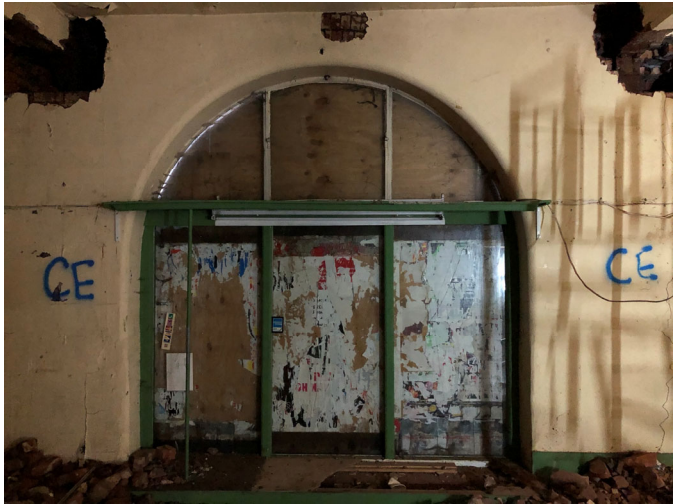
- 1.3.6 Following further inspection of the ground floor windows (windows 5, 6 & 7) with temporary lighting, we noted the ground floor arched windows to be in fair condition, and determined that they are a modern retrofitted timber frame window, with a single glazed glazing pane dating circa 2000. We noted an upper fan light section, which appeared to be original to the building which had been overpainted using modern materials. The window was inoperable and painted shut, with missing ironmongery and furniture.

| 32. | Typical view of timber retrofitted arched windows to the ground floor. | A photograph of a ground-floor arched window. The window is retrofitted with a green-painted timber frame. The glass panes are covered in a dense layer of graffiti and stickers. The walls on either side of the window are painted a light cream color and also feature graffiti, including the letters 'CE' in blue. |

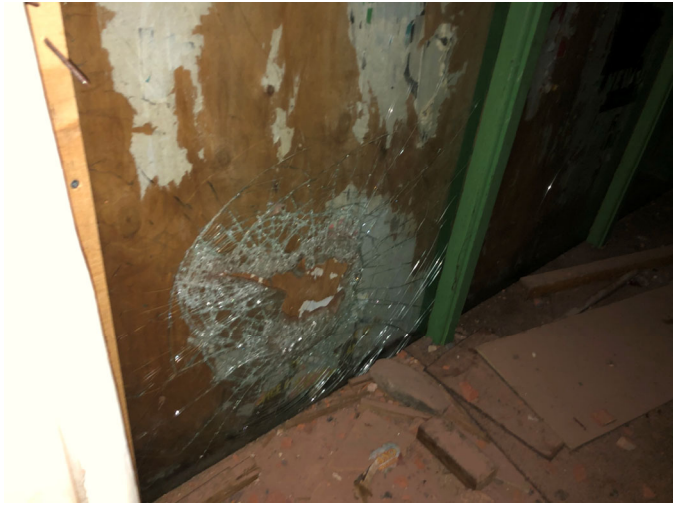
| Item | Location | Element | Number (from left side to right) | Condition/proposed repair method |
|---|---|---|---|---|
| 6. | Back Turner Street Elevation | Windows – Ground floor | 6 | Poor condition – impact damaged glazing throughout. |

| 33. | Typical view of impact damaged glazing panes to arched windows. | A close-up photograph of a damaged glass pane within a green timber frame. The glass is cracked and shattered, with a large area of missing material. Debris is visible on the floor in the foreground. |

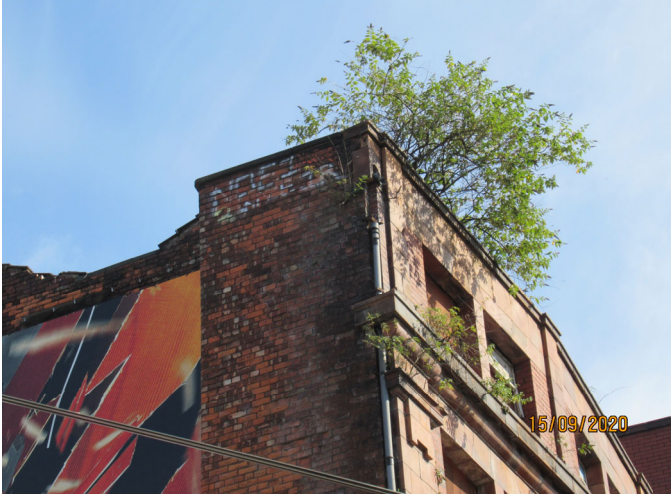
| 36. | View of aerosol graffiti and vegetation growth to defective brickwork. | |

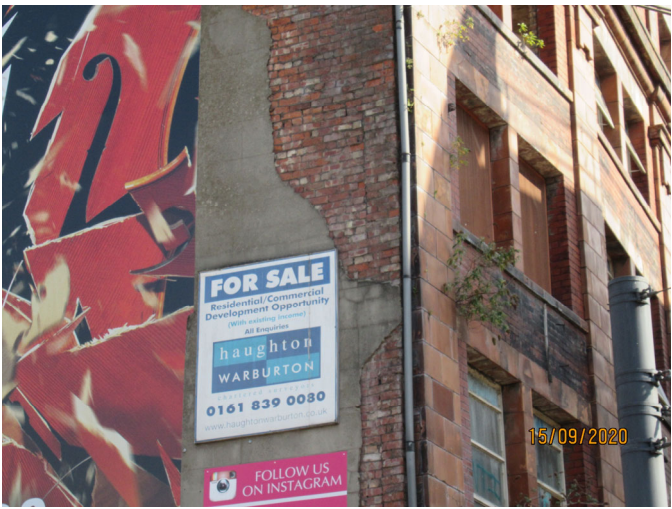
| 37. | Typical view of cement render to elevation. | |

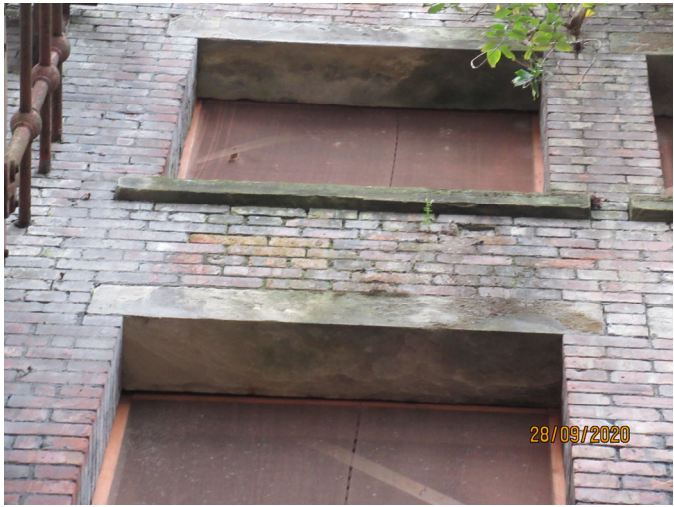
| 40. | Typical view of degraded mortar and brickwork elevations. | |

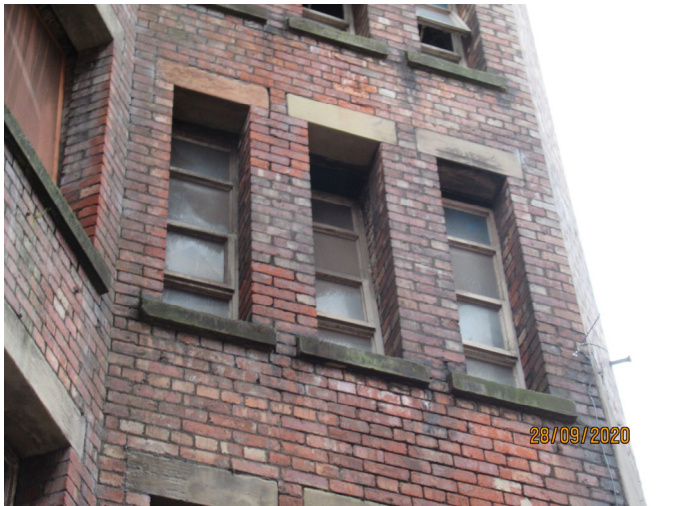
| 41. | Typical view of degraded mortar and brickwork elevations. | |

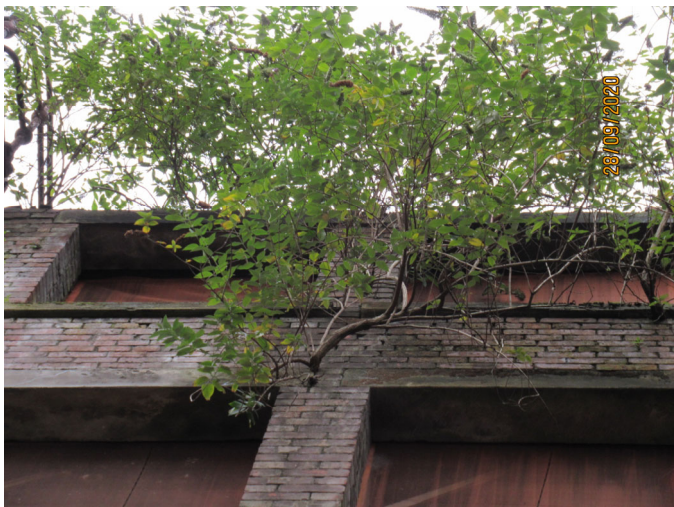
| 42. | View of extensive vegetation growth to brickwork elevation. | |

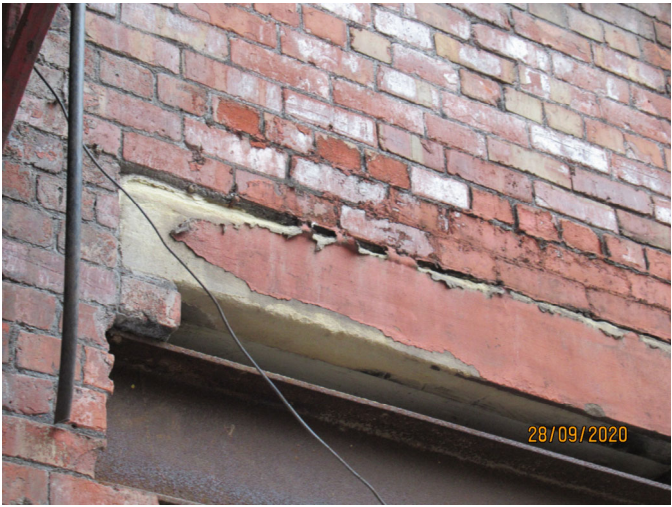
- 1.3.9 To the rear elevation, there is minor stone decay to isolated lintels caused by general weathering which is normal based on the age and location of the elements. We do not deem any intervention or repairs to these areas at this time due to the decay only being in the early stages. Should any aesthetic repair be required, we can provide an appropriate, sensitive and reversible repair method.

| 43. | View of early stone decay to limestone lintel. | |

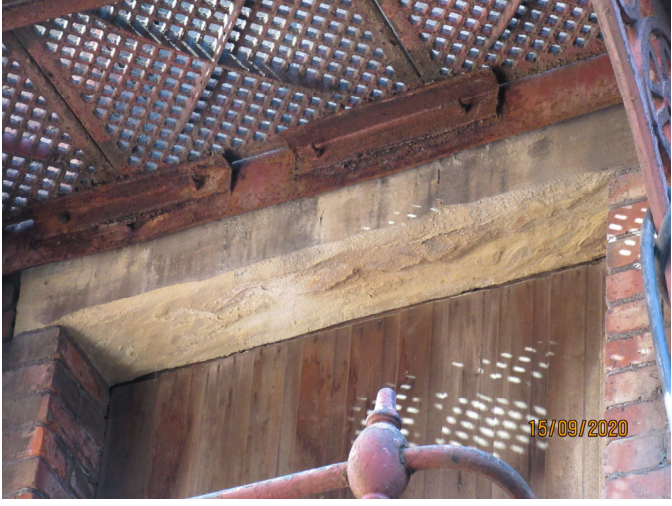
| 44. | Typical view of early stone decay to limestone lintel. | |

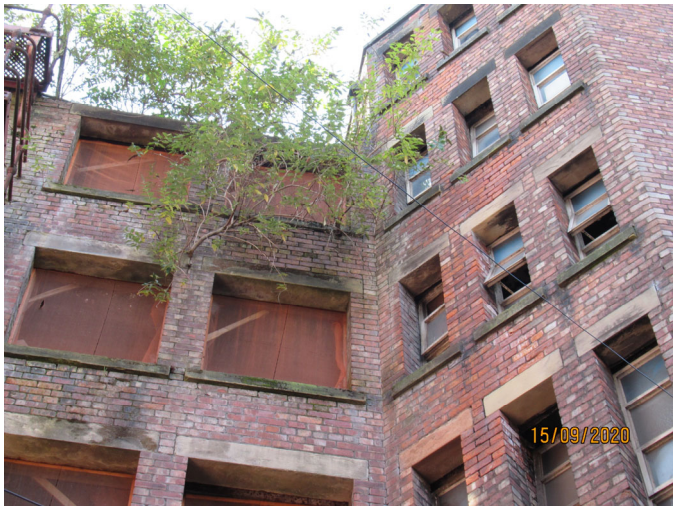
| 50. | Typical view of modern retrofitted windows to rear elevation with vegetation growth to elevation. | |

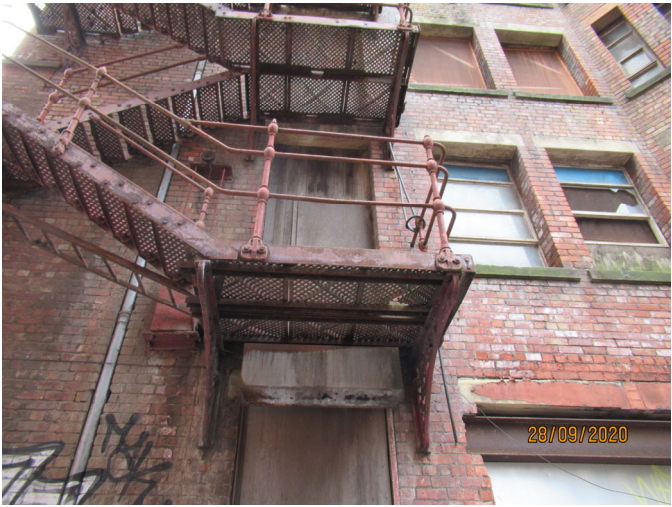
| 52. | General view of corroded iron staircase. | <p>A photograph showing a general view of a corroded iron staircase on a brick building. The staircase is made of dark, rusted metal with a mesh railing. It is attached to a red brick wall. A date stamp '28/09/2020' is visible in the bottom right corner of the image.</p> |

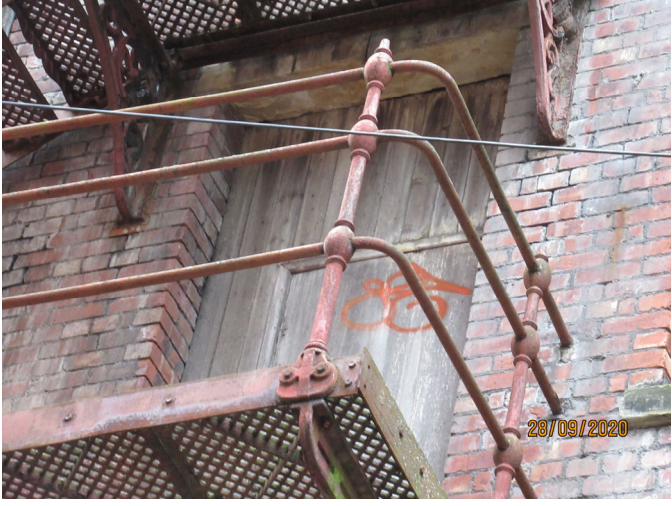
| 53. | Typical view of corrosion to iron staircase. | <p>A close-up photograph showing the corrosion on the iron staircase. The metal is heavily rusted and discolored. A date stamp '28/09/2020' is visible in the bottom right corner of the image.</p> |

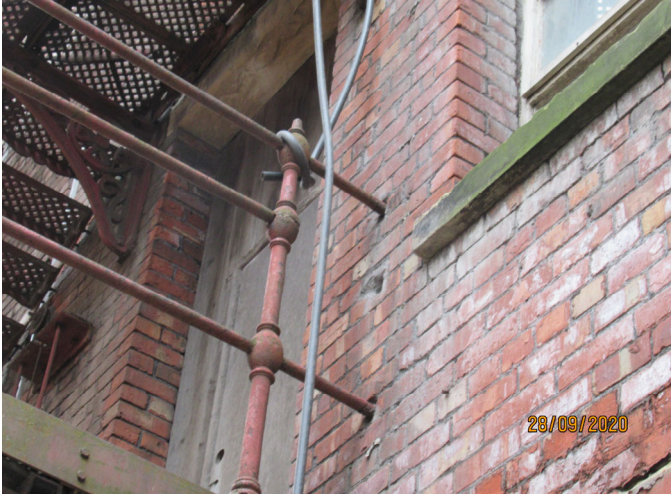
| 54. | View of missing balustrade rail. | <p>A photograph showing a view of a missing balustrade rail on the iron staircase. The metal structure is visible, and the rail is missing. A date stamp '28/09/2020' is visible in the bottom right corner of the image.</p> |

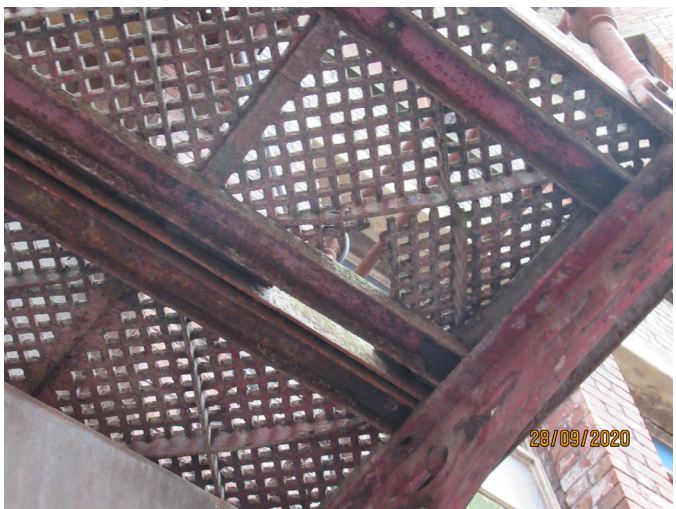
| 55. | View of corroded cast iron floor grille. | |
