# **Hexagon Tower**

Deterioration of Cladding  
Pre-planning Report

March 2021

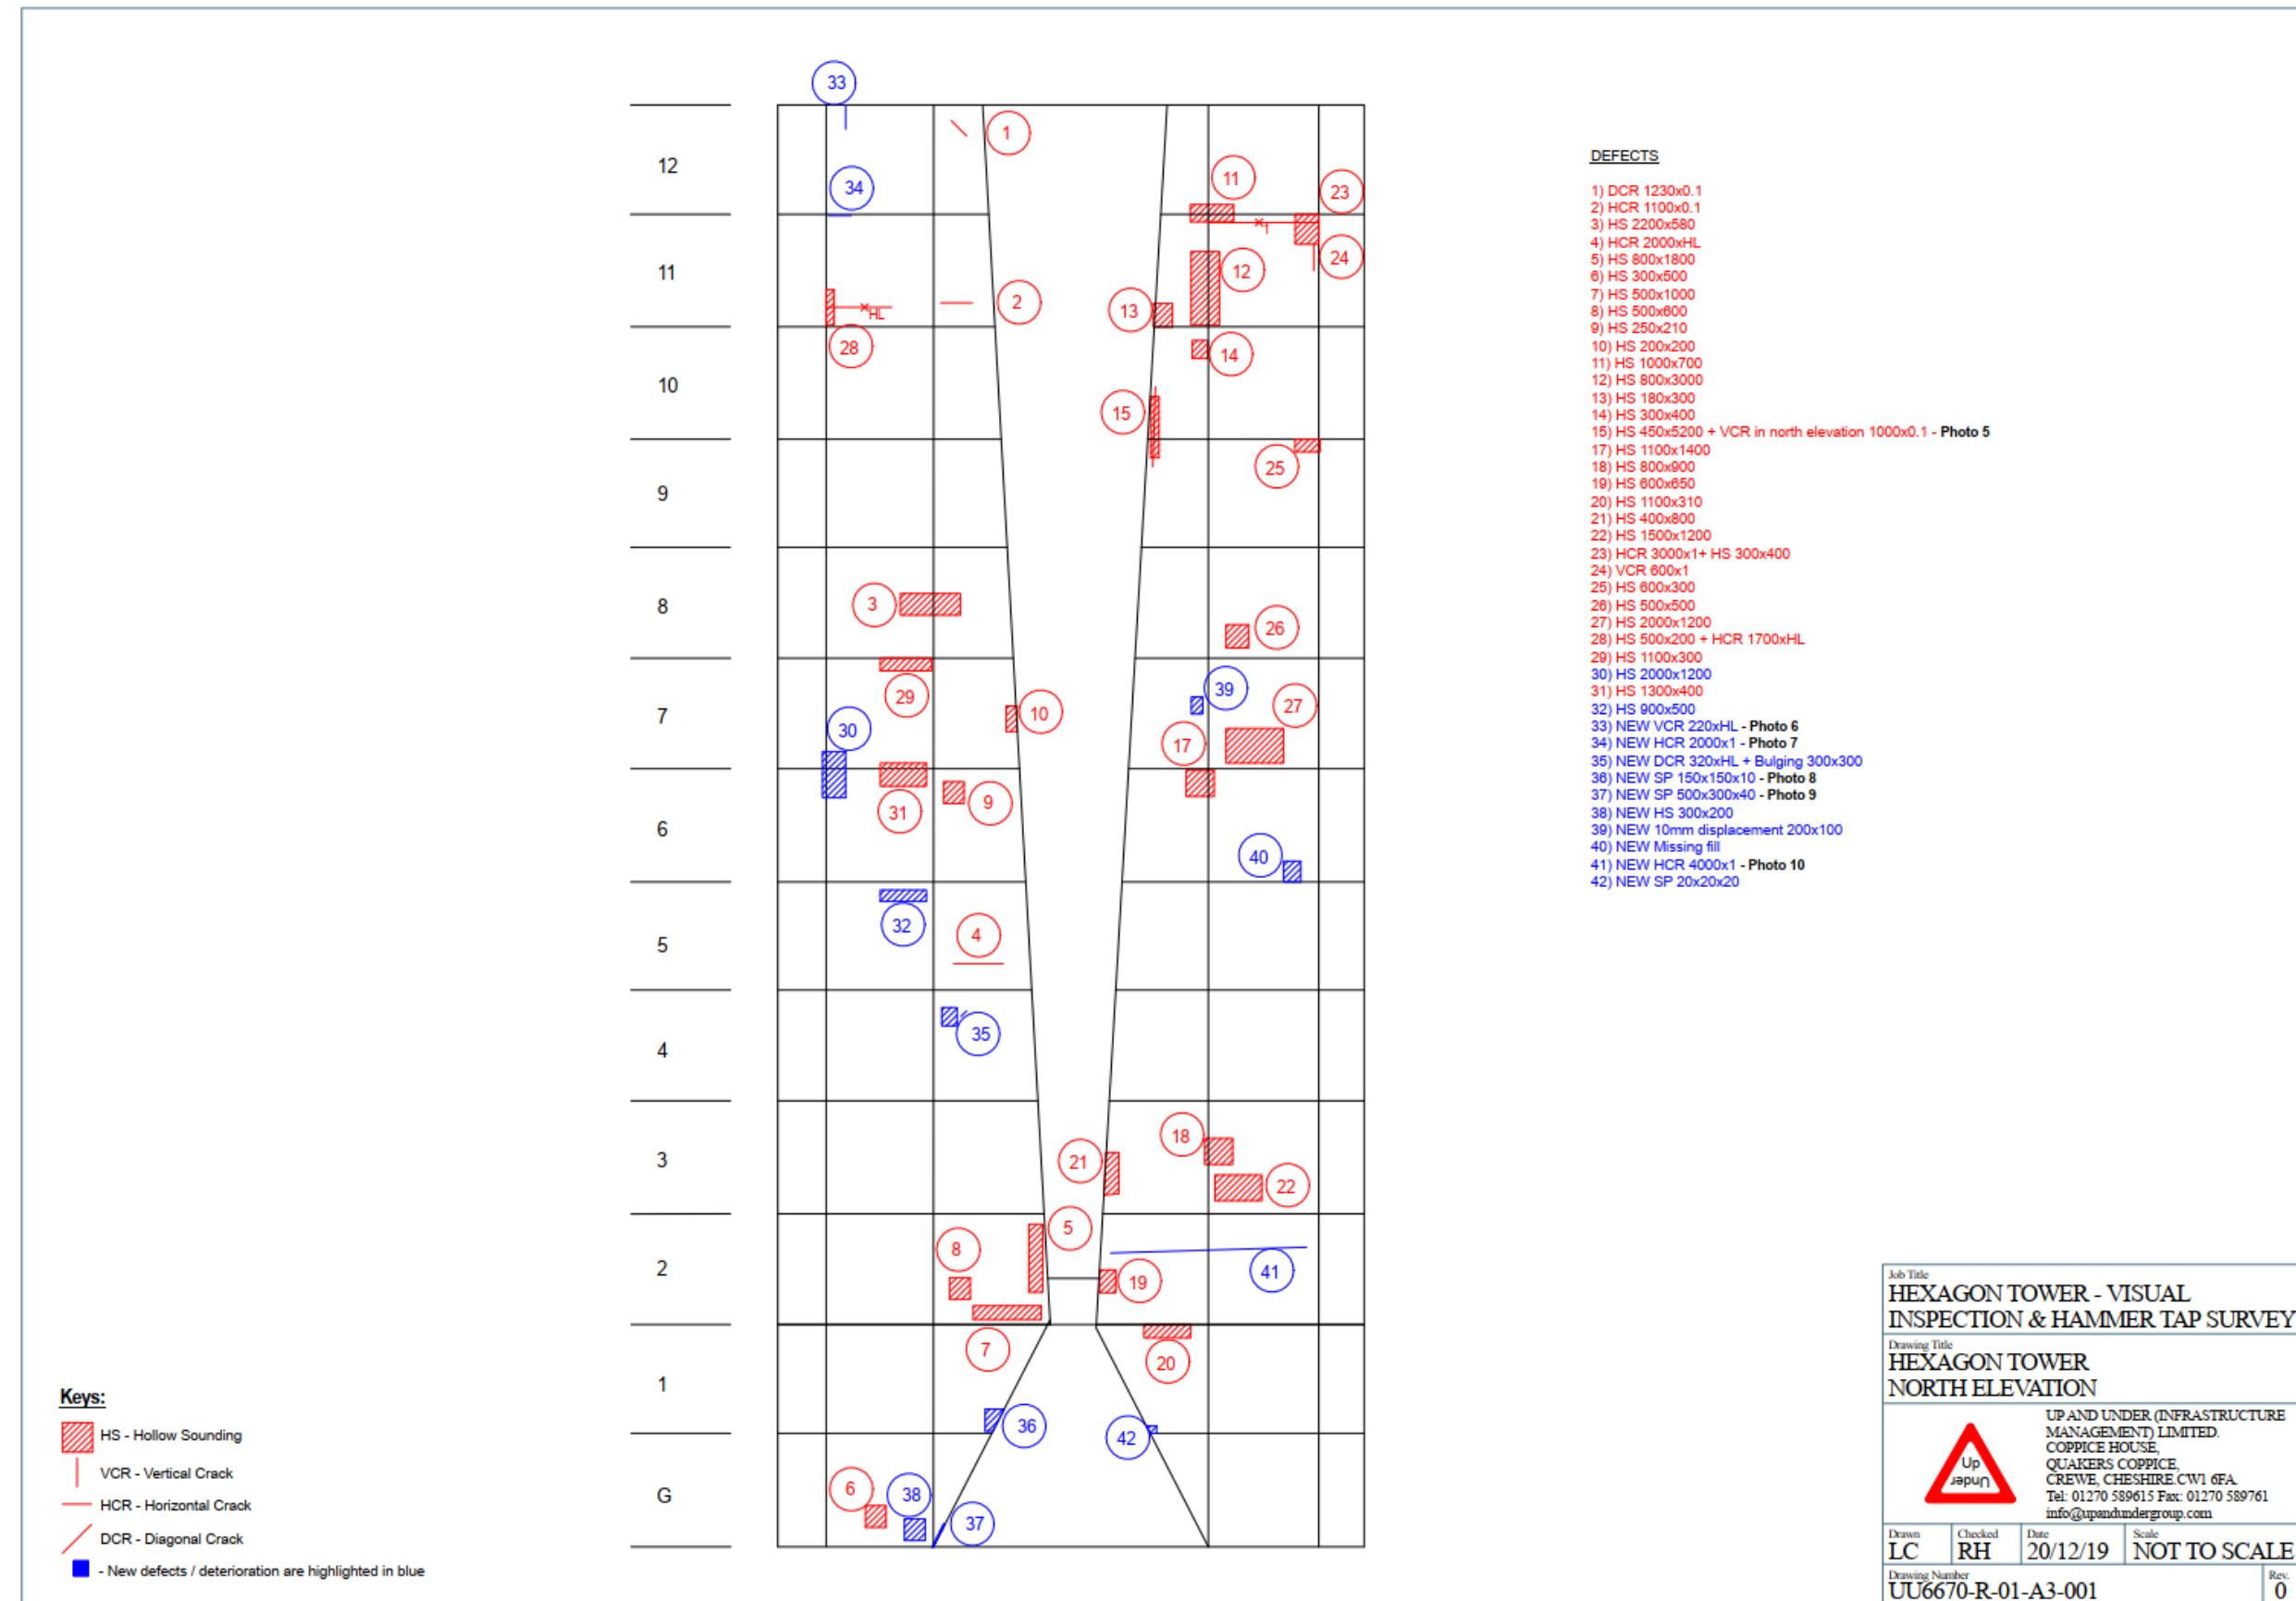
Figure A.1: Hexagon Tower north elevation defects (December 2019)

Due to the large size of the cladding panels present on the north and south elevations of the main tower, these are the areas of greatest concern. The south elevation in particular has a number of panels with multiple defects.

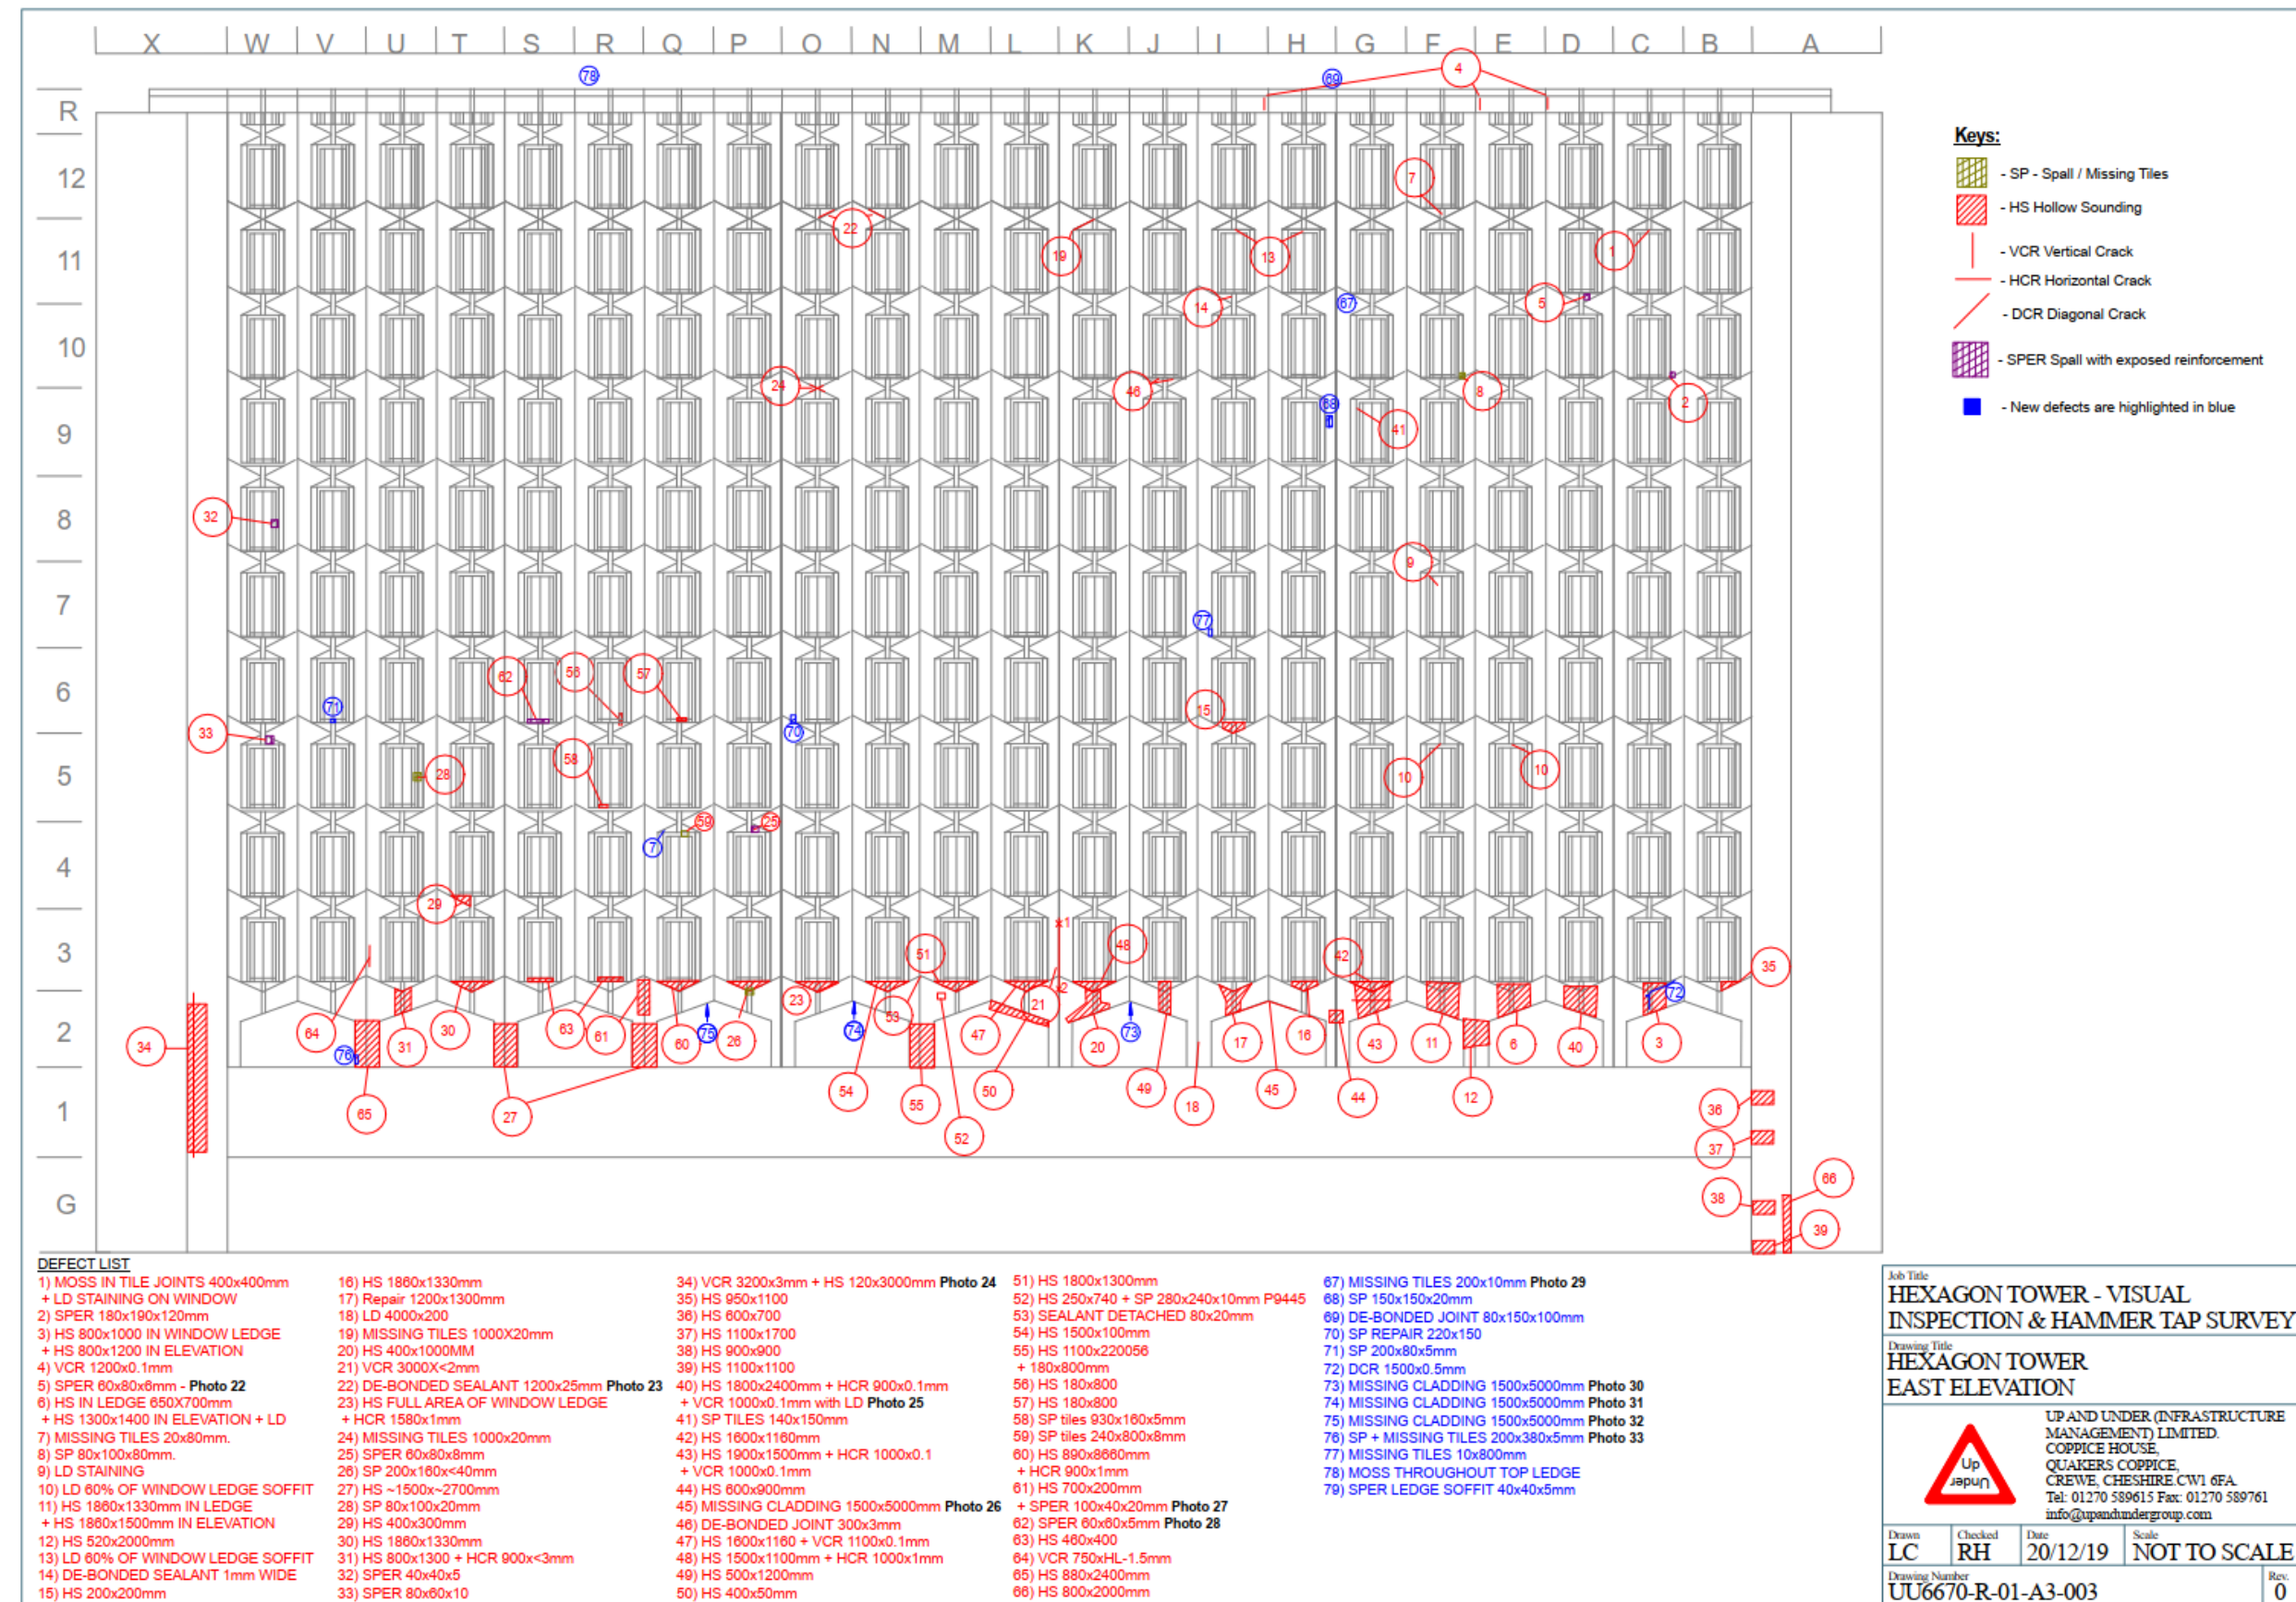
Figure A.3: Hexagon Tower east elevation defects (December 2019)

The defects noted to the east and west elevations of the main tower tend to be smaller in size, likely a combination of the smaller size of the cladding panels and better detailing between panels. The exception to this is at second floor level (above the annexe roof level), where there are a number of large areas of debonded cladding. These defects are almost continuous along the eastern elevation of the tower.

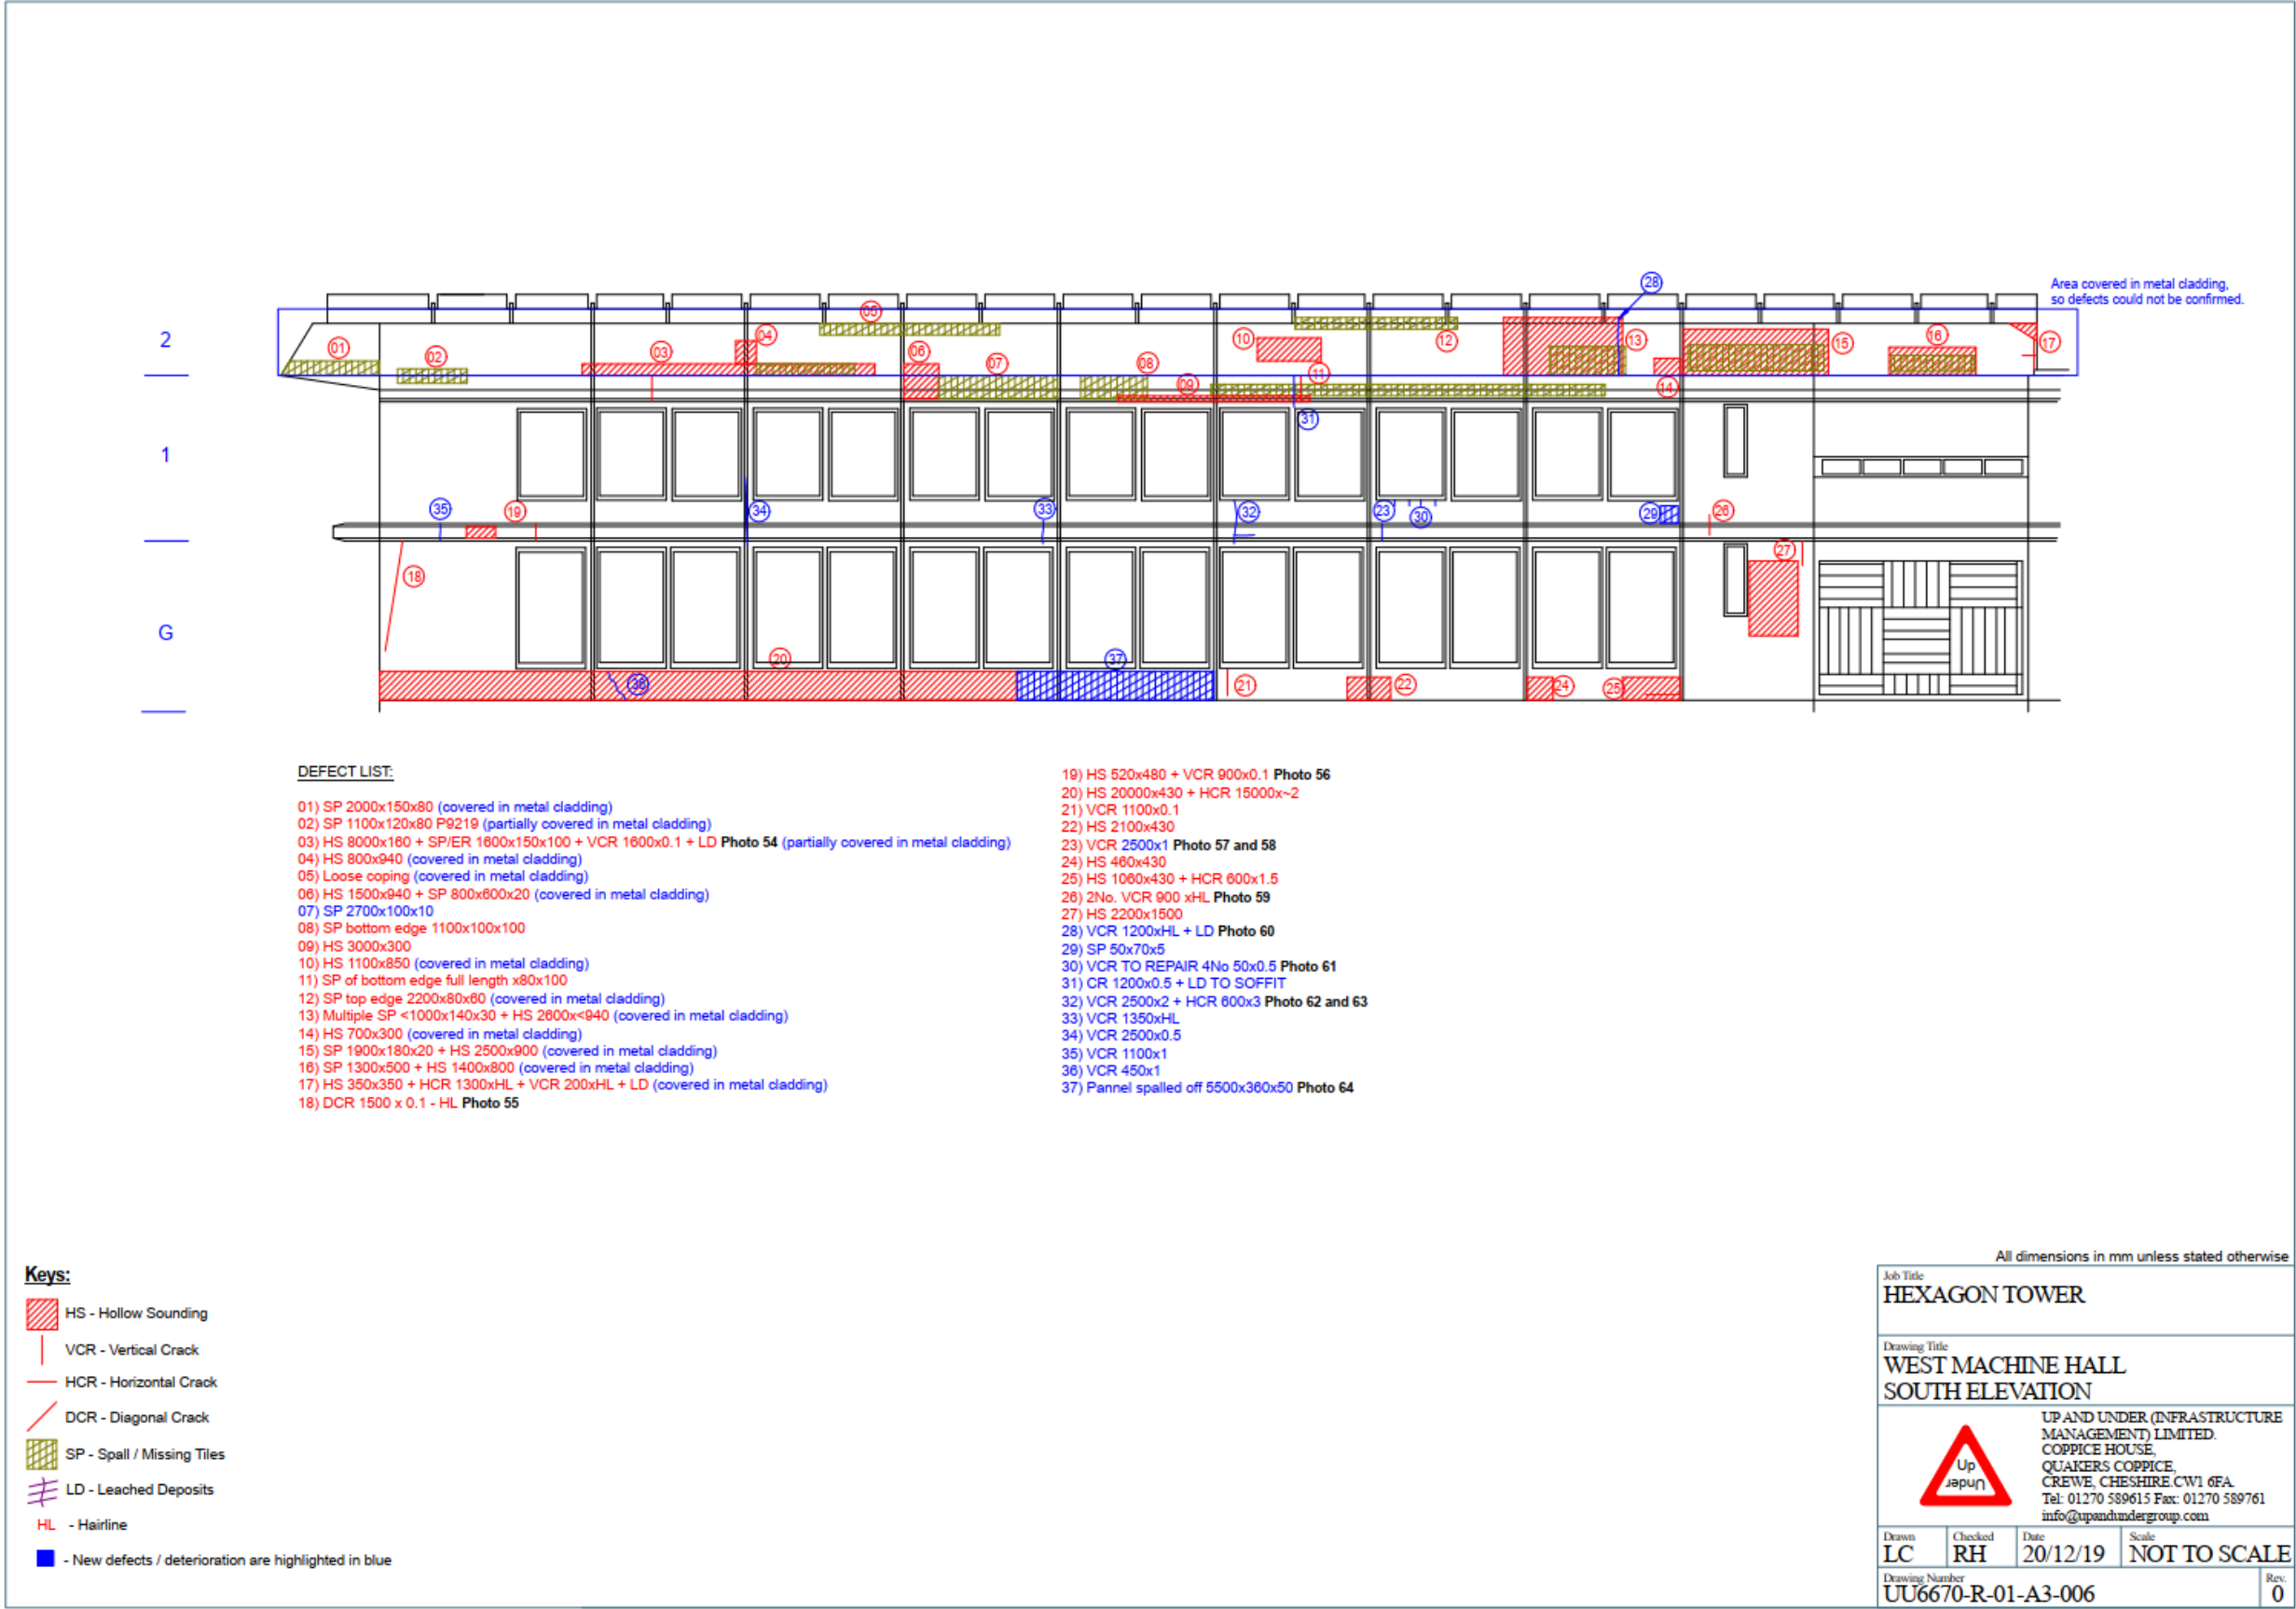
Figure A.6: Hexagon Tower West Machine Hall south elevation defects (December 2019)

Many of the cladding defects which were identified to the machine hall annexes affected the first floor cantilever, which has now been over-clad. The most severe defects which remain affect the south elevation of both annexes, however these tend to be at ground level therefore have a reduced risk of causing injury or damage by spalling.

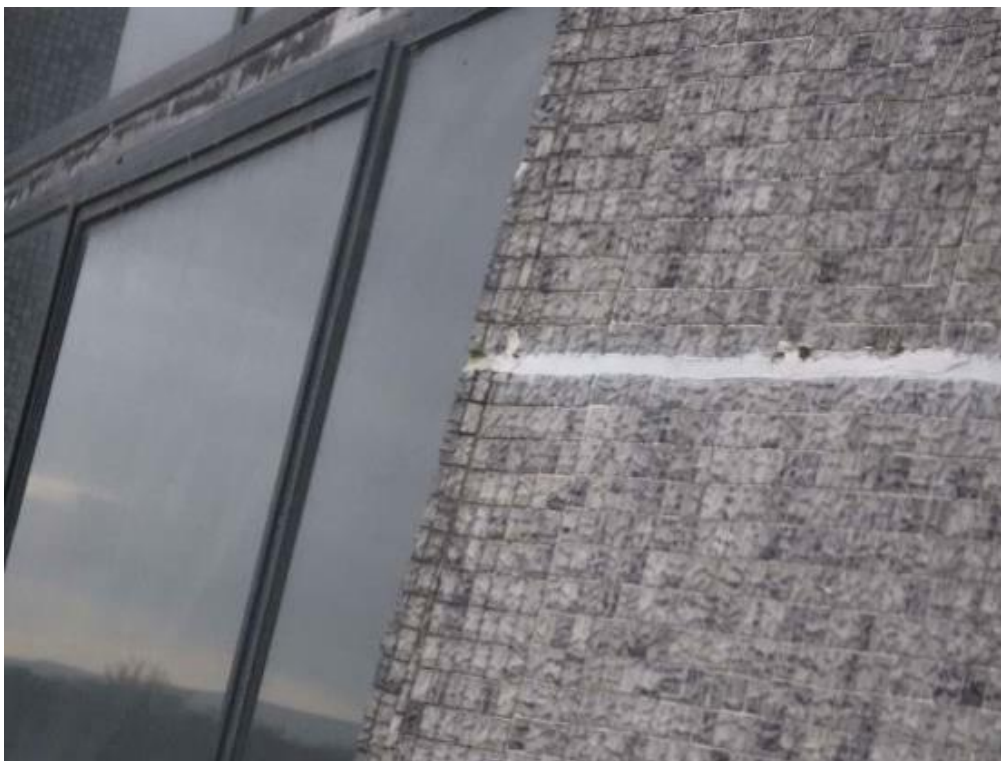
**Photo B.5: A view showing a vertical crack to the 10th storey of the north elevation**

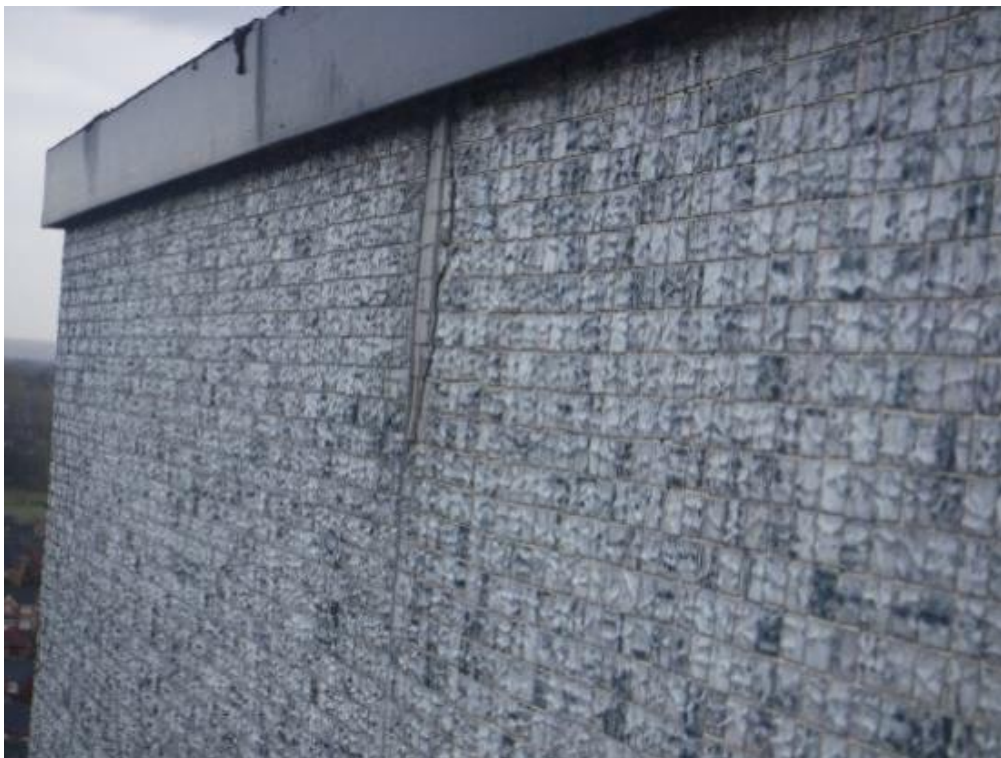
**Photo B.6: A view showing a new vertical crack in the 12th storey of the north elevation**

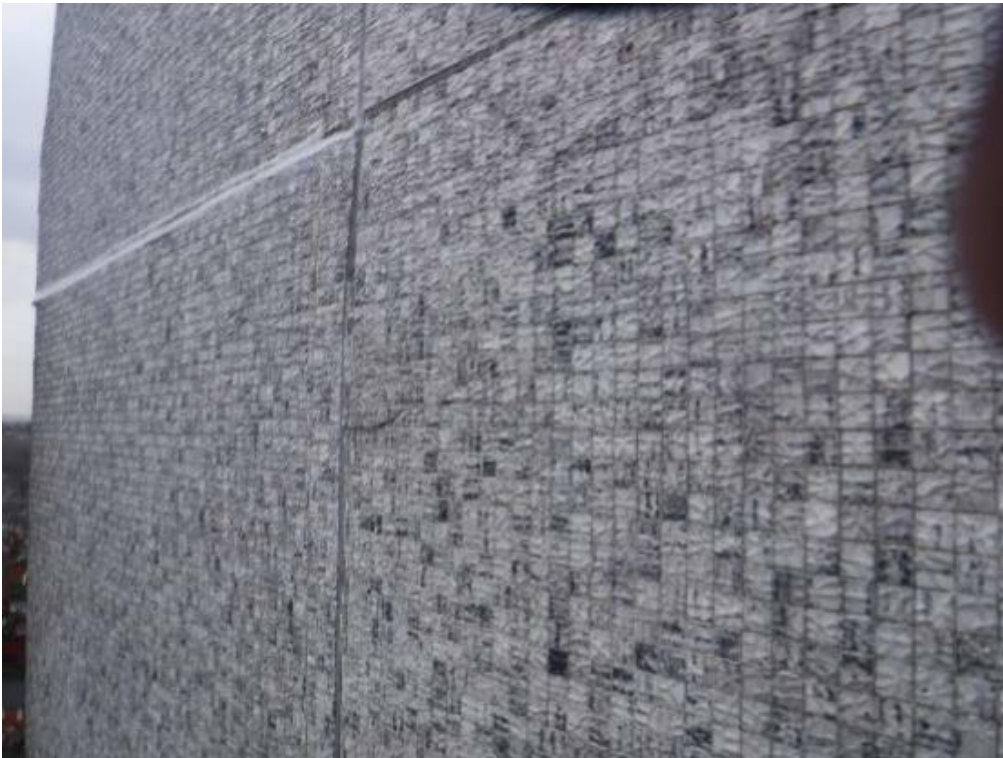
**Photo B.7: A view showing a new horizontal crack to the 11th storey of the north elevation**

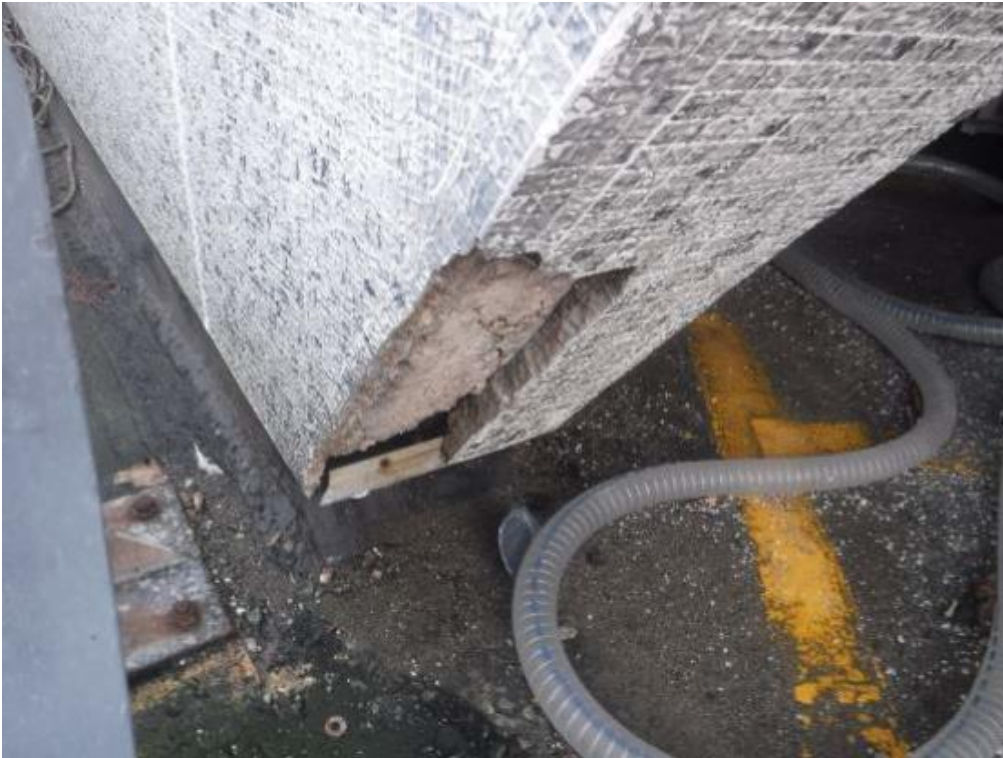
**Photo B.9: A view showing a 'new' area of spalling at ground level in the north elevation**

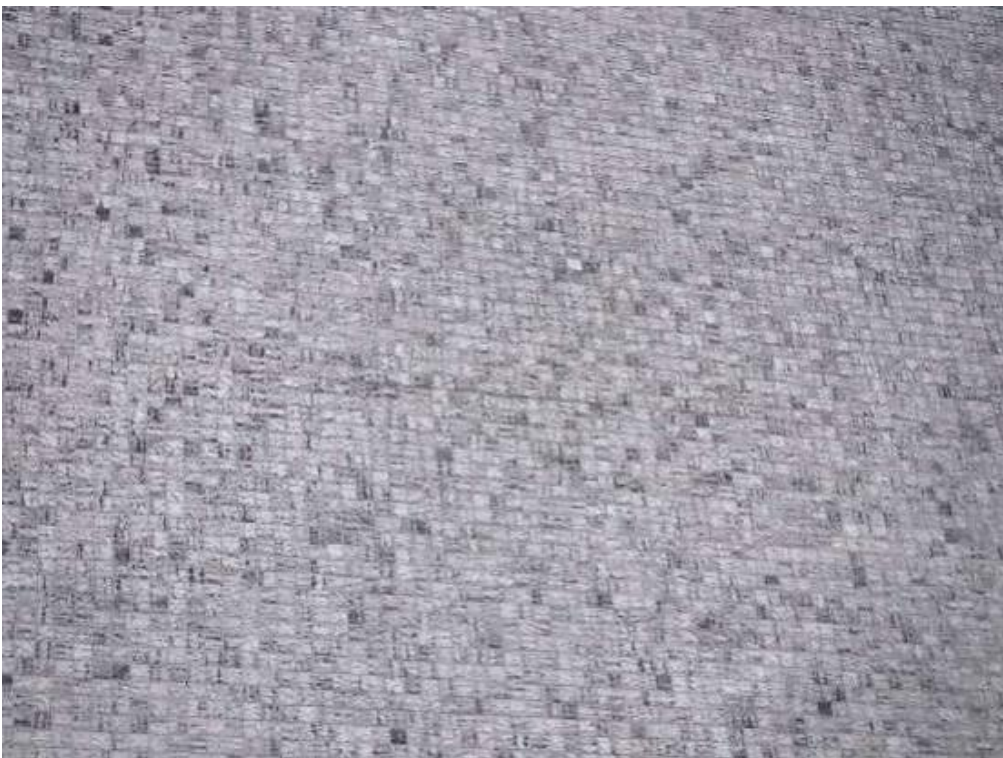
**Photo B.10: A view showing a 'new' horizontal crack to the 2nd storey of the north elevation**

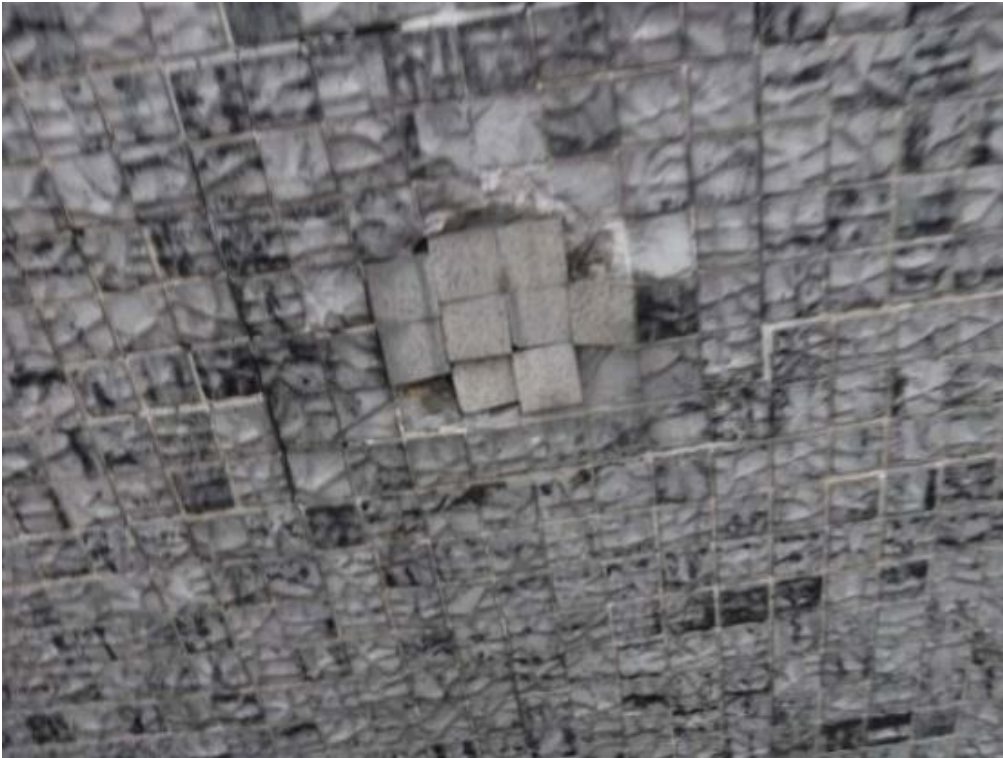
**Photo B.13: A view showing a poor repair to the 6th storey of the south elevation**

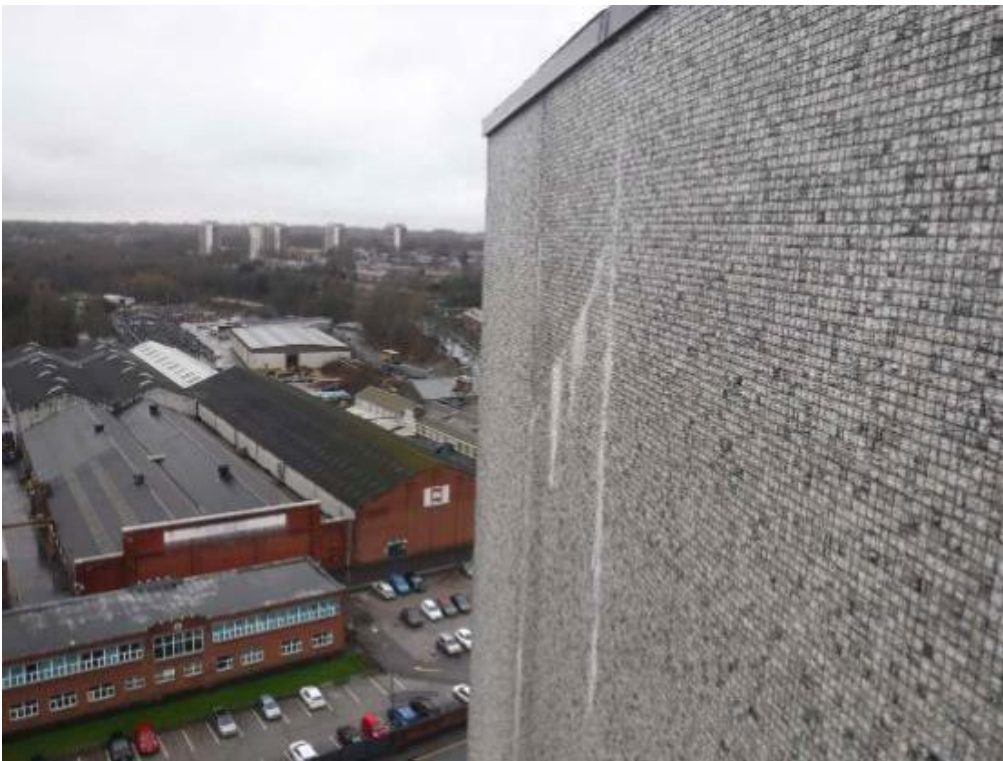
**Photo B.14: A view showing a diagonal crack with leachate deposits to the 12th storey of the south elevation**

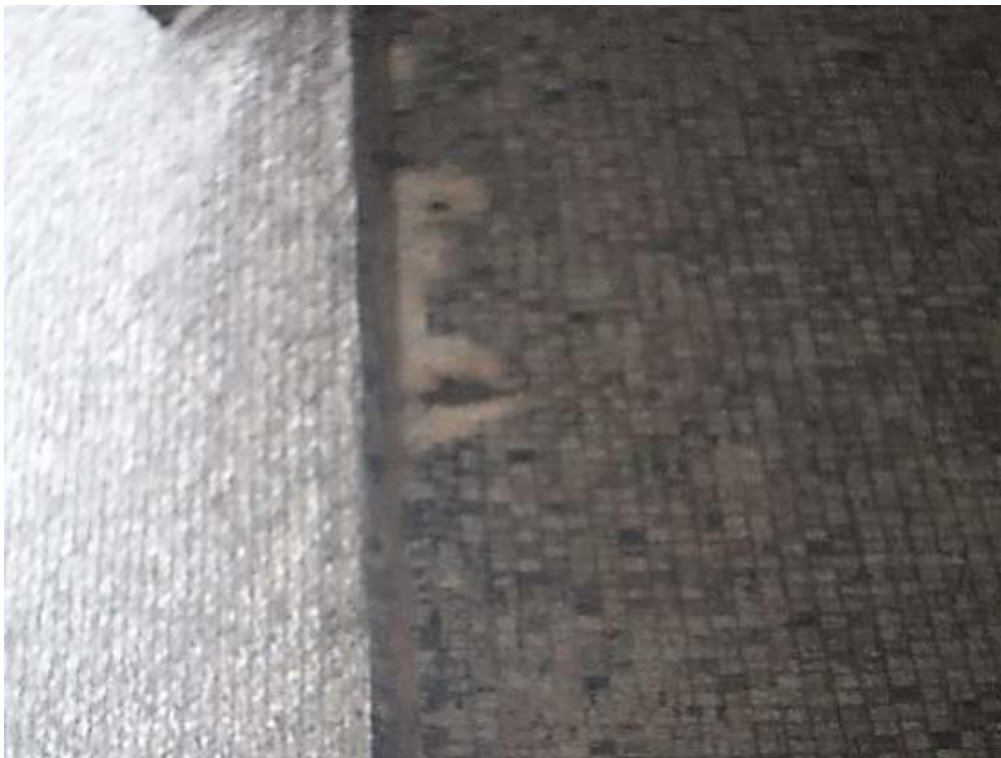
**Photo B.21: A view showing an area of spalling with exposed reinforcement to the south entrance**

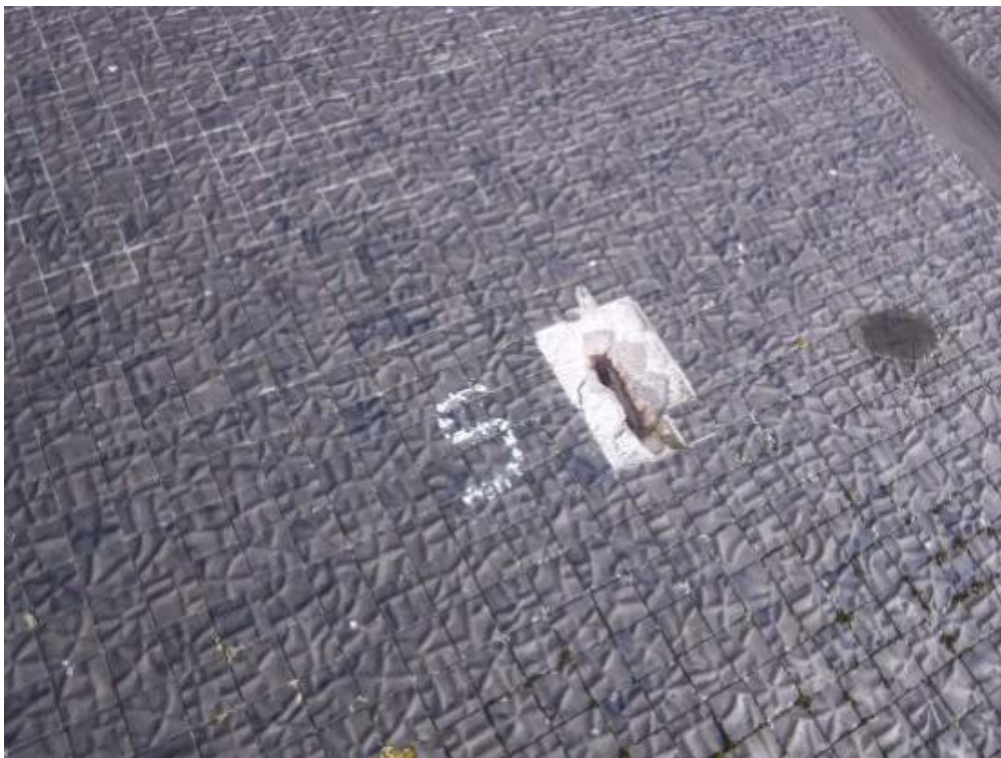
**Photo B.22: A view showing an area of spalling with exposed reinforcement to the east elevation (row D storey 11)**

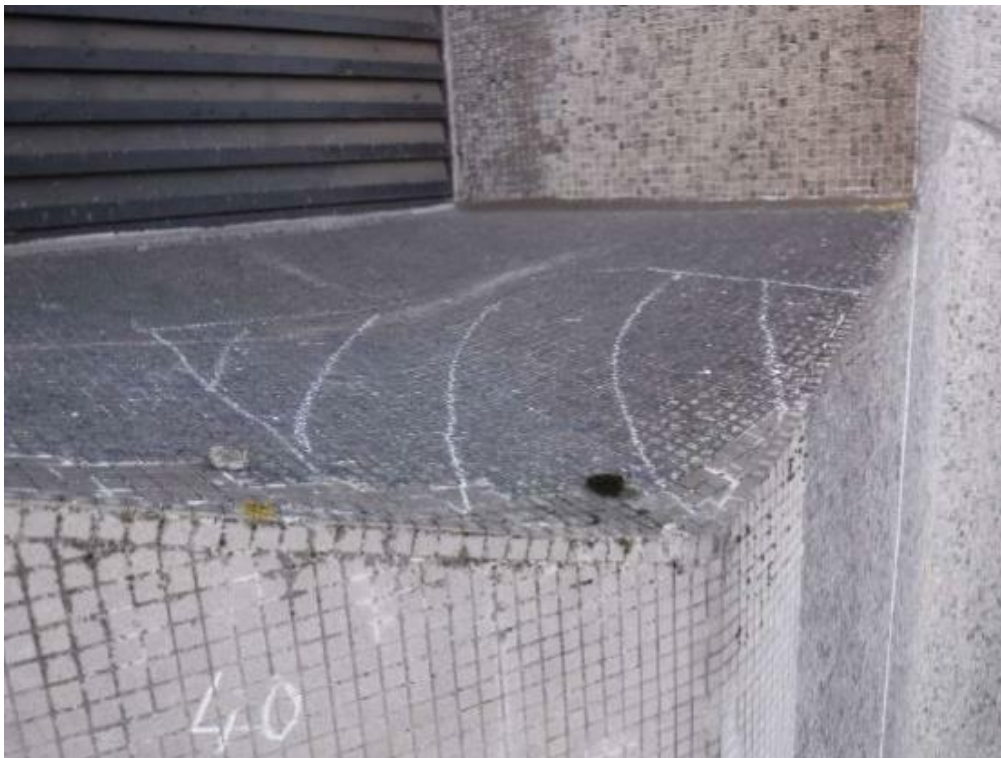
**Photo B.25: A view showing an area of hollow sounding cladding with a vertical and horizontal crack in the east elevation (row D storey 2)**

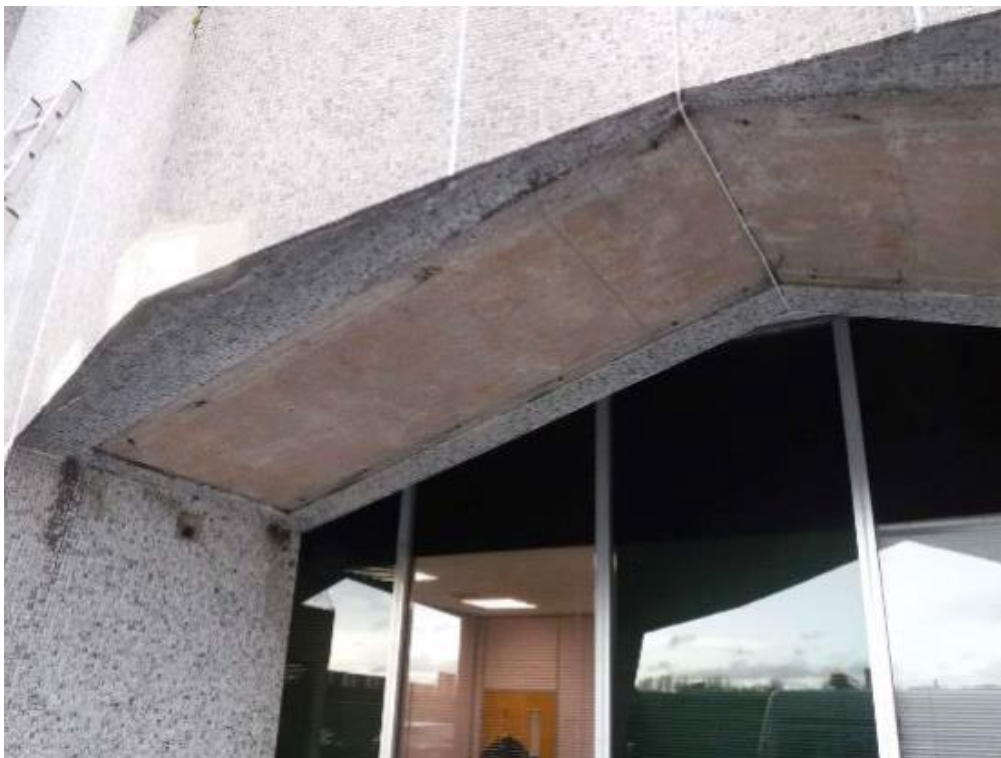
**Photo B.26: A view showing missing cladding to the east elevation (row I storey 2)**

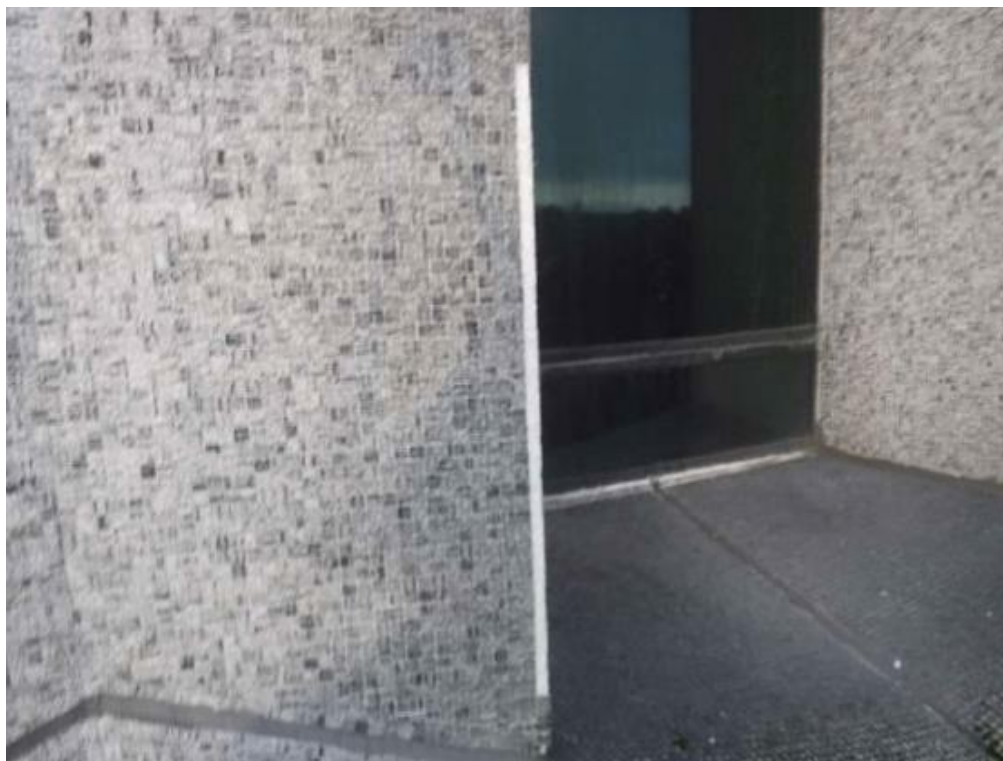
**Photo B.29: A view showing missing tiles to the east elevation (row G storey 11)**

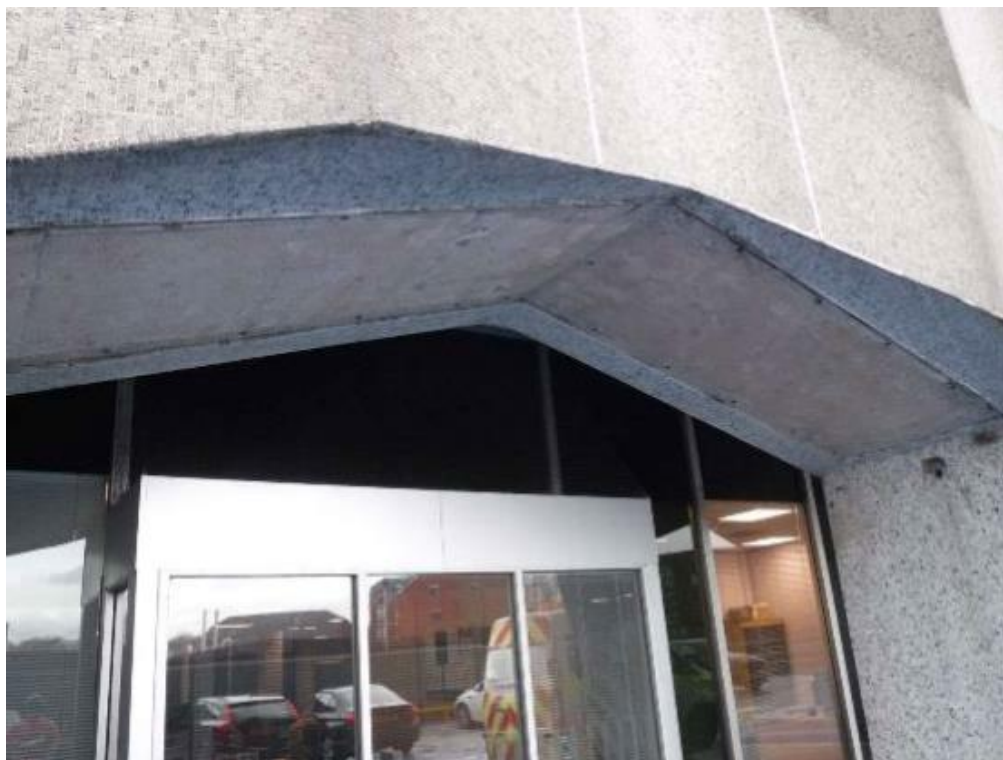
**Photo B.30: A view showing missing cladding to the east elevation (row K storey 2)**

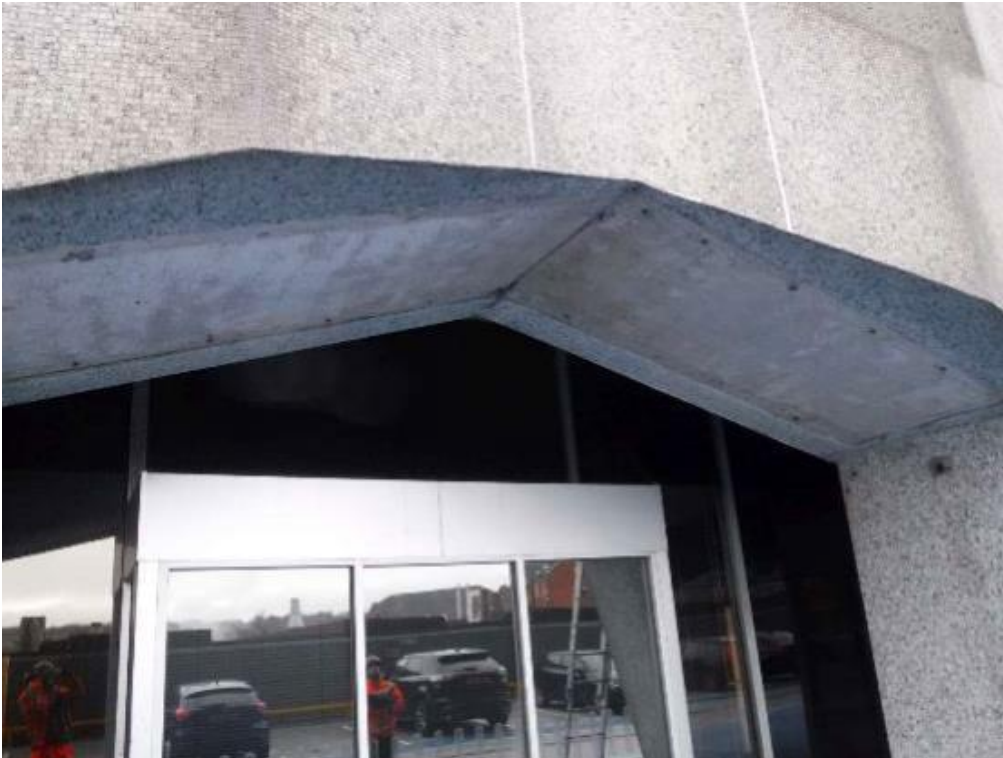
**Photo B.31: A view showing missing cladding to the east elevation (row O storey 2)**

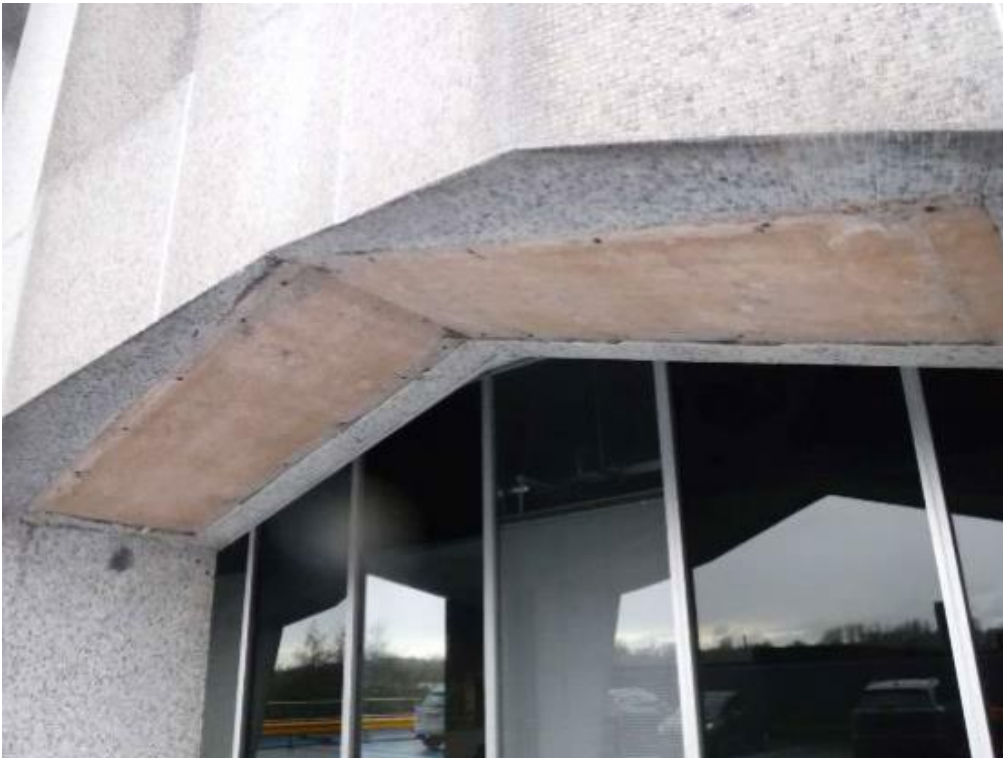
**Photo B.32: A view showing missing cladding to the east elevation (row Q storey 2)**
