# **Hexagon Tower**

Deterioration of Cladding  
Pre-planning Report

March 2021

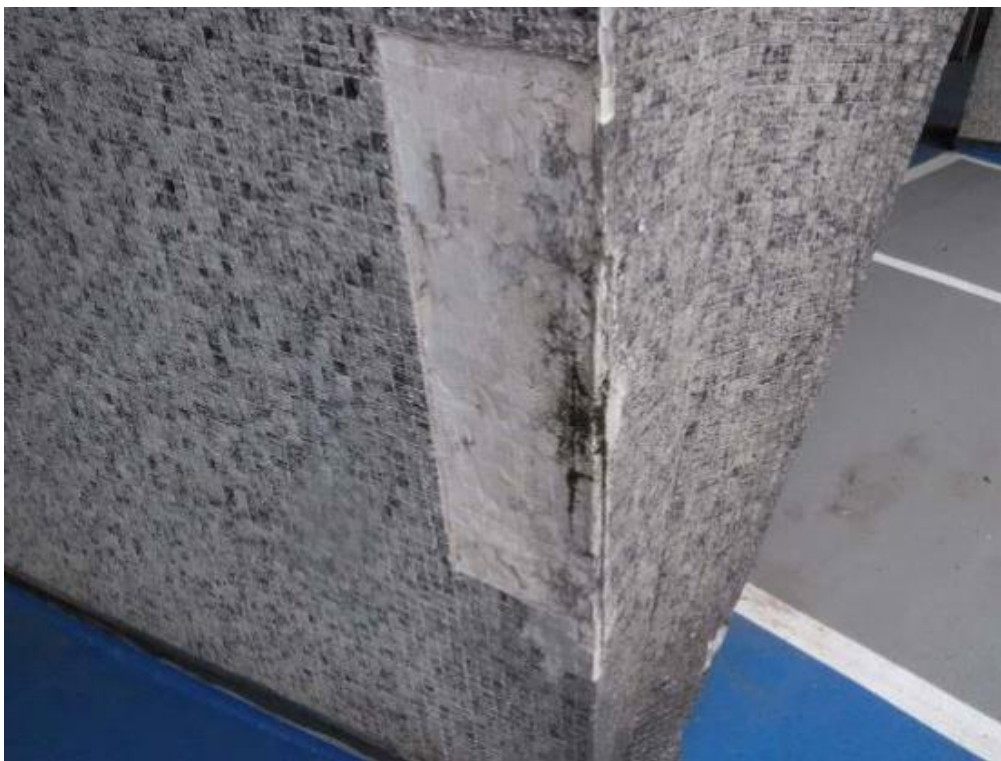
**Photo B.33: A view showing missing tiles to the east elevation (row V storey 2)**

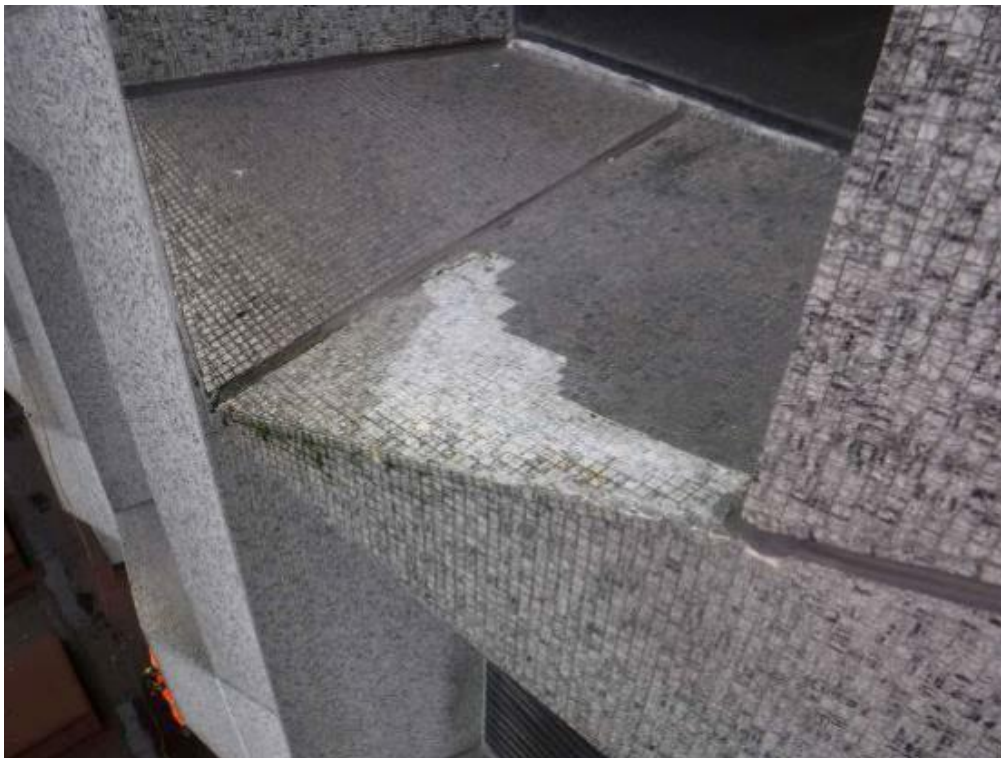
**Photo B.34: A view showing missing tiles to the west elevation (row BL storey 4)**

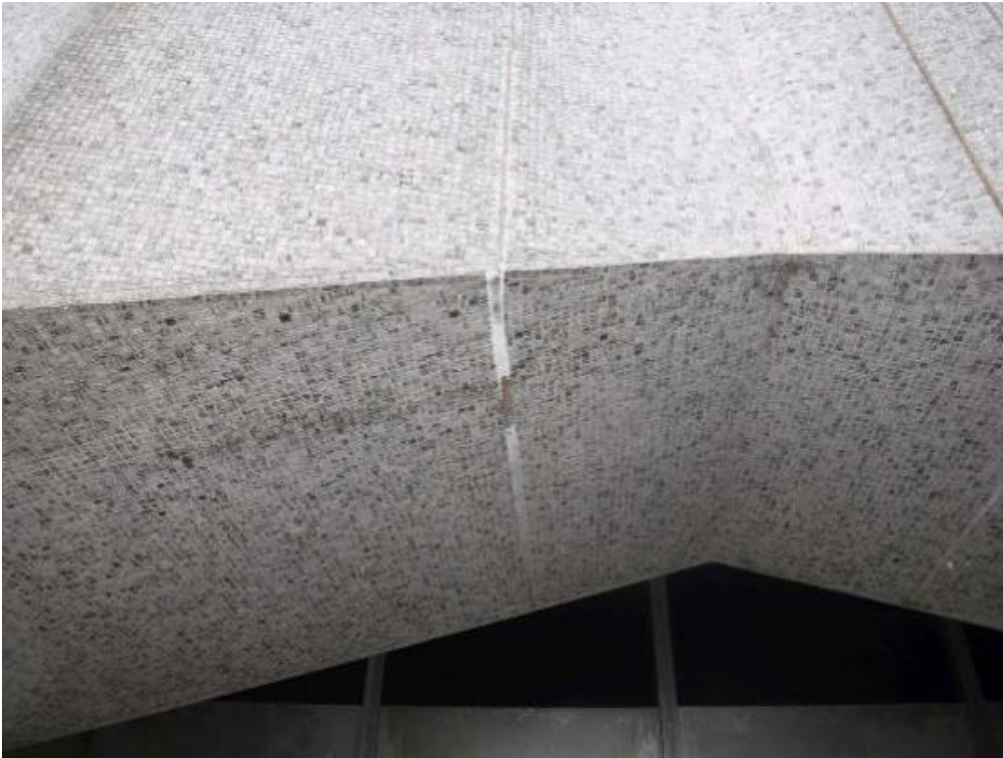
**Photo B.35: A view showing de-bonded sealant (row BM storey 2)**

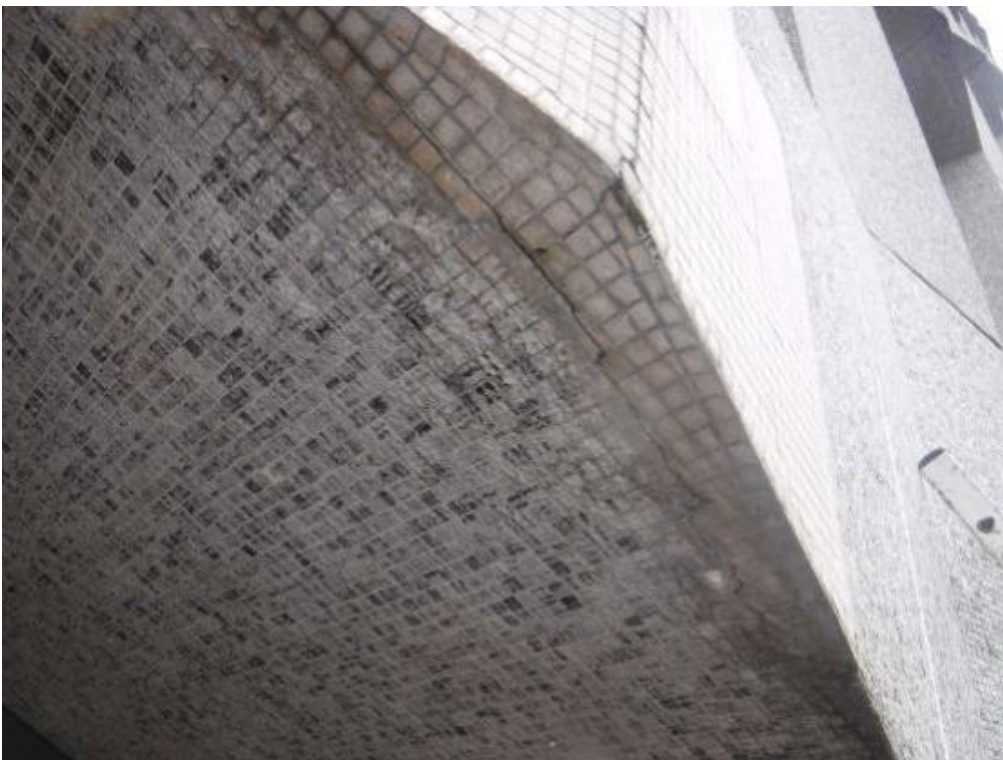
**Photo B.36: A view showing a horizontal crack in the window reveal soffit of the east elevation (row BI storey 2)**

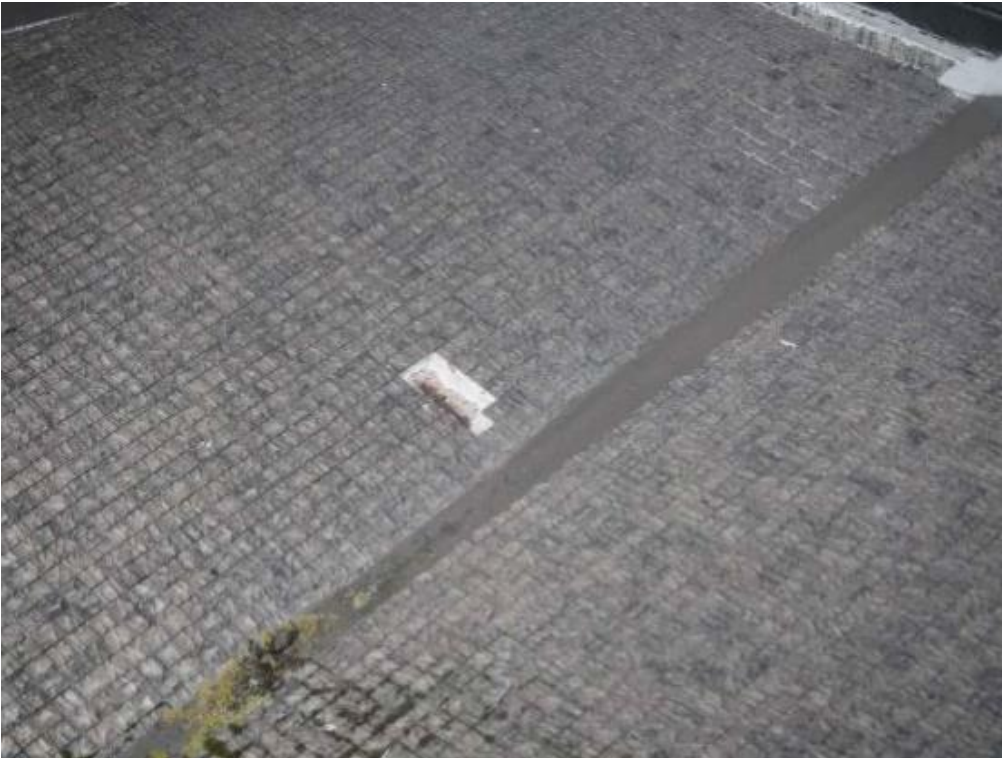
**Photo B.37: A view showing spalling with exposed reinforcement (row BR storey 11)**

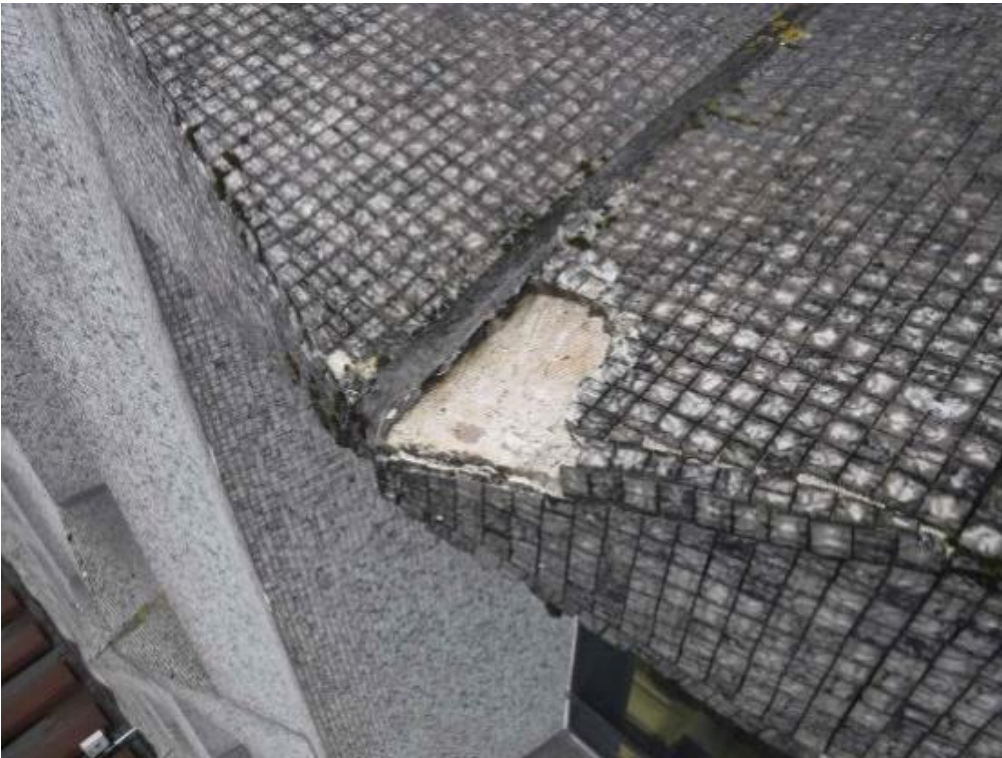
**Photo B.38: A view showing missing tiles to the west elevation (row BD storey 11)**

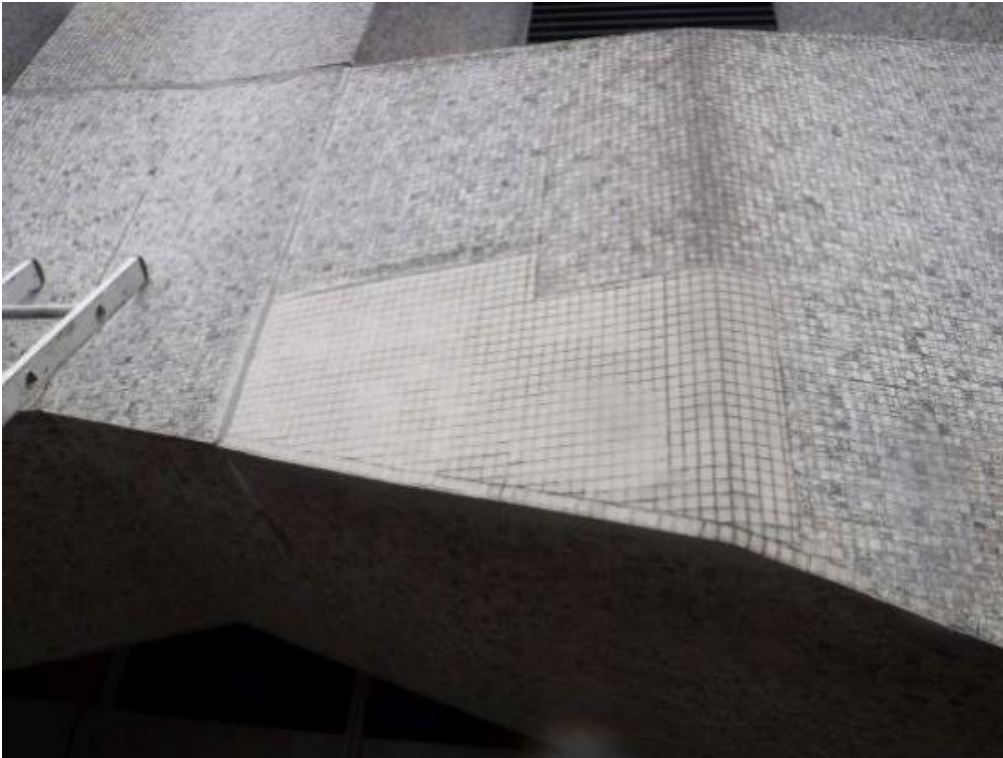
**Photo B.39: A view showing hollow sounding repaired cladding (row BJ storey 2)**

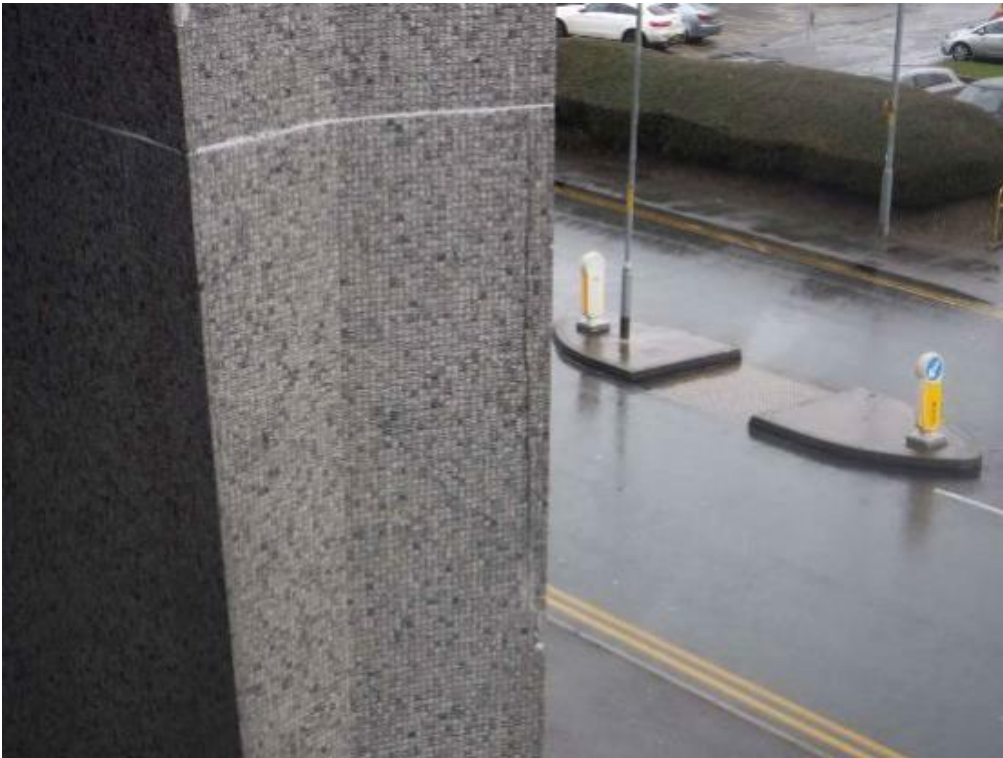
**Photo B.40: A view showing a vertical crack in the west elevation (row BA storey 2)**

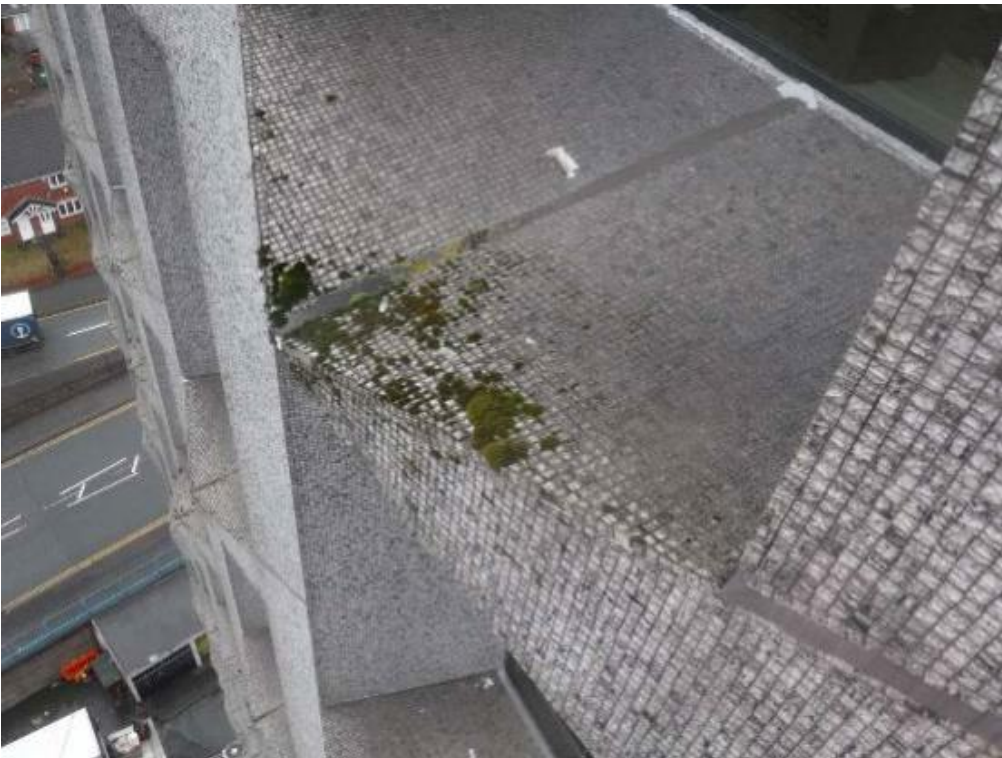
**Photo B.42: A view showing moss growth to the west elevation (row BR storey 11)**

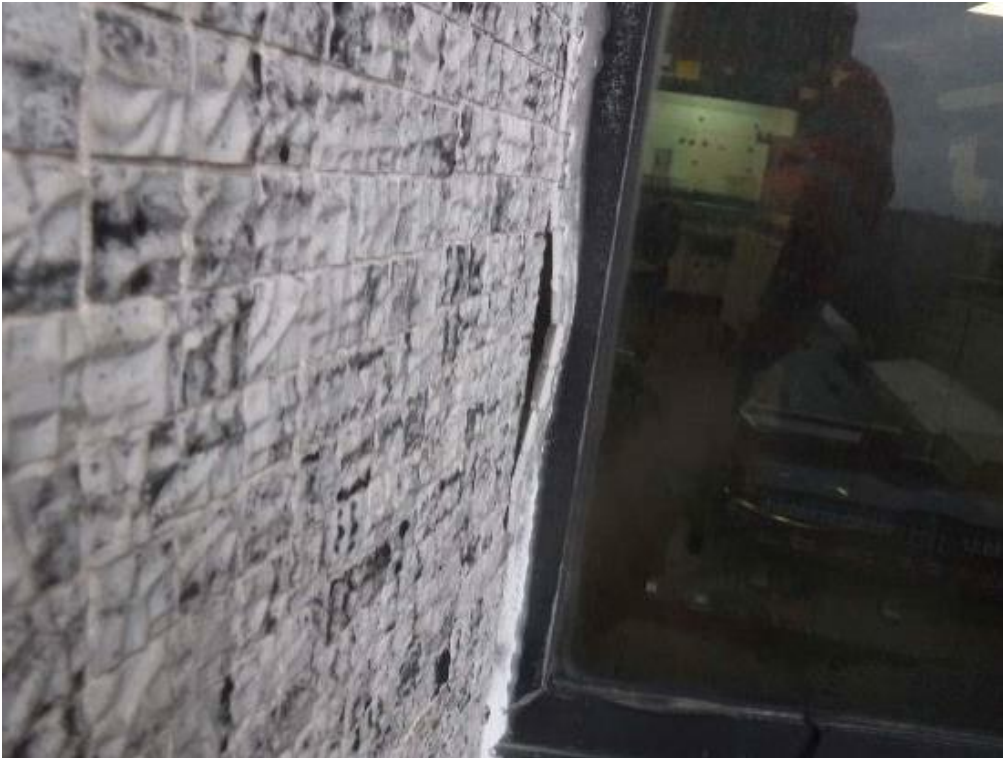
**Photo B.43: A view showing loose tiles to the west elevation (row BQ storey 10)**

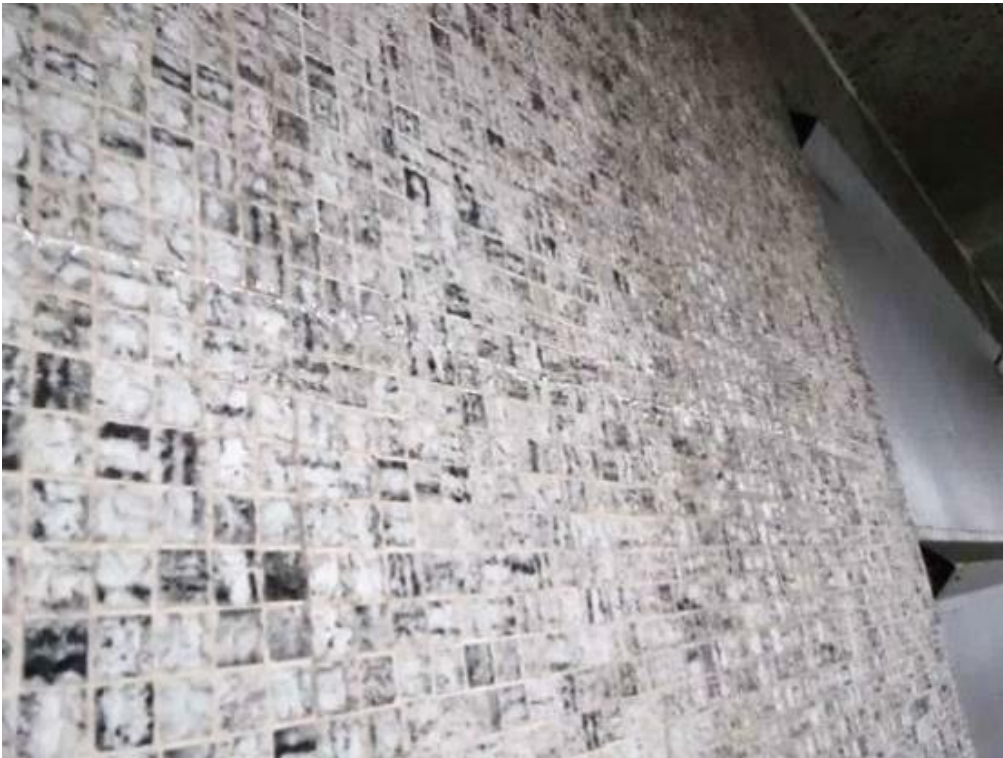
**Photo B.45: A view showing a horizontal crack in the elevation (West machine hall north elevation)**

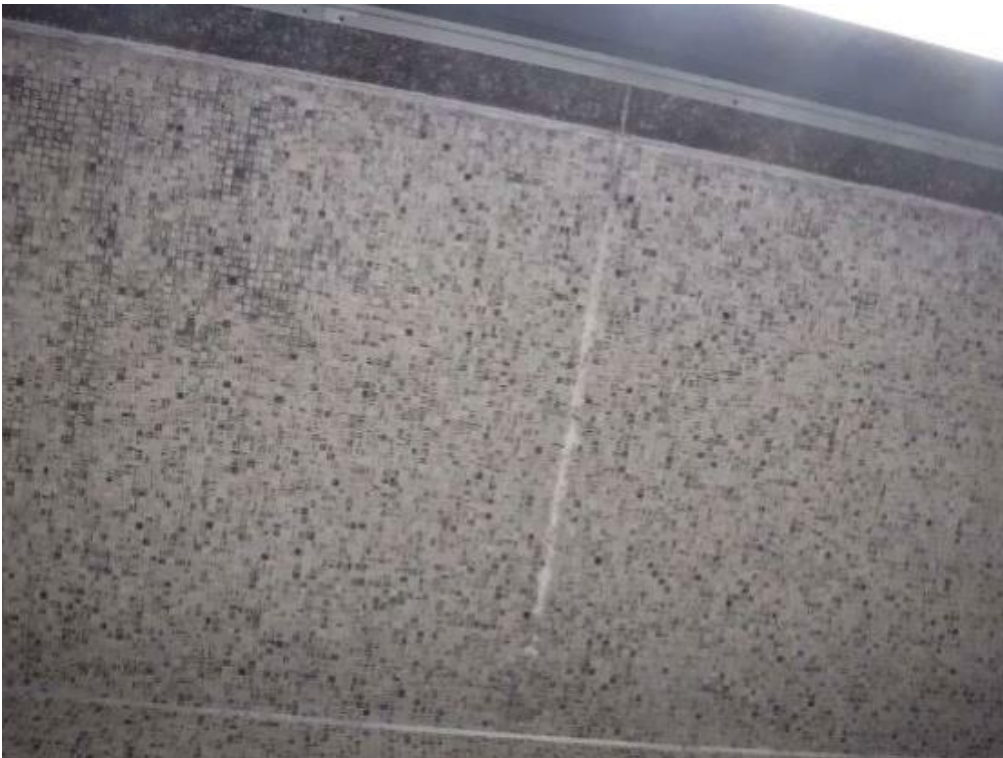
**Photo B.46: A view showing a crack in the soffit of the upper cantilever (West machine hall north elevation)**

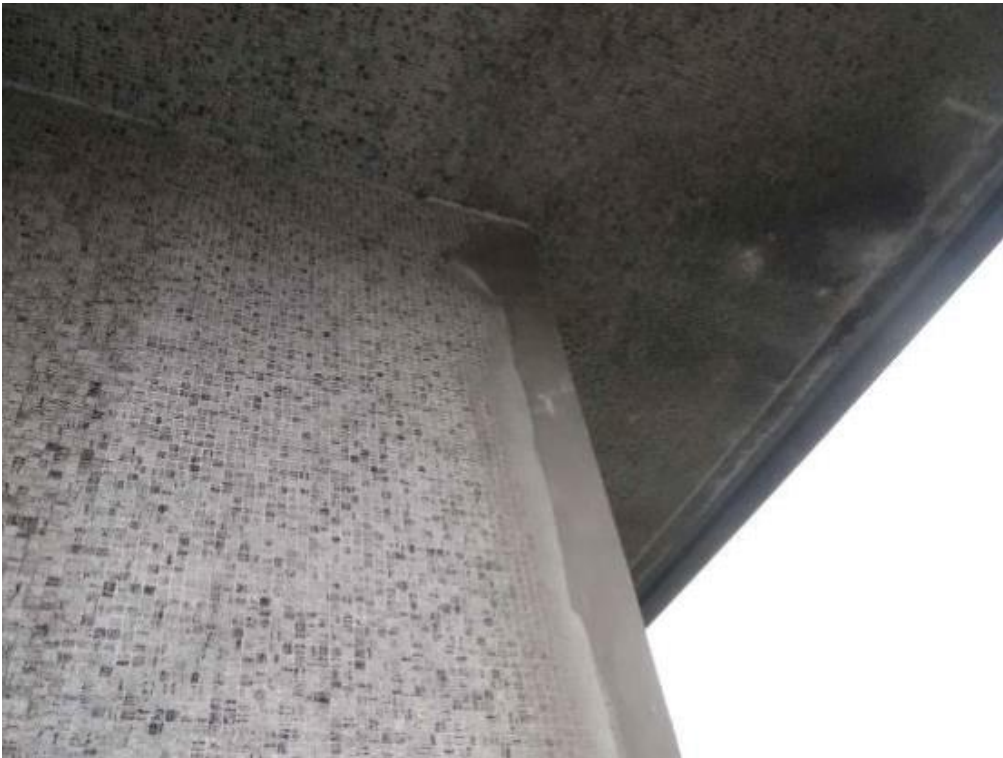
**Photo B.47: A view showing a repaired vertical crack to the elevation (West machine hall north elevation)**

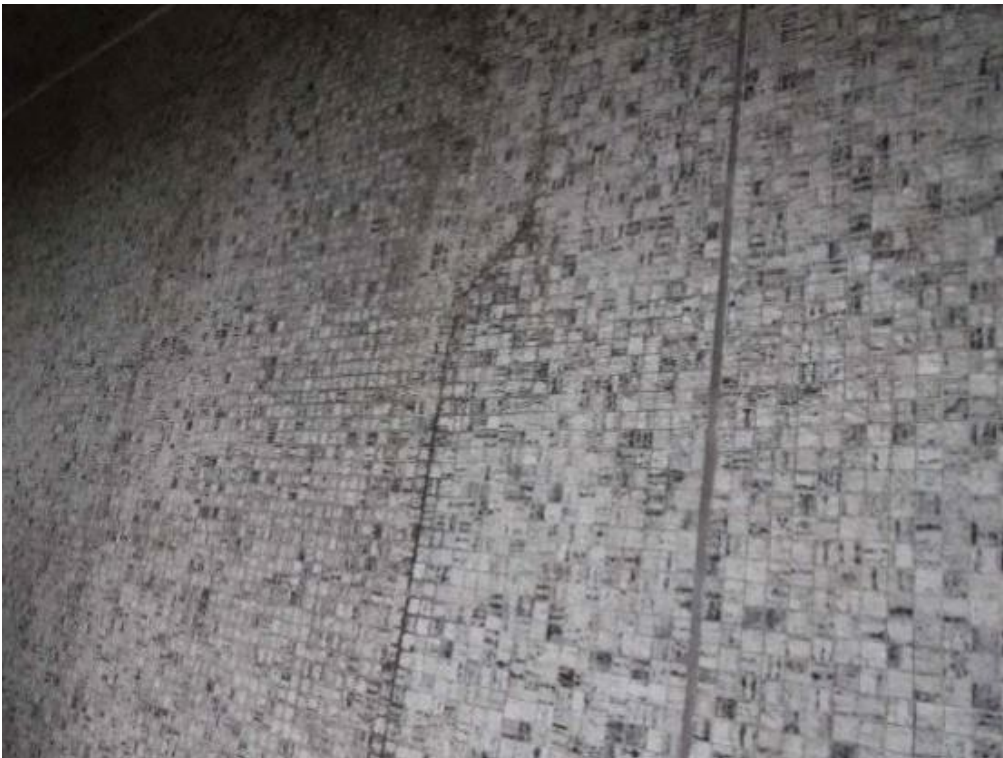
**Photo B.48: A view showing a vertical crack in the north elevation of the West machine hall**

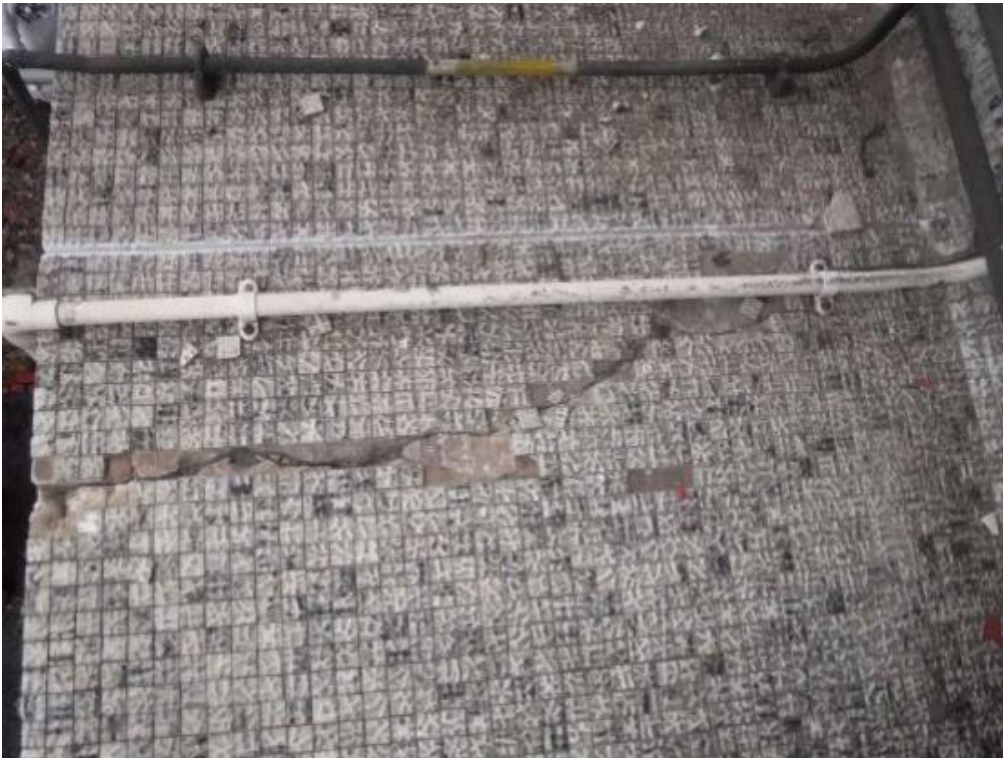
**Photo B.51: A view showing a crack in the top face of the lower cantilever (West machine hall north elevation)**

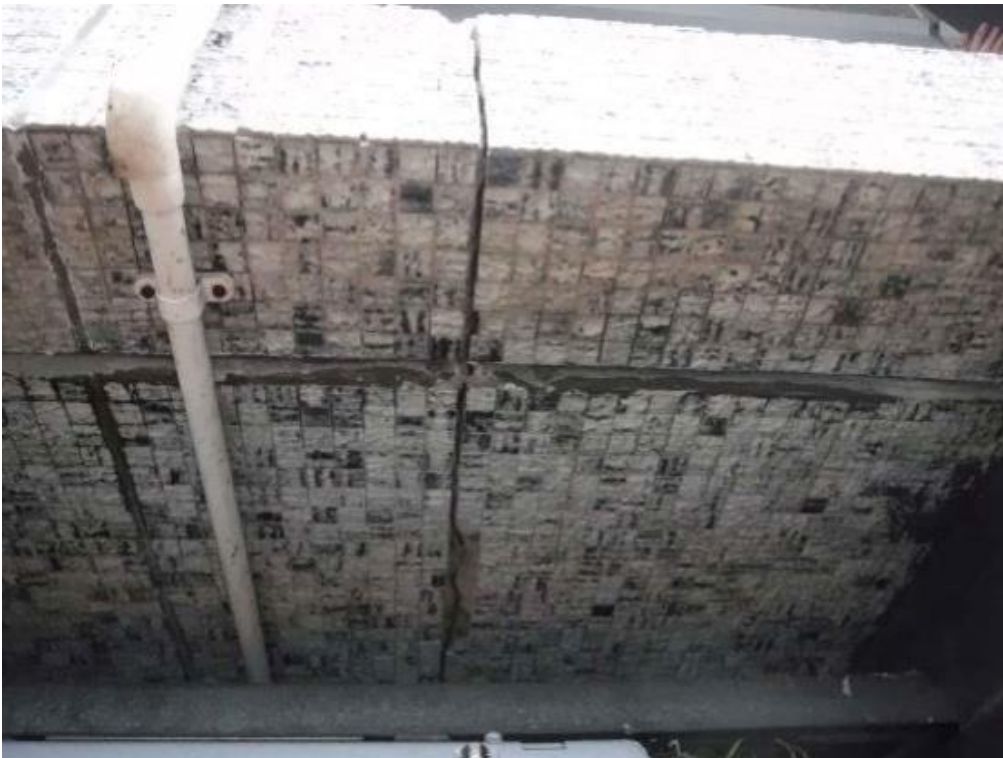
**Photo B.52: A view showing a crack in the soffit of the lower cantilever (West machine hall north elevation)**

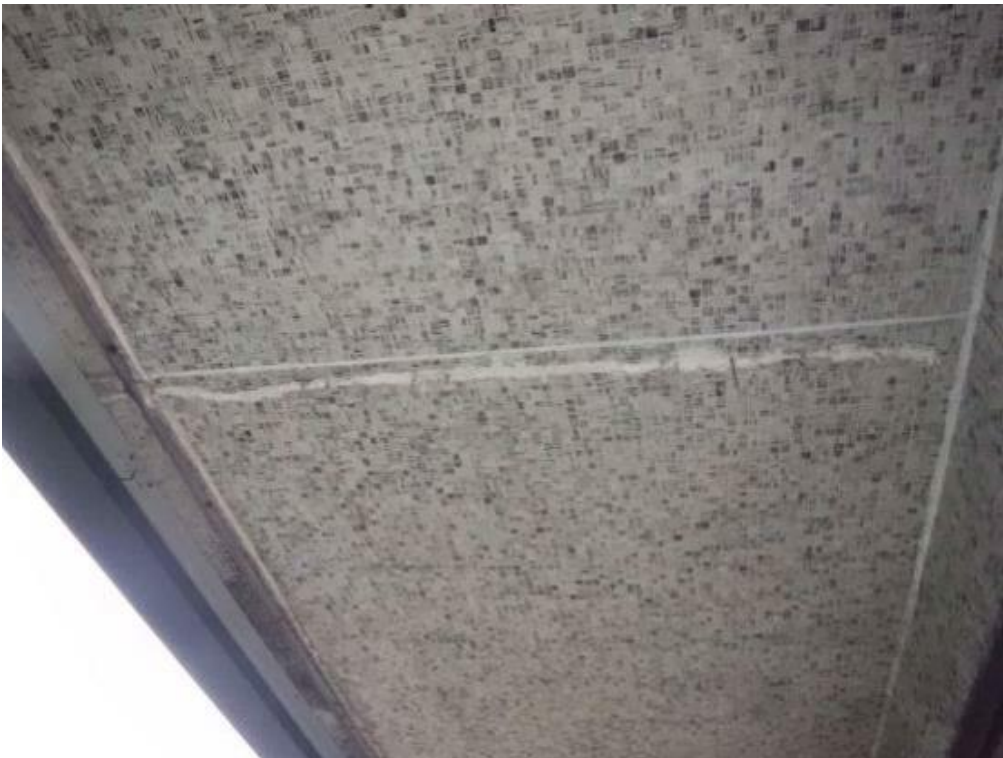
**Photo B.54: A view showing a crack in soffit of the upper cantilever (West machine hall south elevation)**

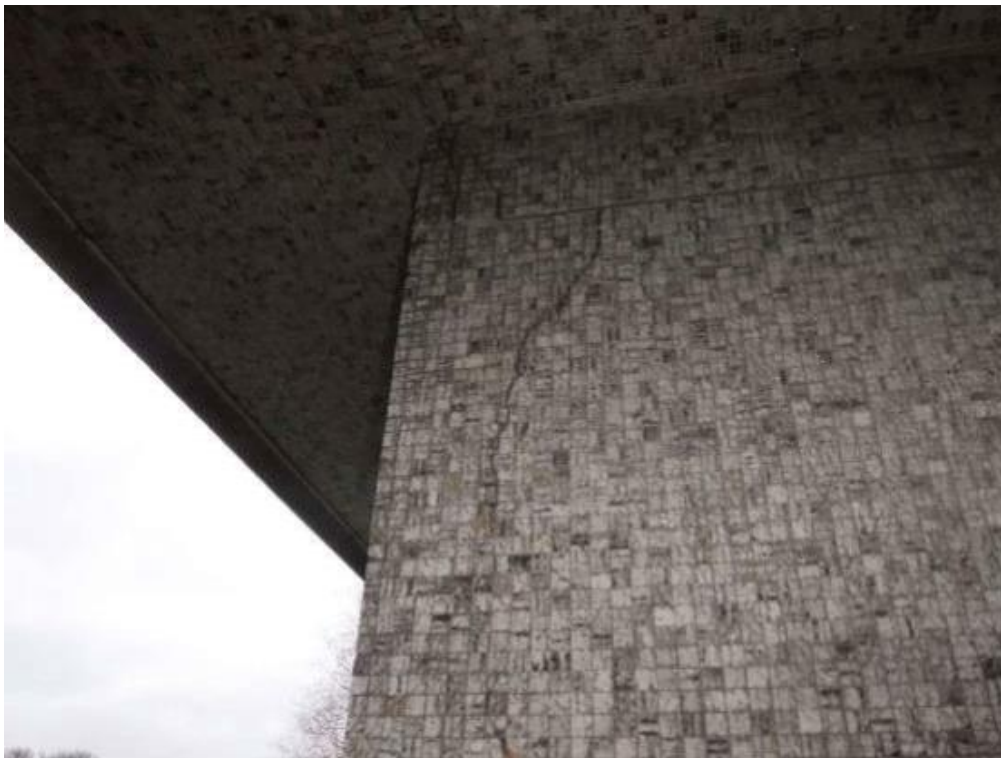
**Photo B.55: A view showing a diagonal crack in the south elevation (West machine hall)**

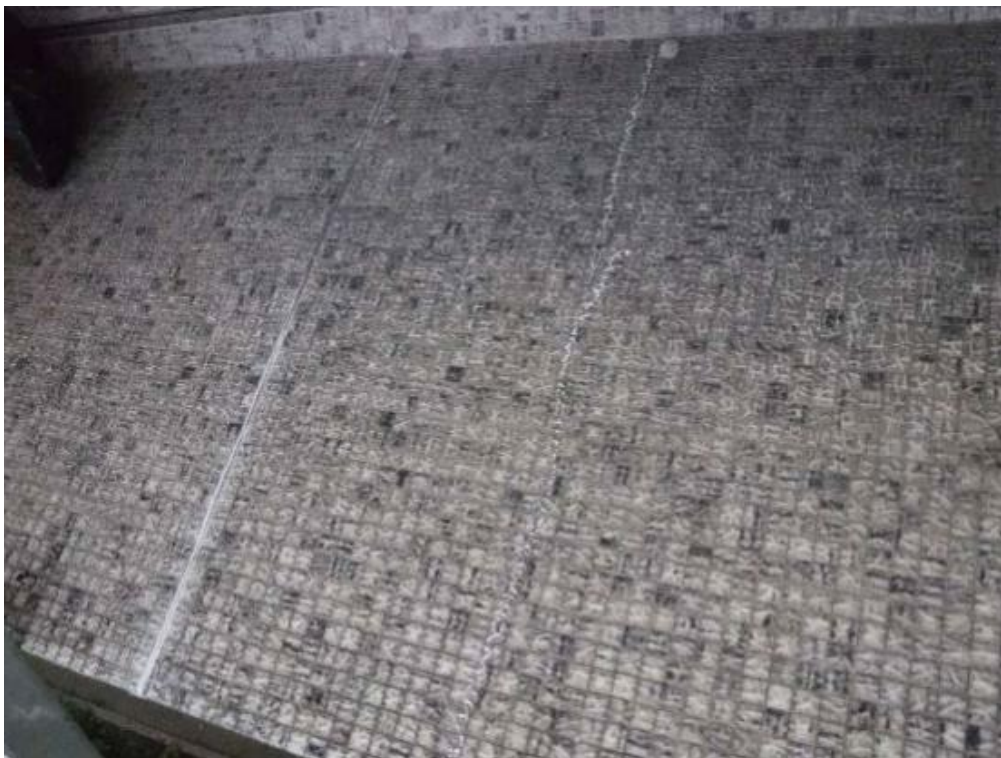
**Photo B.56: A view showing a crack in the top face of the lower cantilever (West machine hall, south elevation)**

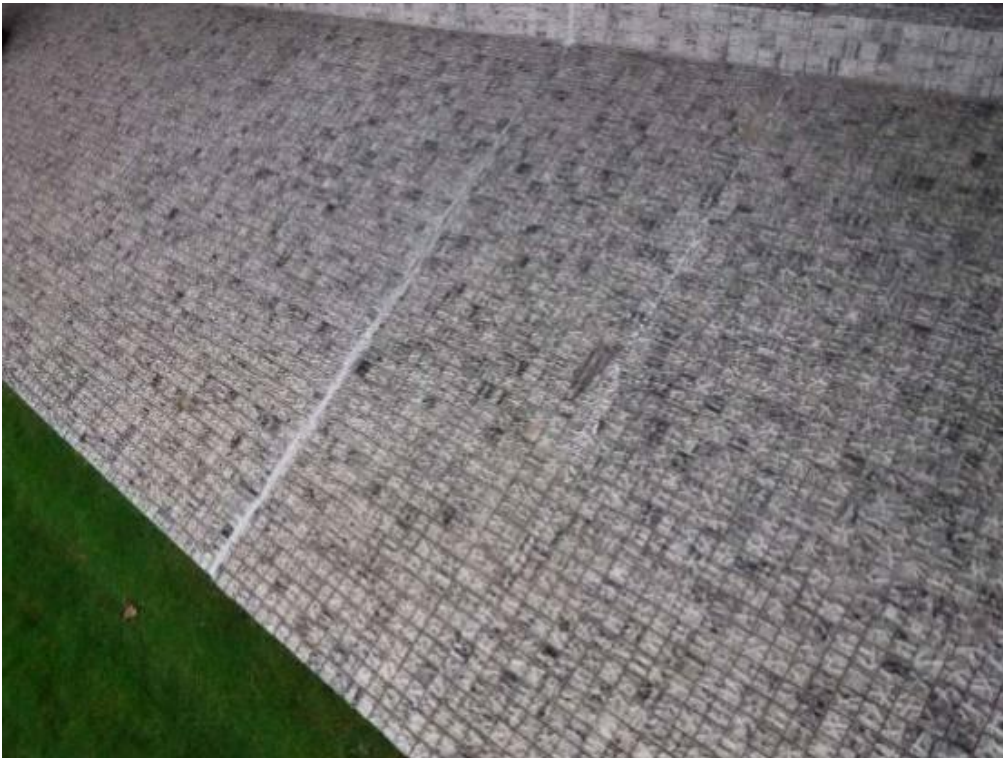
**Photo B.57: A view showing a crack in the top face of the lower cantilever (West machine hall south elevation)**

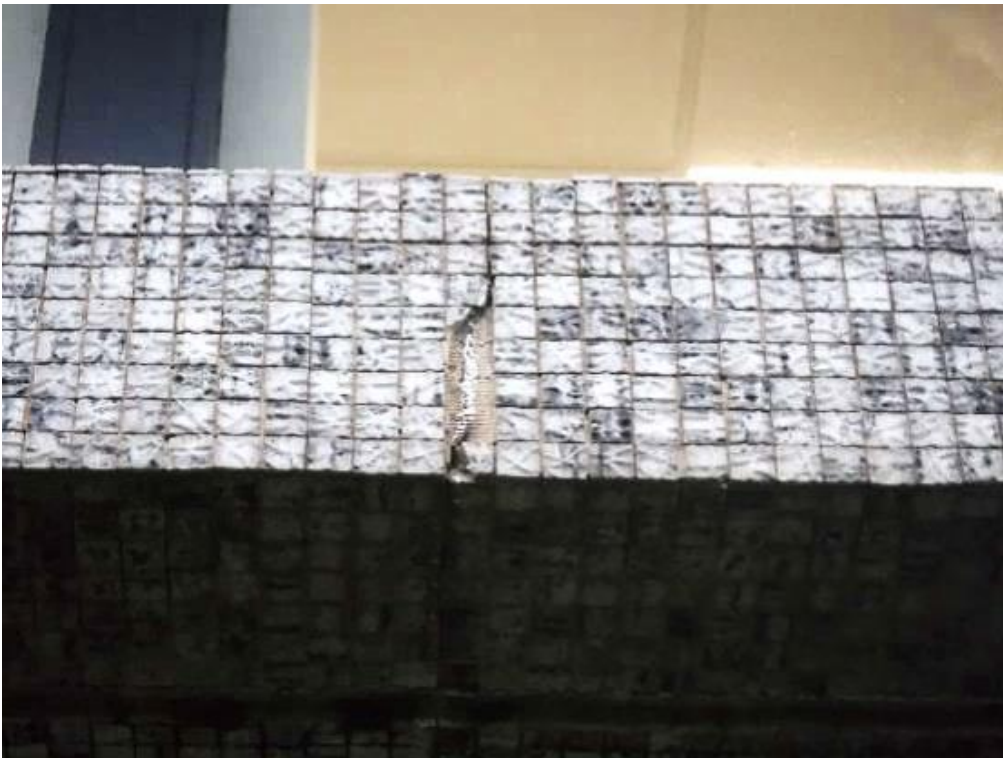
**Photo B.58: A view showing a crack in the lower cantilever elevation (West machine hall south elevation)**

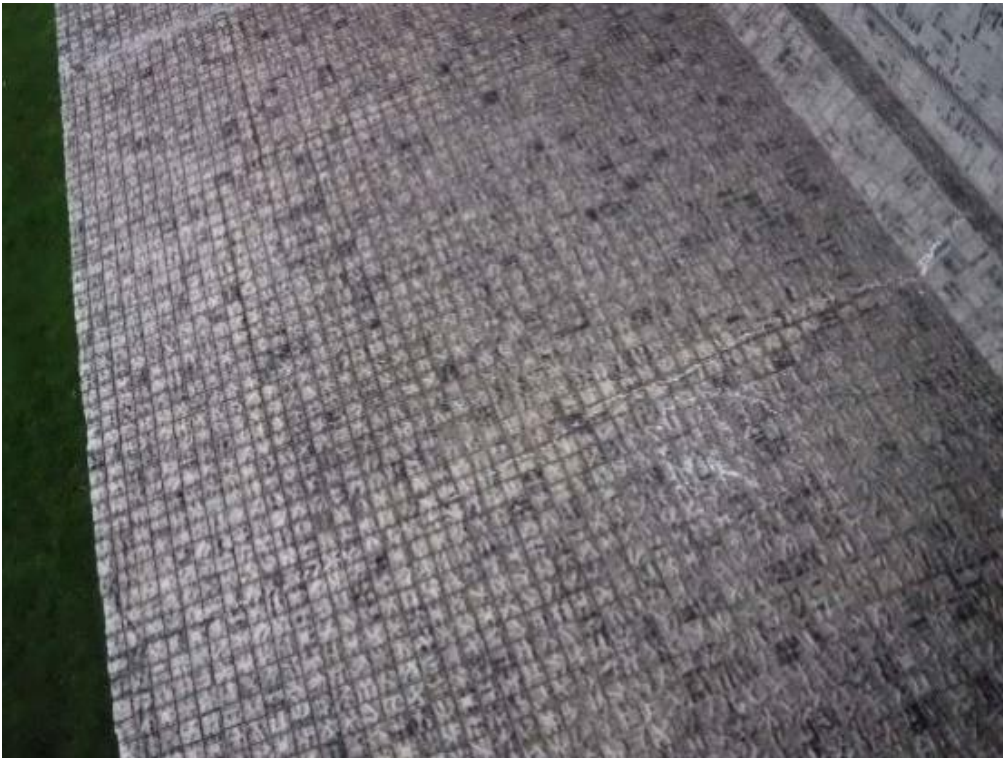
**Photo B.59: A view showing a crack to the top face of the lower cantilever (West machine hall, south elevation)**

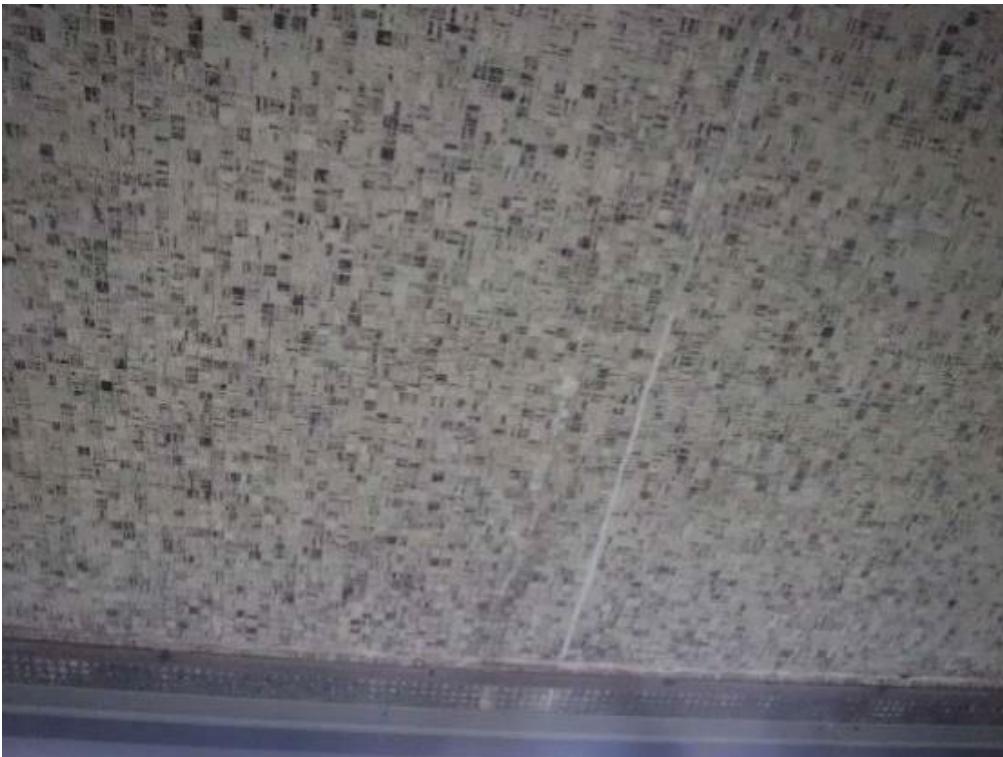
**Photo B.60: A view showing a crack in the soffit of the upper cantilever (West machine hall, south elevation)**
