**Doc Ref: 2987-01-HTN01**  
**April 2021**

**Pre-Construction Footway Condition Survey**

**Piccadilly Warehouse, Manchester**

# **Highways Technical Note 01**

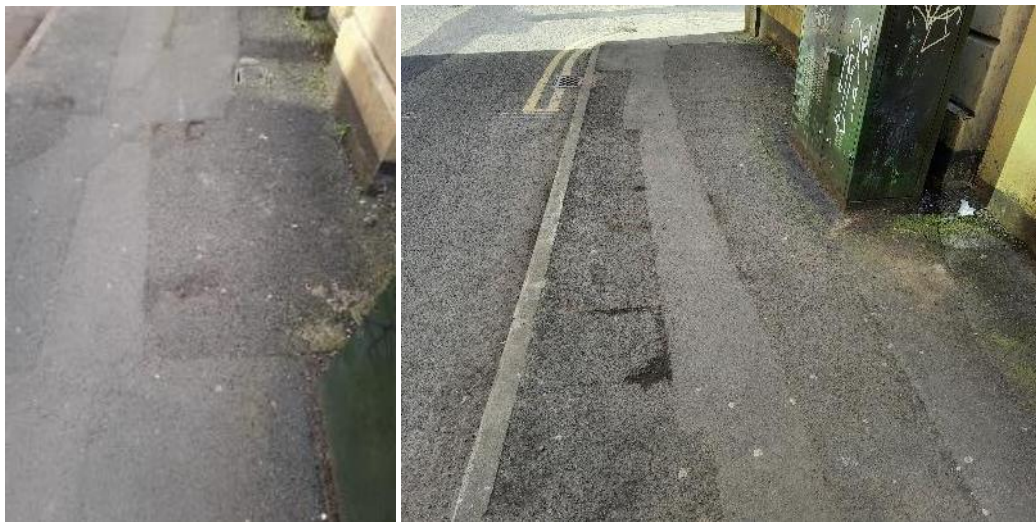
- 3.1.1 Minshull Street runs in an approximate north-west / south-east orientation along the eastern frontage of the proposed development site. The footway along the Minshull Street frontage of the site is approximately 25m long and 2m in width and is surfaced with asphalt.
- 3.1.2 There is general deterioration of the footway surface, and there is a strip of reinstated surface running along the centre of the footway for the full length of the development site, indicating where utility works have been undertaken.

**Figures 3.1 and 3.2 – Illustration of reinstated strip of footway surface**

- 4.1.2 Within the survey area there is general deterioration of the footway surface on Minshull Street, and there is a strip of reinstated surface running along the centre of the footway for the full length of the development site. There are localised areas of pitting and cracking in the asphalt surface, and patches of vegetation were observed growing from the base of the wall of the development site.

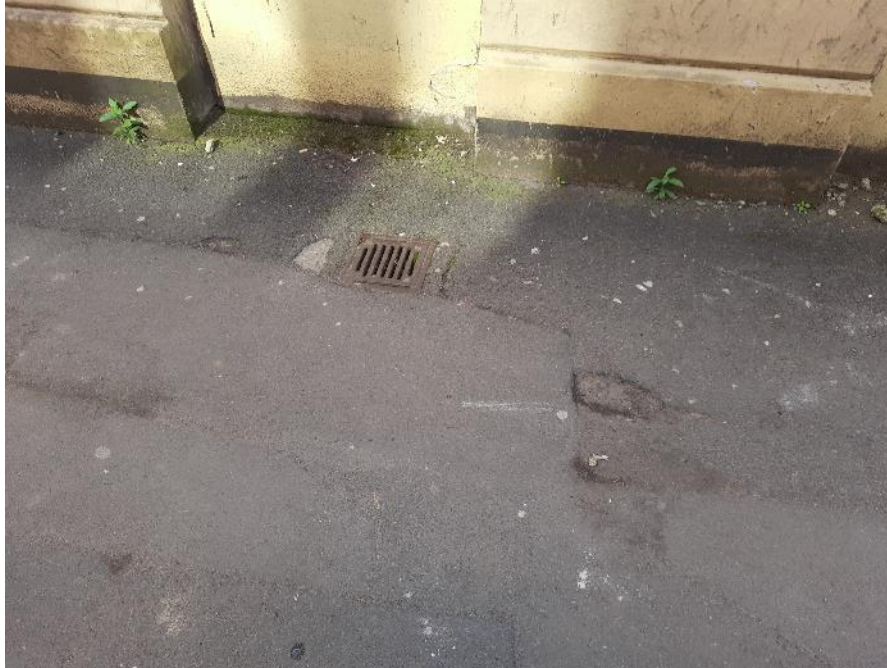
- 3.1.3 There are localised areas of pitting within the asphalt surface, and patches of vegetation growing from the base of the wall of the development site. Adjacent to the kerb at the Bloom Street junction there is a small patch approximately 1m x 0.5m in area where the asphalt surface is cracked adjacent to a service chamber and where loose short lengths of kerbstones are present on the corner radius.

**Figure 3.3 – Localised pitting in footway surface**

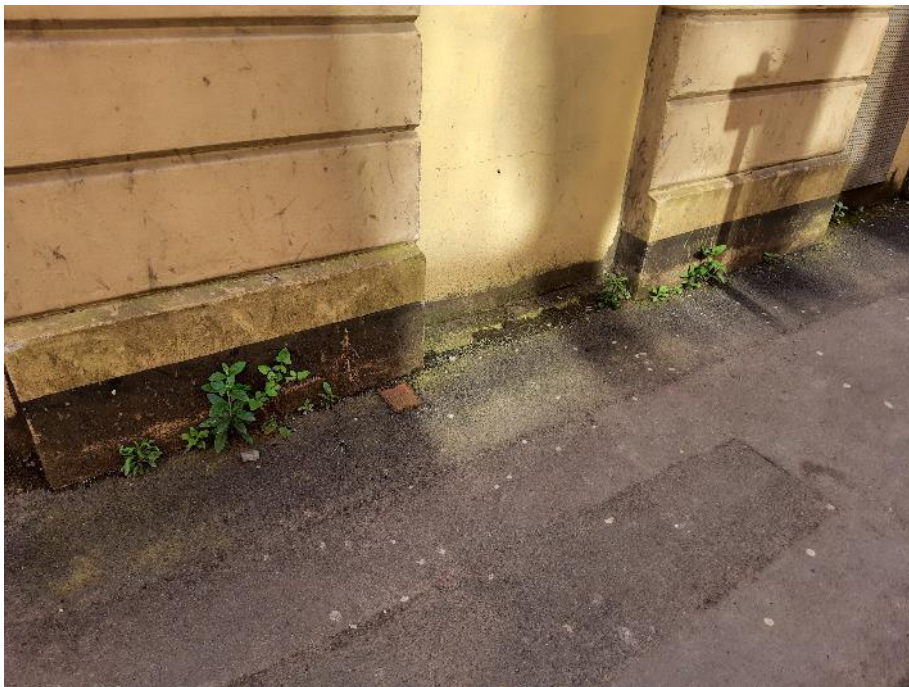
**Figure 3.4 – Patches of vegetation at base of development site**

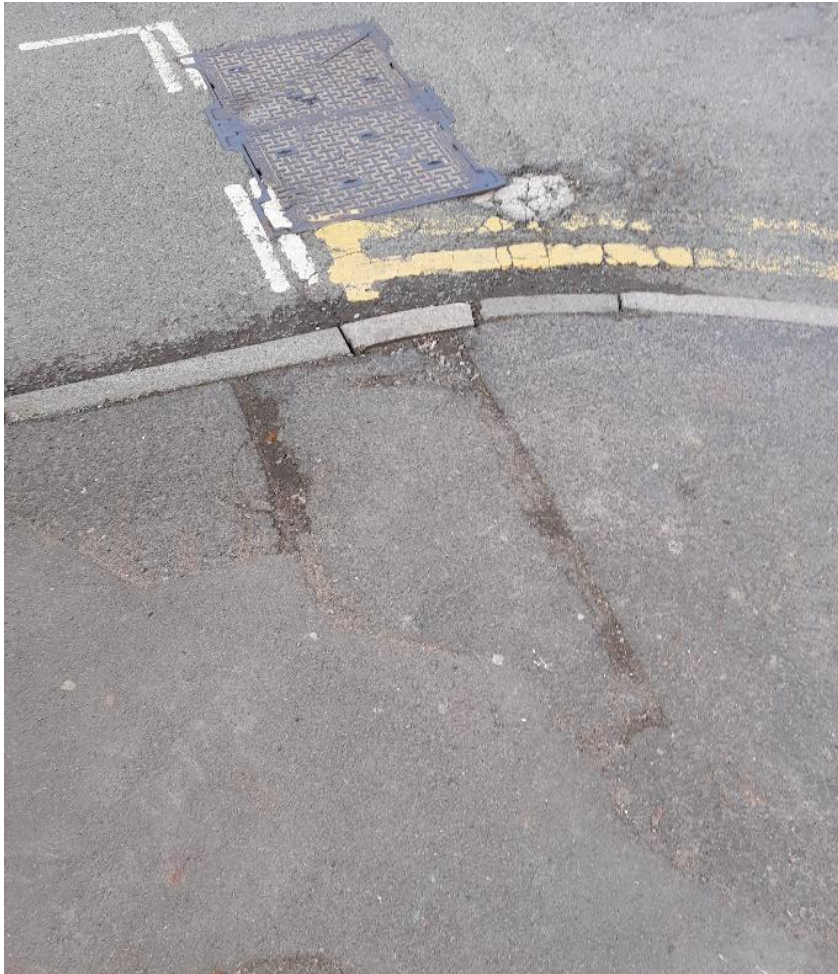
**Figure 3.5 – Area of cracked asphalt adjacent to service chamber and loose kerbstones (Bloom St / Minshull St junction)**

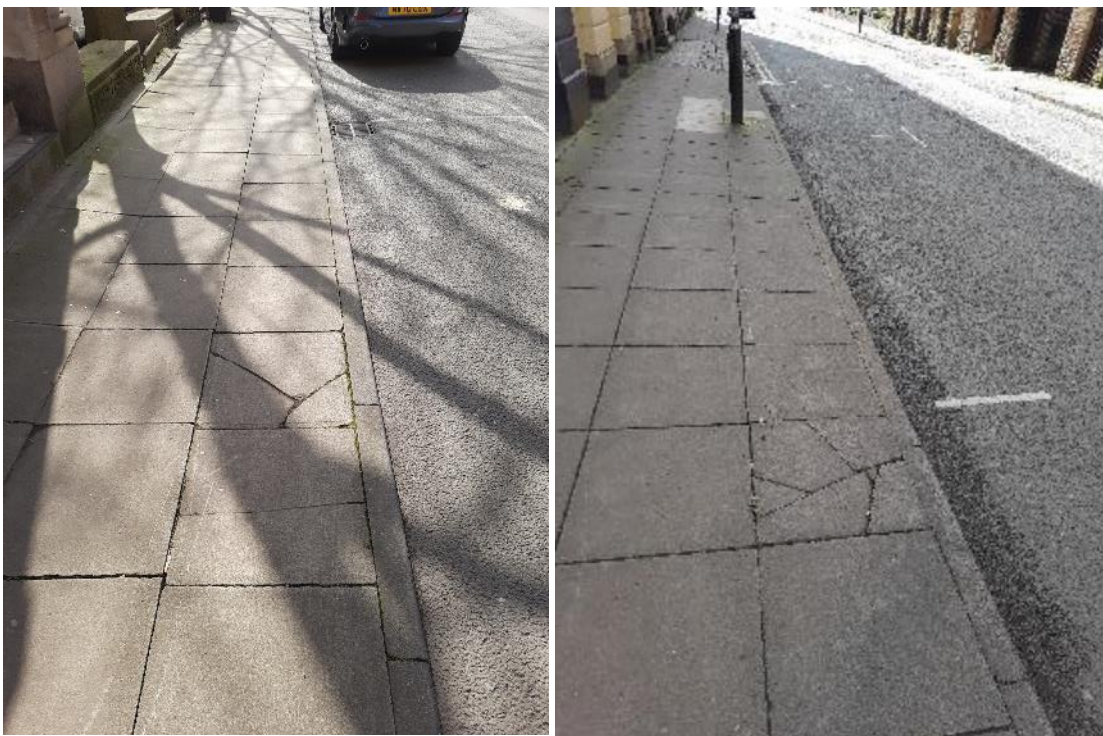
- 3.2.1 Bloom Street runs in an approximate south-west / north-east orientation along the northern frontage of the proposed development site. The footway along the Minshull Street frontage of the site is approximately 44m long and 1.8m in width and is surfaced with paving stones, with a cobbled area at the interface between the two existing site buildings.
- 3.2.2 The footway surface is generally in reasonable condition along the frontage of the development site, although the survey identified a total of 9 cracked paving stones. 6 of these were along the Mindel House frontage, with 3 along the 11 Bloom Street frontage.

**Figures 3.6 and 3.7 – Cracked paving stones alongside 11 Bloom Street (left) and Mindel House (right)**

- 4.1.3 The Bloom Street footway is generally in good condition although a number of individual cracked paving stones were observed. The edge of the footway immediately adjacent to the wall of 11 Bloom Street is raised for a distance of approximately 10m at the south-western corner of the development site.

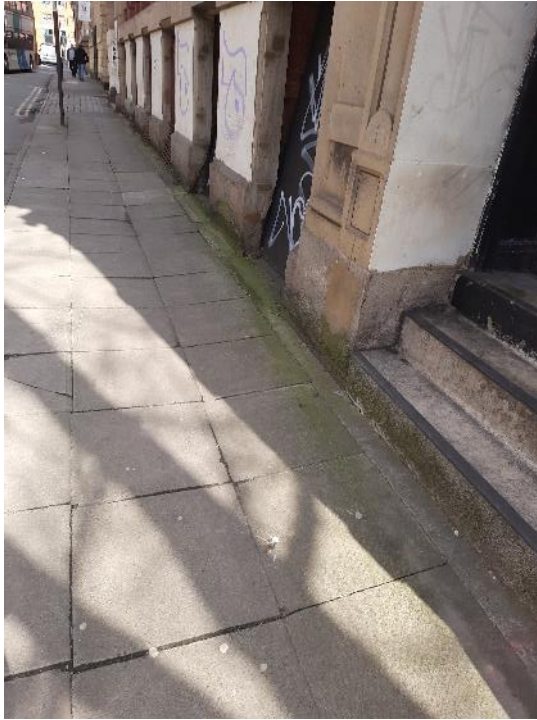
- 3.2.3 To the south-western corner of 11 Bloom Street, looking north-east along Bloom Street the right-hand edge of the row of paving stones immediately adjacent to the building is raised along for a distance of approximately 10m. There are isolated patches of vegetation growing at the base of the walls of the development site.
- 3.2.4 Where the footway crosses the gated alley that runs between the two buildings which comprise the development site, the footway is surfaced with cobblestones. No obvious defects were observed on this section of the footway.

**Figure 3.8 – Raised edge of paving stones alongside 11 Bloom Street**

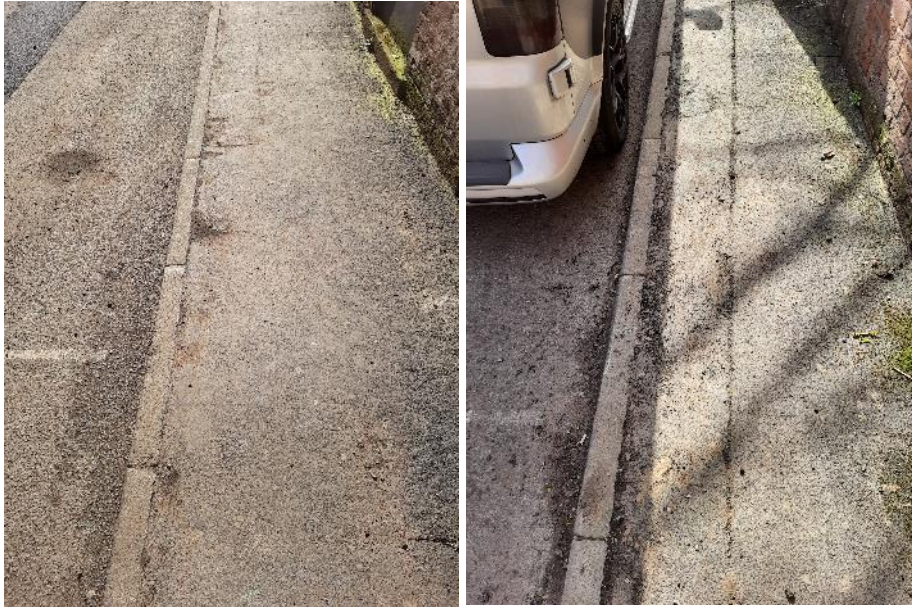
- 3.3.3 There is cracking in the asphalt along the edge of the kerb line in several places alongside both Mindel House and 11 Bloom Street. At the south-west corner of 11 Bloom Street there is a crack in the asphalt along the centre of the footway which extends for approximately 3m.

**Figures 3.9 and 3.10 – Damage along edge of kerb adjacent to Mindel House (left) and 11 Bloom Street (right)**

- 4.1.4 The footway along Richmond Street appears generally discoloured, with damage along the edge of the kerb in several places and a crack in the asphalt along the centre of the footway at the south-eastern corner of the development site. There is a missing kerbstone on the northern side of the gated alleyway between the two buildings, and some of the utilities outlet covers are damaged.

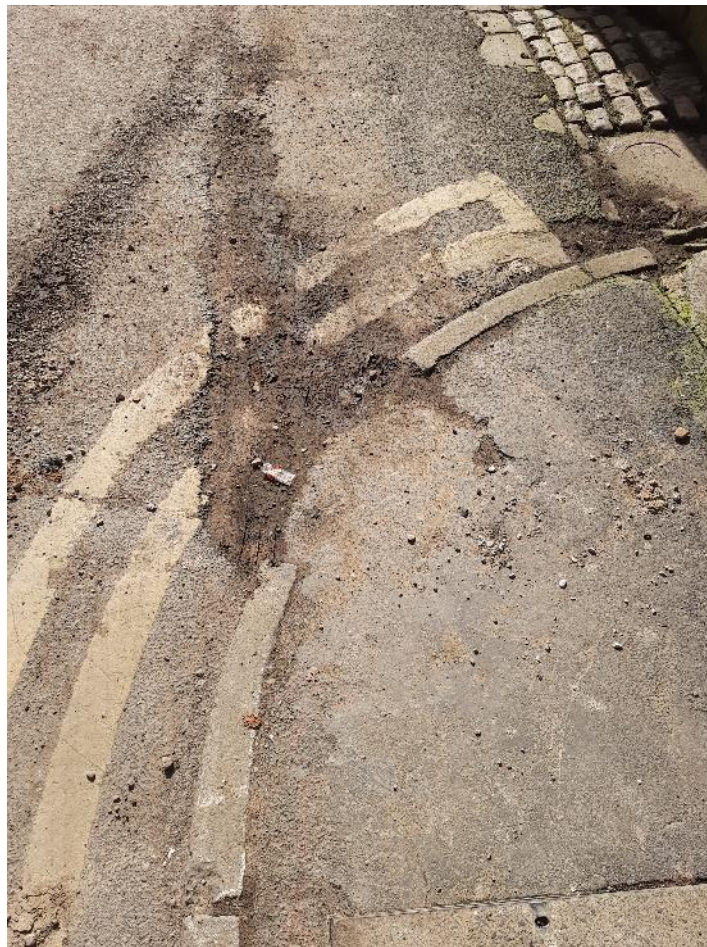
- 3.3.4 Patches of vegetation were observed growing at the base of the walls of the development site along Richmond Street.
- 3.3.5 There is a missing kerbstone on the northern side of the footway where it crosses the gated alleyway between Mindel House and 11 Bloom Street.

**Figure 3.11 – Missing kerbstone on Mindel House side of gated alleyway and surface gouging**

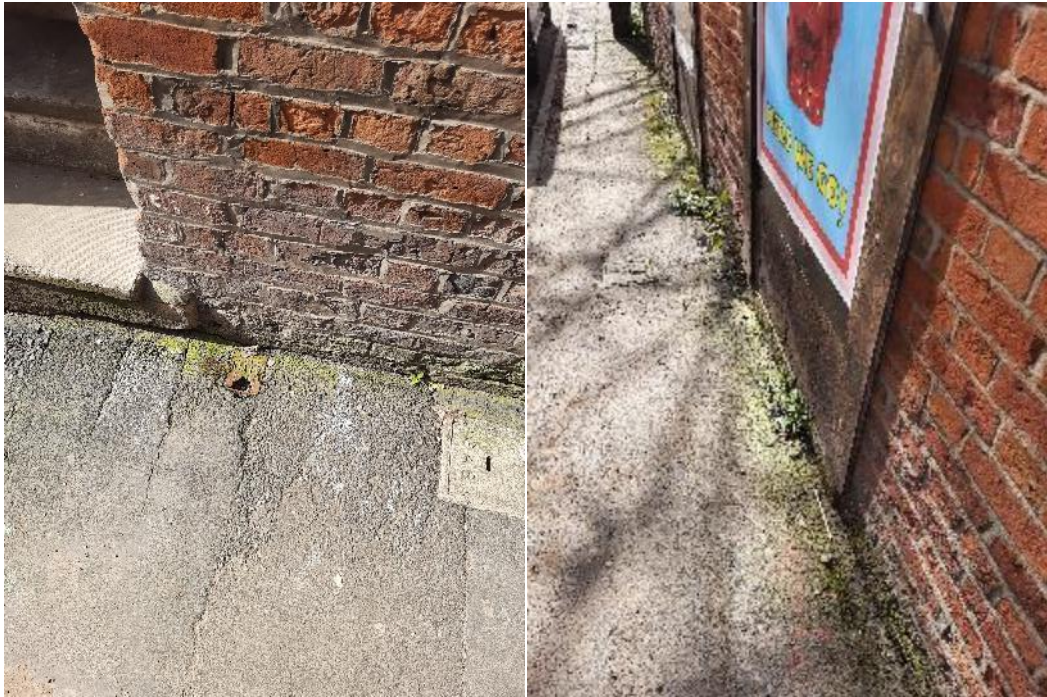
- 3.3.6 There is a broken cable pit access cover at the base of the wall of Mindel House, and two gas main access covers are cracked adjacent to 11 Bloom Street.

**Figures 3.12 and 3.13 – Damaged cable outlet (left) and gas manhole cover (right)**
