Wythenshawe Hall

PROJECT TITLE  
Wythenshawe Hall - Refurbishment Works

DRAWING TITLE  
Ground Floor - Tenant Hall / Suite Area A0/36 - Proposed Works

DRAWING NO. MCC-B01-01-DR-B-0019

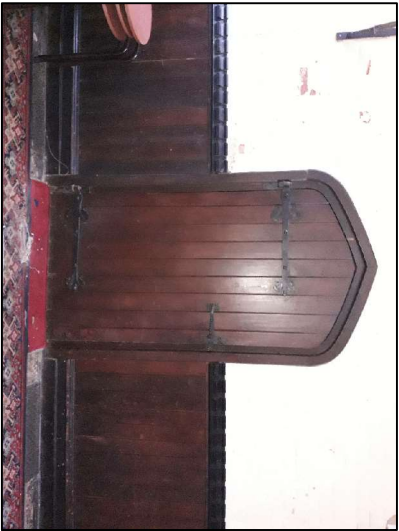
P50 - View of Tenant Hall / Suite A0/36. To plane the bottom of the door which is causing damage to the carpet area when opened and closed.

Adjustment to D5 - To ease and adjust Door D5 which is causing damage to the carpet at the threshold of the door. Allow for removing the door, reducing the bottom edge of the door and rehanging. Ensure the door opens freely and has secure closing.

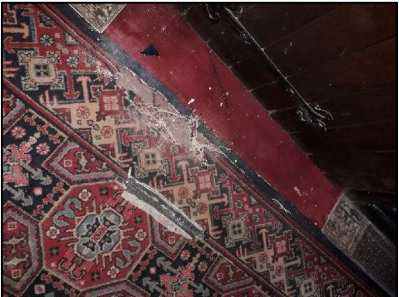
P51 - View of Tenant Hall / Suite A0/36. To carry out repairs to damaged section of carpet at threshold of doorway.

Threshold of Door D5 - Where damage has been caused to the section of carpet at the threshold of Door D5. Allow for appointing a specialist carpet repair company to assess the damage to the carpet and give recommendations for the best method of repair. See ID Risk Item.

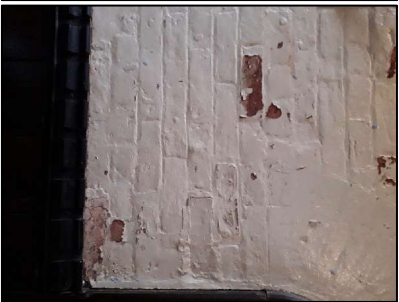
P52 - View of Tenant Hall / Suite A0/36. To remove flaking paint finish to section of brick wall to left hand side of doorway. To prepare surface prime / seal and repaint all brickwork to the hall.

Redecoration Works to Previously Painted Brick Walls in the Tenant Hall / Suite Area A0/36 - To carry out all necessary preparation works to remove flaking paint / friable surfaces. To fill in any holes / cracks with an appropriate filler. Seal new or bare surfaces with a tinned first coat of Absolute Matt Emulsion as manufactured by Little Greene Paint and Paper, all in accordance with manufacturers instructions. To apply 2No. finishing coats of Absolute Matt Emulsion to all painted brick wall surfaces within the hall.

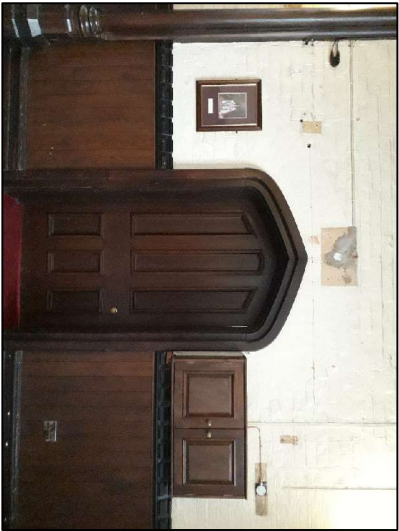
P53 - View of Tenant Hall / Suite A0/36. To make good holes in brickwork following removal of redundant electrical equipment. To prepare wall surface and redecorate all painted brickwork.

Redundant Holes - Following previous removal of redundant electrical fixtures above Door D6, to fill remaining holes in the brickwork ready for redecoration. Include for using a coarse lime putty mortar mixed 3/1 (sand : lime) ratio.

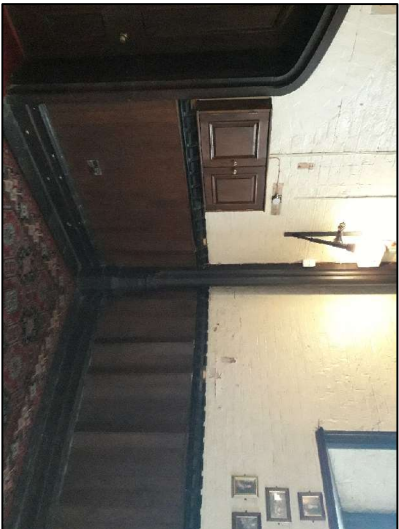
P54 - View of Tenant Hall / Suite A0/36. Timber T & G handling below dado rail has blown outwards due to damp penetration from historic defective external downspout. To refix 16No. loose vertical boards.

Defective Vertical T & G Boarding - On the rear elevation gable end wall, there has been some damp penetration in the corner from a faulty external R.W.P. The dampness has caused some vertical T & G boarding below the dado rail to blow outwards. Allow for refixing 16No. vertical timber boards.

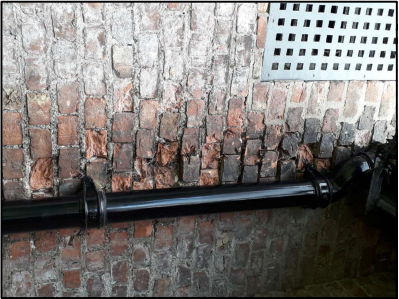
P54b - Rear Elevation gable end wall, defective brickwork joints to be repointed in a lime mortar.

Defective Mortar Joints to Exterior Wall - On the rear elevation gable end solid wall, erosion has occurred of the mortar joints due to a historic defective R.W.P. The defective rainwater goods have since been replaced but the defective mortar joints require making good. Allow for repointing 150m2 of external brickwork in lime mortar.

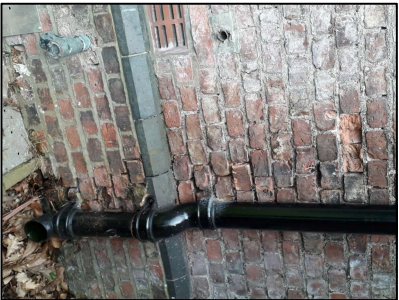
P54c - Rear Elevation gable end wall, defective brickwork joints to be repointed in a lime mortar.
